ENGINEERING REPORT 9682

**GARAGE CONVERSION
1 STRAITS LANE
READ
BURNLEY
BB12 7PE**

CLIENT: ROGER HINDLE FINANCIAL SERVICES LTD

04.10.2024 MP/CH

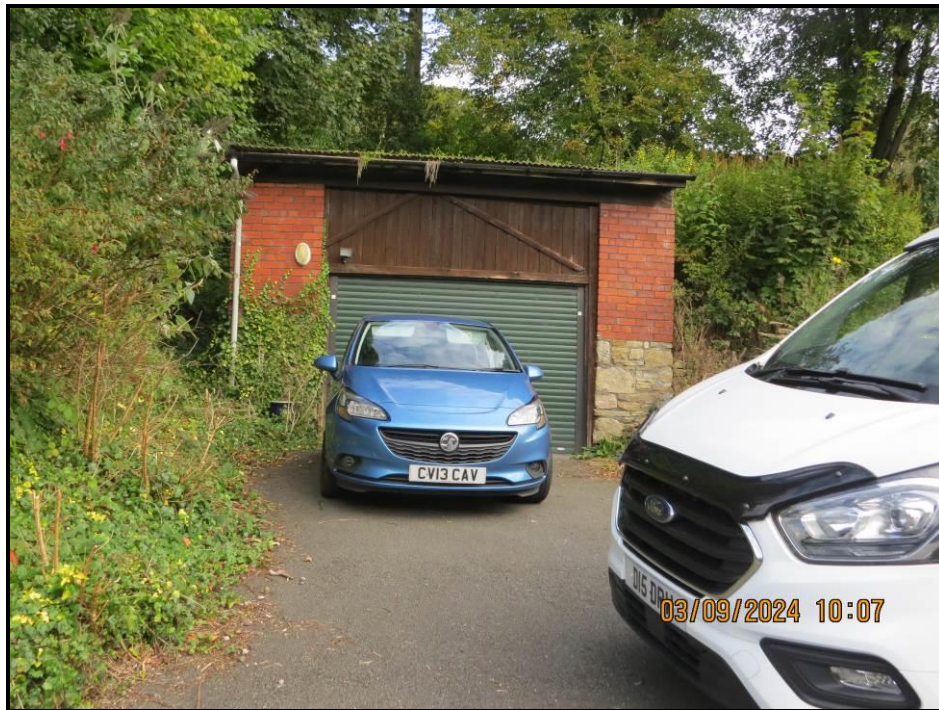
001 Front elevation

- 3.1 The garage extends for a width in the order of 8 metres incorporating 1 metre wide pillars on either side of the roller shutter doorway, the pillars incorporate natural stone plinths 1200mm high with upper brickwork panels in garden wall bond for a further 1.8 metres to eaves level. (Photographs 001, 004).

- 3.2 The pointing to both the stone and brick facing is good, and the vertical and horizontal profile of the pillars is good.
- 3.3 The fascia above the door opening is completed in a vertical 150mm wide boarding with softwood timber bracing beneath the timber door lintel. (Photographs 002, 003).
- 3.4 The asbestos sheet roof projects forward of the front elevation in the order of 600mm with a front gutter discharging to the downspout on the left hand (South West) corner.

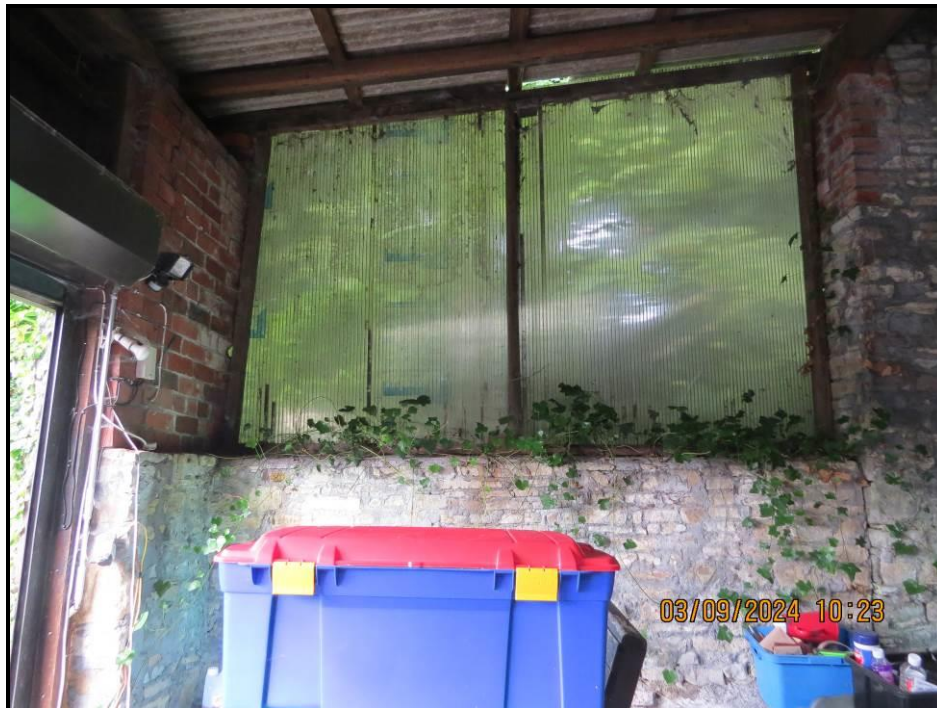
005 Double panel window, Western flank wall

- 4.1 On the rear North West corner of the Western flank wall localised irregular coursing is evident (possibly resulting in the internal 1200mm x 1200mm brickwork buttress evident internally on the North West corner). (Photographs 005, 030, 031, 032).

- 5.1 The South West corner is constructed with a stone plinth approximately 1.8 metres high to the underside of the cill level of the double panelled Perspex window. The stone wall is seated on a variable section concrete plinth approximately 400mm – 500mm high x 600mm wide. (Photographs 005, 006, 027).

- 9.2 The windows to the external section are of a modest construction and will no doubt be replaced during the conversion as will the Asbestos cement roof.

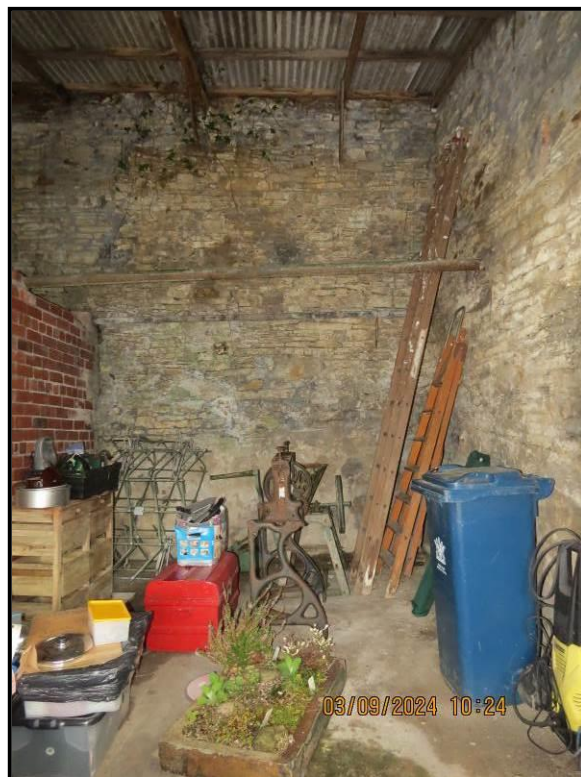
010 North East corner, rear/flank

- 6.2 There are no visual signs of any separation or lateral movement between the rear wall and the return Western and Eastern flanks. (Photographs 008, 010, 011).

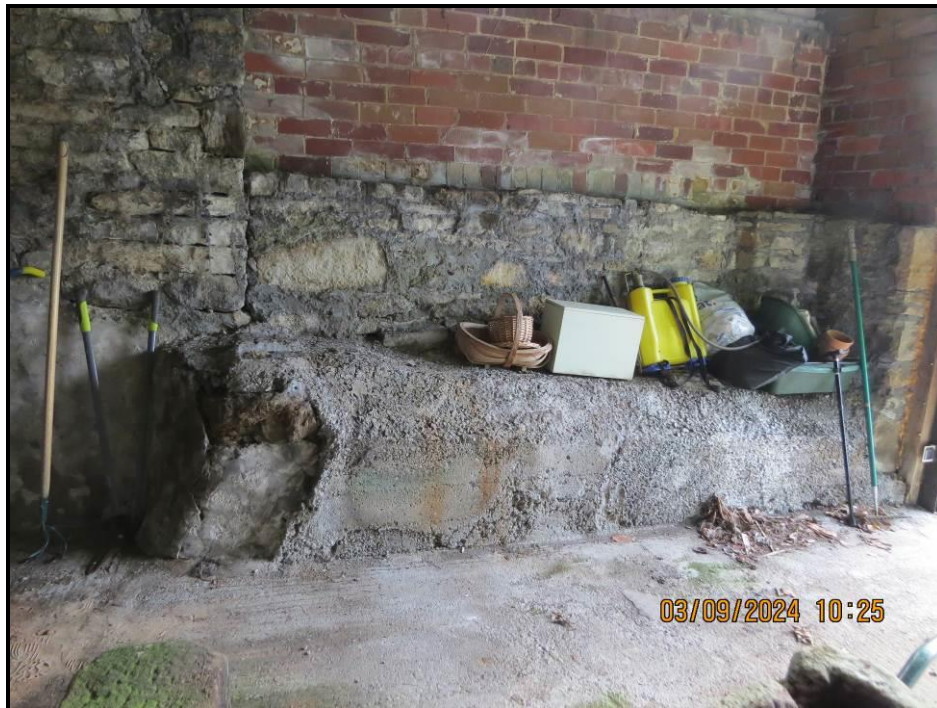
015 Masonry plinth construction, chainage 0 – 3 metres (East)

- 7.1 The Eastern flank extends to the left hand window reveal, the window reveal (repaired) is a mixture of stone and brickwork. The overall profile of the wall is reasonable with some historic minor internal bowing, evident where the steel struts have been provided to give lateral bracing between the Eastern and Western flanks, at a height of around 2 metres above floor level. (Photographs 011, 012, 015, 023).

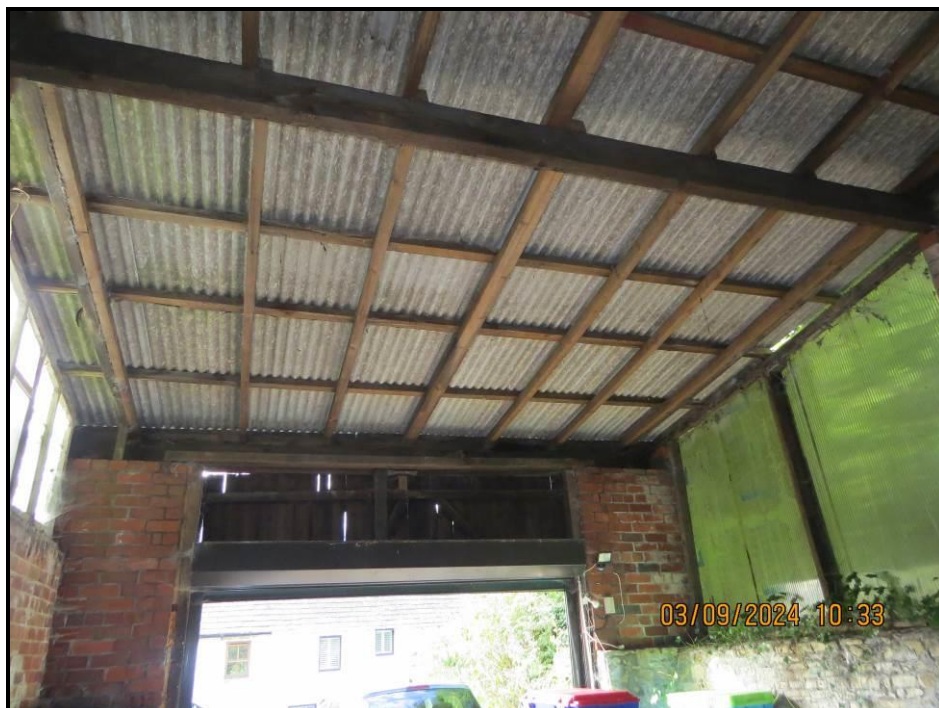
021 Roof – general arrangement

- 8.1 The roof to the unit is completed in small 6 Asbestos cement supported on a purlin/rafter roof construction with satisfactory profiles for the current loading. (Photographs 021, 022, 026).

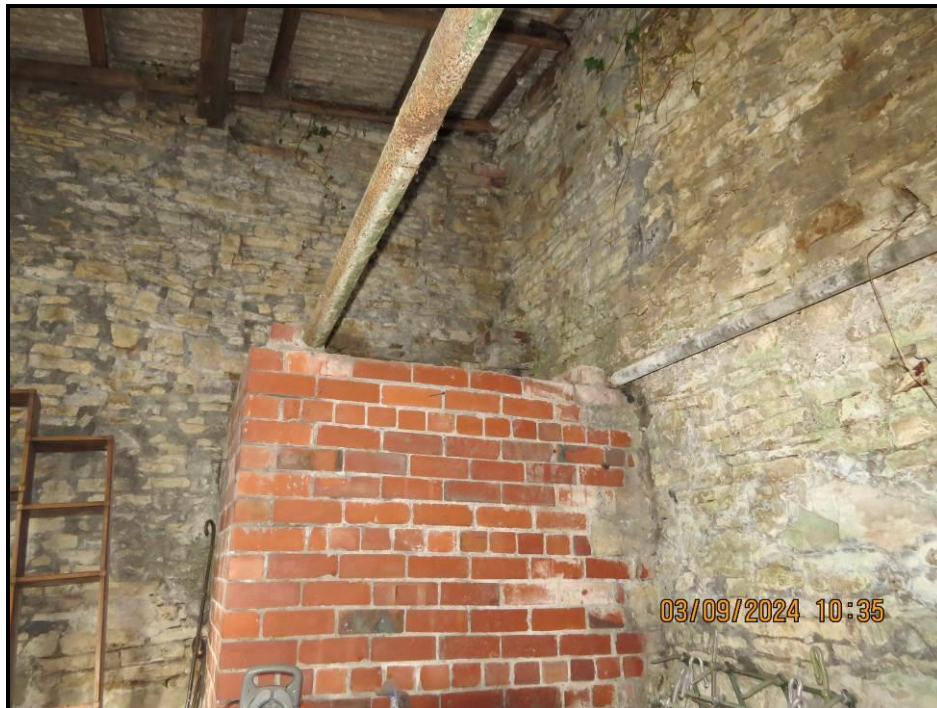
024 Buttress support to steel struts

- 5.5 The buttress also provides support with 75mm diameter metal struts spanning between both flank walls. (Photographs 024, 032, 034, 035).
