## **Barn 1 at Writtenstone Farm, Writtenstone Lane, Longridge, PR3 2ZN**

### **Structural Condition Survey for Conversion to Dwelling**

PSC-859 – B1

February 2024

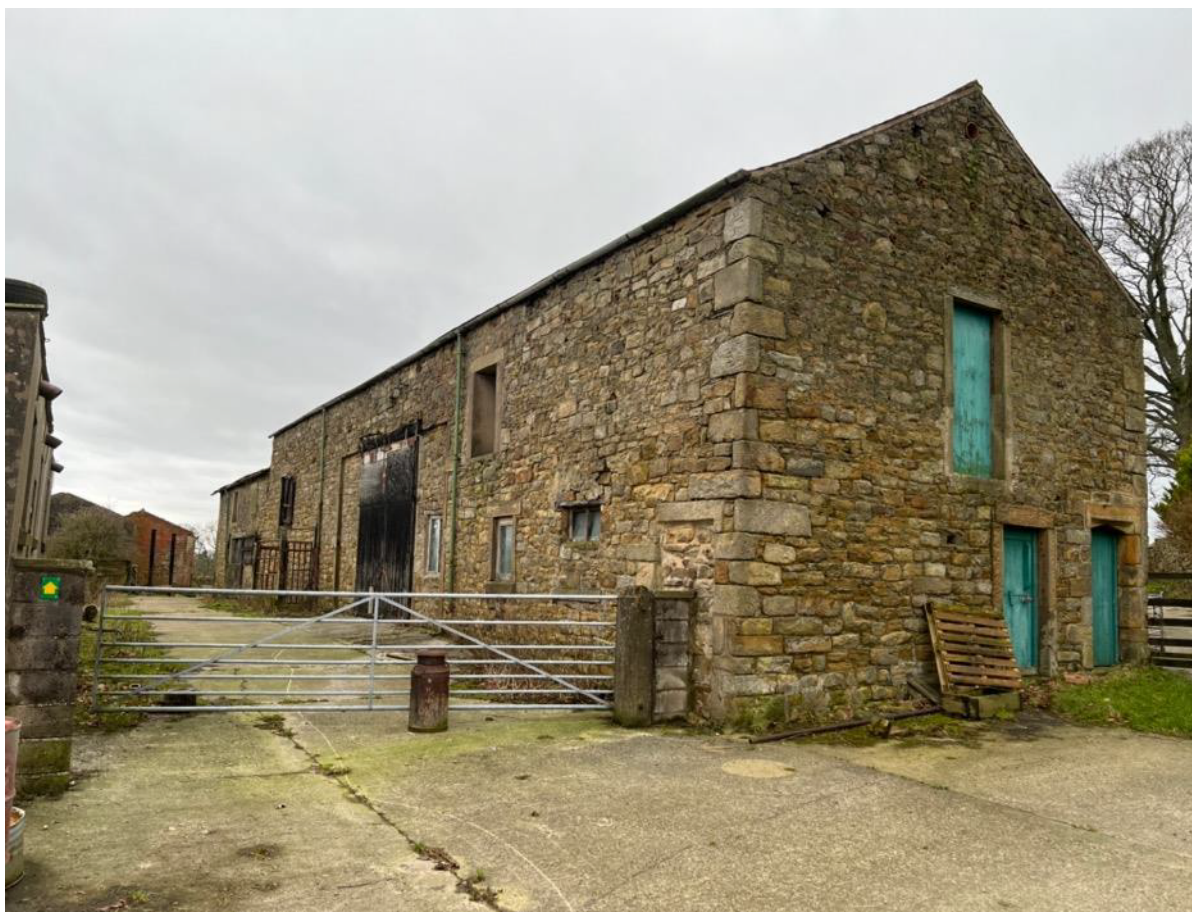
Photo 1 - South East and North East Elevations

level together with the large main barn door (photos 1 to 6). A further door opening at the north east end has been blocked up (photo 2). There are 2 further openings at a higher level, giving access to the loft areas of the barn. The main barn door has a recessed area of stone to accommodate the sliding doors (photos 4 to 6). This section of the elevation has the benefit of guttering and downspouts which are in a poor condition.

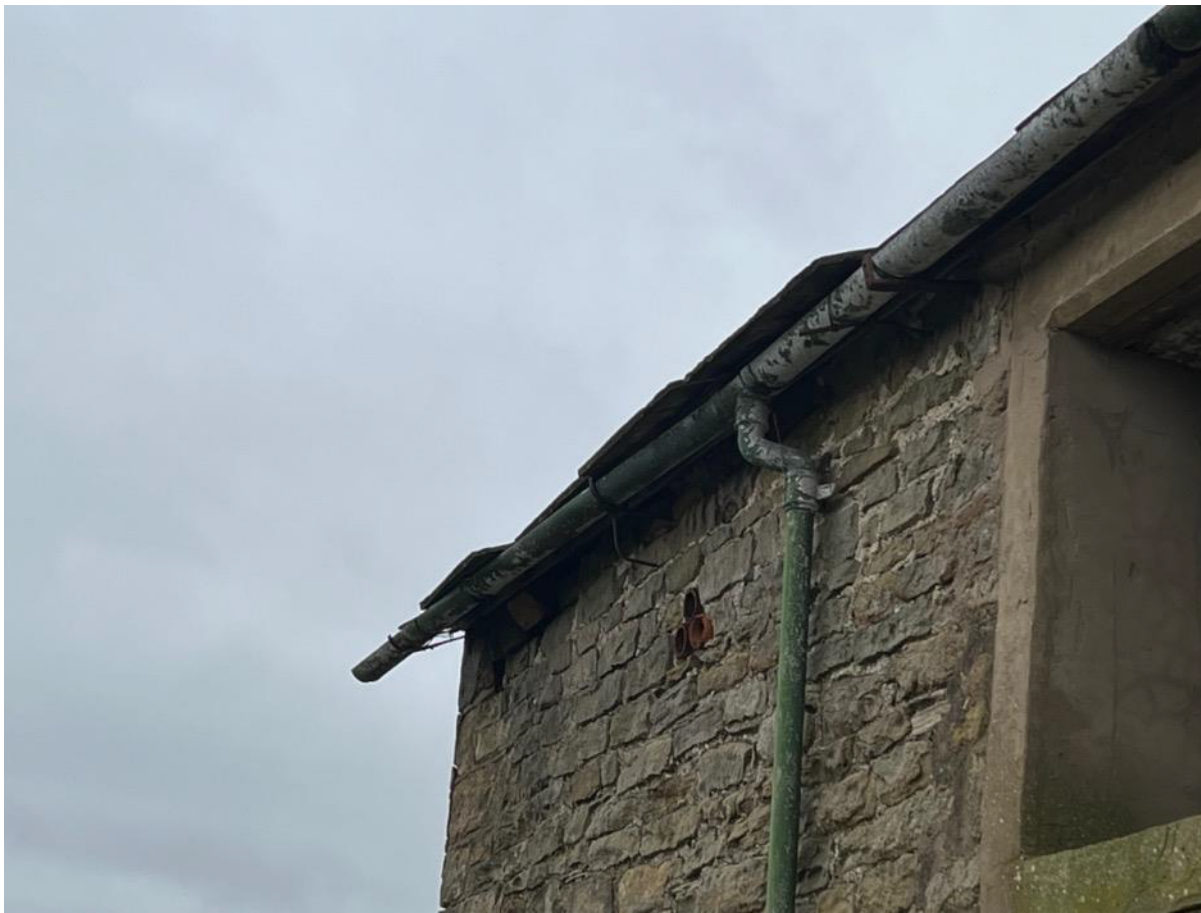
The smaller section of barn to the south west has a single large door opening at ground floor level and 2 further openings at a higher level giving access to the loft areas of the barn (photo 10). There are also further vents at a high level formed by field tiles (photos 10 to 12 & 14). The south west corner of the elevation has been rendered at the lower levels and this may indicate some previous damage underneath caused by vehicular collisions (photo 14). This section of the elevation has the benefit of guttering and downspouts which are in a poor condition.

Photo 12 - South East Elevation – west section showing flags to roof

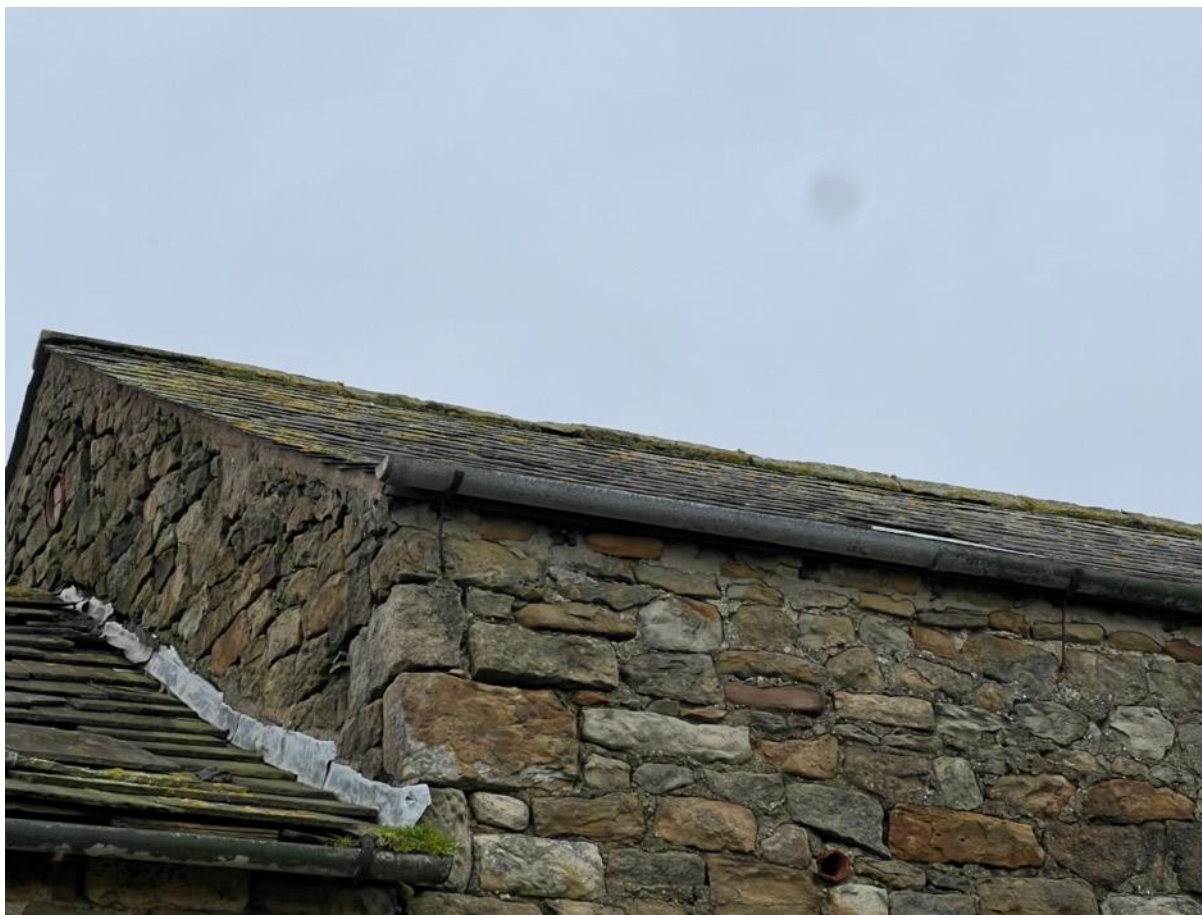
Photo 14 - South East Elevation – west section

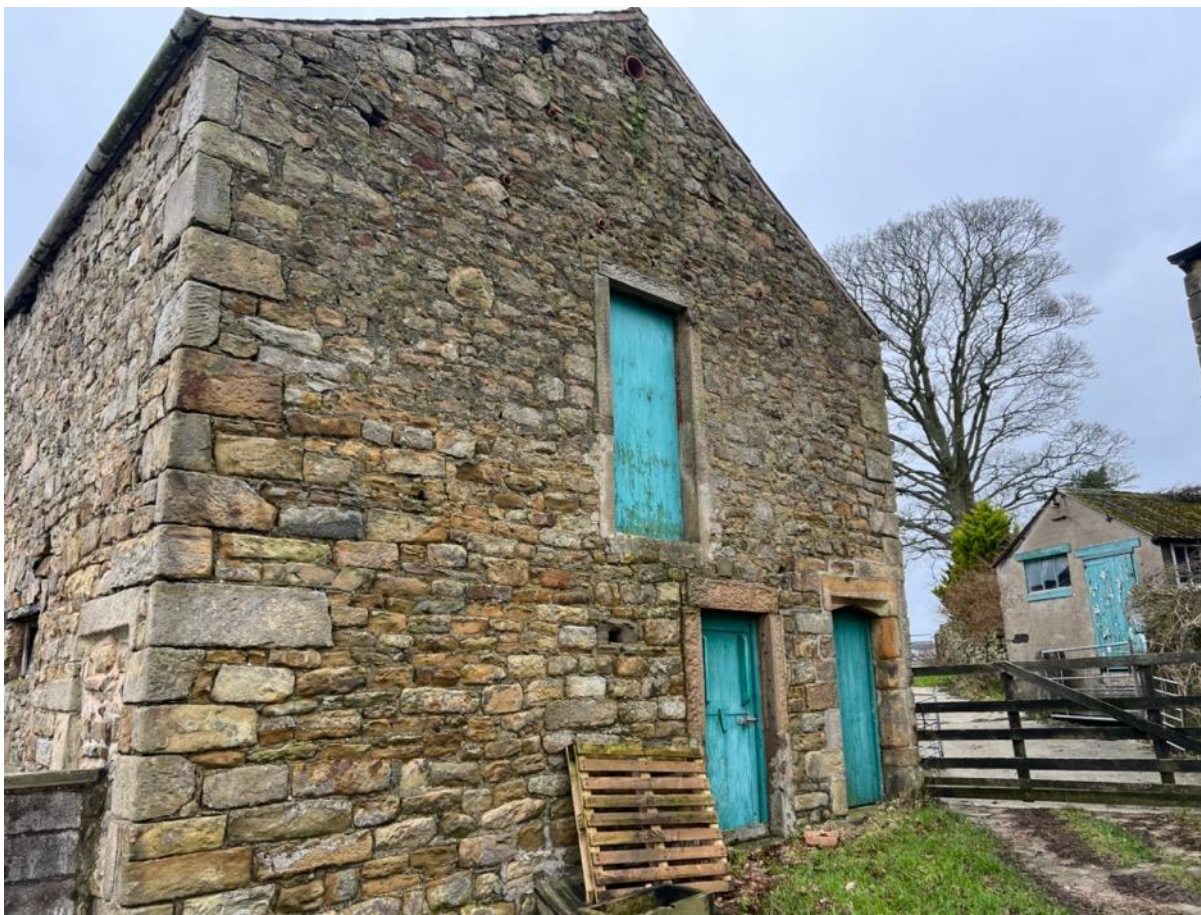
This wall is a 500mm thick random stone wall with two door openings at ground floor level and an upper door opening to the loft area (photo 28). There are several vents at a high level formed by field tiles (photo 28). The wall is plumb, reasonably well pointed and free from signs of movement. As with the south west gable it can be seen that the ground rises along this elevation towards the rear.

Photo 28 - North East Elevation

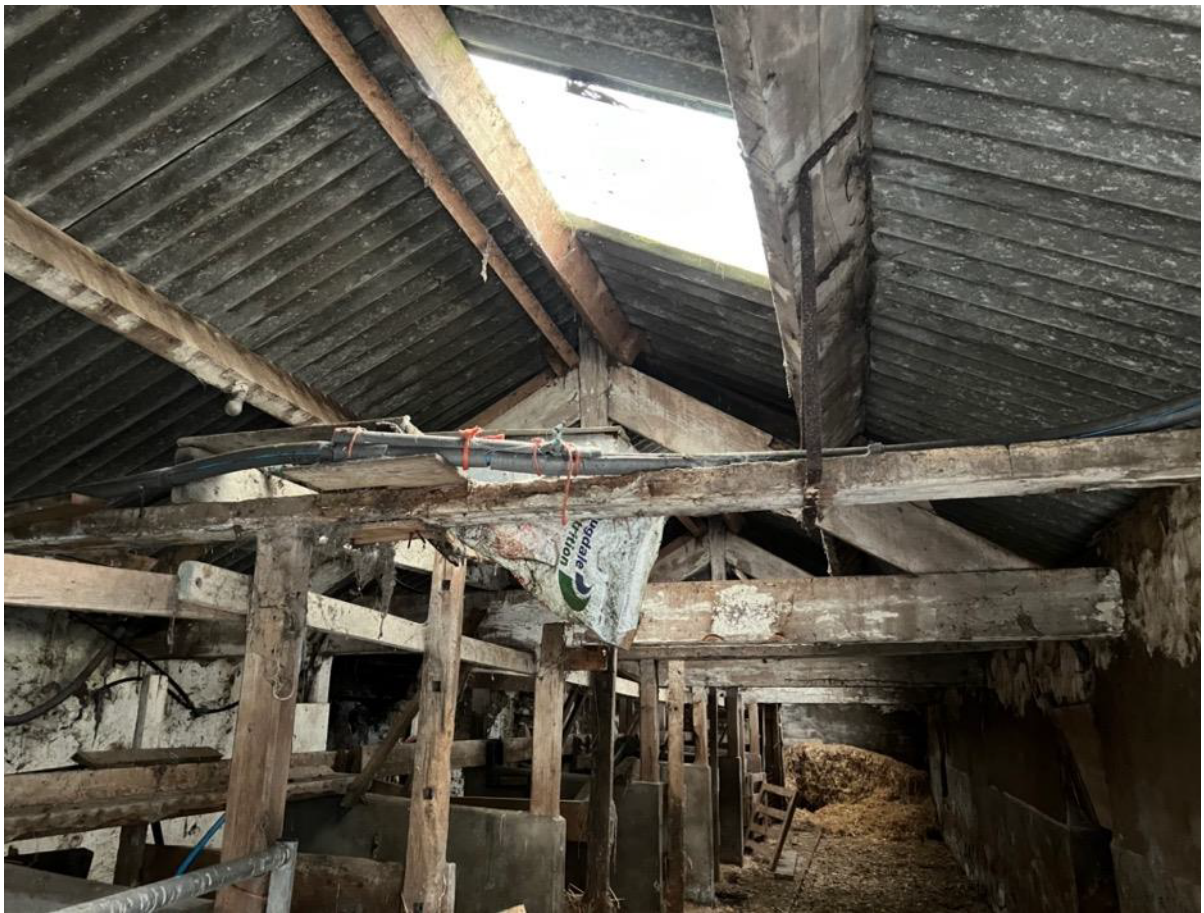
Photo 32 – Internal rear shippon

This section of the building is a full length shippon with a solid concrete floor (photos 32 & 35). The building shows no sign of previous or ongoing movement to walls or floors. The roof structure is of a timber construction with timber purlins and trusses (photos 32 to 35). There is evidence of damp/rot to the structural timbers but this is not extensive and likely to be treatable. Photo 37 shows an internal opening made in the rear wall of the main barn to provide access. The lintels are steel universal beam sections and these are in reasonable condition.

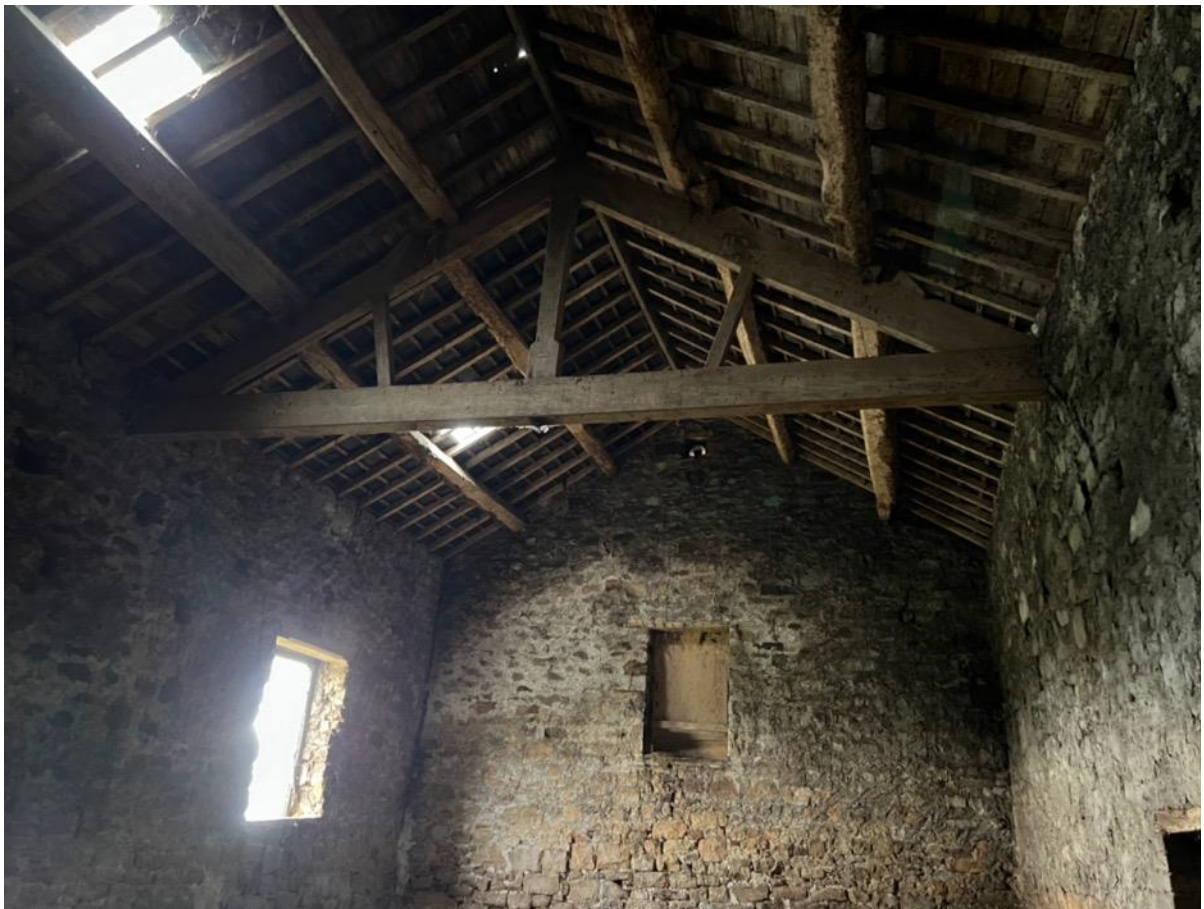
Photo 38 – main barn east

This largest area of the barn is full height at the south west end (photo 38) and has a loft area at the north east end (photo 42). The ground floor is concrete with the loft area constructed in timber. Internally, there is little or no sign of previous or ongoing movement to the walls or floor. The timber trusses are generally in a reasonable condition with little sign of rot or infestation (photos 44 & 45). The truss to the north east end appears to be older and has some signs of

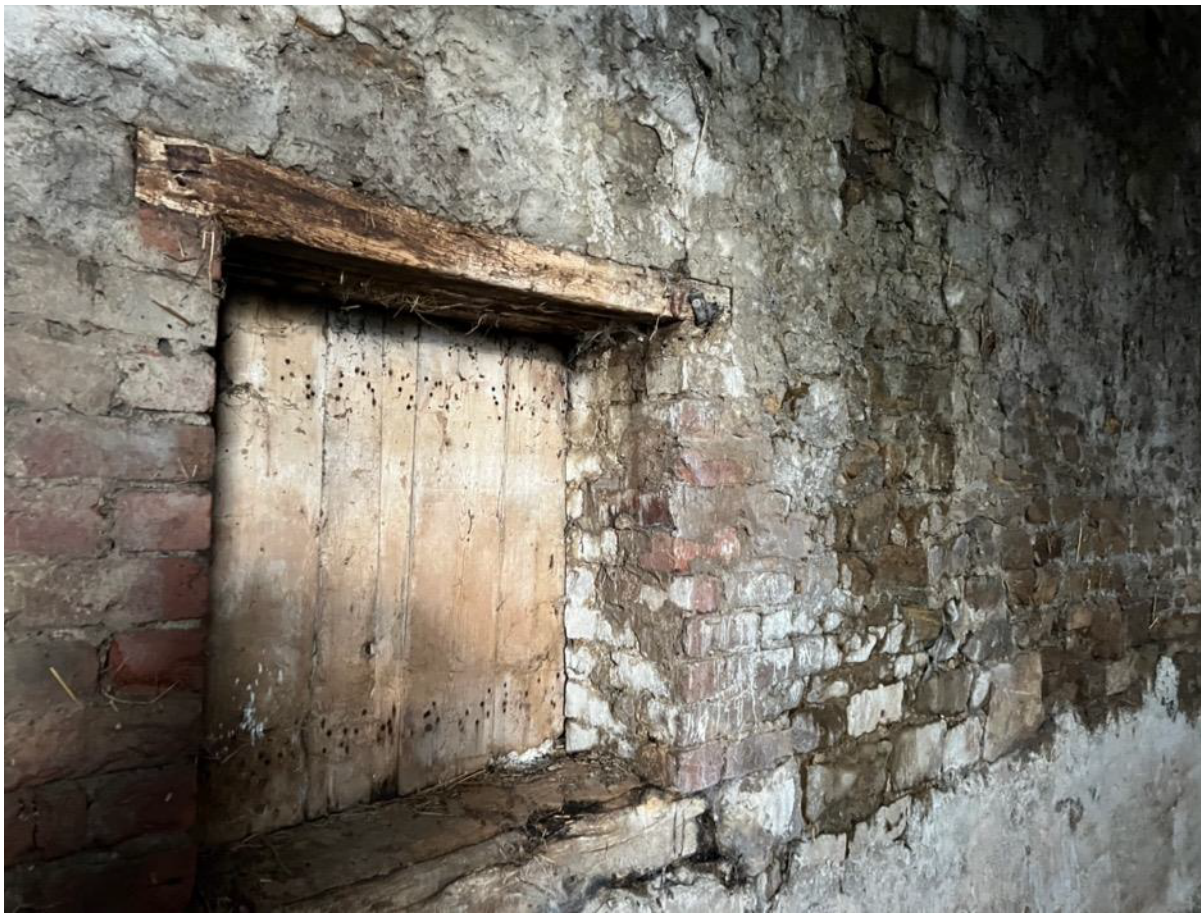
Photo 42 - main barn east

rot and/or infestation (photo 42). The slate roof can be seen to be under boarded (photo 45). The timber loft structure is in a reasonable condition with no major signs of rot or infestation.

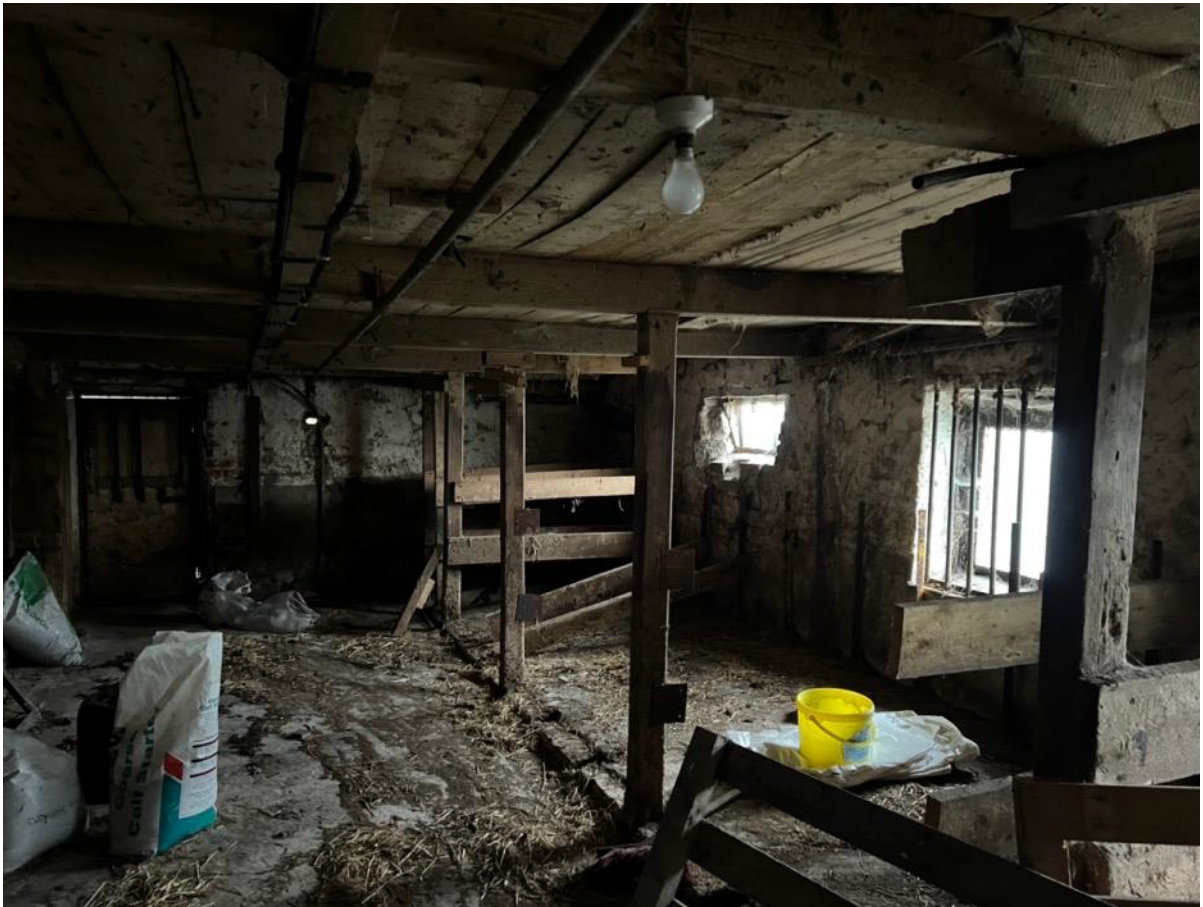
Photo 45 - main barn east – truss detail
