Barn at Park Farm, Whalley Road, Barrow, Clitheroe, BB7 9YS

Structural Condition Survey for Conversion to Dwellings

PSC-891

June 2024

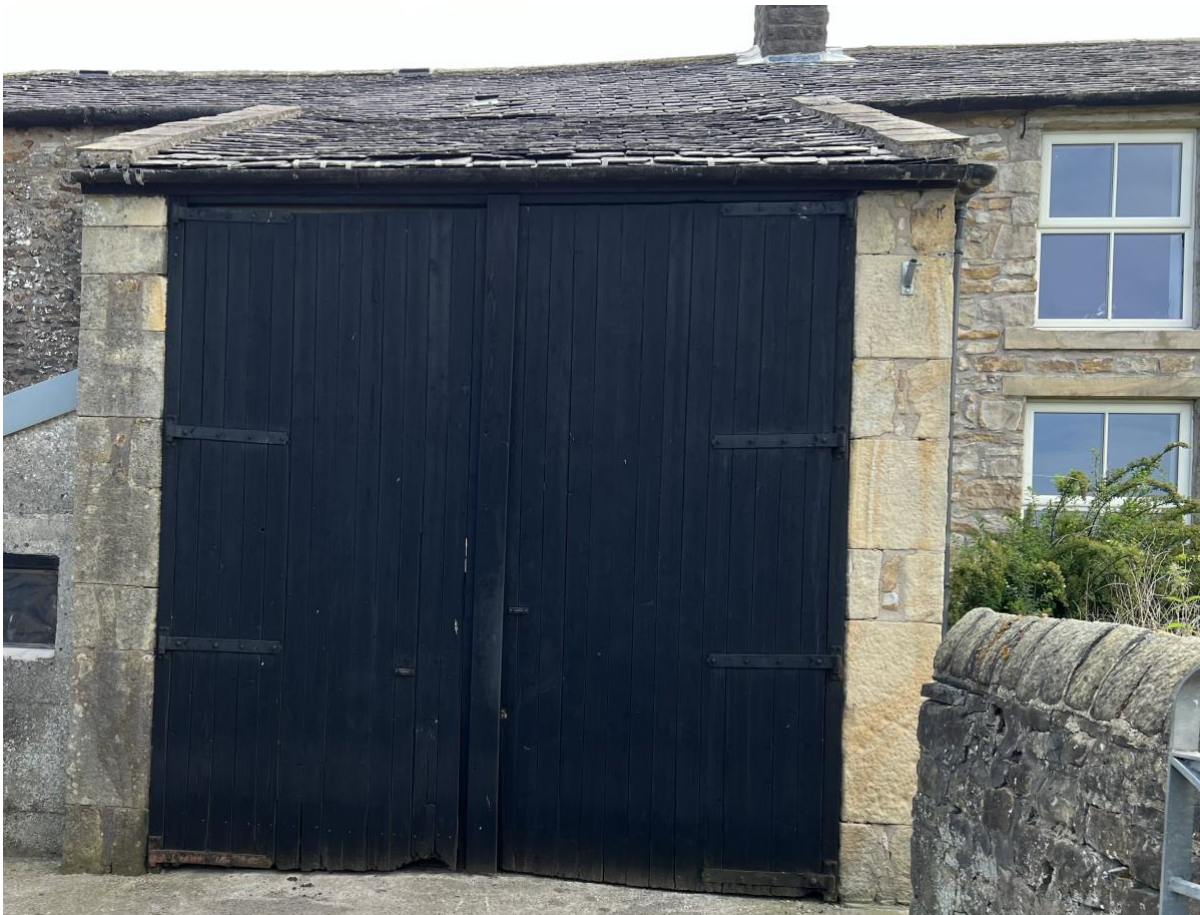
Photo 5 – South West Elevation

This elevation is built in random sandstone and the wall is 450mm thick. The wall is in good condition. It is plumb and well pointed. There are no signs of previous or ongoing movement. There are 5 standard door openings, 3 window openings and the main barn door at ground level. There are 3 openings to the loft area together with vents at first floor level (photo 6).

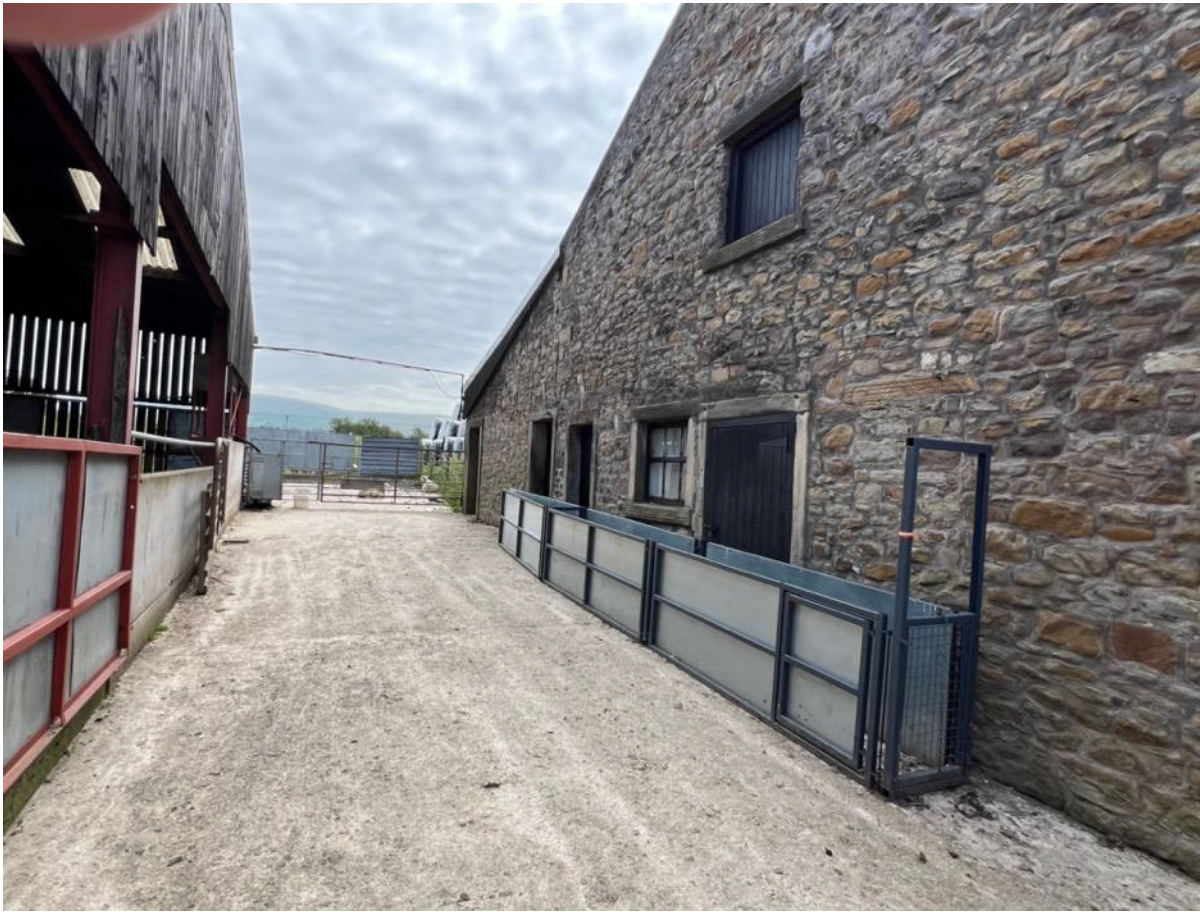
Photo 10 – North West Elevation

This elevation includes the gable to the main barn and the single storey outrigger to the rear of the barn (photo 9). The gable is built in random sandstone and the wall is 450mm thick. The wall is in good condition. It is plumb and well pointed. There are no signs of previous or ongoing movement. There are four door openings at ground floor level and one window. There is a further opening to the loft level above. Photo 11 shows the raised roof with the section of timber cladding above the stonework. The timber is in good condition with no sign of rot or infestation.

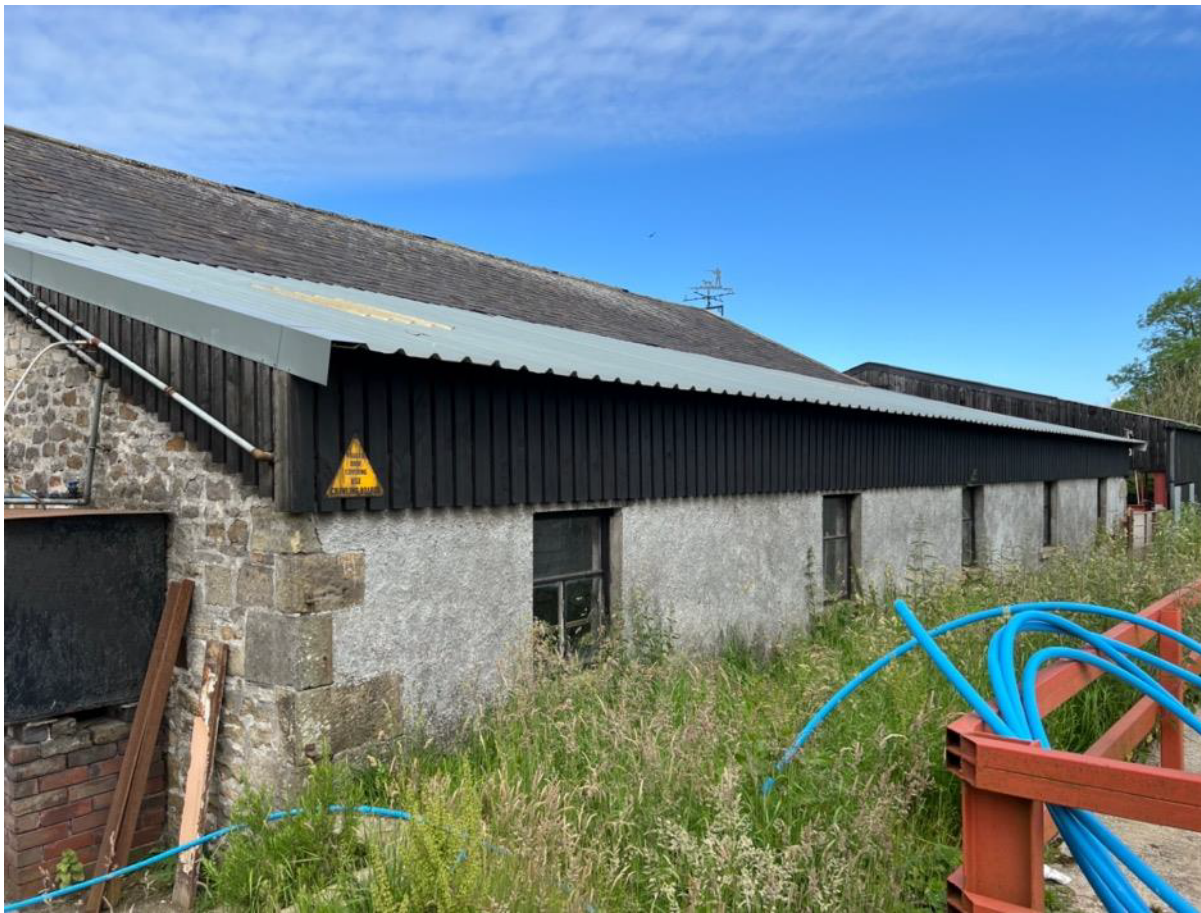
Photo 15 - North East Elevation with south east elevation

This rear elevation is a 450mm thick random stone wall five window openings. The wall is plumb and has been rendered. The wall is free from any sign of previous or ongoing movement. All the photos show the timber cladding added when the roof was raised. The timber is in good condition with no sign of rot or infestation.

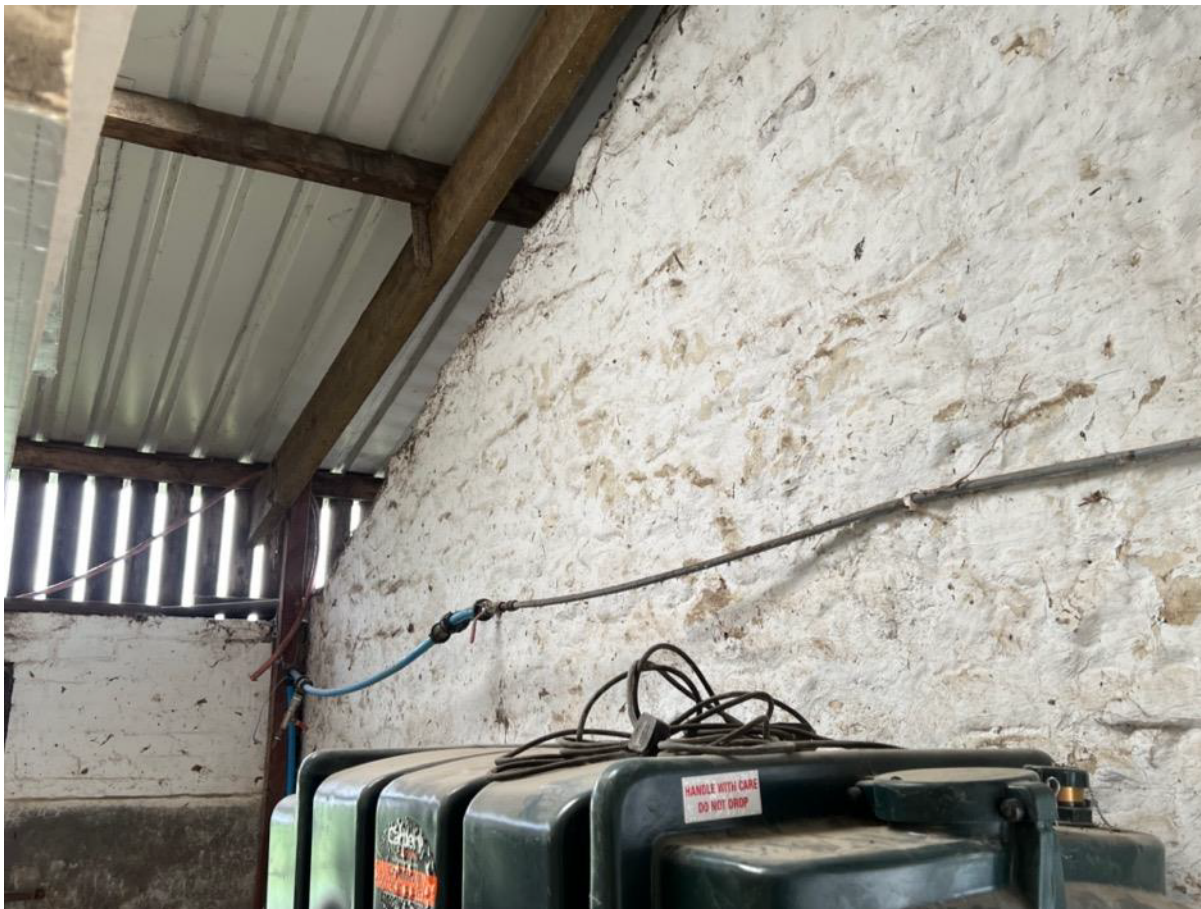
Photo 18 – Internal to rear single storey section

Main section – This section of the building is a shippon area with mono pitch timber trusses carrying the roof above (photo 20). This area, including the wall with the main barn, shows no sign of previous or ongoing movement to walls or floors. The ground floor is solid concrete (photo 23). The timber trusses, purlins and rafters appear in reasonable condition with no clear signs of extensive rot or infestation.

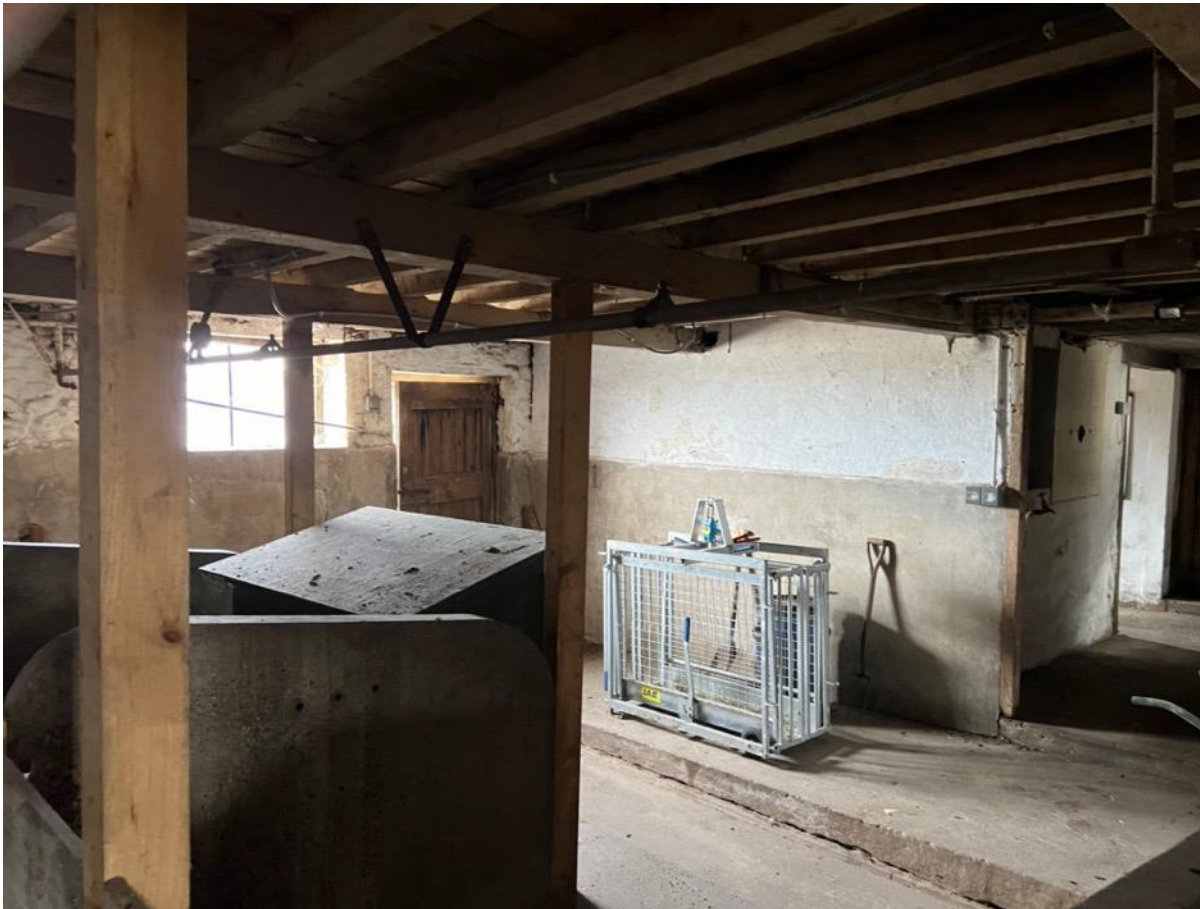
Photo 36 - Internal main barn – mid section

The cow parlour is shown in photos 36 to 39 and this too has concrete floors and stalls, with a timber floor to the loft above supported by timber posts (photo 38). The internal walls are all in good condition, plumb and well pointed/rendered. There is no evidence of previous or ongoing movement. The timber is in good condition with little or no sign of rot or infestation.

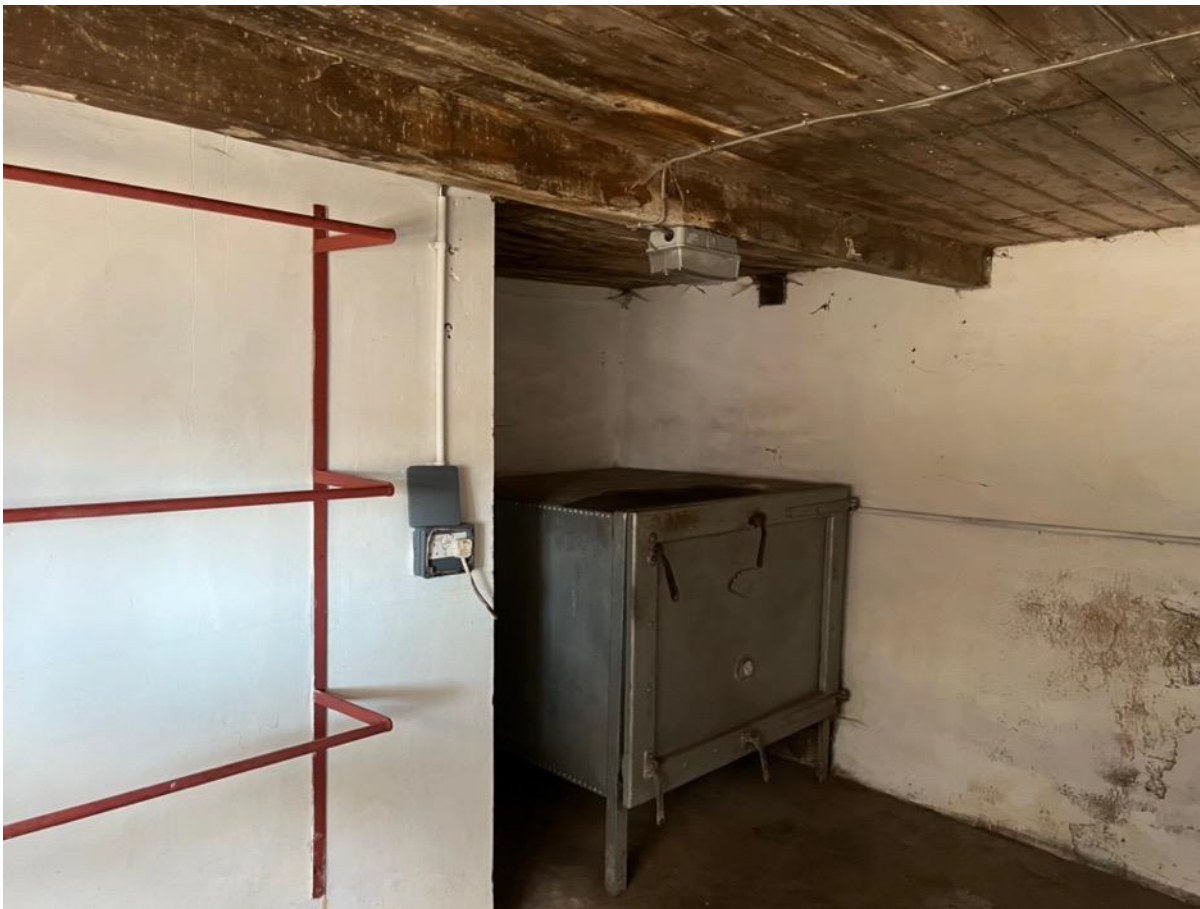
Photo 40 - Internal main barn – north west end

The store and office area at the north west end is shown in photos 40 to 43, with the two areas split by a lobby area. The floors are solid concrete and the dividing walls to the lobby are built with 100mm brick/block. The dividing walls between the main barn sections are 450mm wide. This area is in good condition with no sign of previous or ongoing movement.
