# **Structural Appraisal**

## **Fair Oak Barn**

**John West**

**Ref: A18**

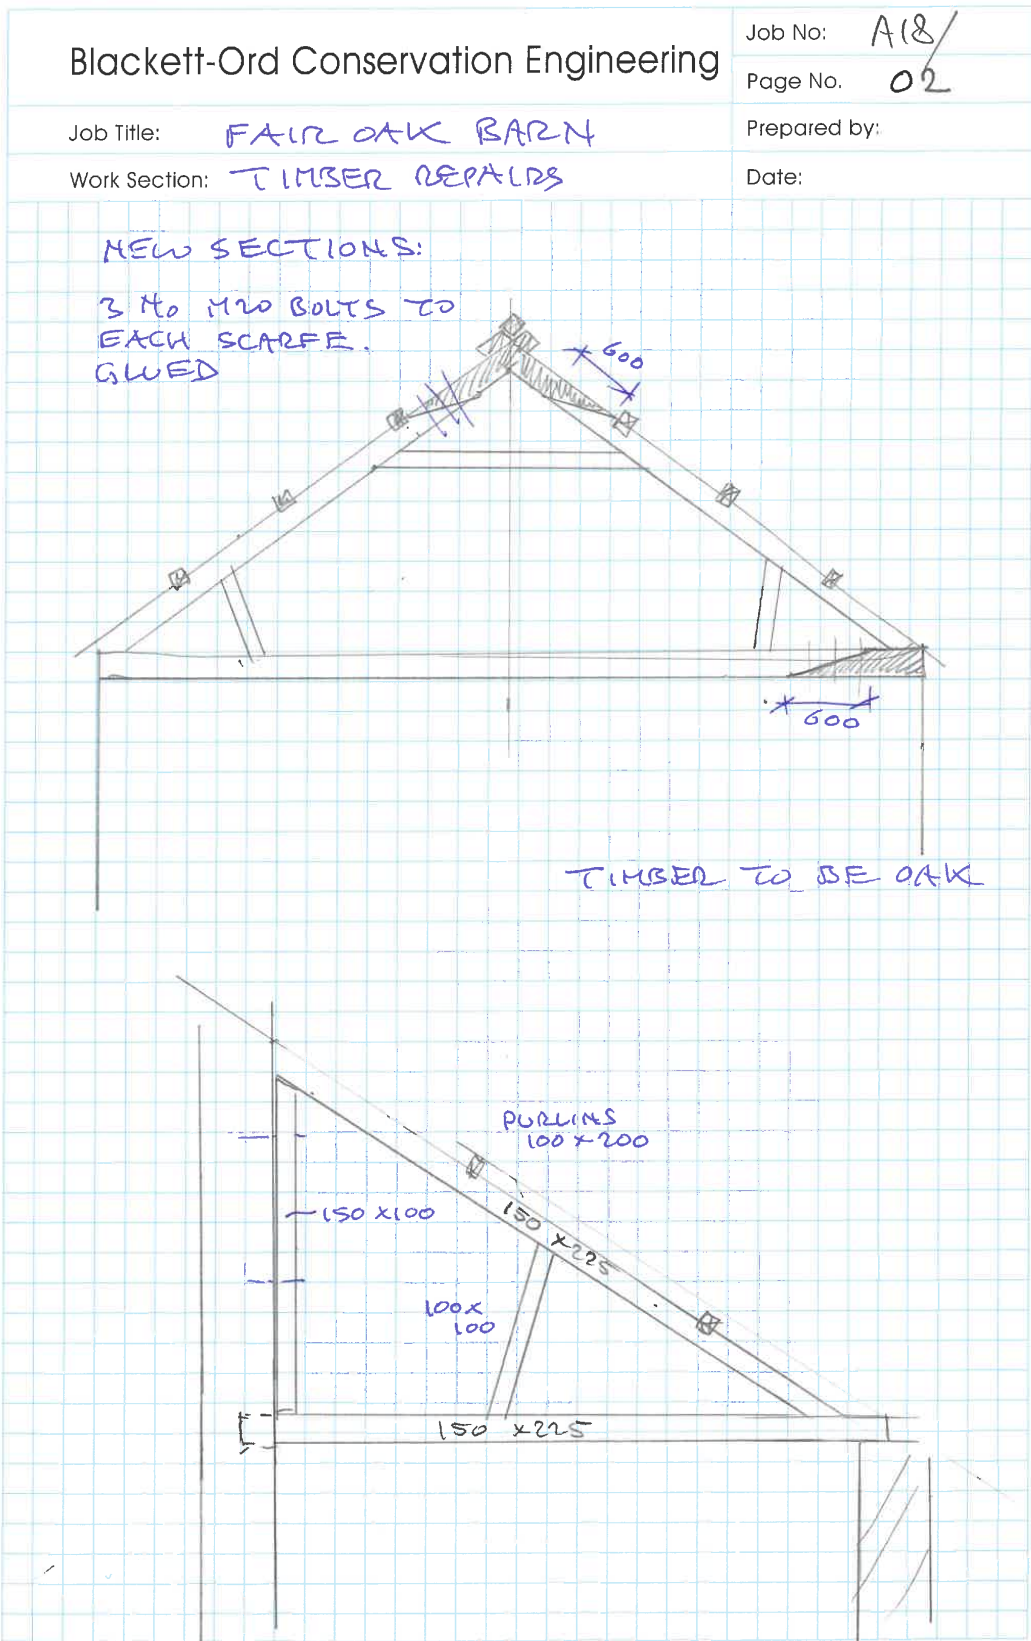
BARN AT FAIR OAK FARM  
STRUCTURAL REPAIRS - PLAN

The foundations have not been exposed or inspected, but some subsidence has occurred on the north-west corner of the main barn. The ground is very wet in this area, which could be the cause of the problem. The area should be drained and allowed to dry out. Steel ties should be introduced as mentioned below.

The south-east corner of the main barn has been damaged by vehicles. The collapsed area should be rebuilt, and a kerb introduced to keep vehicles away from the wall at this point.

The arch over the cart entrance is missing a voussoir stone, and the masonry above has dropped as a result. The inner half of the wall over the opening is carried on a curved timber beam.

The proposed repairs are shown on Drawing No. A18/01.

The cracking in the north wall should be pointed up and steels introduced across the gable wall to prevent further movement.

The rear extension should be tied on to the west wall as shown on the drawing. The entrance arch should have its missing voussoir replaced.

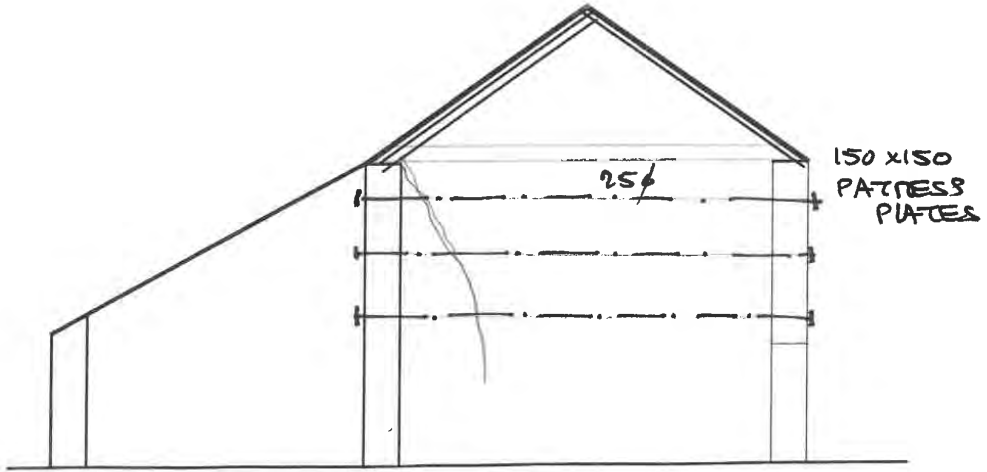
SECTION AA

The roof of the main barn is carried on five collared and tie trusses. The two at the south end have had their ties reinforced with additional timber. The central truss has a rotten tie beam where its west end bears on the wall. The second truss from the north has wet rot at its apex, affecting the principals, and the adjacent ridge pieces. The north end ridge too has been affected by wet rot. Otherwise, the purlins appear to be sound, but this can only be confirmed after the slating has been stripped and the tops of the purlins can be inspected.

The two roof trusses that need repairing are shown on the drawings. In addition, two ridge pieces should be like for like replaced.

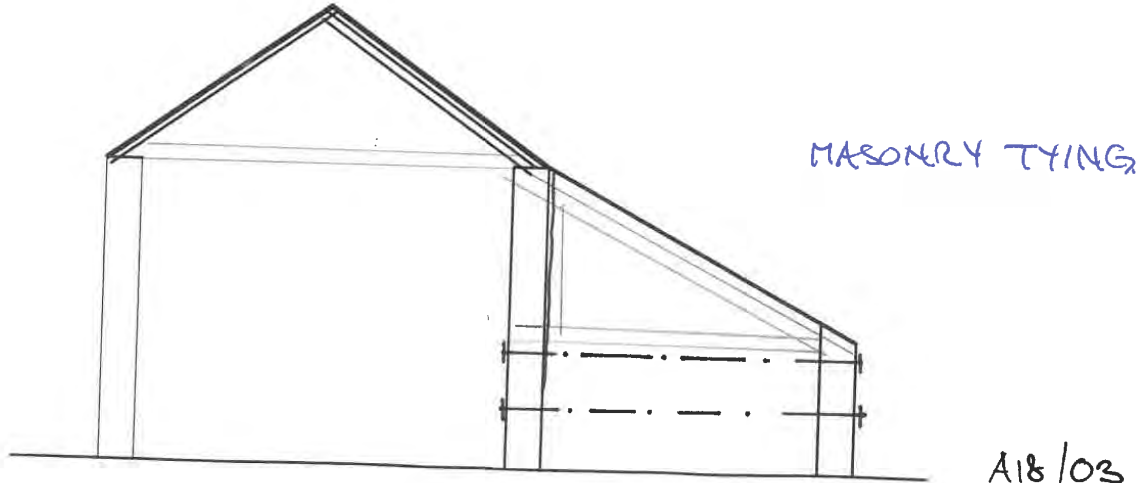
SECTION BB

The truss in the outshut is suffering from rot and the tie beam has deflected excessively.

The truss in the extension should be replaced.
