Written Stone Farmhouse, Longridge

BAT SURVEY REPORT

September 2024

Report Ref: 093_04

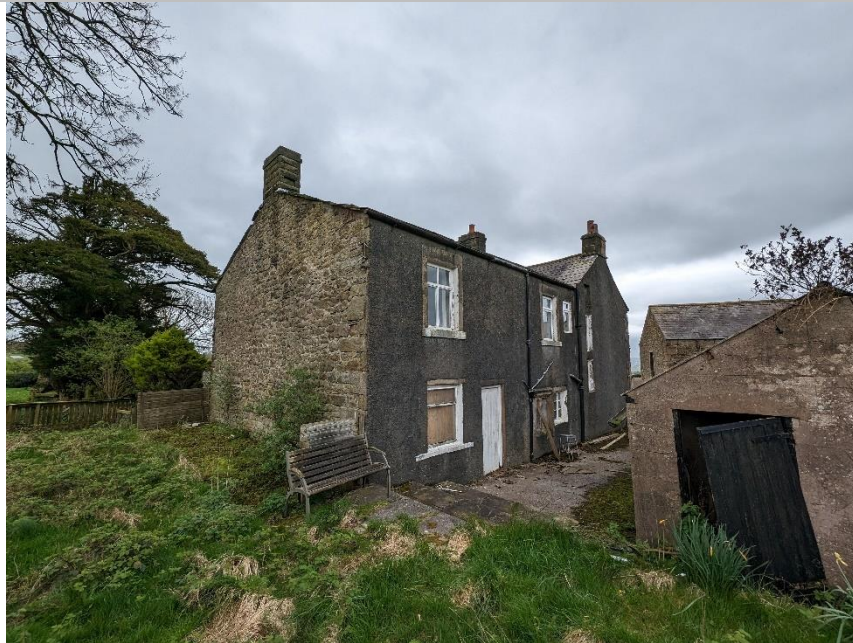
Photo 1.
North-east
elevations

The roof comprises two intersecting gable roofs which form an L-plan. The southern roof had slates and the northern roof had traditional stone tiles. The northern section had missing, misshapen and slipped tiles – all presenting suitable roost egress points for bats. This included lifted and missing tiles on the north roof verge. The southern section appeared to be in better repair. The lead flashing on the chimney on the north gable and the chimney on the east gable were slightly lifted presenting potential roost features for bats.

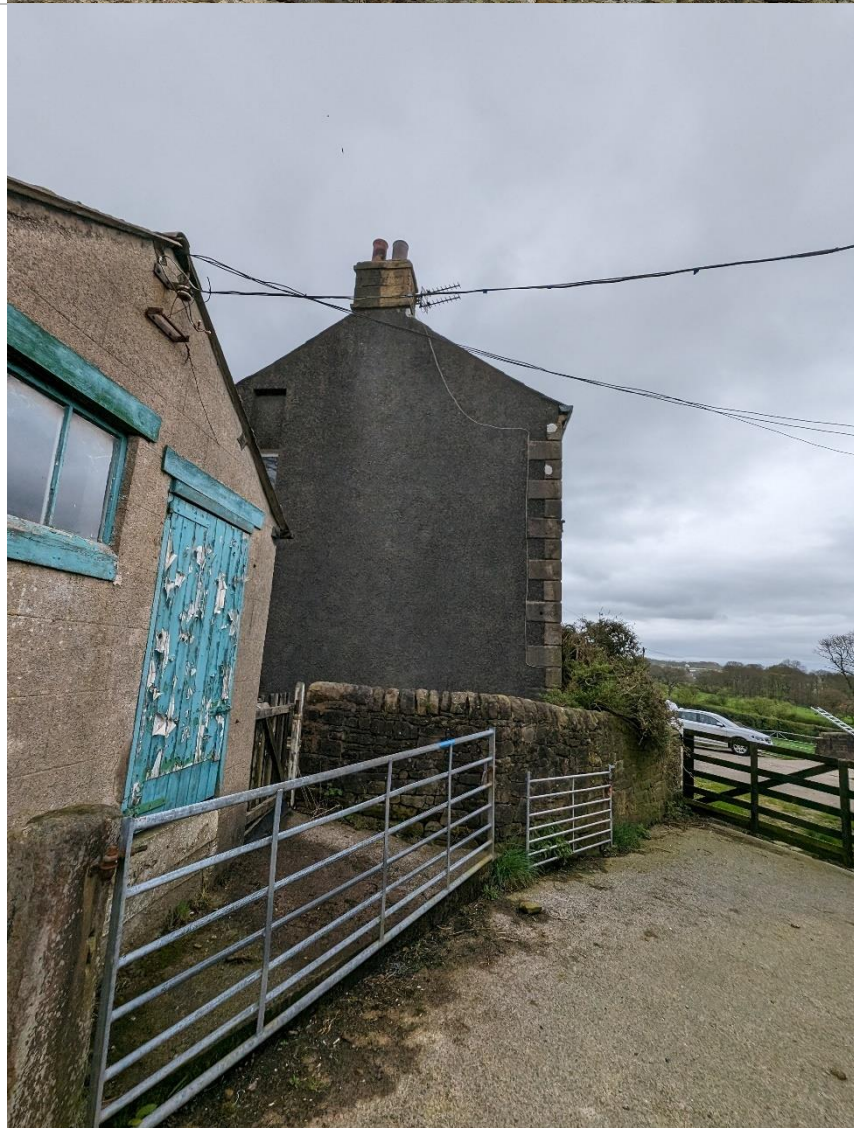
Photo 4.

West gable

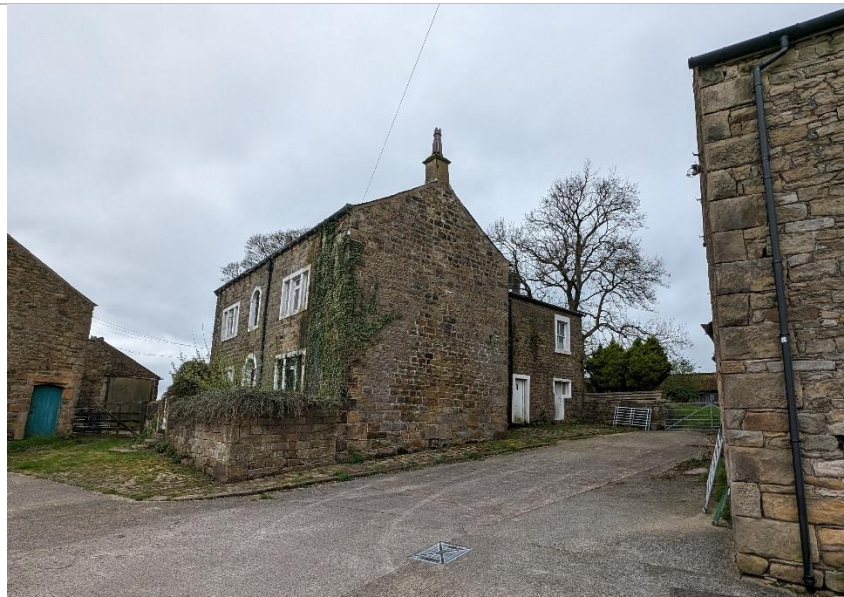
Photo 5.
South-east
elevation

There were also gaps in the stonework on the east elevation. This included a gap in the south-east corner just below the roof and gaps within the centre of the wall. Such gaps appeared to present suitable conditions for roosting bats.
