## **Barn at Parsonage Farm, Church Street, Ribchester, PR3 3YE**

### **Structural Condition Survey for Conversion to Dwelling**

PSC-690-CAR1 – Rev B

August 2024

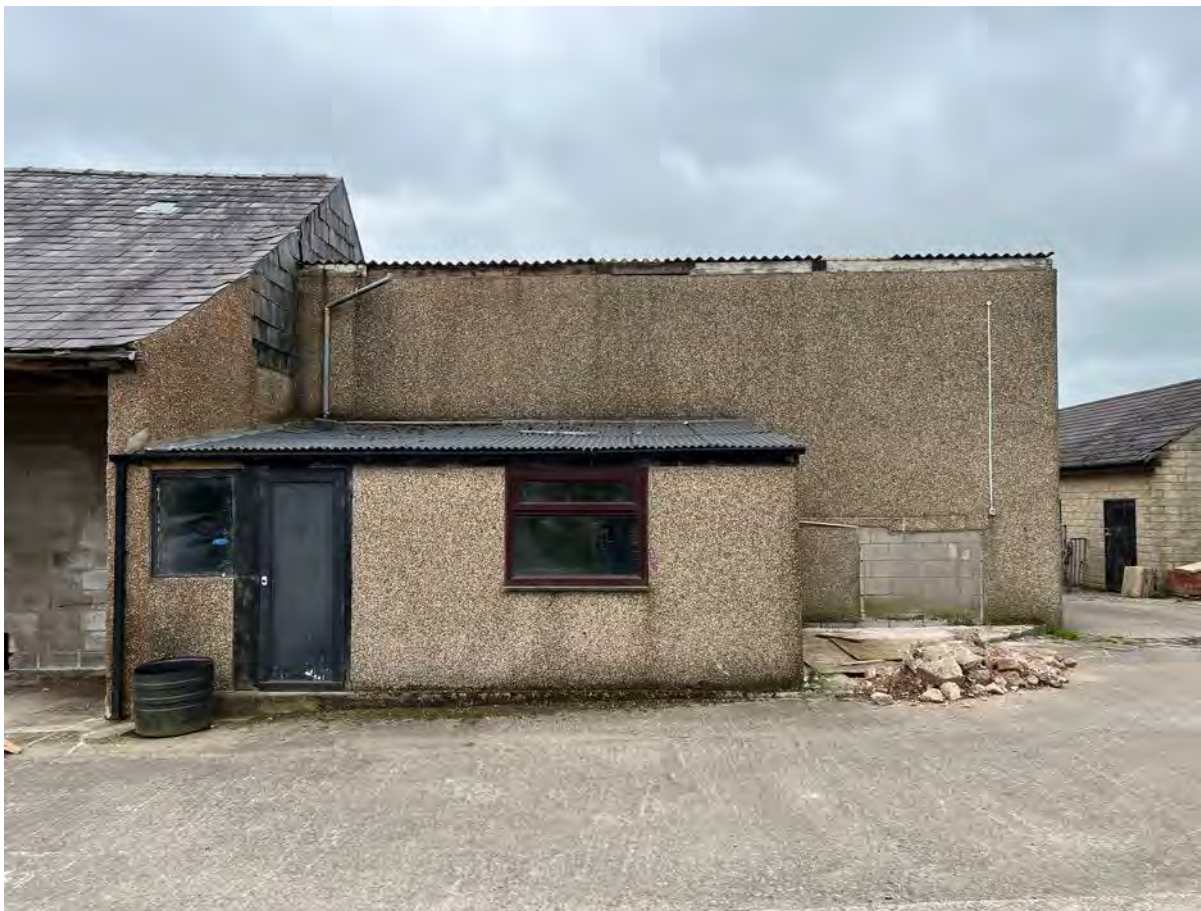
Photo 2 – North East Elevation - Extension

The single storey extensions are built in 220mm concrete block and have a shallow pitched profiled sheet roof. They are formed by three rooms with a door to each plus two small windows and a hatch at ground level. The walls are plumb and free from movement and damage.

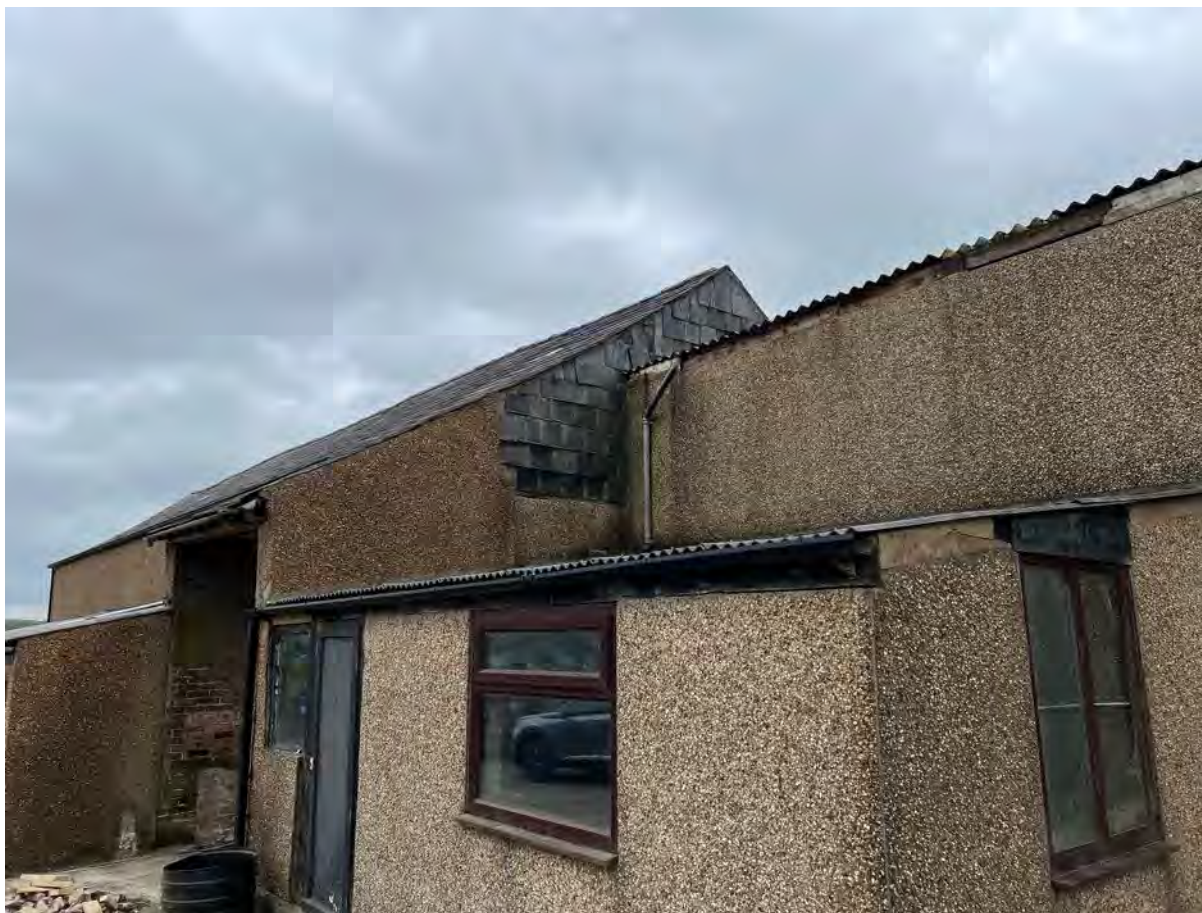
Photo 4 – North East Elevation

The original brick wall to this elevation is constructed with clay brick and is approximately 400mm thick. The wall has a pebble dashed render. Single storey extensions have been added to this elevation as can be seen in Photo 1. In addition, the original barn has been extended to the northwest with a blockwork extension which has also been pebble dashed (photo 2). This extension appears to have replaced two original bays of the brick barn as evidenced by internal inspection and exploratory excavations externally. The walls to this elevation are generally plumb, the render is in reasonable condition and free from signs of movement. The elevation benefits from guttering and downspouts.

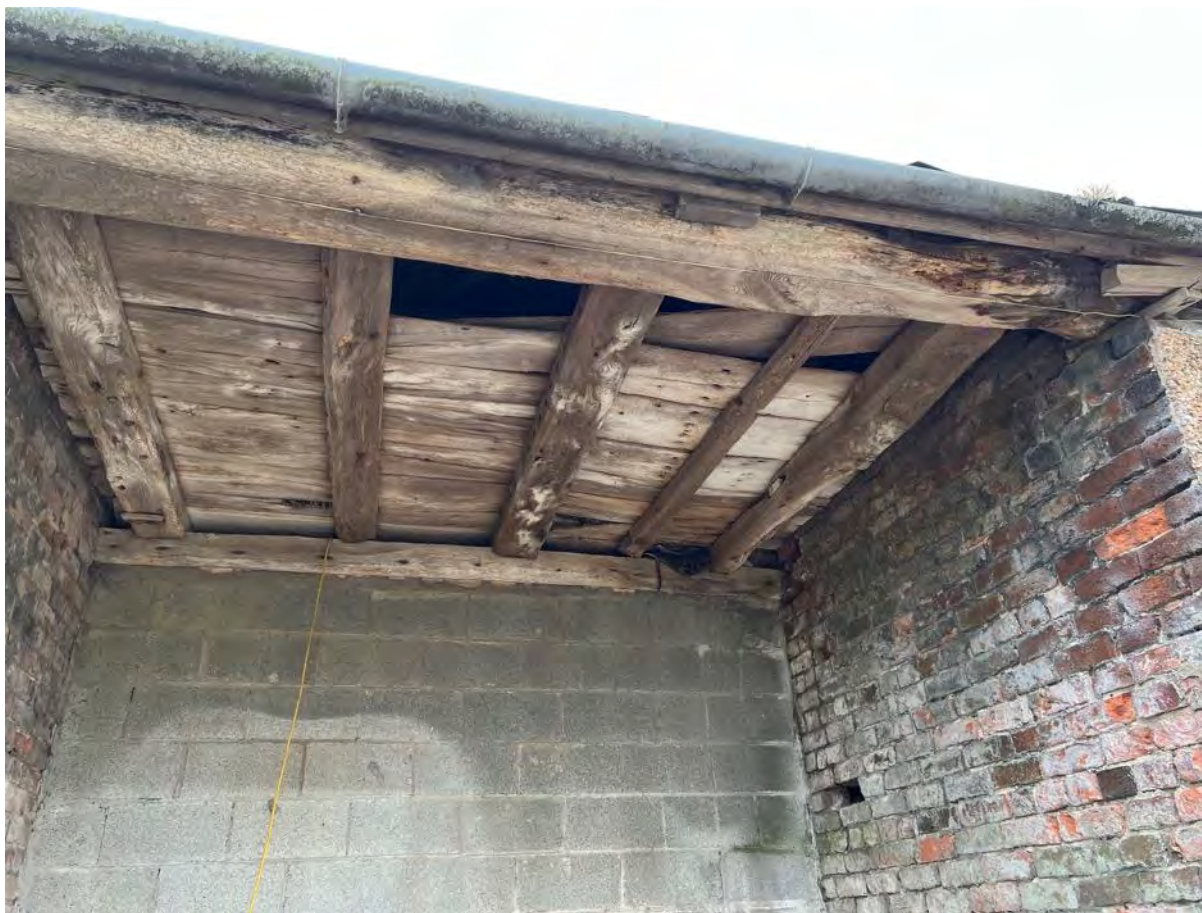
Photo 6 – North East Elevation – Original Barn Entrance

The original barn door (photo 5) has been blocked up with concrete blocks. Photos 5 to 7 show the original unrendered brickwork and the timber to the roof/overhang. The brickwork is in good condition, reasonably pointed and generally plumb. There are two high level window openings in the original wall, above the single storey extension (photo 9). At the eastern end there is a further window opening at ground floor level (photo 14). The original brickwork can also be seen in photo 15 which shows an area adjacent to the gable where the render has been removed at a low level. Again, the brickwork appears in good condition given the age of the building.

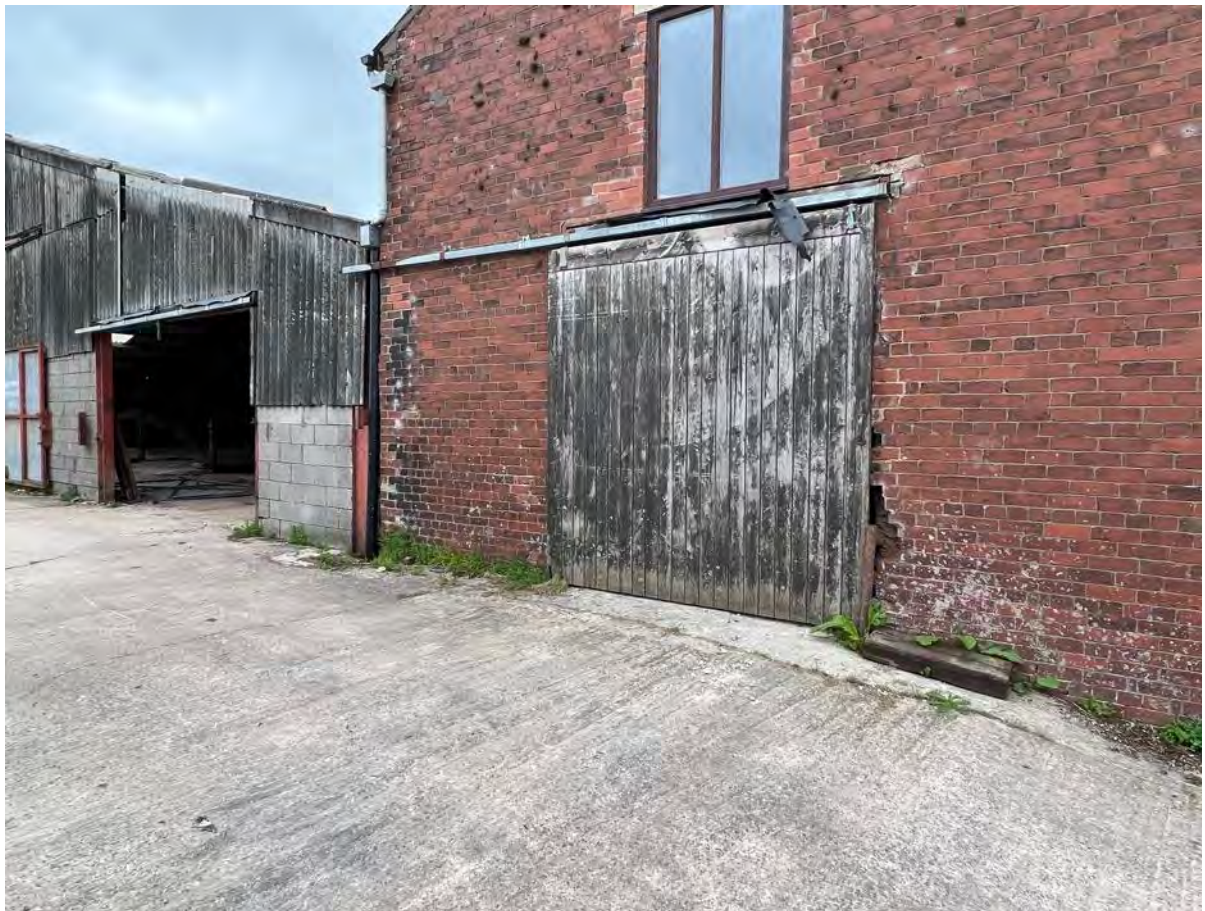
Photo 18 – South East gable

The elevation is a 500mm thick brick wall. It appears to have had an extra skin of brickwork added externally using Accrington Brick. The wall is in good condition, plumb and well pointed. There is no sign of structural movement. The elevation has a large door opening with a window above (photo 17). There are 3 vents in the brickwork above the window (photo 20). Photo 21 shows the steel column to the large steel framed extension to the south.

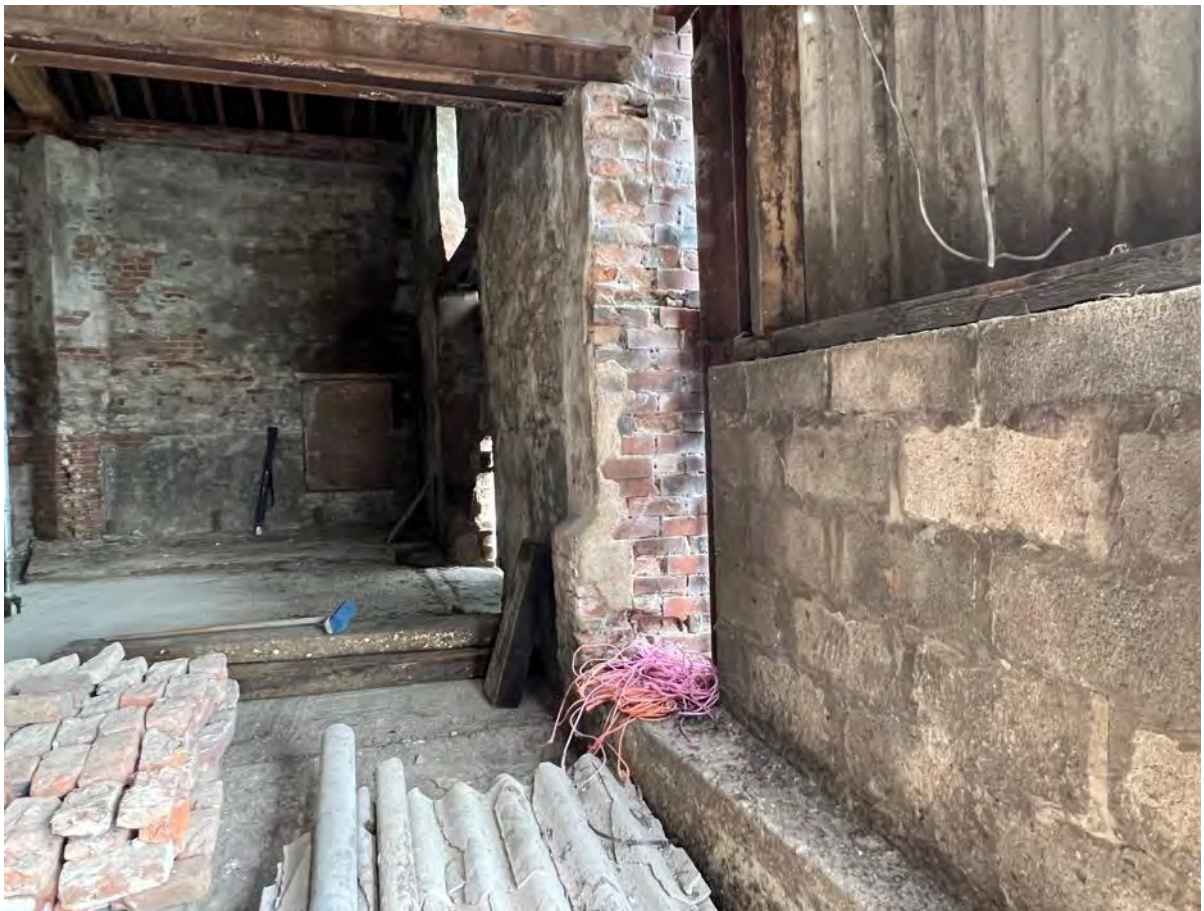
Photo 24 - South West Elevation

The south elevation of the brick barn sits within the large steel framed extension to the south as can be seen in photo 23. The brick walls are 400mm thick and the photographs illustrate that the wall has been repaired or had sections blocked up with concrete blocks (photos 29 to 31). There is a large opening in place at the eastern end (photos 23 & 24). A further window opening is in place at a high level towards the western end and this can be seen in photo 49. The walls are plumb and generally well pointed. There is no sign of movement to the wall.

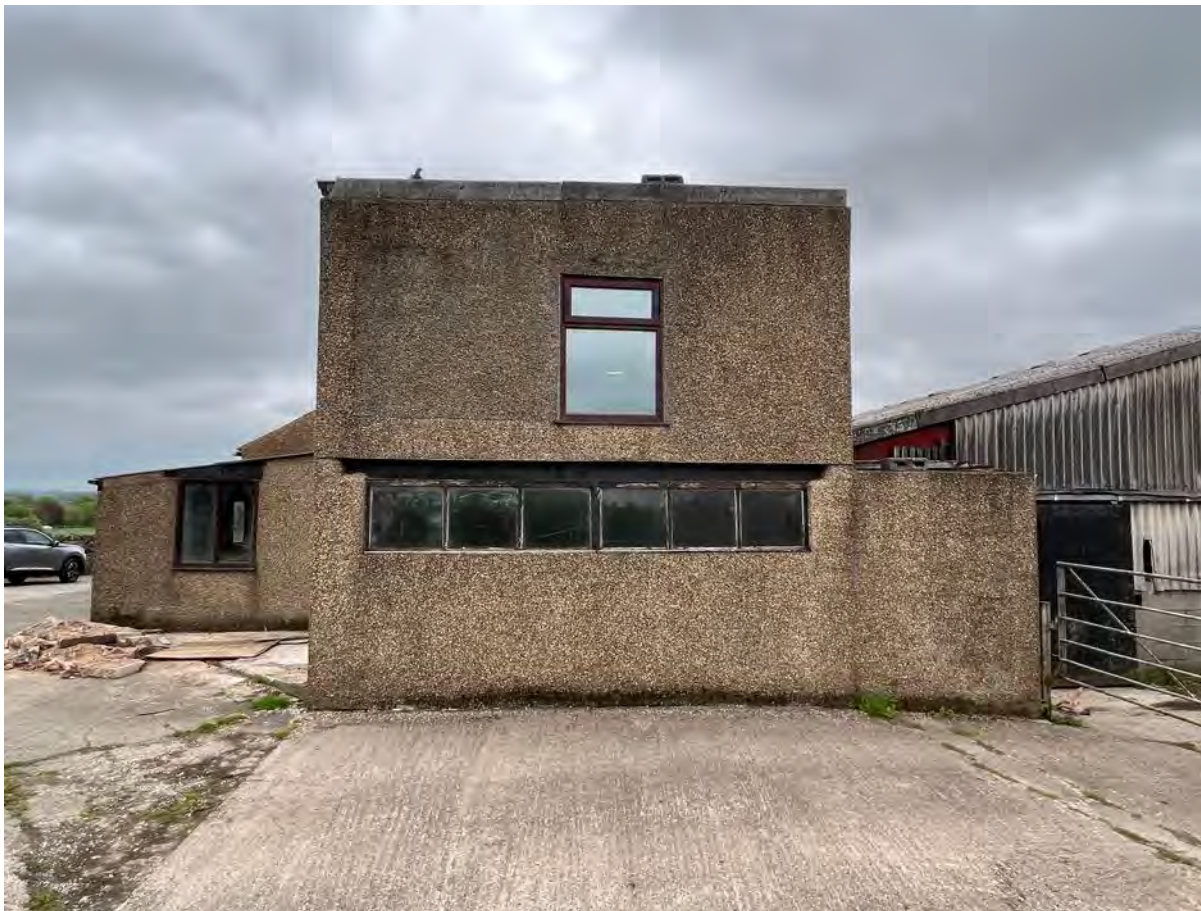
Photo 32 – North West Elevation of extension

The new gable wall to the extension is shown on photos 32 and 65. This is a rendered block wall, it is plumb and is free from movement. The elevation has a long window opening at ground floor level and a single window above. The longer window has a steel beam supporting the blockwork which is in reasonable condition.

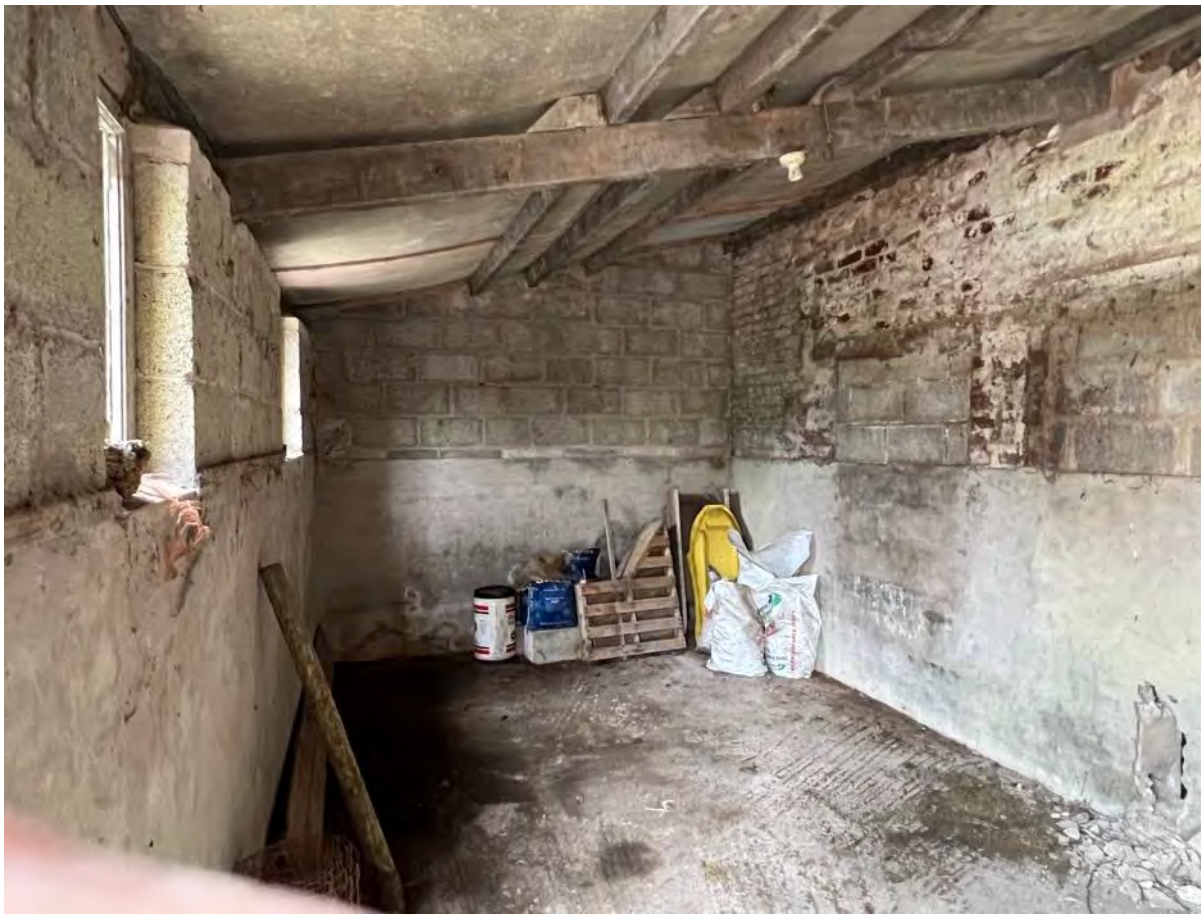
Photo 37 - Internal – extensions to north east elevation

These areas are in a reasonable condition and also inspection of this area gives an indication of the state of the original brick walls to the main barn. This has been rendered at lower levels and areas have been infilled with block (photo 38). The original brick wall and the newer block walls are all free from structural movement and plumb.

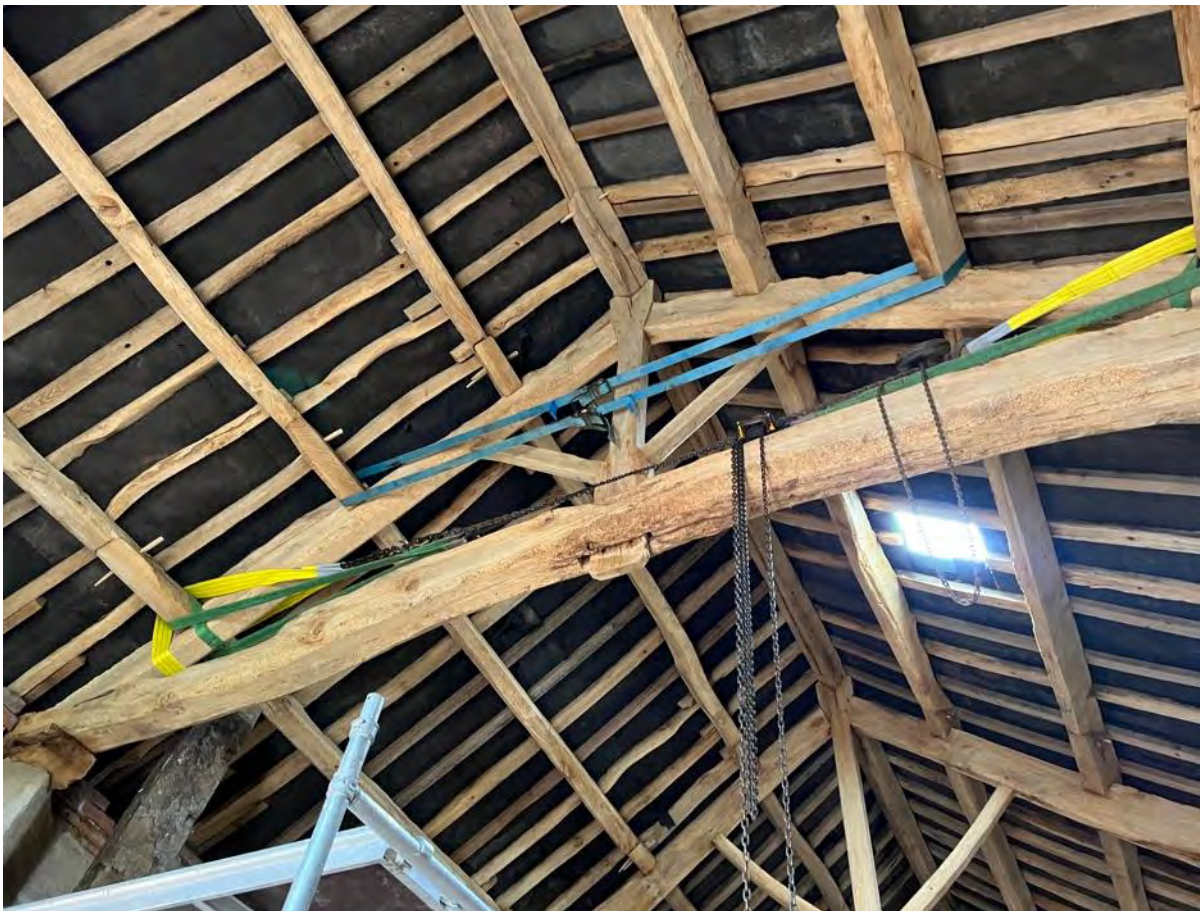
Photo 42 - Internal – main barn

The roof structure can be seen in photos 41 to 43 with the bearing detail of the trusses illustrated in photo 47. The trusses, purlins and rafters appear to be original and are generally in good condition. There are some issues with the trusses including spread and water ingress as indicated on photos 41 & 42. The standard of workmanship and quality of timber used is very high. The roof has been felted and re-slatted over the years.

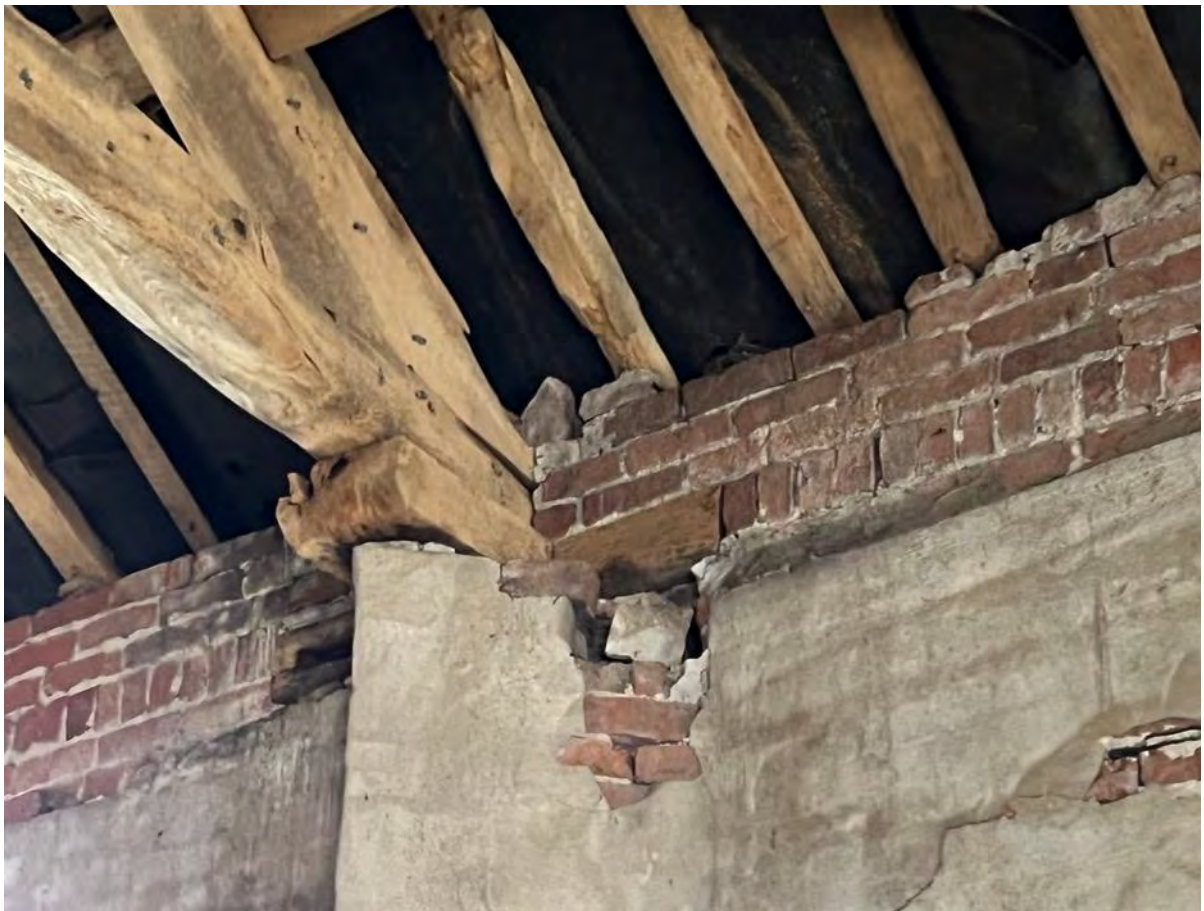
Photo 52 - Internal – main barn

The main barn is an open building to full height as can be seen in photo 40. The brick walls have triangular piers set at regular intervals (approx. 12 feet or 3.7m). These piers are 500mm long on each triangular side. They carry the king post roof trusses above. The brickwork is in reasonable condition but there are some areas of damage and lots of areas where openings have been infilled with blockwork or damage repaired. There is no indication of any structural movement or issues. Photos 46 and 52 show areas of damage to the piers but this is not due to structural movement and can be repaired.

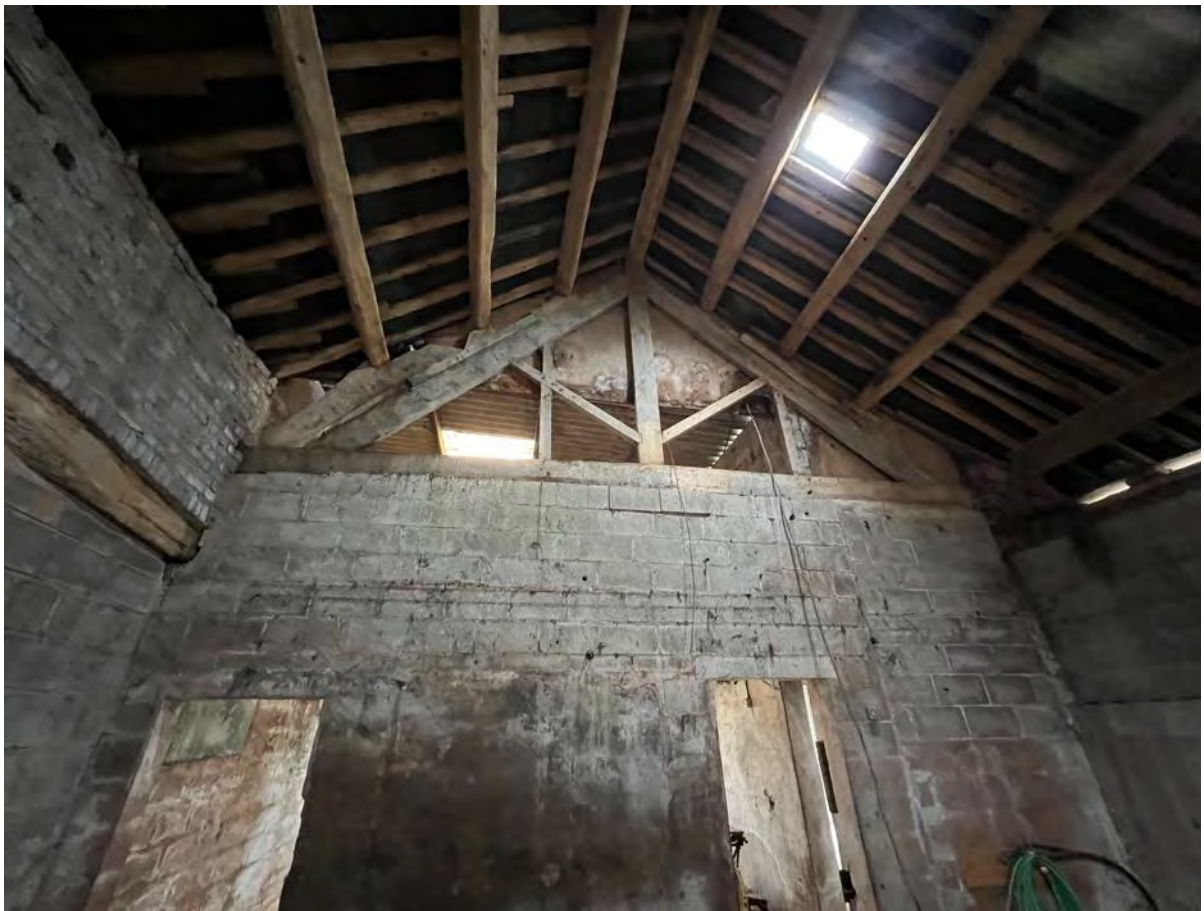
Photo 58 - Internal – main barn – rebuilt gable to main barn to extension at west end

As noted above, the brick barn appears to have originally extended by a further two bays to the west. These bays appear to have been replaced by the blockwork extension at the west end. This is further evidenced on photos 57 & 58 by the presence of a block wall constructed immediately adjacent to the barn door and located directly below a truss. This is clearly not original, and a truss would not have been located at the gable. This block wall is constructed with 200mm blockwork and is plumb and free from movement. There are two openings at ground floor through to the extension. The truss has been left open as can be seen on Photo 58.

As noted above, a new block gable wall has been installed under the westernmost truss (photos 57 & 58). This is at the junction of the original barn and the extension to the north west which is thought to have replaced two more bays of the original barn.

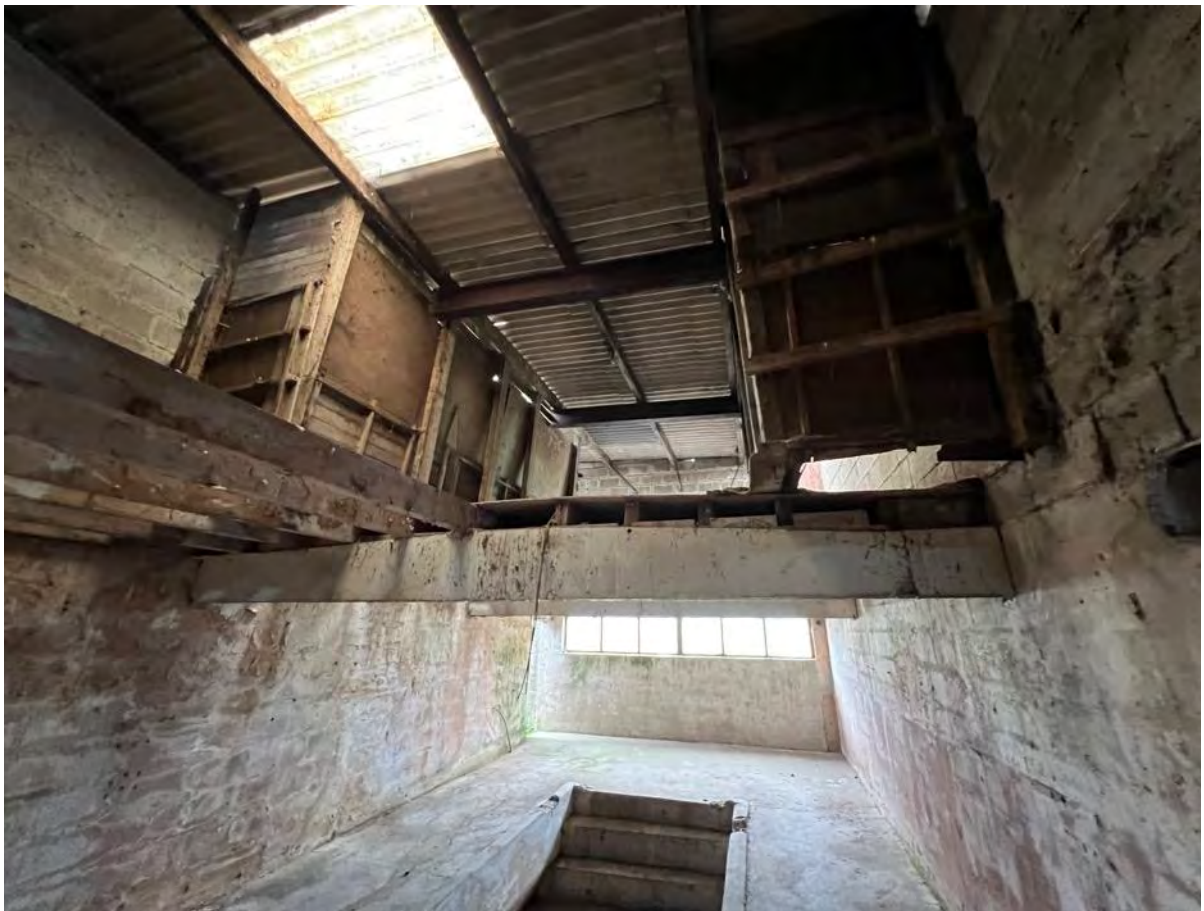
Photo 60 – mezzanine to extension

The extension to the west forms a milking parlour (photo 59) plus an adjacent room (photo 61). The milking parlour has a loft above (photo 60). The extension is in good condition and free from movement.
