**The Barn, Springwood,  
Hurst Green**

**Level 2-3 Historic  
Building Recording**

AB Heritage Project No: 63086

Date: 03/09/2024

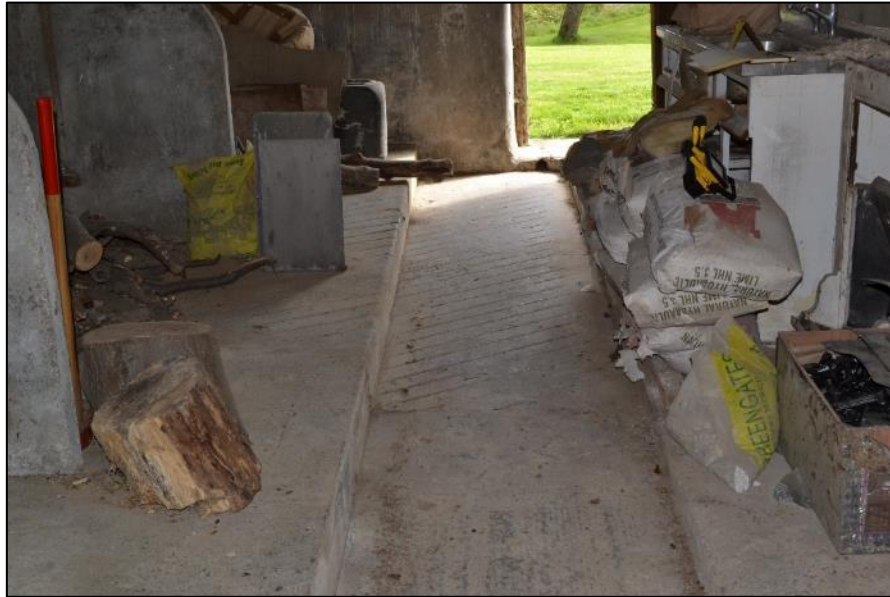
- 4.2.22 The floor is concrete and includes drainage / grip striations, and the waste channel which leads to an external drain via a small hole under the east door (Plate 14).

**Plate 14. Ground floor, concrete dairy floor**

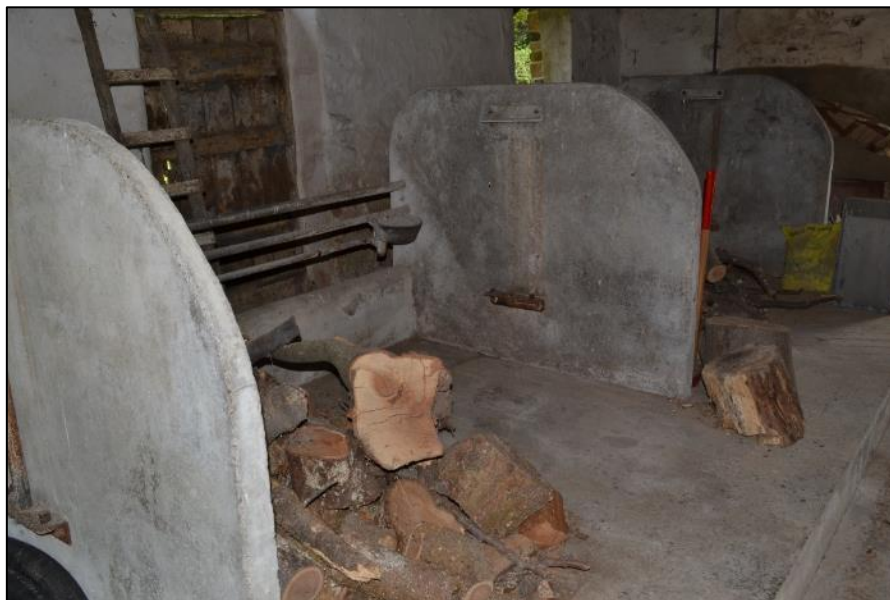
- 4.2.23 The most notable features on the ground floor are the concrete and iron milking stalls. These could accommodate up to four cows, separated from one another by the concrete screens and fitted with drinking water bowls and tethering apparatus (Plate 15).

**Plate 15. Cattle stalls**

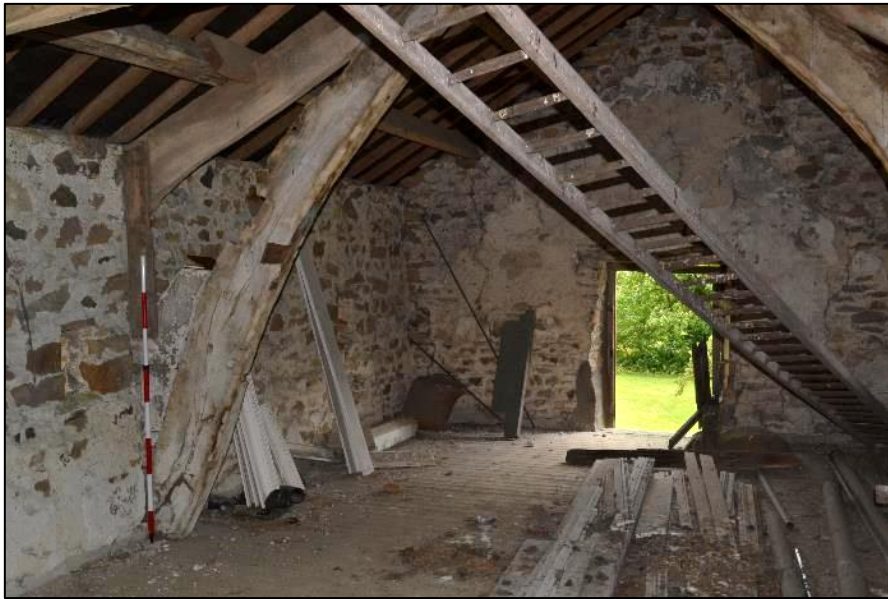
**Plate 18. General shot first floor. Looking east (scale 1.6m)**

- 4.2.31 The floor is close set, regular timber boards, probably of 20<sup>th</sup> century origin.
- 4.2.32 The most remarkable feature on the first floor is the roof structure. This is mainly comprised of substantial, modern, machine cut timbers, but they support two pairs of original timber roof crucks which are in turn supported by the transverse joists seen on the ground floor. With the exception of a single member, the purlins are machine cut modern timbers. Tie beams appear to be modern. Plates 18 to 20 give a broad view of the roof timbers.

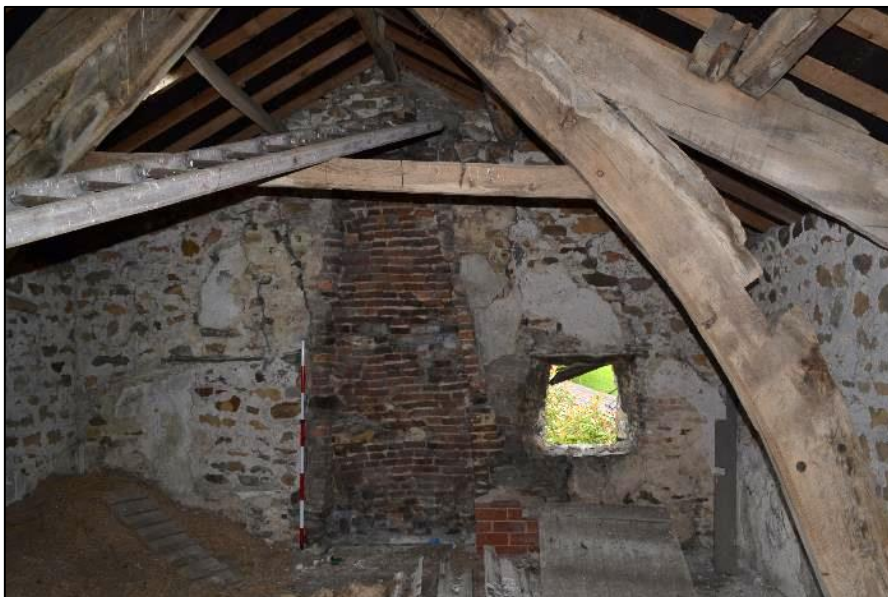
**Plate 19. General shot first floor. Looking west (scale 1.6m)**

- 4.2.30 There are only a few features to note on the first floor. The first is the brick chimney flue that has been constructed into the walls of the west elevation (Plates 12 & 19). The flue is handmade red bricks, and it appears conical in cross section which is how it survives. This feature is curious, and it certainly predates the raising of the roof as there is stone work above the bricks on Plate 19. It is possible that the chimney flue indicates a pre-industrial dairy function for the Barn, where small hearths were used in the creaming and sterilisation process. Alternatively, the flue may be the remains of a domestic smithing forge or even a small malting kiln. Whatever the true function, this feature appears suspiciously free of soot and scorching.

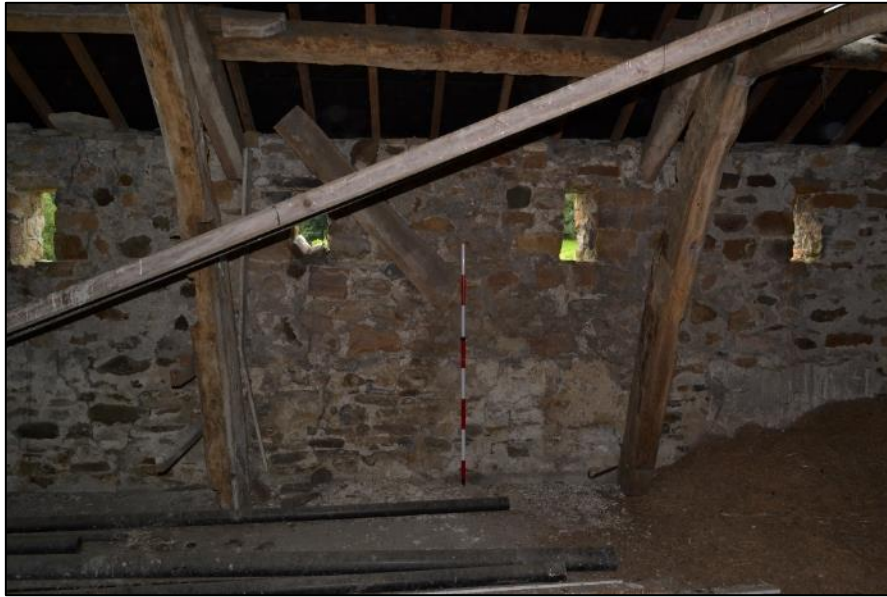
**Plate 20. First floor south elevation and original crucks (scale 16m)**
