**Discharge of Conditions Statement following Planning
Permission under application number 3/2023/0287 and
Listed Building Consent 3/2023/0288**

Mr A Shorten
Bridge End Farm
Slaidburn
Clitheroe
BB7 3AH

HISTORIC BUILDING RECORD

Bridge End Farm, Wood House Lane, Slaidburn BB7 3AH

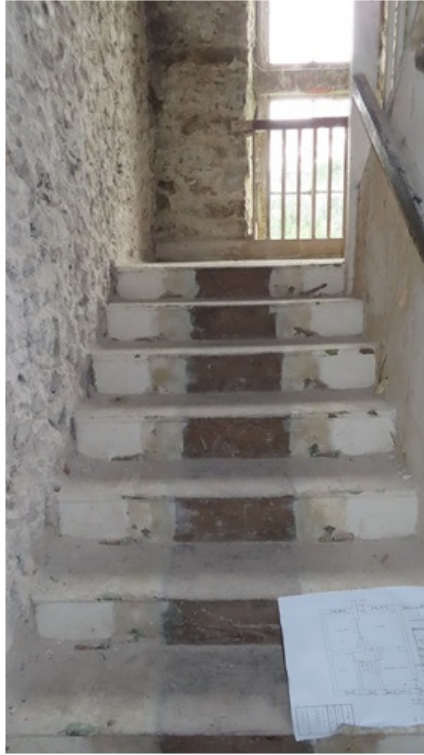
20.

The main timber stair comprises simple newel posts, handrails and spindles; the latter are missing at second floor level (see photos 20,21,34,35,46,47,53).
