BAT PRESENCE / ABSENCE SURVEY

Black Moss Farm

Elmridge Lane
Chipping
Preston
Lancashire
PR3 2NY

Date: 9th September 2024
UES reference: UES03941/08

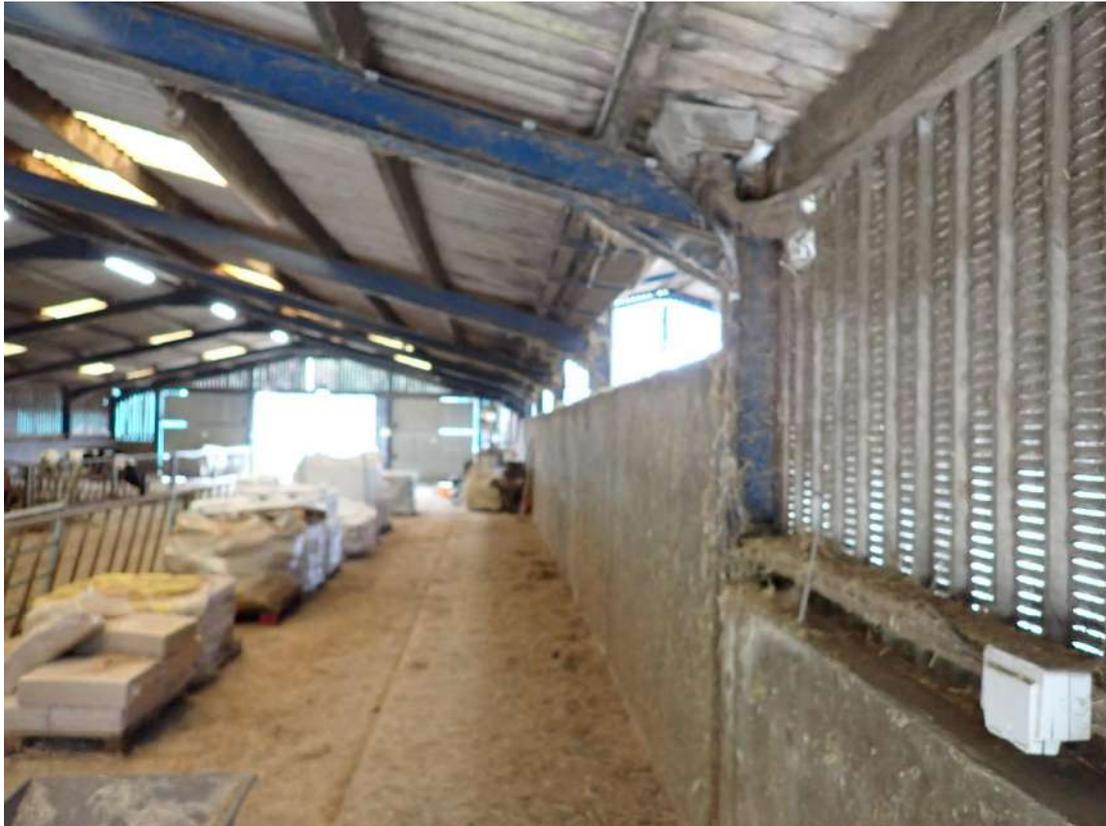
Photograph 67 – View of the interior of Building 4 showing the well lit and exposed conditions inside the building.

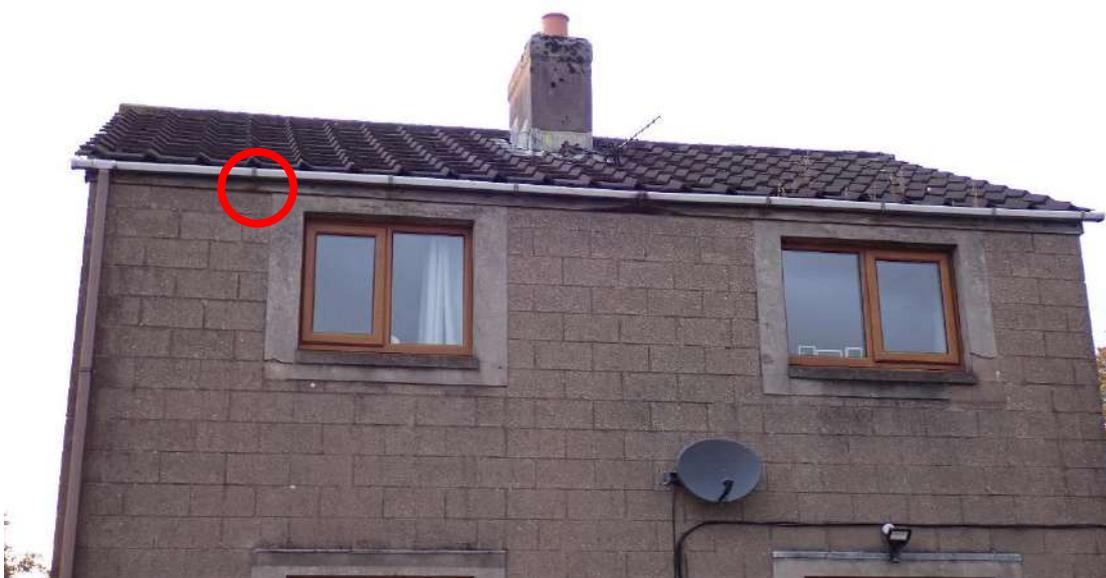
Photograph 68 – View of the southern aspect of Building 1 with Roost 1 circled in red.

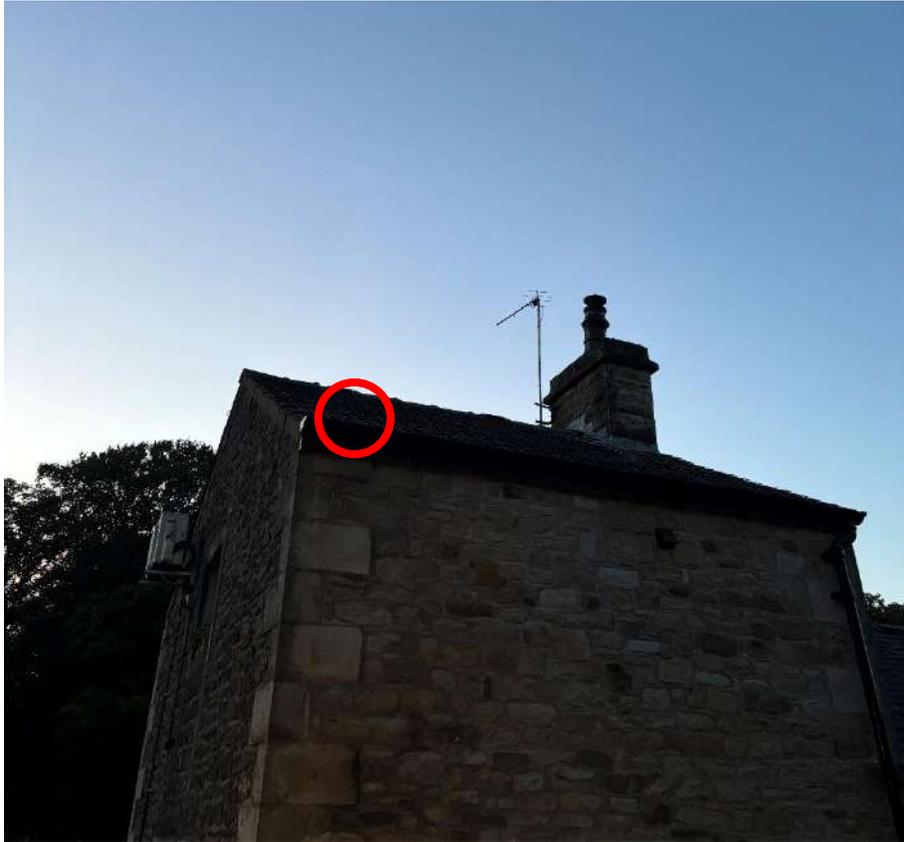
Photograph 69 – View of the entrance to Roost 3 circled in red, located on the western aspect of Building 2.

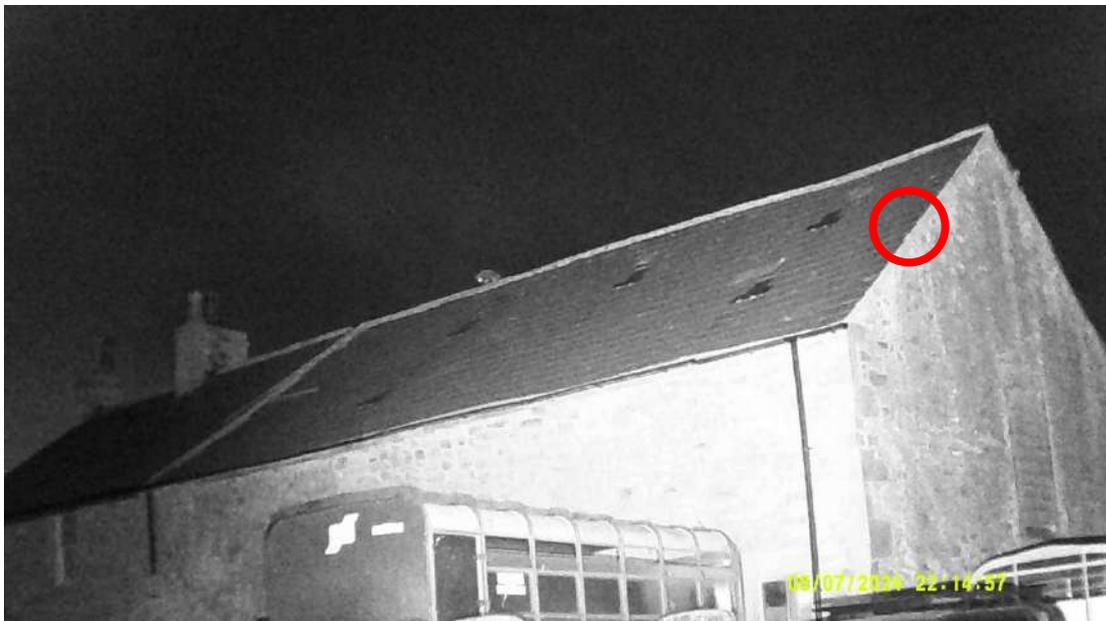
Photograph 70 – View of the eastern gable end of Building 2 with the entrance to Roost 7 circled in red.

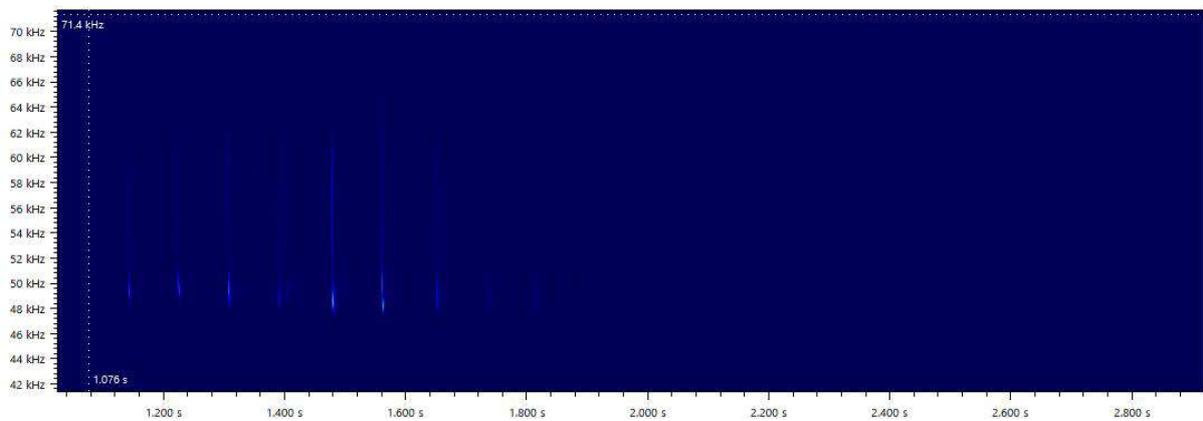
Sonogram 8 – Common pipistrelle recorded emerging from Roost 7 at 21:32, on 07.08.2024.

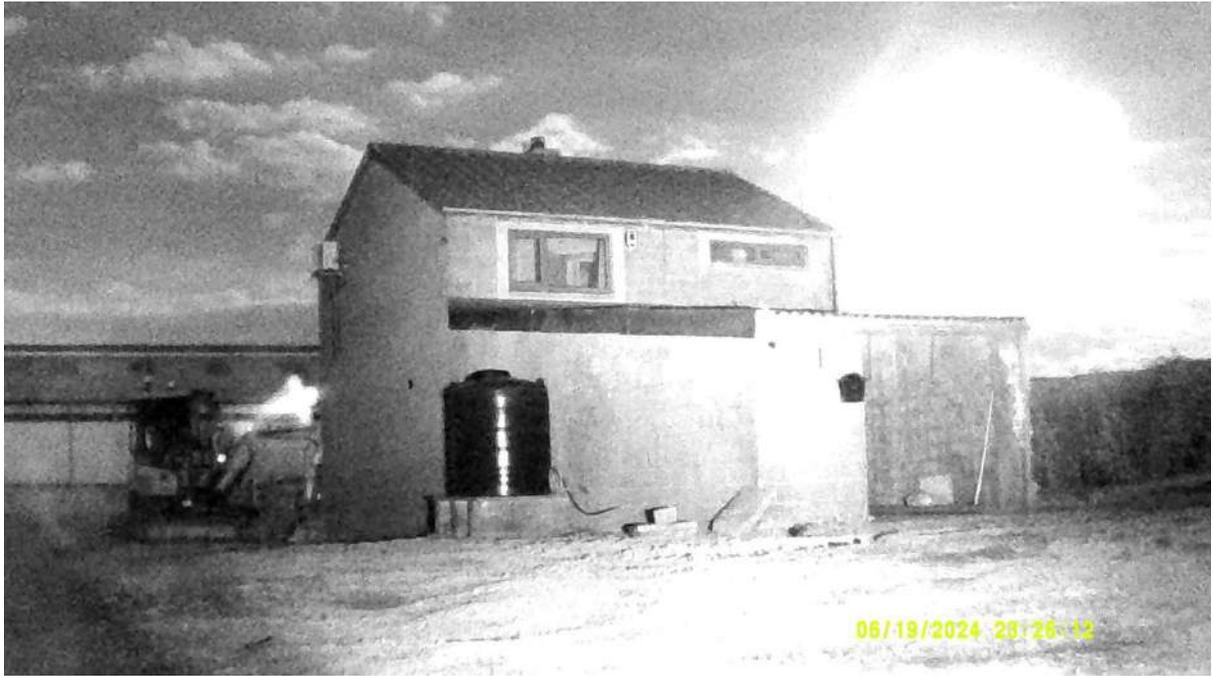
Photograph 1 – Infrared image of the northern aspect of Building 1 at the darkest point in the survey on the 19th June 2024.

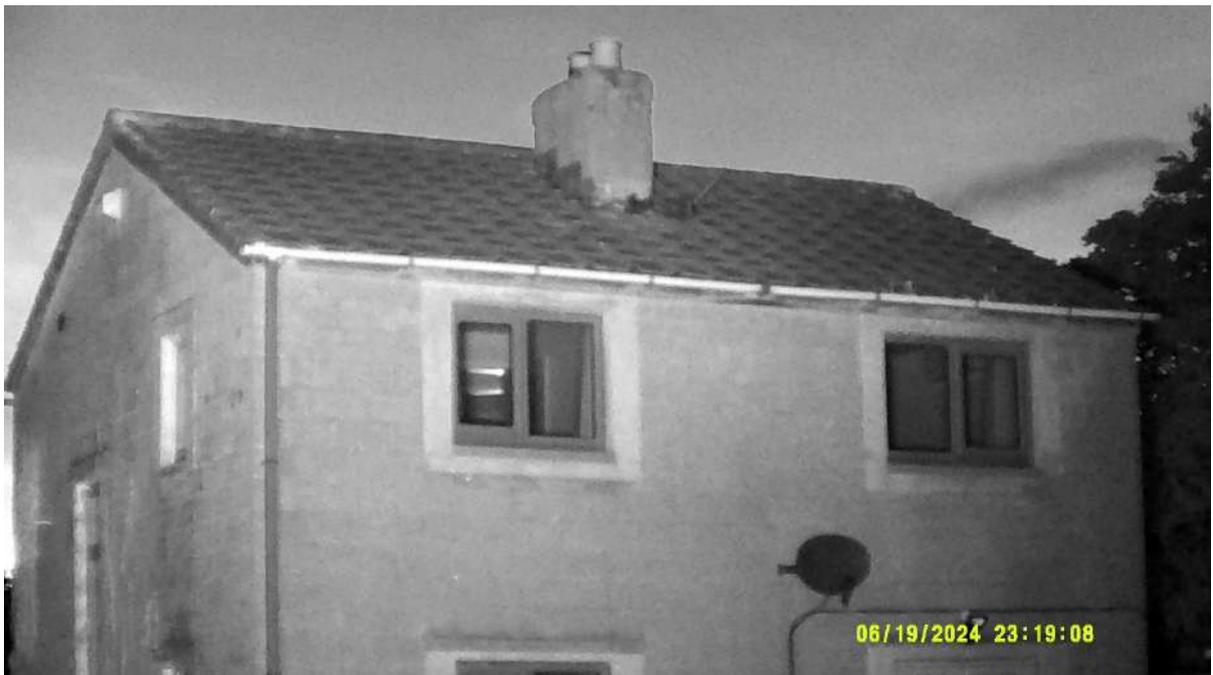
Photograph 2 – Infrared image of the southern aspect of Building 1 at the darkest point during the survey on the 19th June 2024.

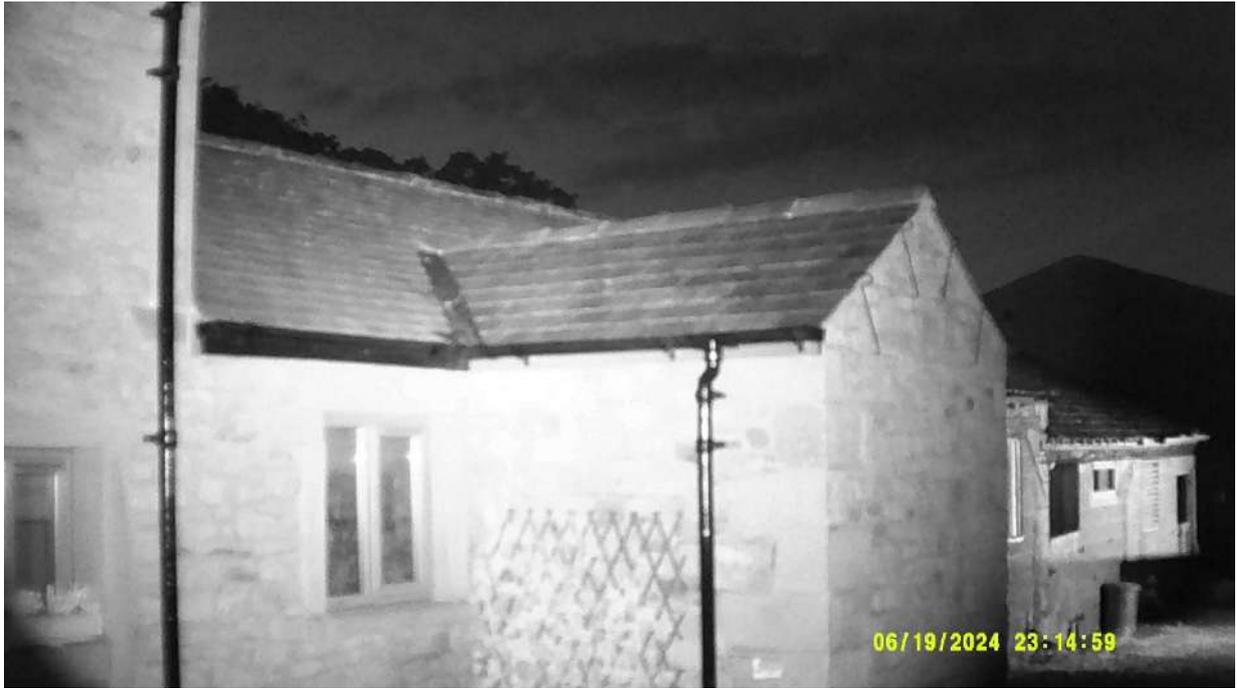
Photograph 3 – Infrared image of the western end of the southern aspect of Building 2 at the darkest point during the survey on the 19th June 2024.

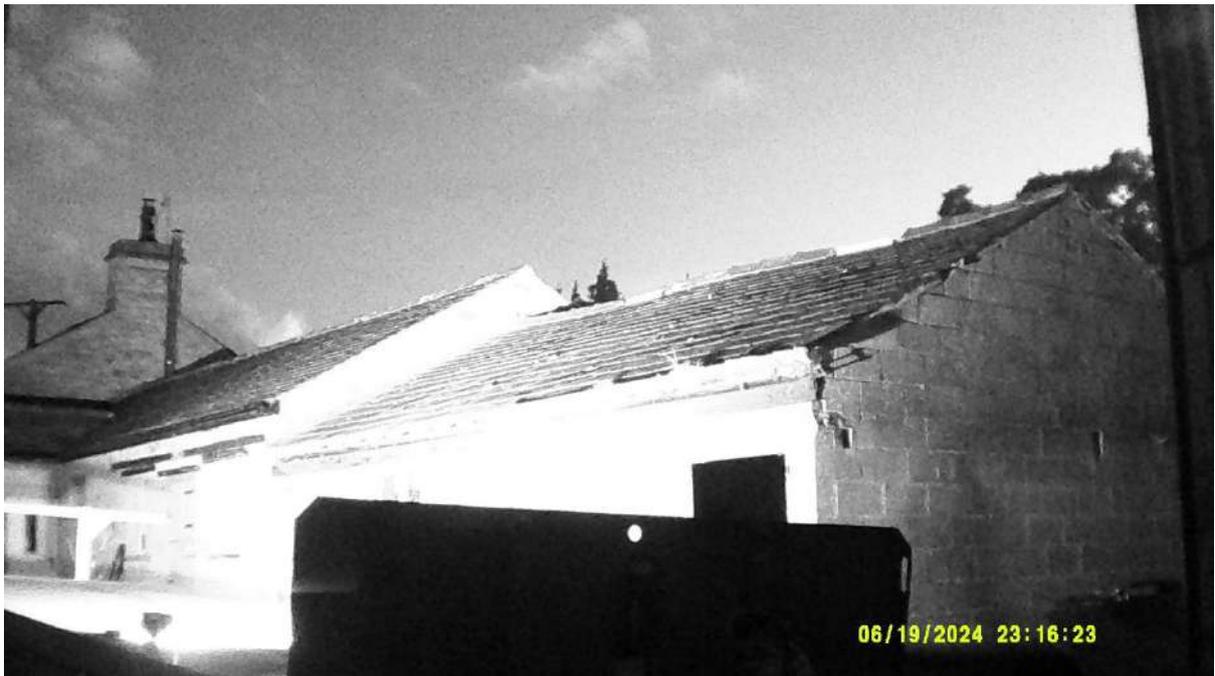
Photograph 4 – Infrared image of the eastern end of the southern aspect of Building 2 at the darkest point of the survey on the 19th June 2024.

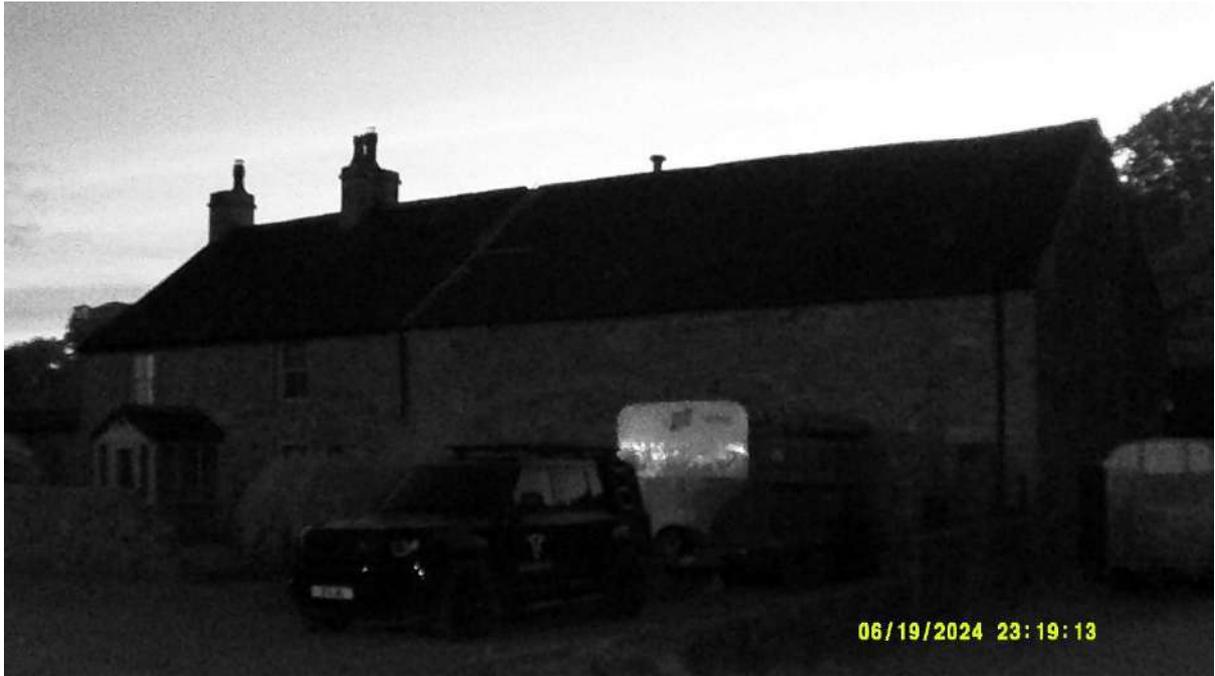
Photograph 5 – Infrared image of the southern aspect of Building 3 at the darkest point of the survey on the 19th June 2024.

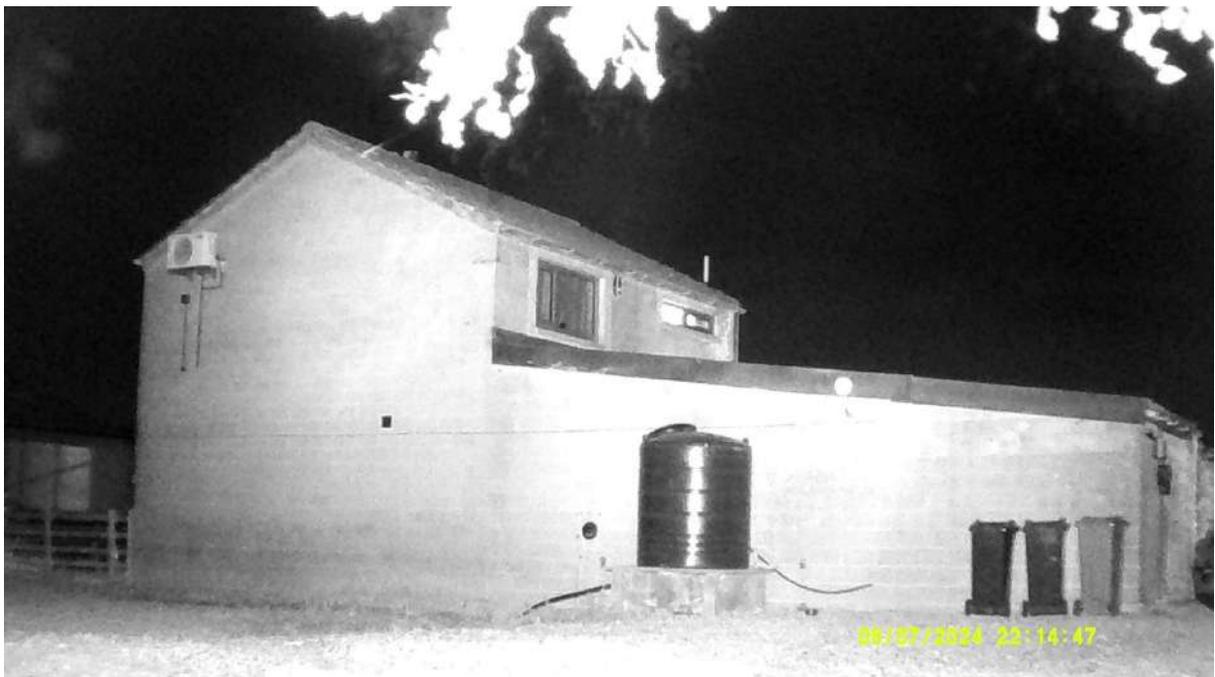
Photograph 6 – Infrared image of the north-western aspect of Building 1 at the darkest point of the survey on the 7th August 2024.

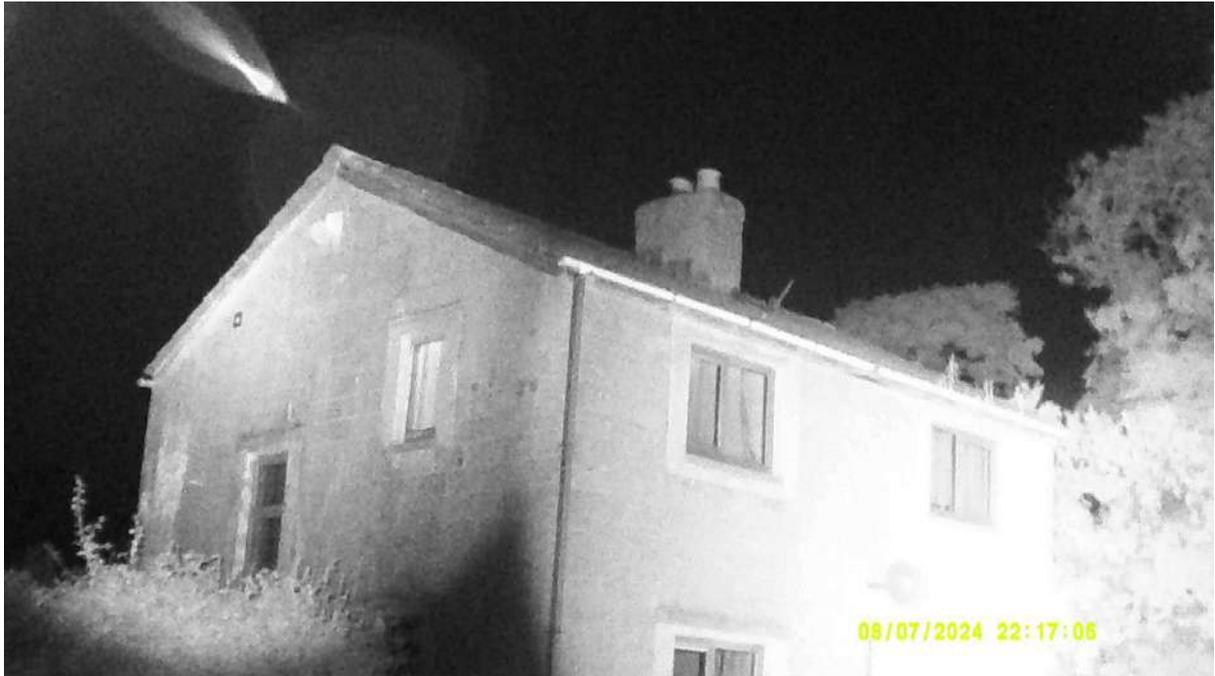
Photograph 7 – Infrared image of the southern aspect of Building 1 at the darkest point during the survey on the 7th August 2024.

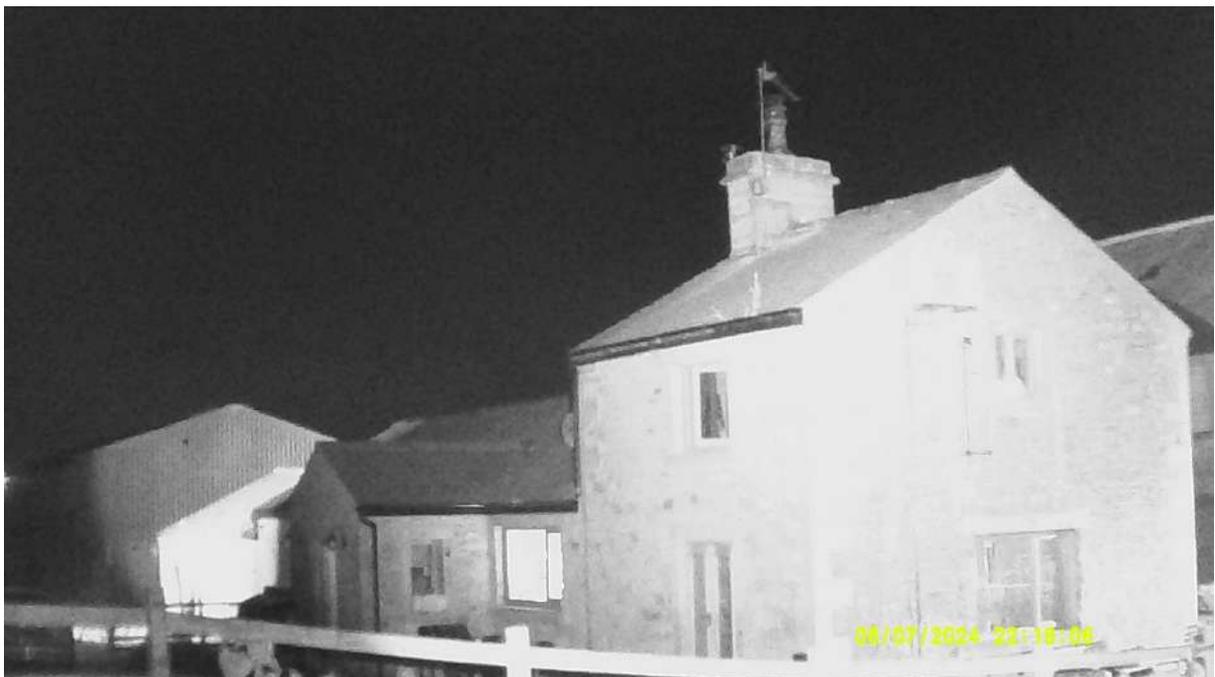
Photograph 8 – Infrared image of the eastern end of the northern aspect of Building 2 at the darkest point of the survey on the 7th August 2024.

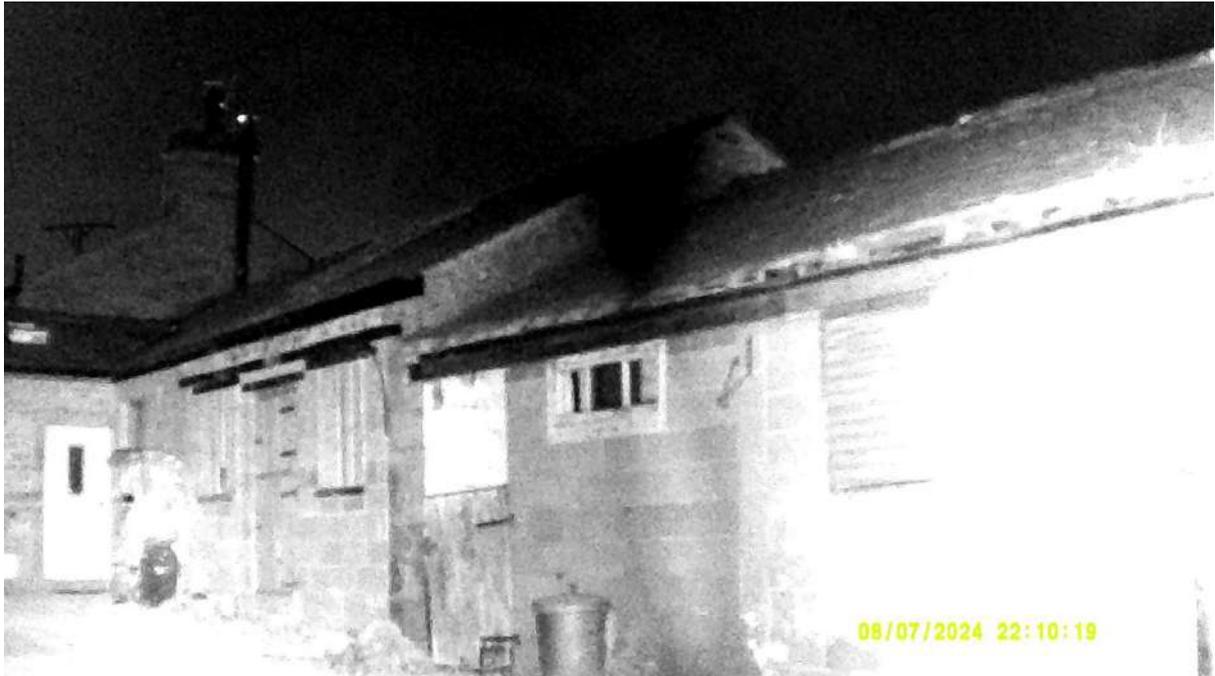
Photograph 9 – Infrared image of the eastern end of the southern aspect of Building 2 at the darkest point during the survey on the 7th August 2024.

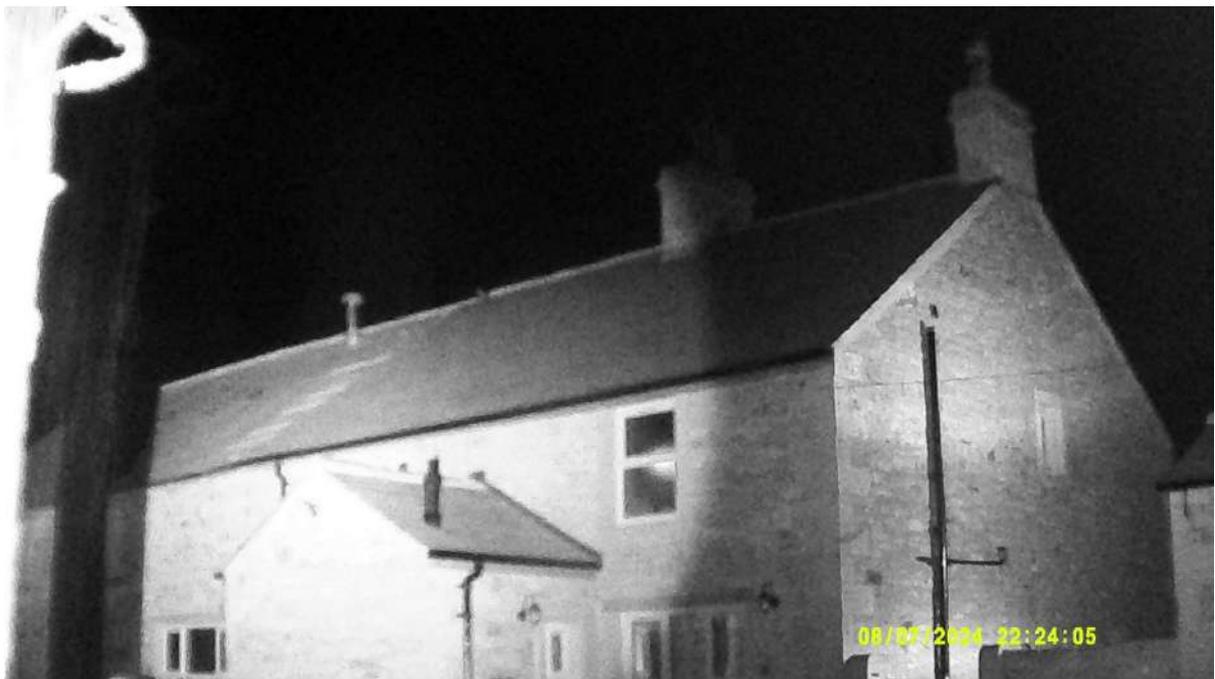
Photograph 10 – Infrared image of the western end of the northern aspect of Building 3 at the darkest point of the survey on the 7th August 2024.

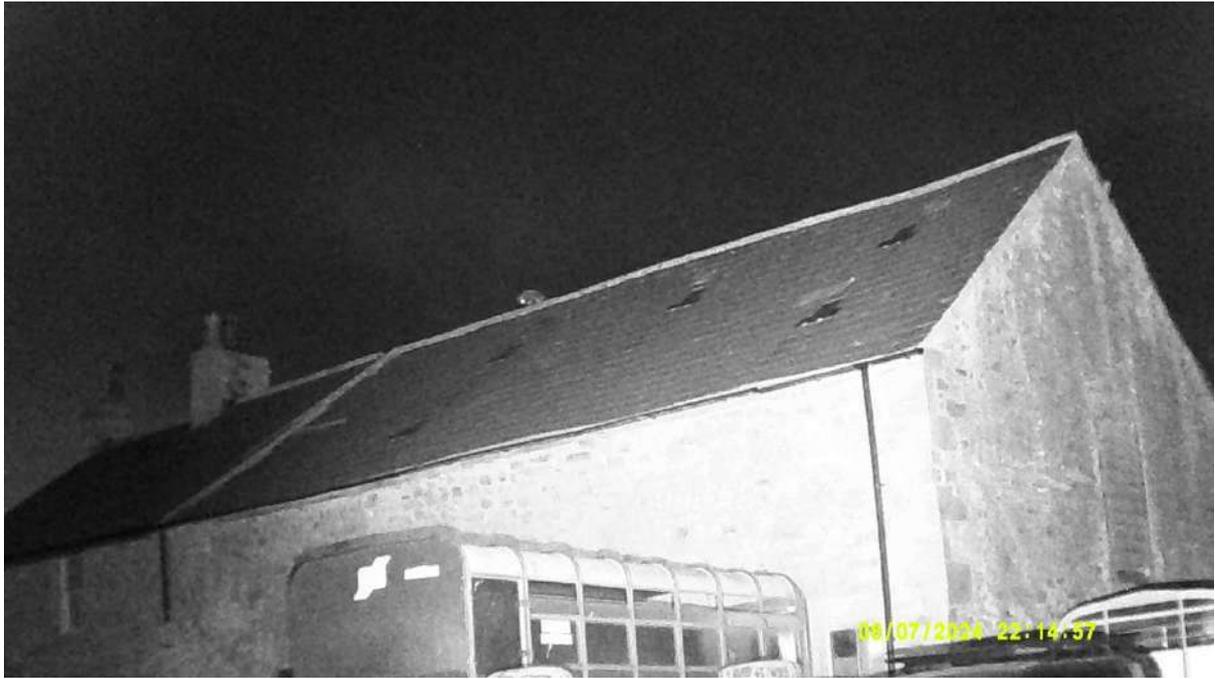
Photograph 11 – Infrared image of the eastern end of the southern aspect of Building 3 at the darkest point during the survey on the 7th August 2024.
