ARBORICULTURAL REPORT
(BS 5837:2012)

LAND AT
NORTHCOTE ROAD
LANGHO
BLACKBURN
BB6 8BG

December 2024

Job Number 4986

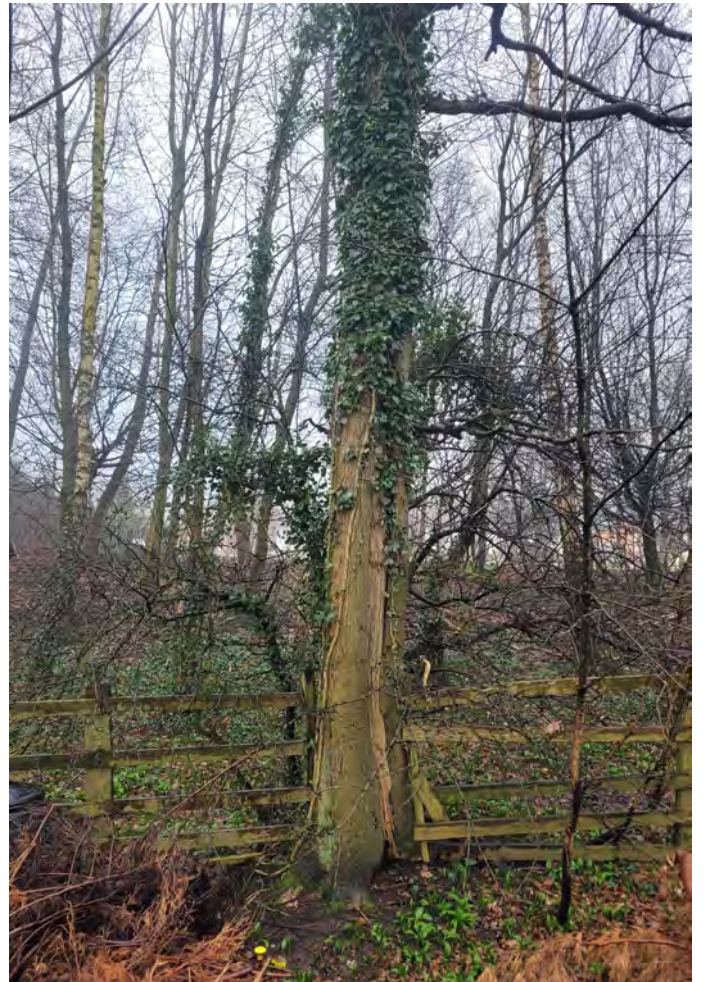
Tree No.	Species	Dbh (mm)	Height (m)	Age	Crown Spread				Crown C	Cond R	Observations and Comments	Preliminary Recommendations	ERC (Yrs)	TQC R	RPA (m ²)	RPA Circle Radius (m)
					N	E	S	W								
T17	Oak	570	17	M	4	6	7	5	4	C	Located on the boundary with crown bias to the east. It has major stem decay due to a longitudinal wound, possibly previously hit by lightning. High crown.	n/a	10+	C2	146.98	6.84
T18	Lawson Cypress	400	8	EM	2.5	2.5	2.5	2.5	0	A	Located within garden of the adjacent property. Good form and vigour. Close to house.	n/a	10+	C1	72.38	4.80
T19	Deodar Cedar	590	10	M	4	5	5	6	1.5	B	A well-shaped specimen located within the front garden of the adjacent property. Good vigour. Evidence of previous height reduction works.	n/a	20+	B2	157.48	7.08
