Ref: 25E/3549/07

**RE: SUPPLEMENTARY REPORT ON NORTH WALL TO FARMHOUSE**

Further to my Structural Appraisal Report dated January 2025, I would confirm that an accurate electronic dimensional survey of the north elevation has been undertaken to identify the extent of lateral deformation which has occurred to the wall. 5No sections through the wall have been prepared to show the extent of lateral deformation which has occurred. This is identified in the attached drawing.

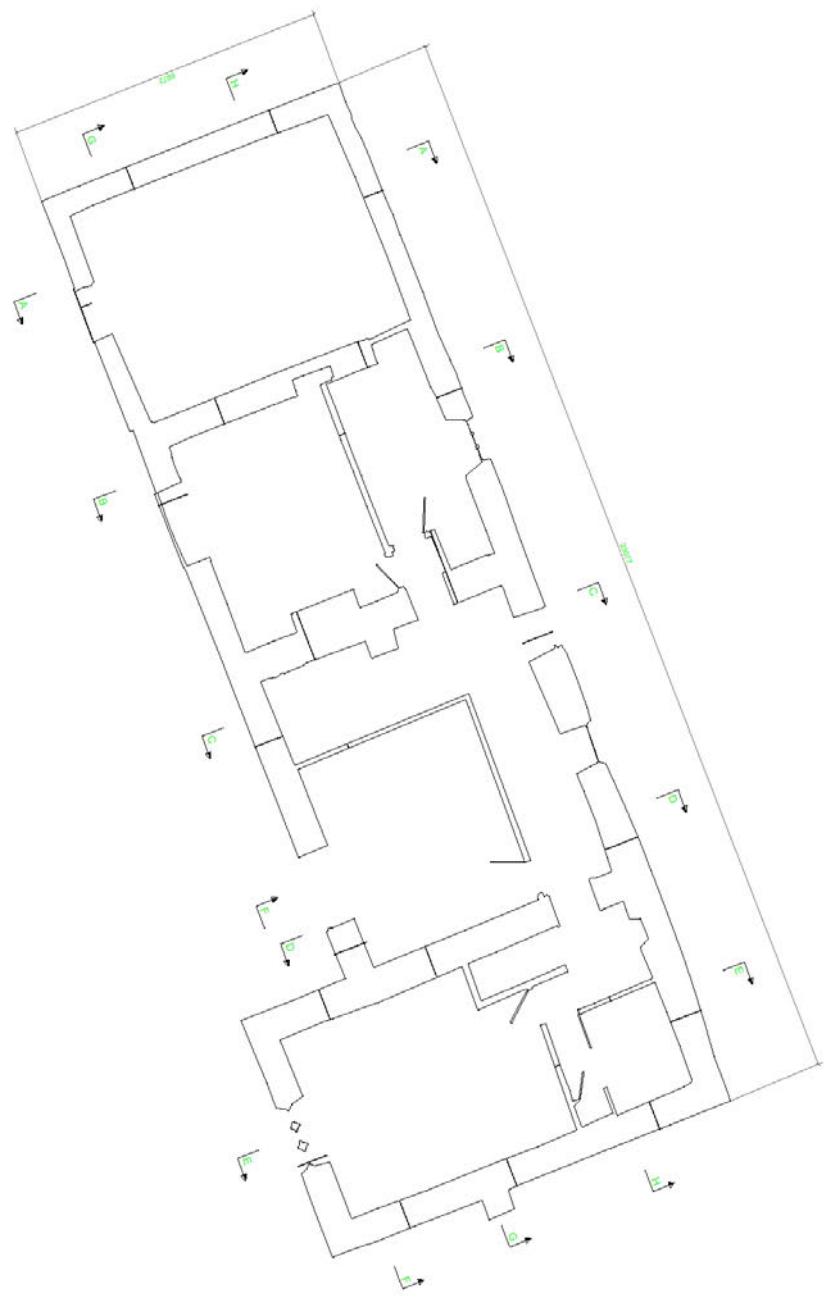
Farmhouse - Existing First Floor Plan

The results show the following deformations:-

1. Lateral deformation of 68mm with an overall thickness of 478mm.
2. Lateral deformation of 162mm with an overall thickness of 714mm.
3. Lateral deformation of 129mm with an overall thickness of 818mm.
4. Lateral deformation of 197mm with an overall thickness of 806mm
5. Lateral deformation of 164mm with an overall thickness of 704mm.

The survey has identified that the thinnest part of the wall with a minimal deformation of 68mm was 478mm. The construction of the wall is likely to incorporate two leaves of solid stone, likely in the region of 150-225mm with through stones tying the two leaves together and with a rubble stone cavity/core.

For a wall to be stable, the extent of deformation is required to be within the middle third of the overall thickness of the wall, subsequently for a wall of 410mm the allowable lateral deformation would be 68mm and for a wall of 550mm thick the allowable extremity of deformation would be 92mm. The thickness of the wall measured is between 478mm and 818mm, this suggests that the outer leaf has bowed to such an extent that the cavity has increased to possibly in excess of 300mm. With a projection of 197mm with a thickness of 806mm the extent of lateral deformation is well outside of what is considered to be acceptable stability. Considering such extensive deformation, strapping or tying of the walls back to the floor is unsuitable and it would therefore be necessary for the whole of the wall to be taken down and rebuilt.
