**Job No. 6955**

**BUILDING STRUCTURAL SURVEY**

PROPOSED CONVERSION OF  
GREEN BARN, PART OF OUTBUILDING 01 AND OUTBUILDING 02  
AT EAVES HOUSE FARM,  
WEST BRADFORD,  
CLITHEROE,  
BB7 3JF

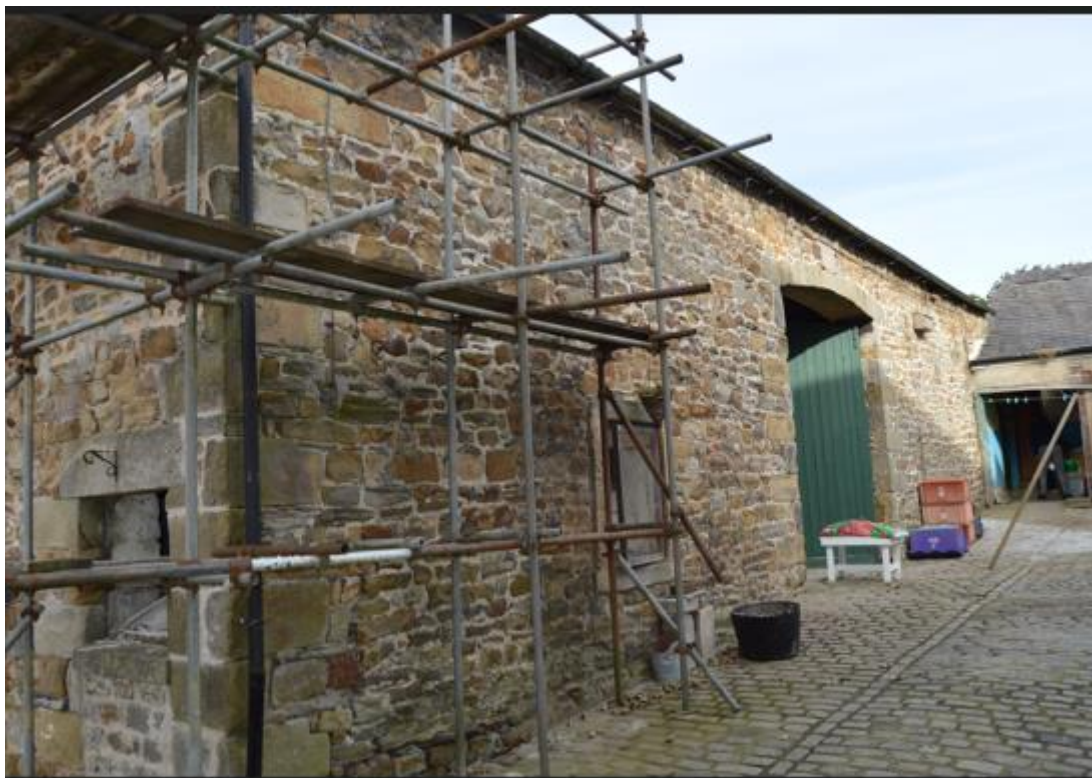
*PL01: East facing photo of Green Barn (Front Elevation)*

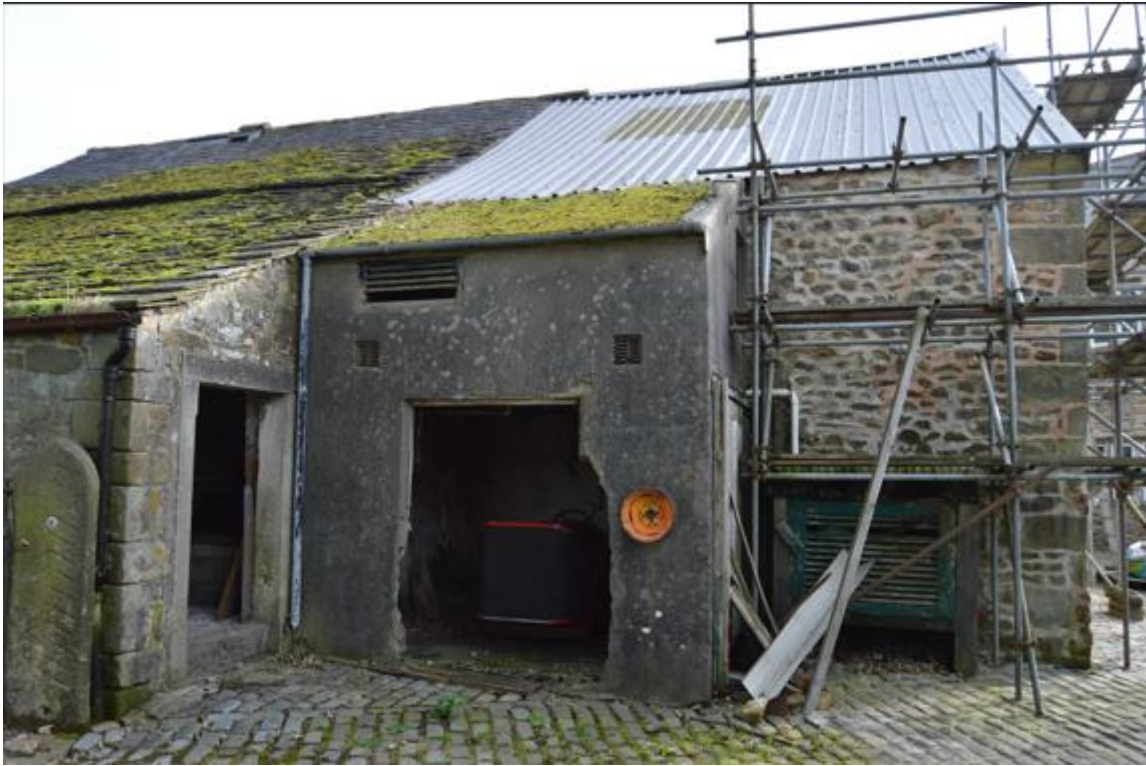
*PL04: West facing photo of Green Barn, shippon and rendered lean to addition to original barn (Rear Elevation)*

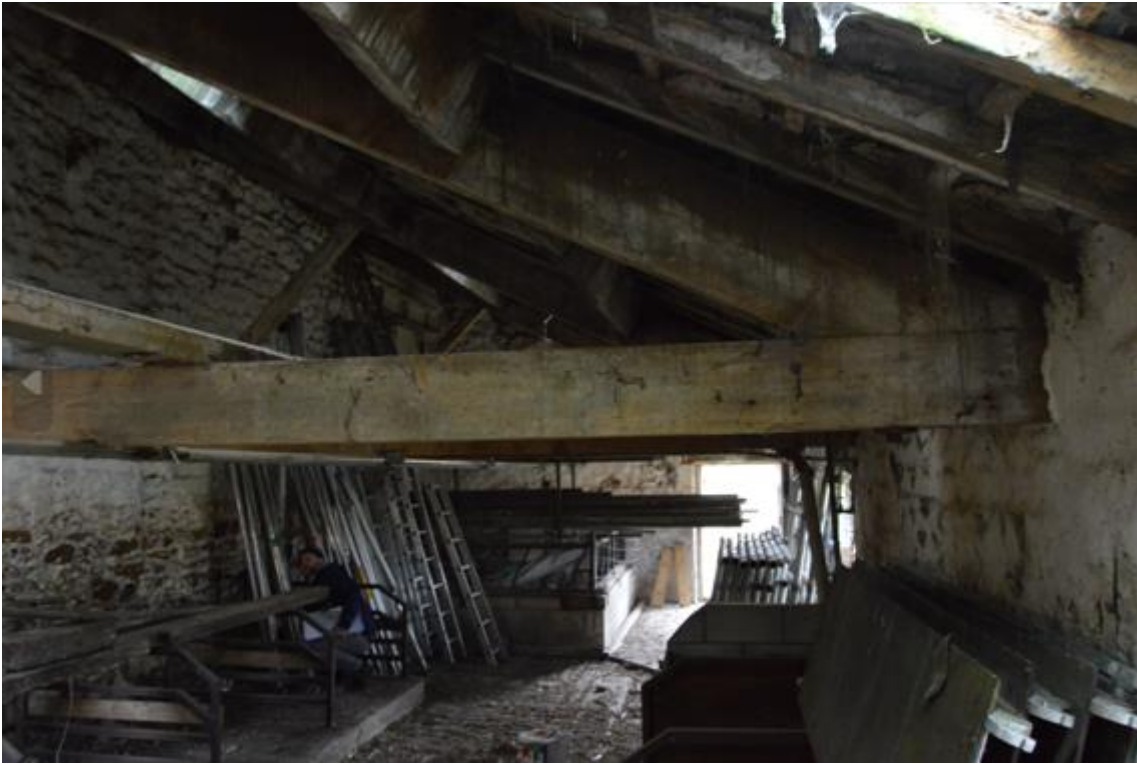
*PL08: Internal photo of Green Barn Shippon looking to the south*

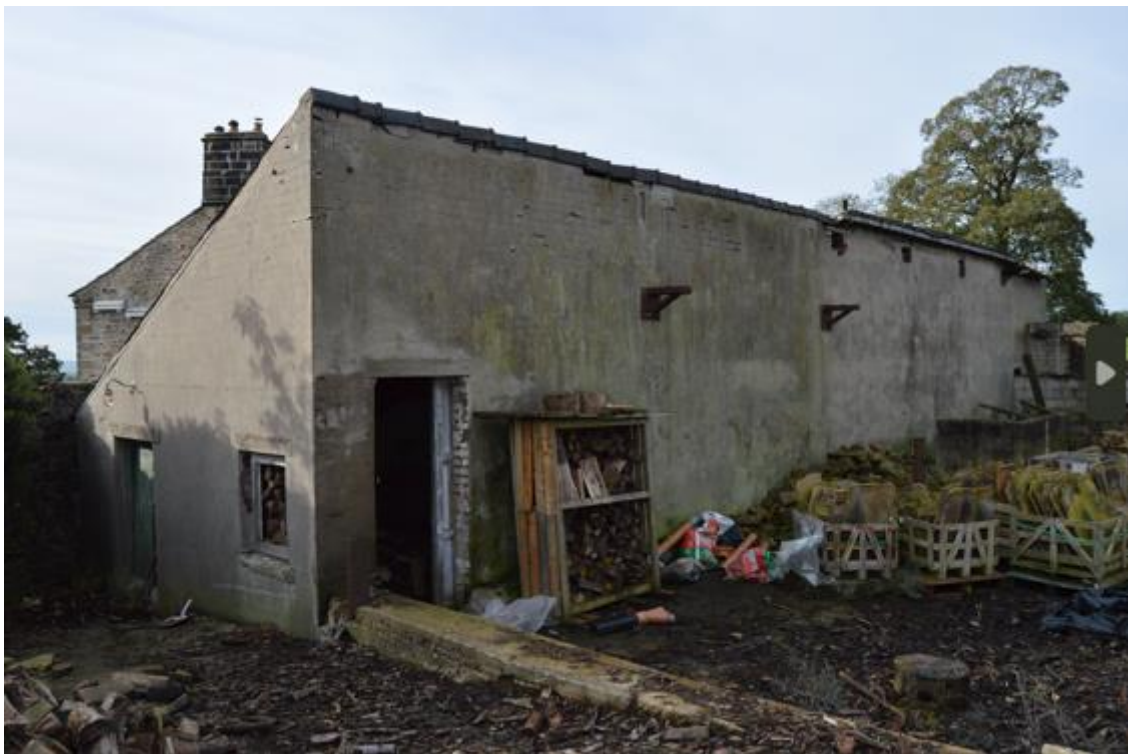
*PL09: Outbuilding 2; more recent construction comprising of solid brickwork / blockwork walls rendered with mono pitch roof. To be refurbished and altered for use as proposed garages.*

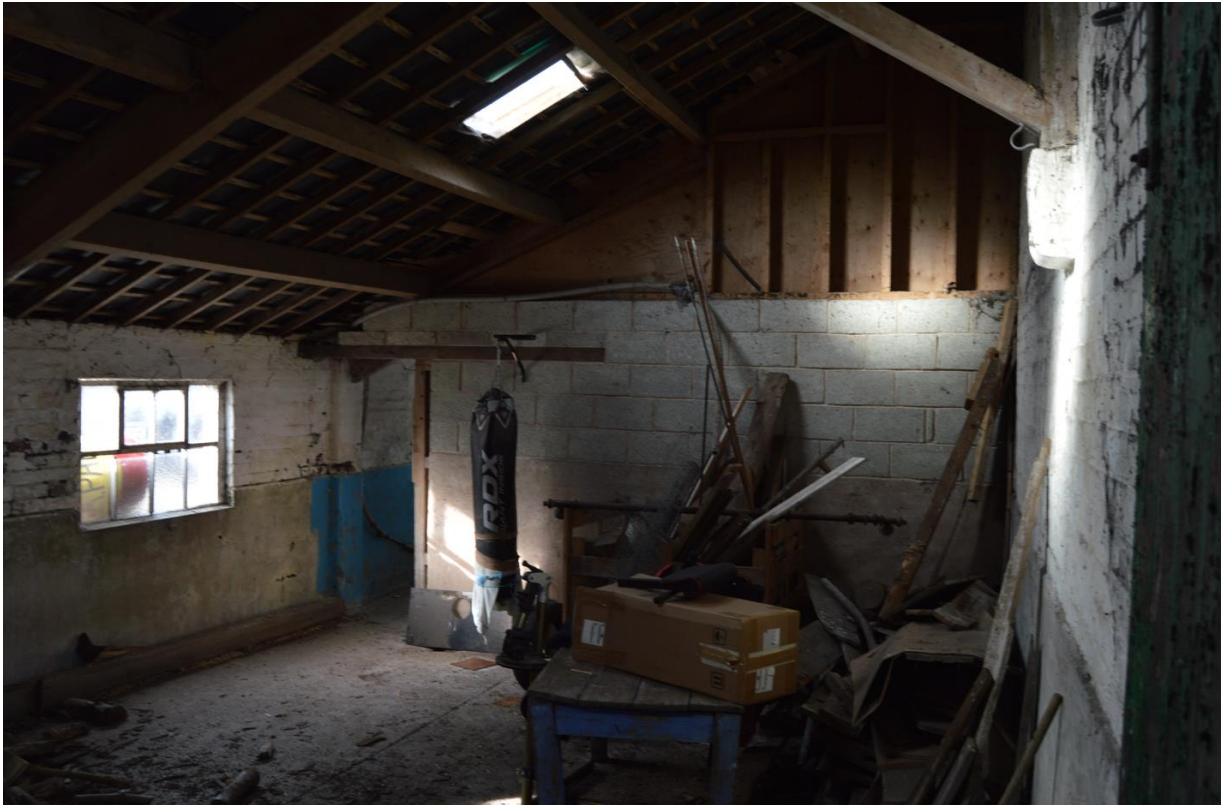
*PL10: Outbuilding 2; more recent construction than Green barn, internal photo showing mono pitch rafter and purlin roof with supporting half trusses all in more recent sawn timber than the barn. To be refurbished and altered for use as proposed garages.*

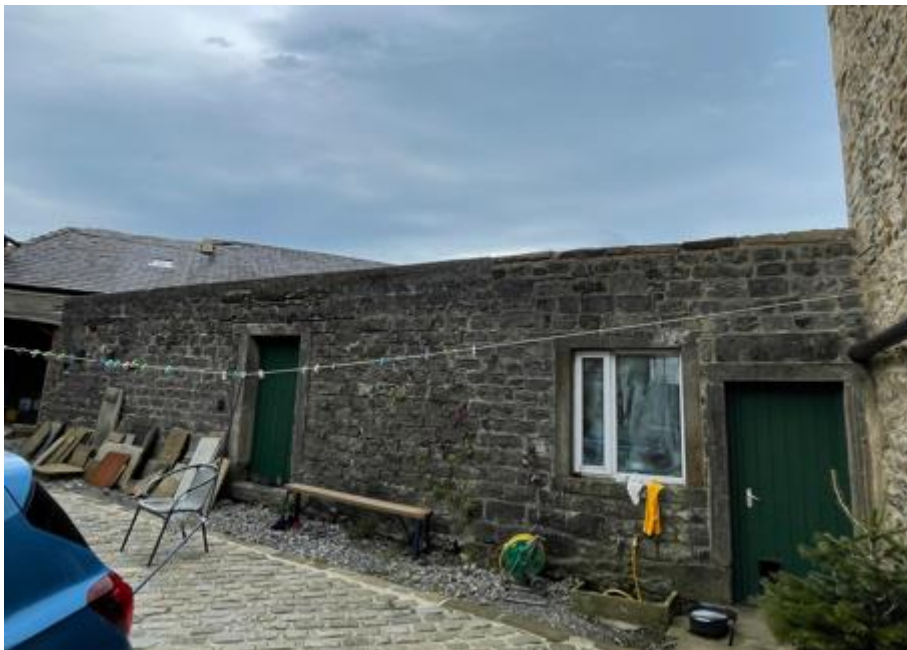
*PL11: Outbuilding 1; The right hand side is currently used for plant room, it is proposed to refurbish the end section on the left hand side to use as office accommodation. Structurally the walls are in natural stone and the refurbishment will consist of dry lining internally without disturbing the existing building fabric.*

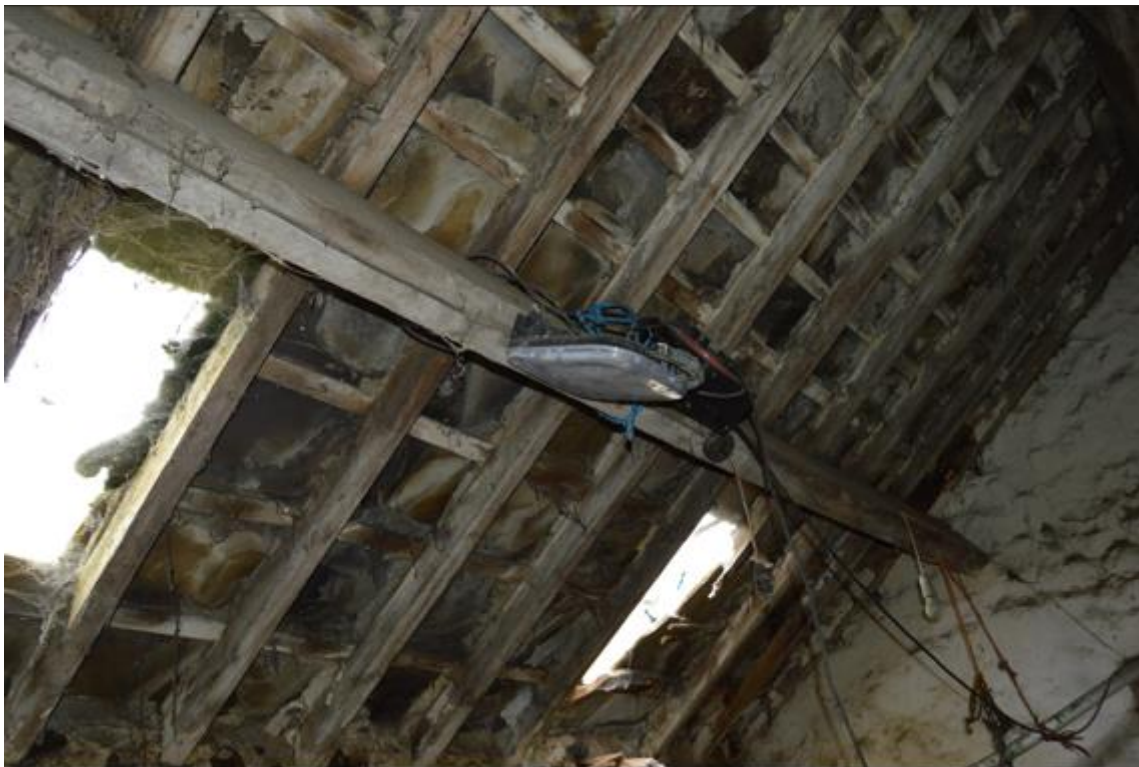
*PL16: Photo showing underside of shippon roof, comprising of purlins and rafters with stone slates / flags over.*

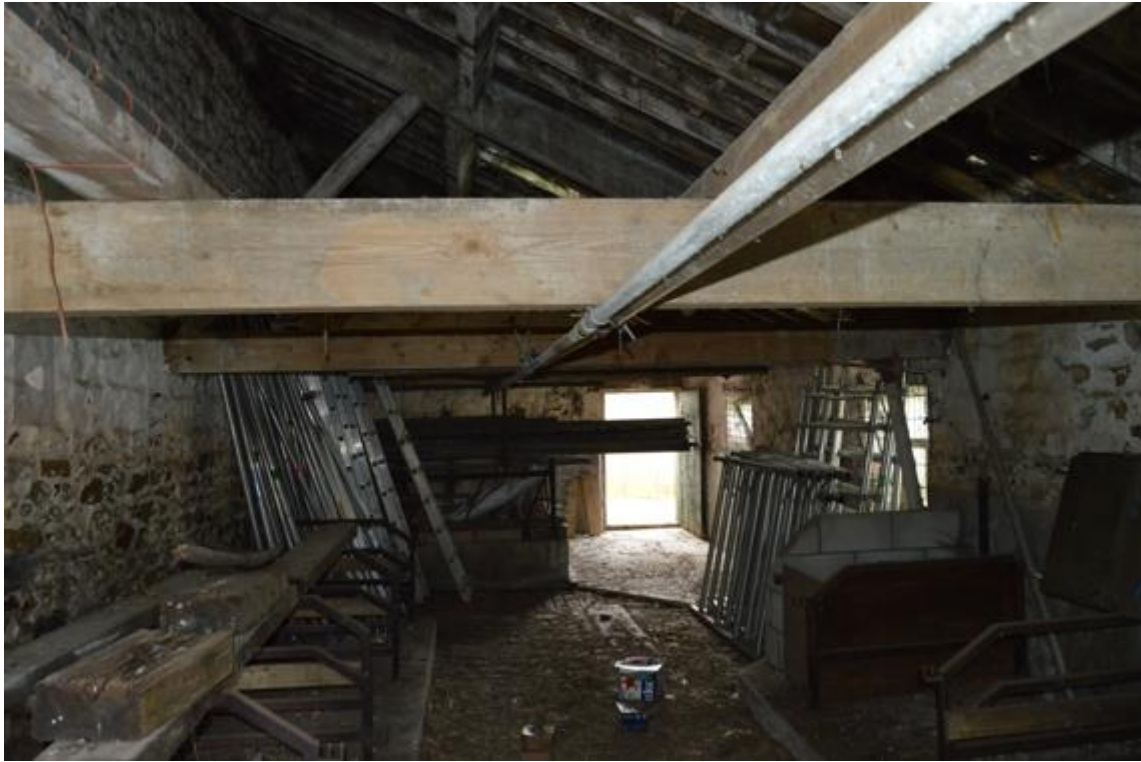
*PL17: Photo showing underside of shippon roof, comprising of sawn timber half trusses purlins and rafters with stone slates / flags over.*

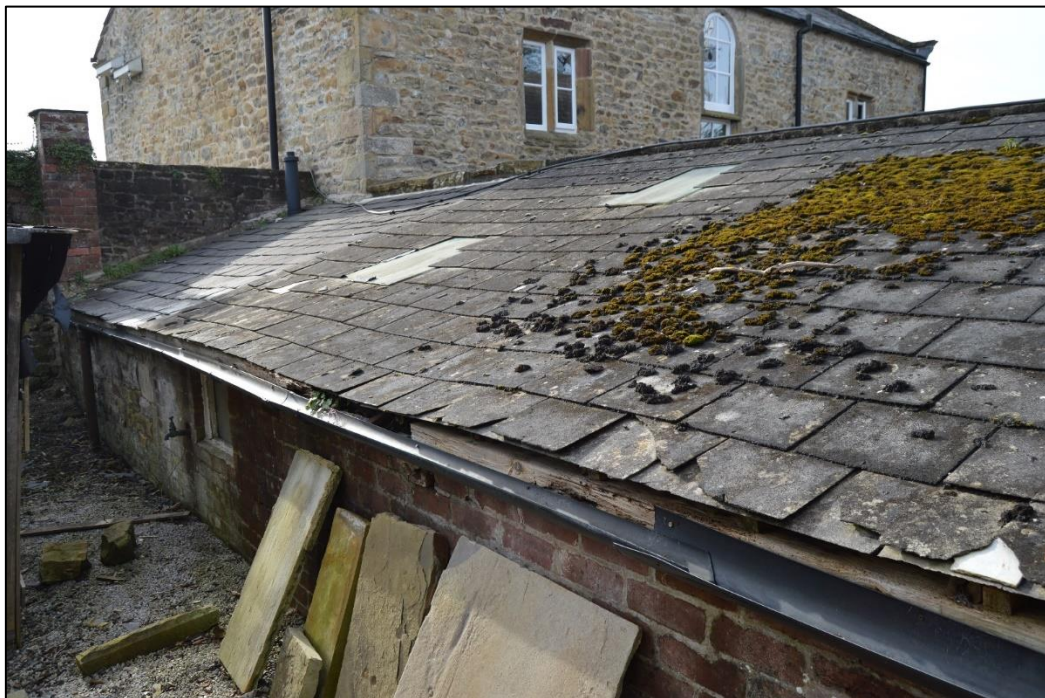
*PL18: Photo showing slate/tile roof finish over Outbuilding 1 (which adjoins Eaves House Farm to the rear)*

*Outbuilding 1: The roof structure to outbuilding 1 is constructed of sawn timbers throughout and all appear to be in good condition. The trusses and purlins these are built into the solid brick and stone walls and can all be subject to localized damp. Overall the condition of the roof is good and is fit for conversion for the proposed home office usage. It is advised that it is re-roofed including a breathable underlay over the rafters before battening and re-fixing slate along with reclaimed slate to match existing. It is also recommended that all roof timber is treated with SIKAGARD as recommended to the barn see below.*
