Bridge End Farm

Historic Building Report: Analysis and Interpretation

J. Deadman Historic Buildings Survey and Research

2025

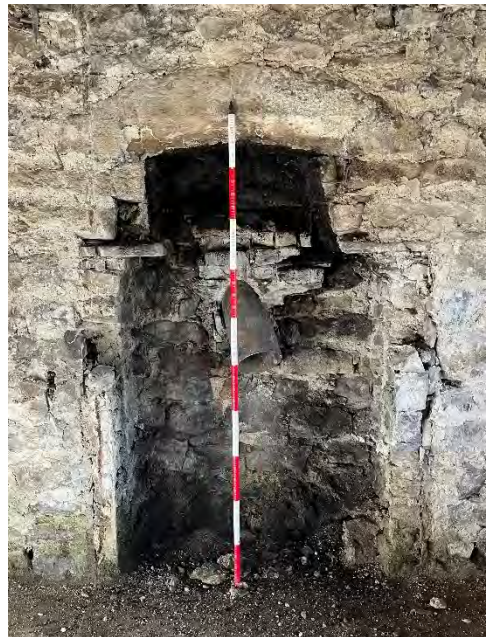
Plate 28

The fireplace in the parlour, formerly with a ‘60s’ surround, (*pers.comm.*) has been removed. A chamfered length of stone remains in situ above the opening which probably acted as a relieving arch over the original fireplace. Its design would suggest it came from an earlier building. (plate 28)

Detail of relieving arch

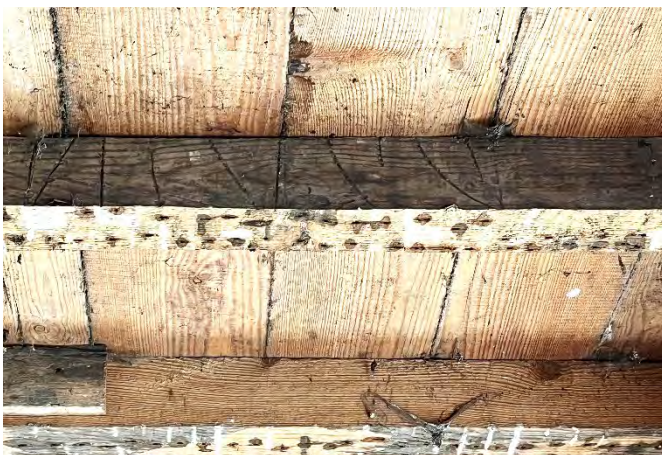
Plate 30

*Joist with possible Baltic timber marks.
18th/19th century*

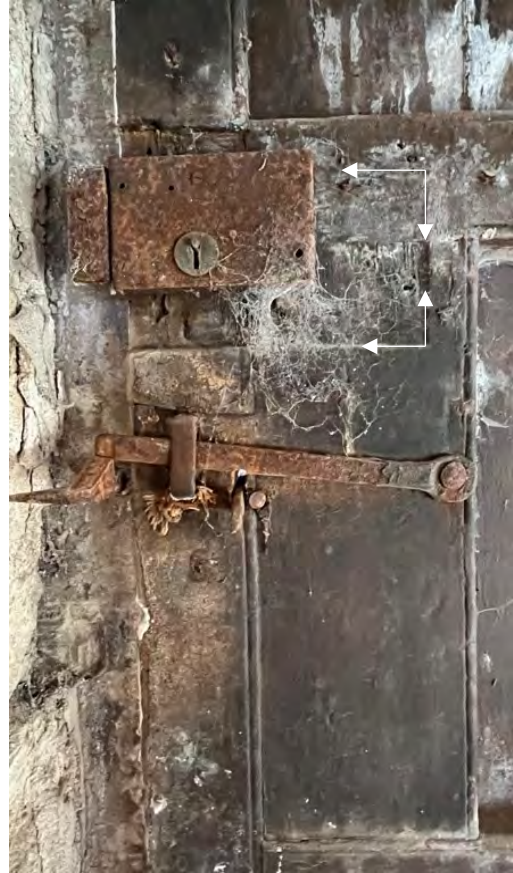
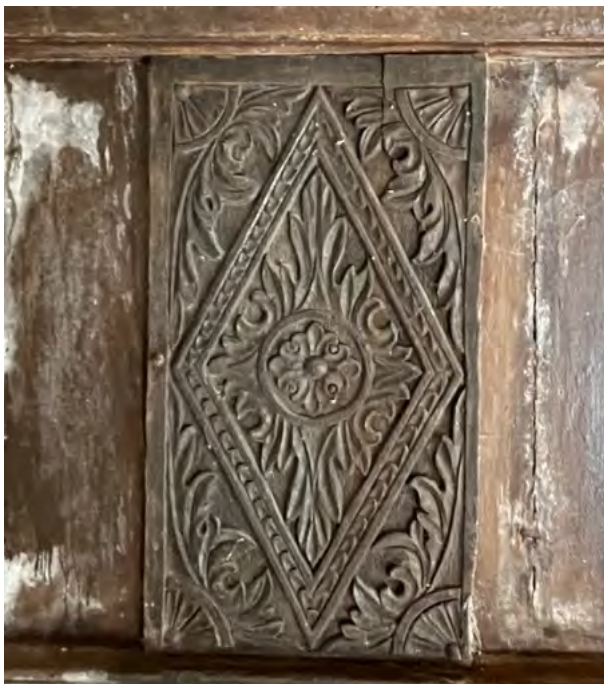
Plate 34

The latch and lock are not original, but replace earlier fittings. The latch is blacksmith made and probably dates to the 19th century. The lock has replaced a much larger one as evidenced by the seating seen behind it. (Indicated by arrows)

The inset panel is beautifully worked and may be of 17th century origin.

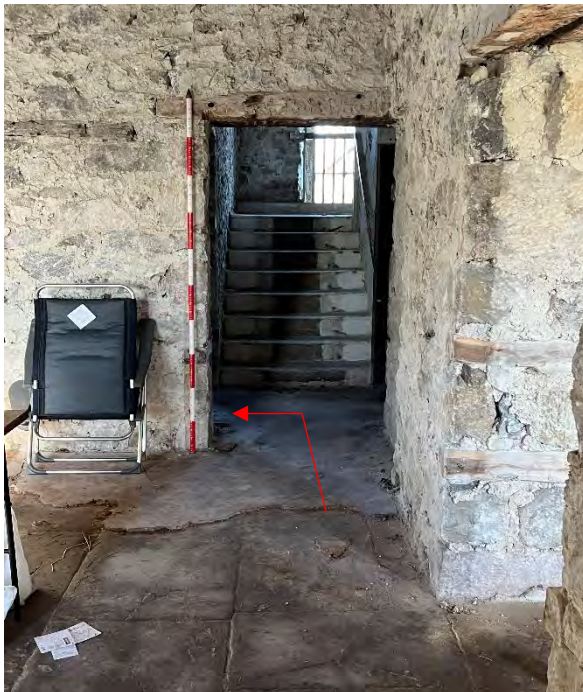
Plate 35

Stair well viewed from the housebody. Kitchen to left.

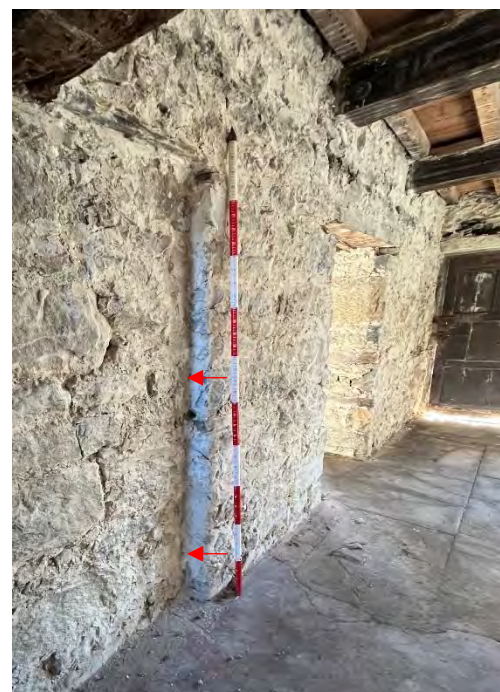
Plate 36

The kitchen is located behind the housebody and accessed off a small lobby area at the bottom of the stairs. The cross wall is recessed 10 cm at the access point between housebody and lobby, suggesting the door opened into the housebody, the recess allowing for the door to be opened flush with the wall. This design feature is frequently seen in cattle byres to allow ingress and egress of cattle without injury. It is not unknown in domestic buildings.

View to front showing door recess.

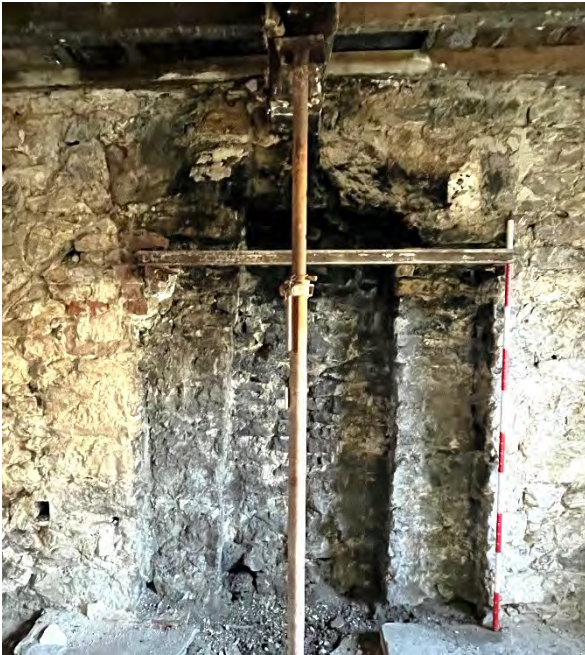
Plate 37

The main feature of the kitchen would have been the fireplace. The original appears to have been removed. 20th century quarry tiles suggest a later insertion, also removed. An iron bar has been used latterly as the supporting lintel.

Kitchen fireplace.

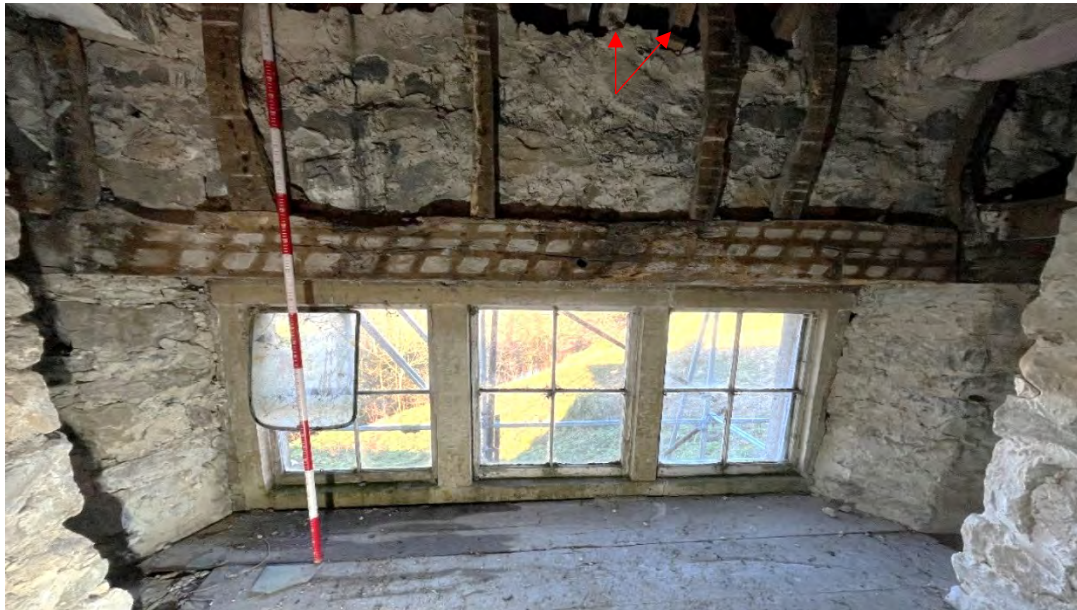
Plate 52

The rafters and battens in the attic space, and visible here behind the wall, appear to be relatively modern, and may suggest that both the attic and half landing ceiling were underdrawn against an earlier roof structure. Certainly the survey of 1911 describes the attics as 'under drawn'. (ref page 12)

Rafters behind wall.

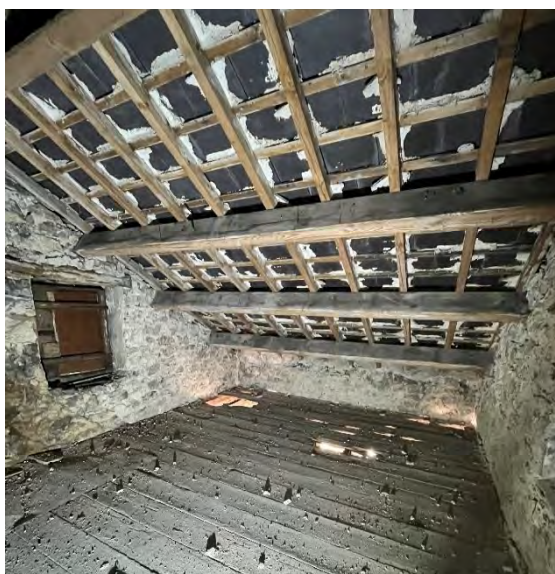
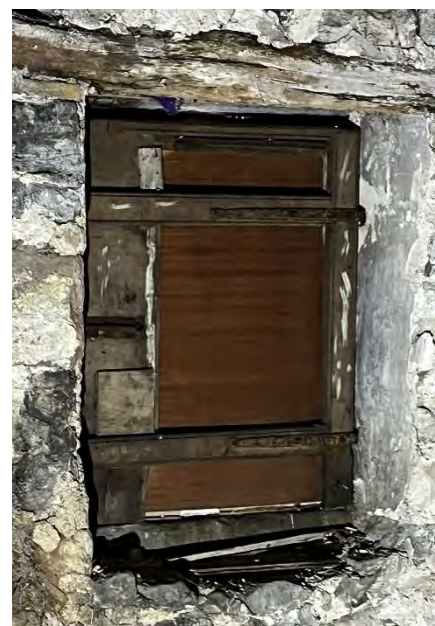
Plates 57 and 58

Room east with small window, previously boarded. The frame, battens, one board and hinges remain.

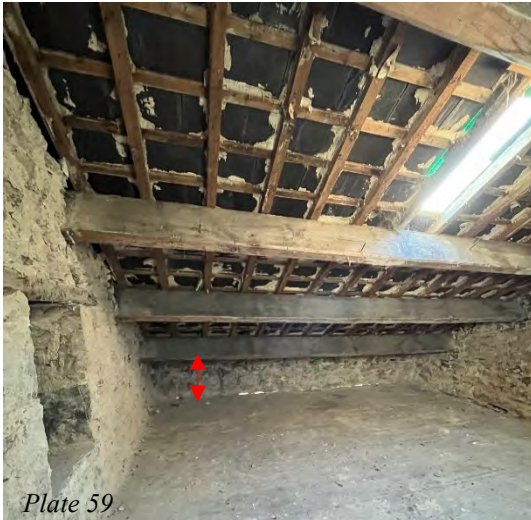
Plate 59

*Room west. Cross wall with aperture.
Roof light on south slope.*

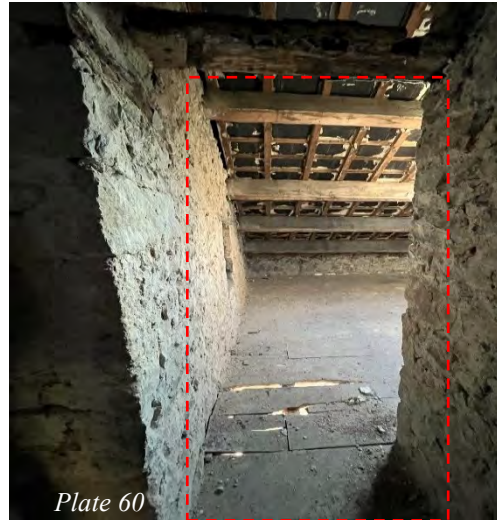
Plate 60

The entry points to each room are located either side of the cross wall. The doors and frames are missing, but the associated heavy wooden lintels remain in situ . There is no fill above the lintels which may suggest there was an opening above each door to maximise available borrowed light.

*Location of former doorway into west room
with lintel over, and open space above*

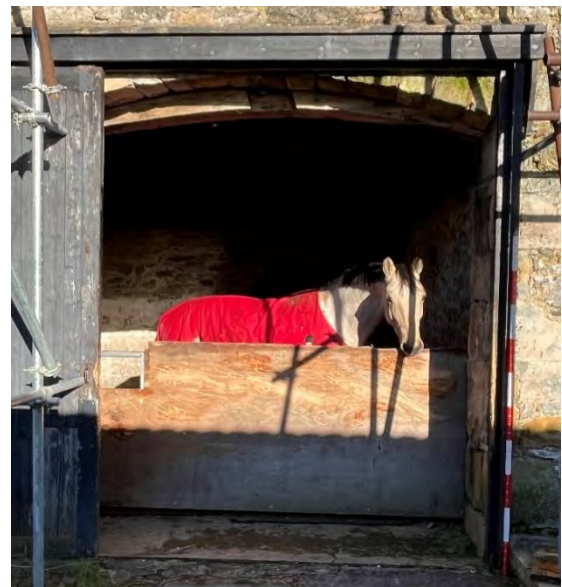
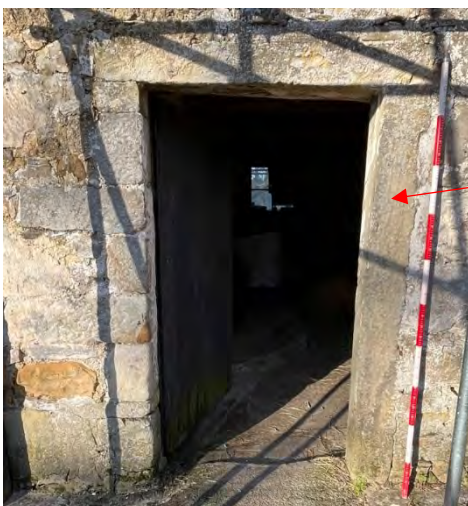
Plates 64,65

Beyond, is the byre entry, a plank door with standard 19th/20th century ironmongery. Note the reveal to right is a later replacement, the original possibly having suffered from cattle damage.

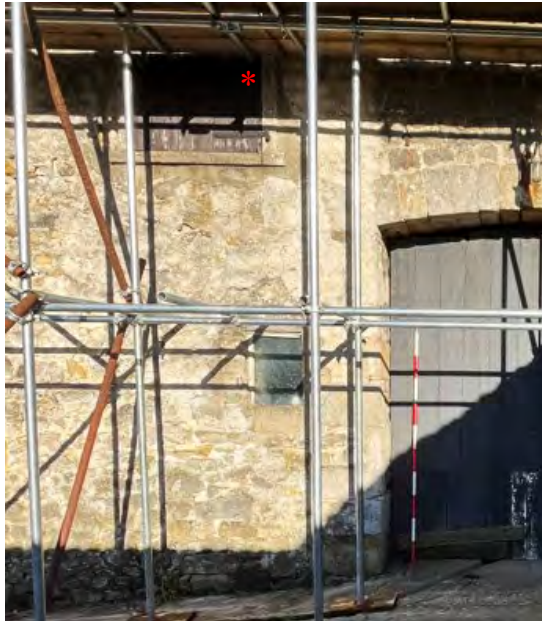
At the lower level is a small opening, too high at 140cm for a muck hole, but possibly designed/inserted to light the head end of the byre. It has a modern wooden lintel.

At the upper level is a forking hole from where hay could be offloaded from a cart onto the loft above the byre.

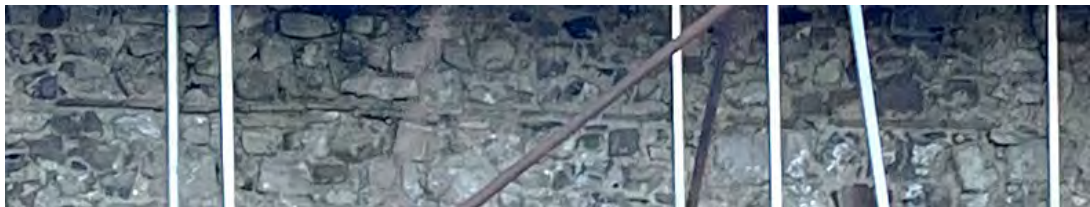
Plates 68, 69

Straight joint ?

Window, possible site of earlier muck hole

Window, with monolithic jambs, lintel and cill

Working from west to east is first, a large window with monolithic sandstone jambs, lintel and cill. Although stylistically 19th century in design it is remarkably unweathered considering its north facing location. It has been reduced in size with brick blocking. Although a doorway is frequently found in this location in a hay mew, there is no evidence for straight joints below the window to indicate the location of a former entry. Either the window was a later insertion or simply replaced a smaller aperture.

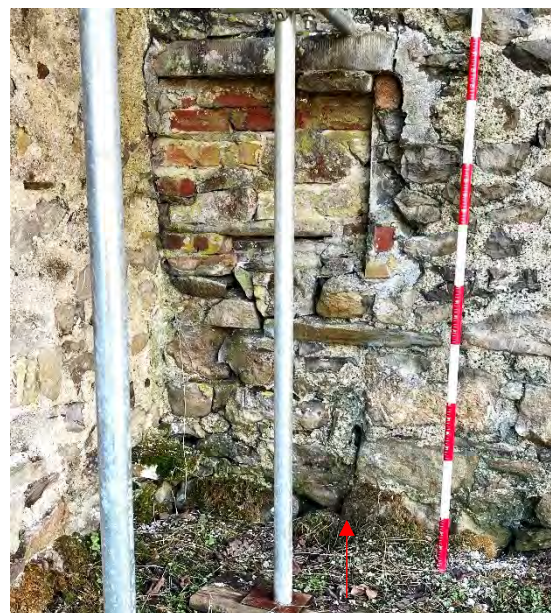
Plate 73

Query straight joint

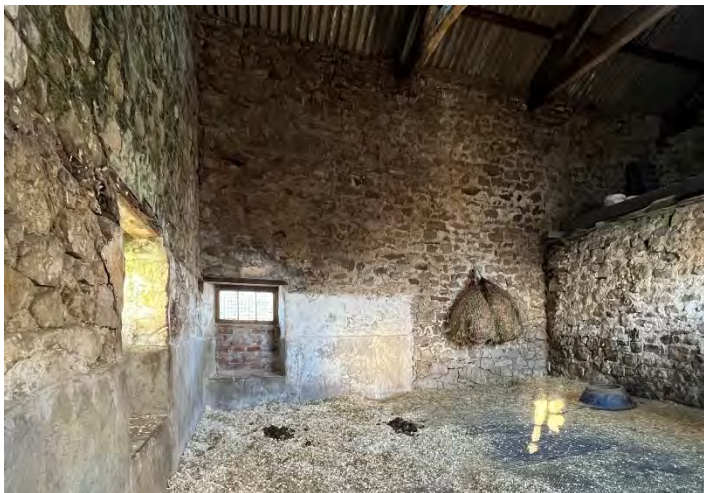
Former mew and cart bay viewed from the pedestrian entry on the yard elevation.

To the right is the stone cross wall which separates the byre from the rest of the building. The open space above is the hay loft.

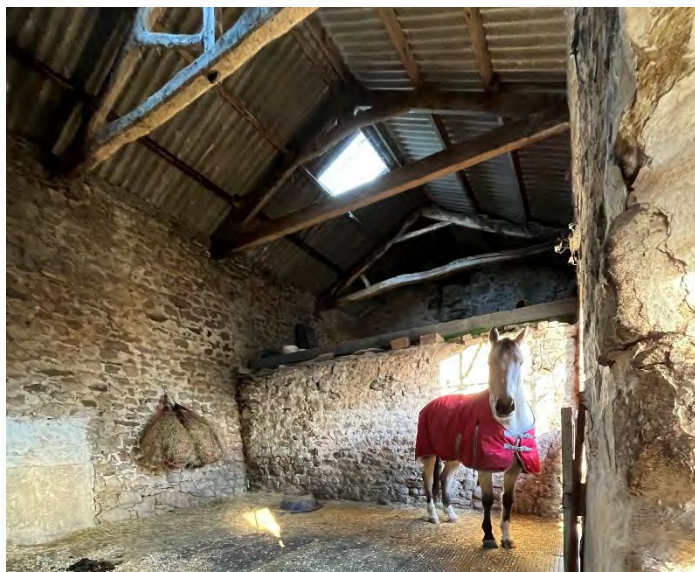
Plate 75

View looking towards the loft over the byre.

The three trusses, all of different construction are described further on page 45

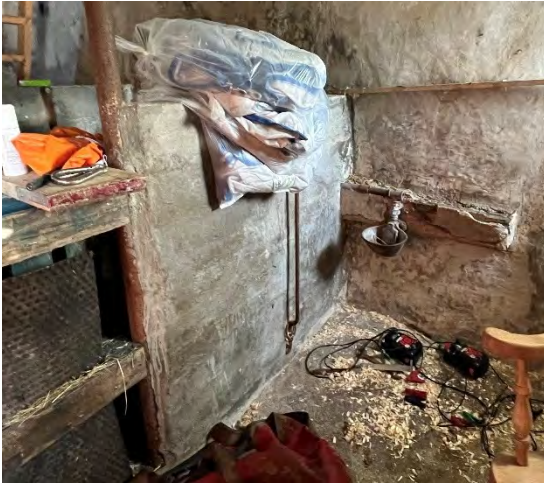
Plate 77

Concrete stall with steel end poles, tethering bars, and water holders.

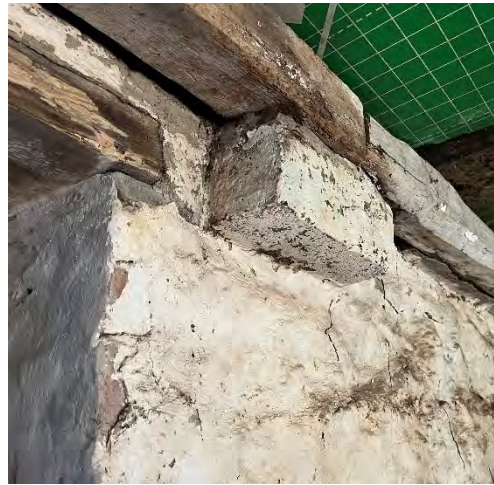
Plate 78

Trimmer beam lodged on stone corbel

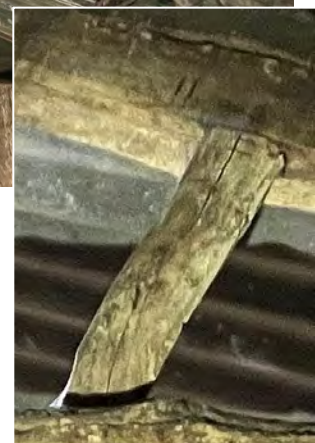
The roman numeral, 11, is neatly chiselled into the wood, suggesting it is 17th or 18th century in date. A shallower, less precise mark as created by a rase knife, would suggest an earlier 16th century date.

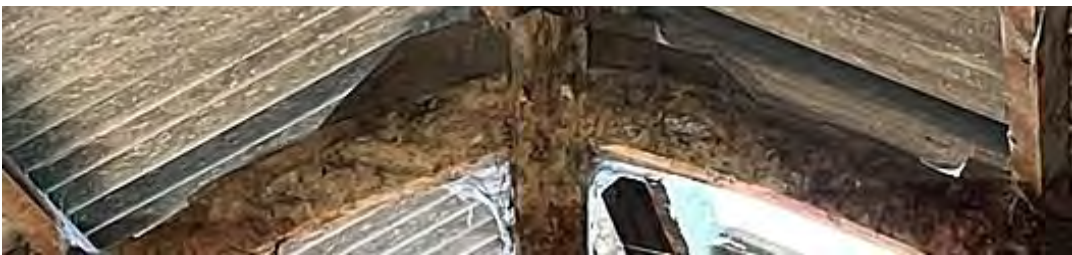
Plate 83

Head of king post with slightly cambered principal rafters

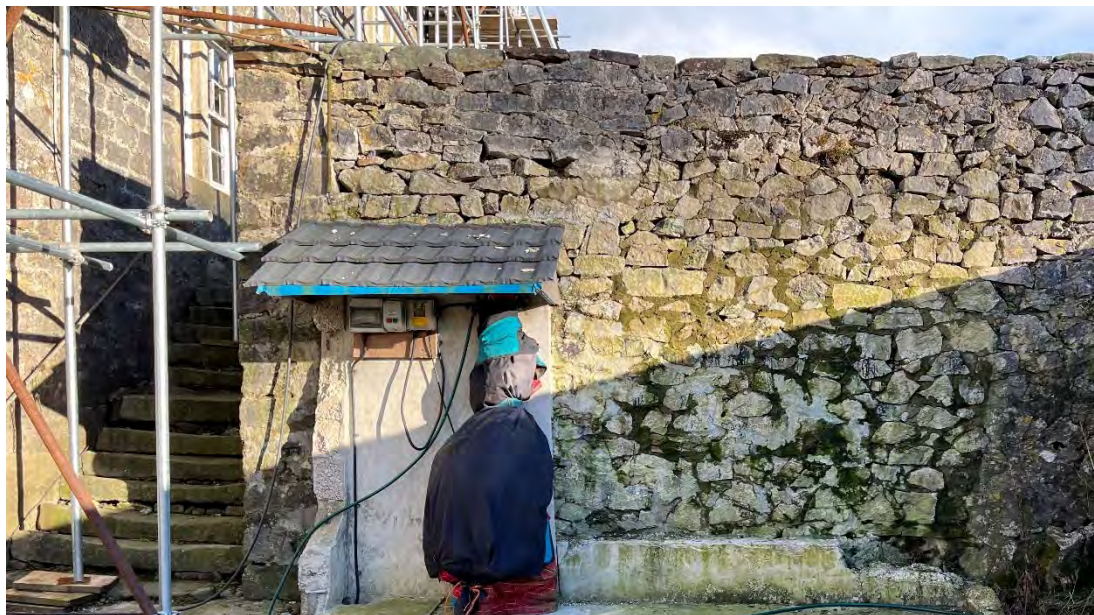
Plate 86

Rear, with banking and revetted wall designed to accommodate the fall of the land. Rubblestone to rear elevation as farmhouse, with long and short corner quoins

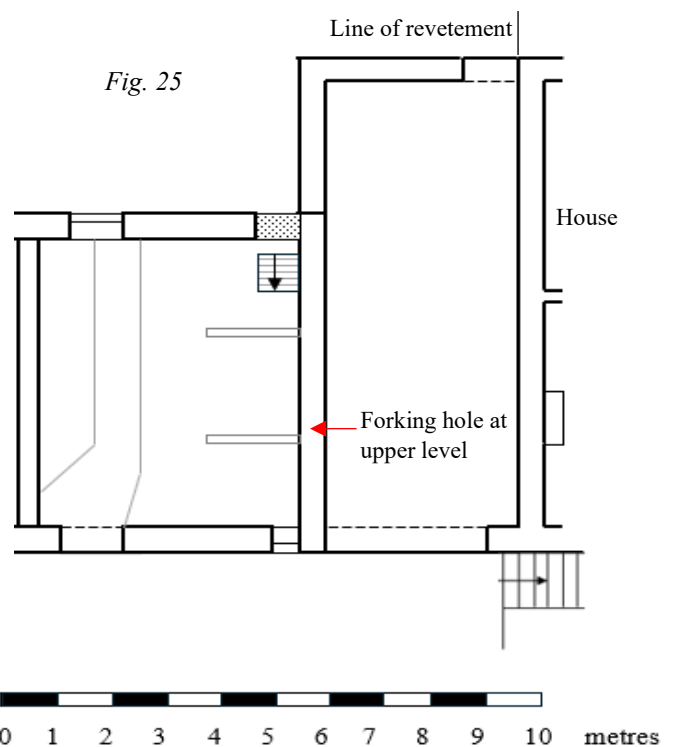
With the exception of a small, plank-lined cupboard with double doors located to the west, the walls are devoid of features.

Cupboard

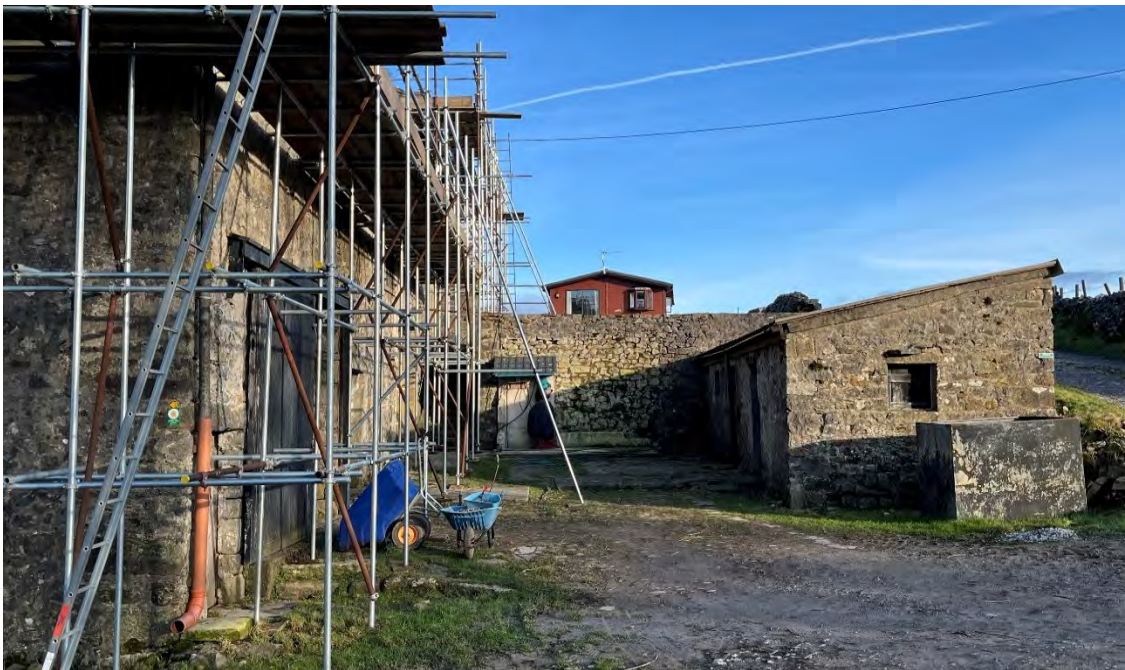
Plate 92

Yard viewed from the west

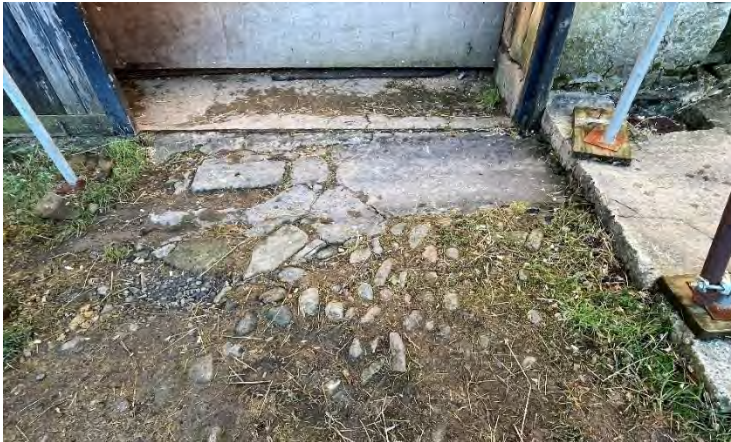
Plate 93

The yard has partially been laid to concrete although cobbles are visible, laid east west, and may well extend underneath the modern cover.

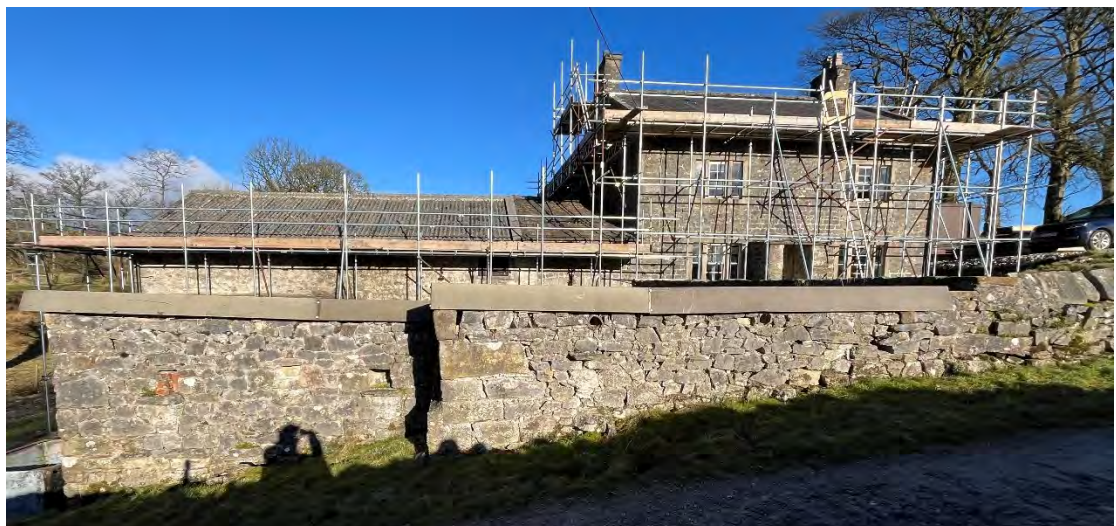
Plate 95

Byre and pig sty viewed from the track side

The building set against the garden wall is a small byre comprising two cattle stalls, possibly to house either calves or sick animals. The cement render walls and a stall divider of concrete suggests this was used as such, certainly during the 20th century.

The second has a cobbled floor and may have served as a pigsty. The rear wall of this unit has three recesses reminiscent of hen holes. It may have been lofted originally..
