Preliminary Roost Assessment

2 Chapel Close
Brockhall Village
Blackburn
BB6 8HU

For
Mr & Mrs Turner

Gritstone Ecology

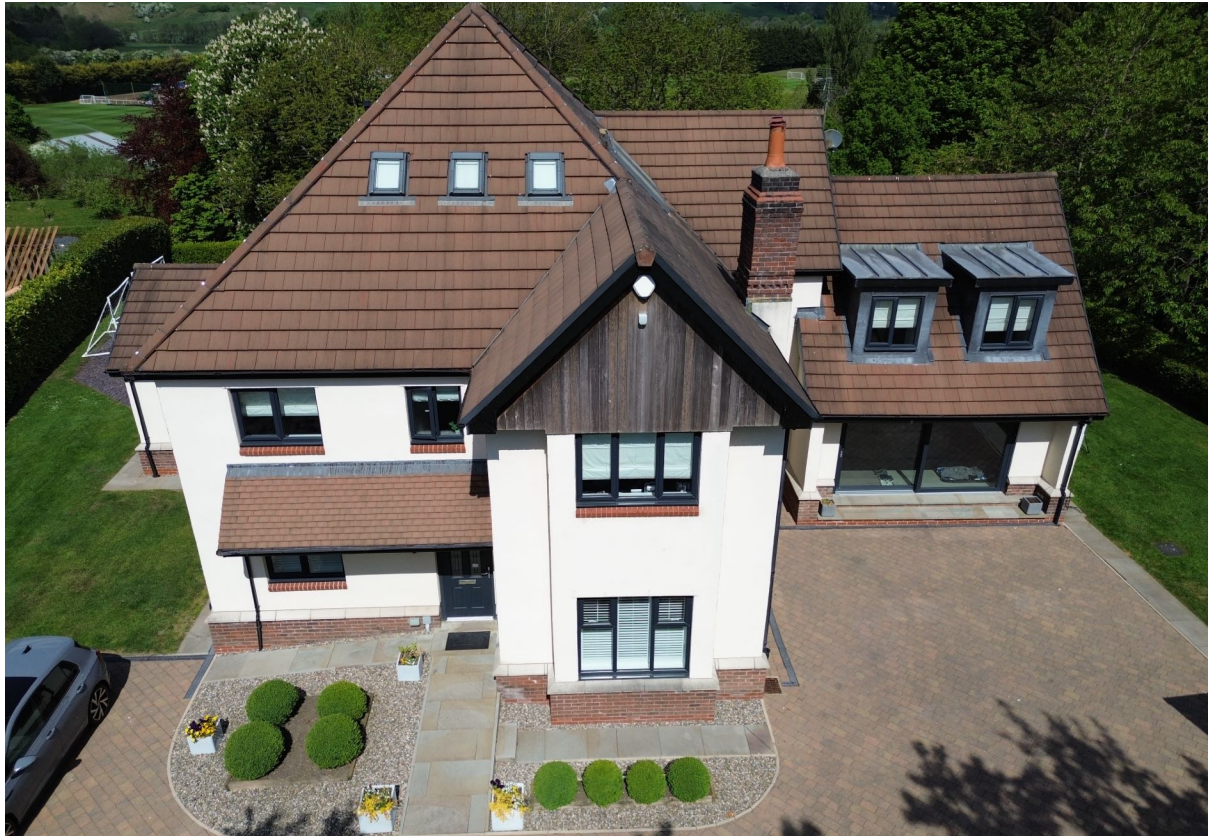
Roof and ridge tiles are in good condition; ridge tiles are mechanically fixed. There are no gaps between roofing materials which could be used by roosting bats.

External are brick, and are covered with a modern white render. Walls and render are in good condition, with no cracks, or missing mortar which could be used by crevice dwelling bats.

1 – The front of the house.

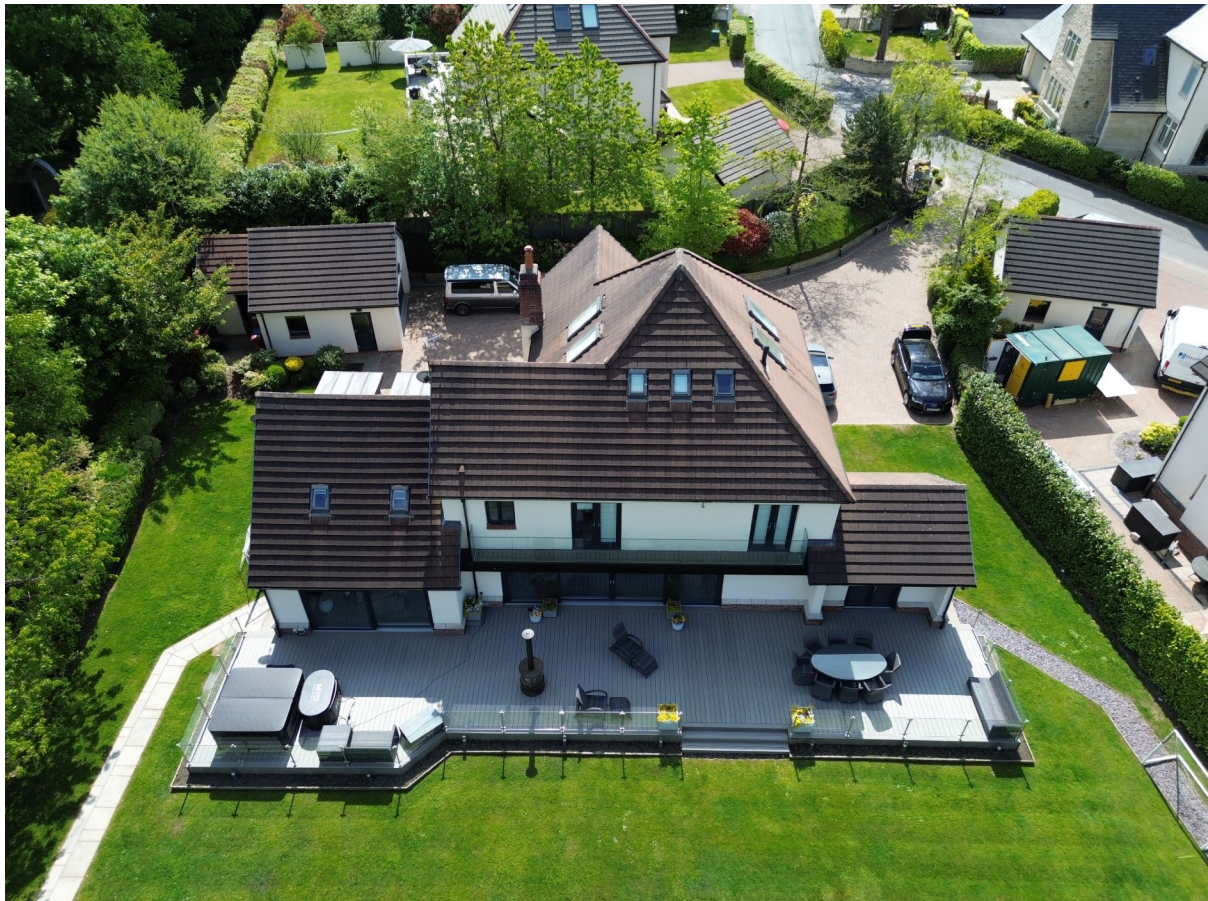
The house and garage have **negligible suitability** for use by roosting bats. This is as the buildings are modern, well maintained, in good condition, and as no suitable roosting opportunities were noted during the building inspection.

2 – The rear of the house and garage.

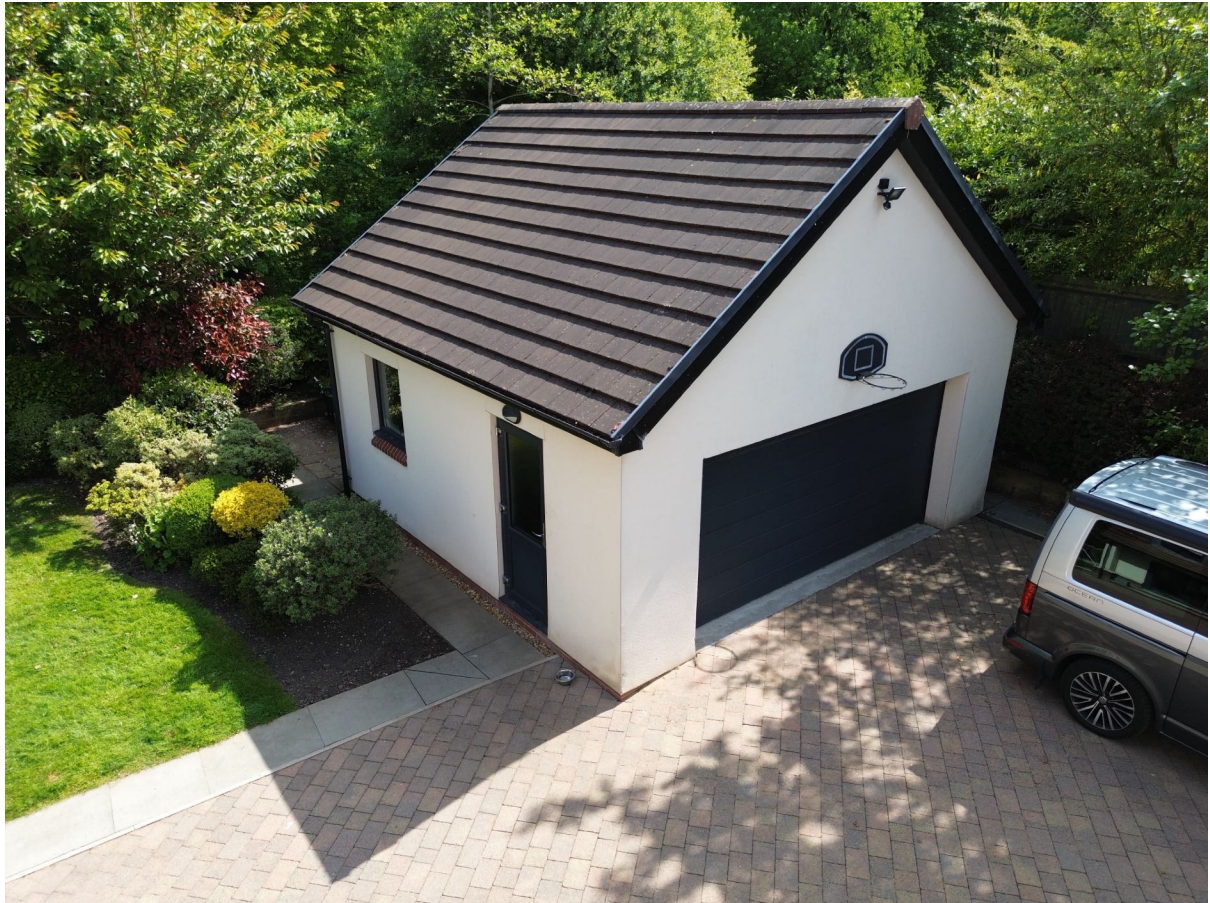
The garage has a single roof void, which is used for storage, and accessed regularly. The roof has a timber rafter and purlin structure, lined with a modern breathable membrane. Roof lining is in good condition with no tears, or gaps.

3 – The garage.
