Project**Project Name:** 2024-11-30882 The Garage Site Dunsop Bridge BB7 3BB**Project Date:** 20/01/2025**Inspection Standard:** MSCC5 Sewers & Drainage GB (SRM5 Scoring)

Project Notes**Survey Comments****Job 2****525mm outfall across the field.**

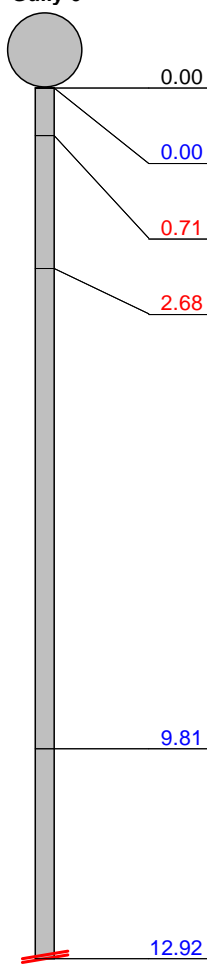
0.00	GY	Start node, gully, reference: Gully 6	00:00:00		
	0.00	WL	Water level, 10% of the vertical dimension: fast flowing	00:00:01		
	0.71	H	Hole in drain or sewer from 7 o'clock to 12 o'clock	00:00:13	Branch BX_4dce1f ac-847e-4	5
	2.68	BJ	Broken pipe at joint from 12 o'clock to 12 o'clock	00:00:26	Branch BX_191e6 468-be29-	4
	9.81	CUW	Loss of vision, camera under water	00:01:27		
	12.92	SA	Survey abandoned: unable to pass obstacle under water level	00:02:06	Branch BX_95dcf5 90-9860-4

STR No. Def	STR Peak	STR Mean	STR Total	STR Grade	SER No. Def	SER Peak	SER Mean	SER Total	SER Grade
2	165.0	19.0	245.0	5.0	0	0.0	0.0	0.0	1.0

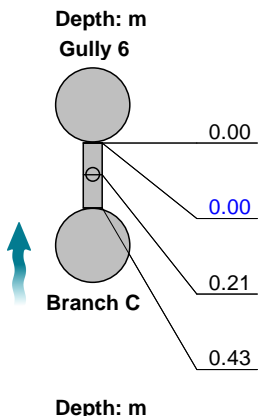
0.00	GY	Start node, gully, reference: Gully 6	00:00:00		
		0.00	WL	Water level, 5% of the vertical dimension	00:00:03		
		0.21	JN	Junction at 12 o'clock, 150mm dia	00:00:12		
		0.43	OCF	Finish node, other special chamber, reference: Branch C: line capped	00:00:16	Branch CX_a2c598b8-e010-

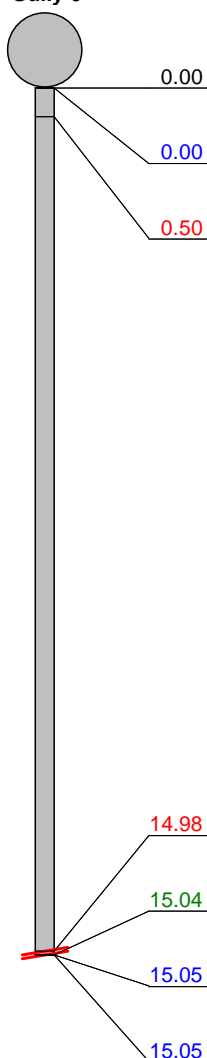
0.00	GY	Start node, gully, reference: Gully 6	00:00:00		
	0.00	WL	Water level, 5% of the vertical dimension: fast flowing	00:00:03		
	0.50	CC	Crack, circumferential from 12 o'clock to 12 o'clock	00:00:09	Gully 6X_e1248 4a8-6243-	2 / 2
	14.98	H	Hole in drain or sewer from 10 o'clock to 03 o'clock	00:00:57	Gully 6X_0b174 38e-793e-	5
	15.04	OBX	Other obstacles, other object in invert from 03 o'clock to 6 o'clock, 15% cross-sectional area loss: stone fallen from hole	00:01:07	Gully 6X_c4e54 004-587e-	5
	15.05	REM	General remark: Cannot remove stane with juetter for fear of collapsing pipe	00:01:07		
	15.05	SA	Survey abandoned: unable to pass	00:01:07
