Ref: S1 Bonstone Brook

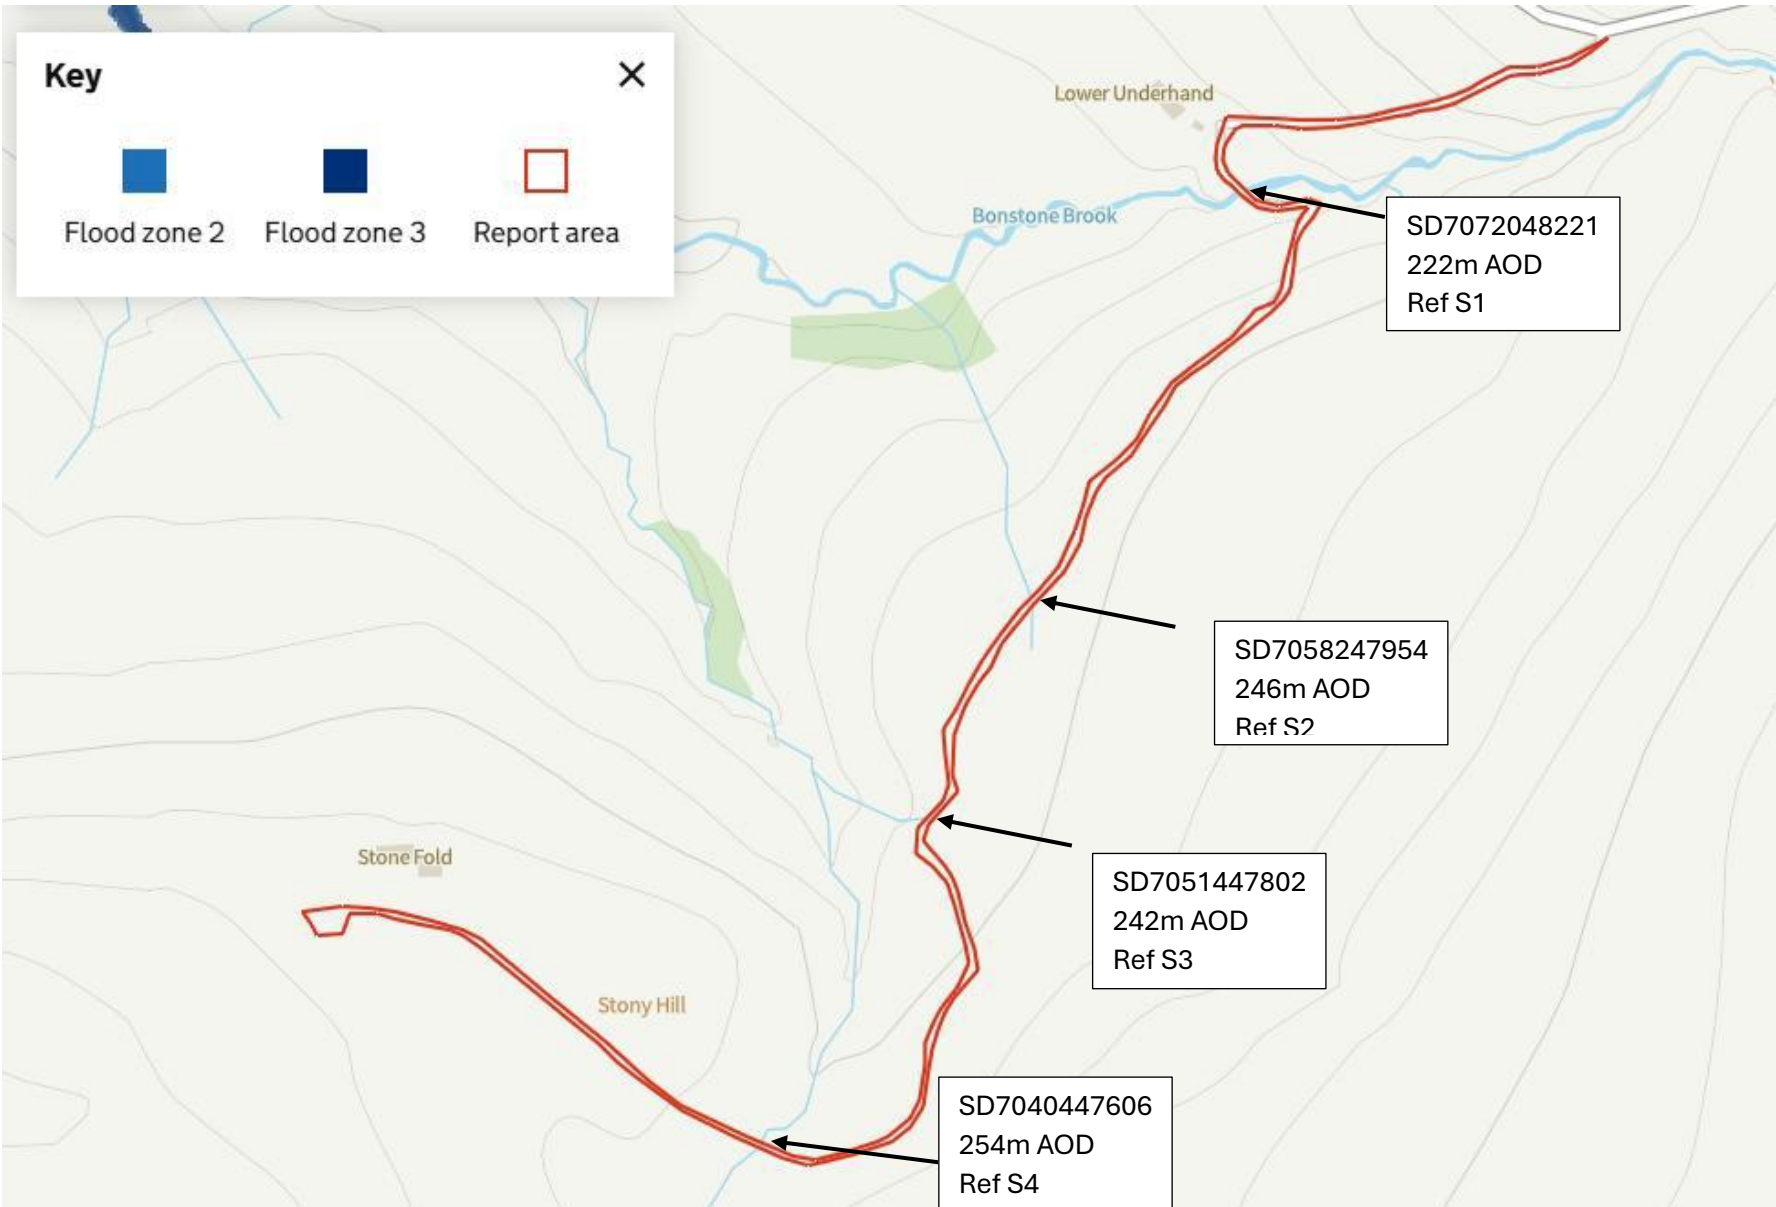
Upstream and downstream images. The land falls significantly to the downstream. The applicant and residents at Stone Fold have never witnessed flooding. No flooding in Storm Desmond.
