Proposed Repairs

Houlkers Farm, Whins Lane, Read BB12 7RB

Heritage Statement

May 2025

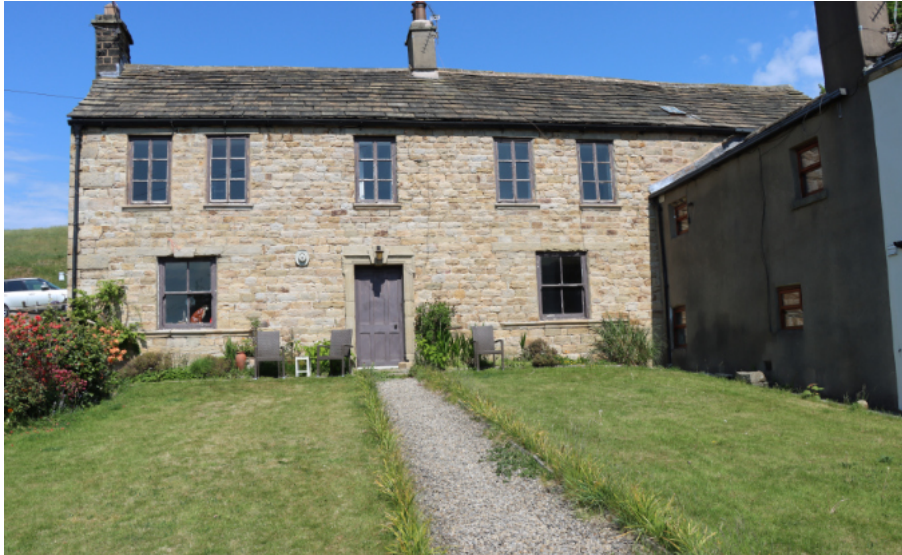
Photograph 1. The front elevation.

Re-pointing the front elevation, and possible hidden strengthening above the ground-floor window lintels.

The lime pointing has eroded. The squared sandstone has narrow joints and is relatively soft. It is proposed to re-point with either a lime putty / sharp sand or a quicklime / sharp sand mix. This will enhance the character of the facade. There are areas of cement pointing above both ground-floor windows. This will be removed and replaced with lime. The stone lintels to both windows may need additional support, and if needed this will be by hidden stainless steel reinforcement or fixings.

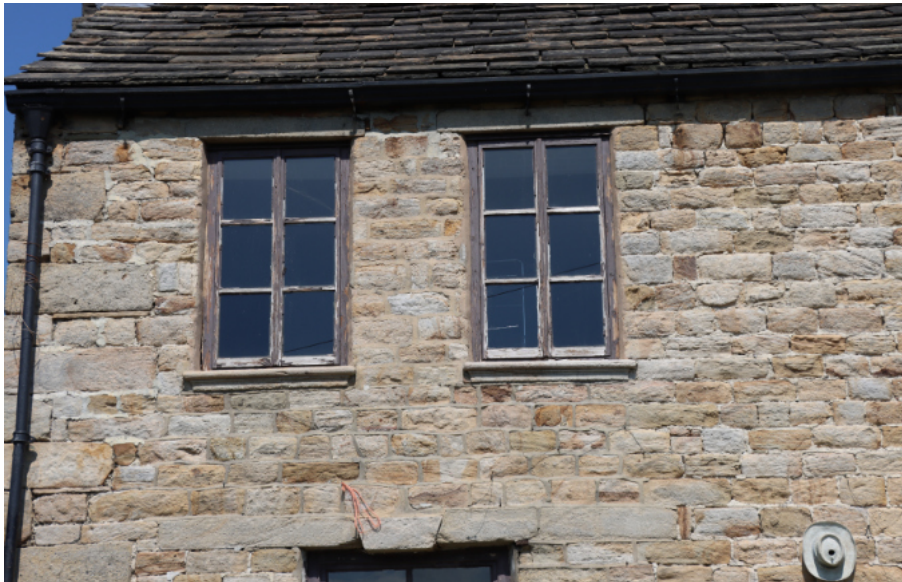
Photograph 3. The left-hand upper windows at the front.

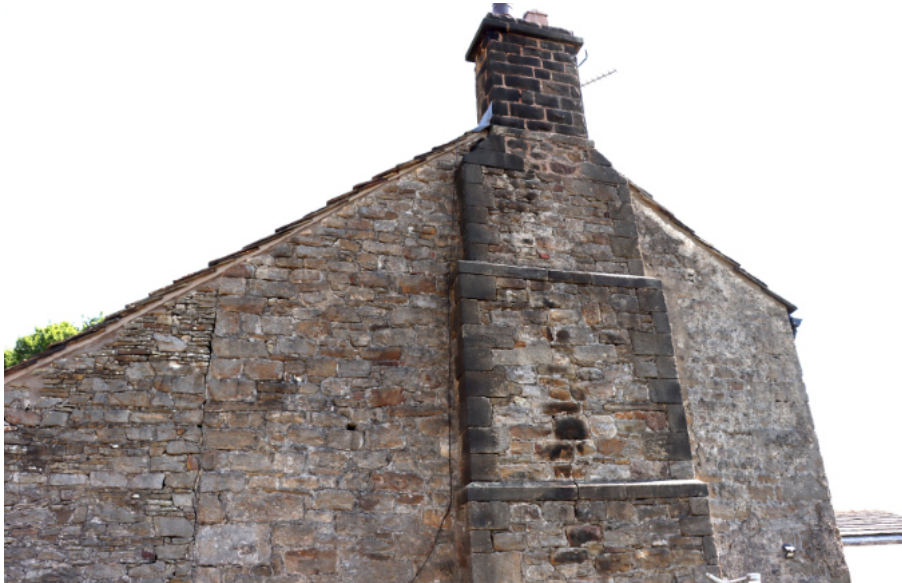
The gable faces the prevailing wind and is suffering from some damp problems internally. Some thin lime roughcast remains to the right and left of the chimney and is evidence that the wall was originally rendered. It is proposed to re-render the whole gable with a roughcast of 'hot lime' or lime putty and coarse sand thrown directly onto the wall and finished with limewash for protection. This will reinstate an original finish and help to eliminate damp problems at this end of the house.

Photograph 7. The west gable wall.

Lime roughcasting and lime washing the west elevation.

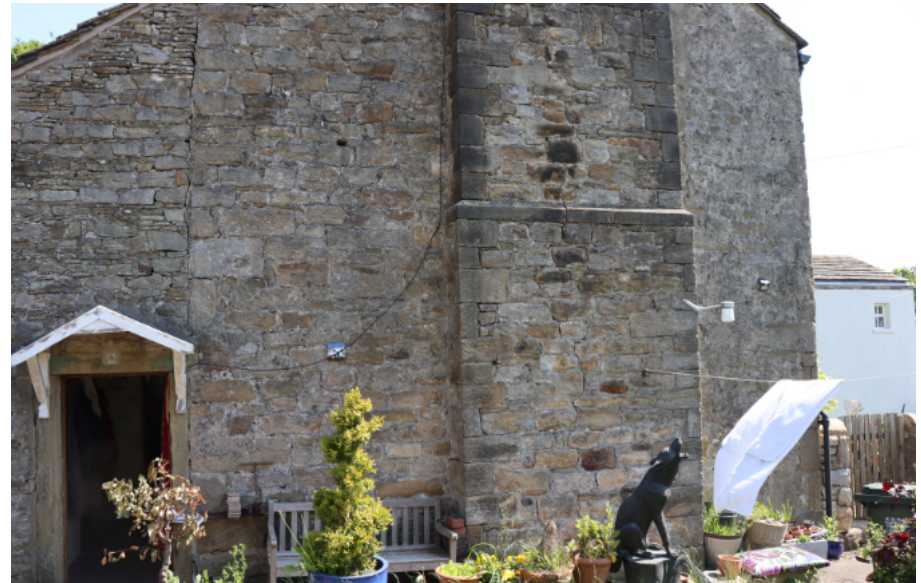
Photograph 8. The west gable wall.

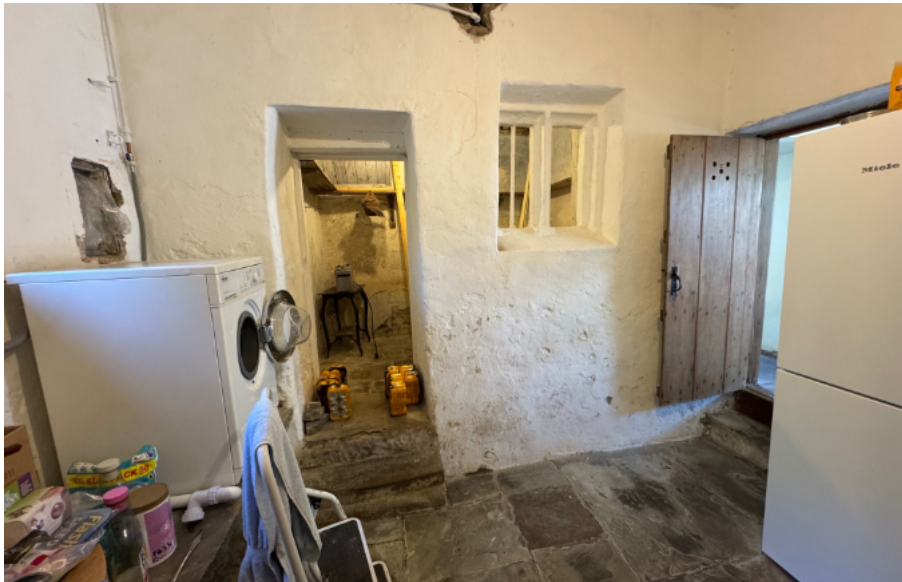
Photograph 15. The interior of the dairy /pantry.

Installation of a gas combi boiler with a balanced flue in the pantry.

The boiler will be mounted on a blank part of the wall, and the balanced flue terminal will be in a location where it cannot be seen from public views. Pipework and radiators will be positioned so that no damage is caused to historic fabric.

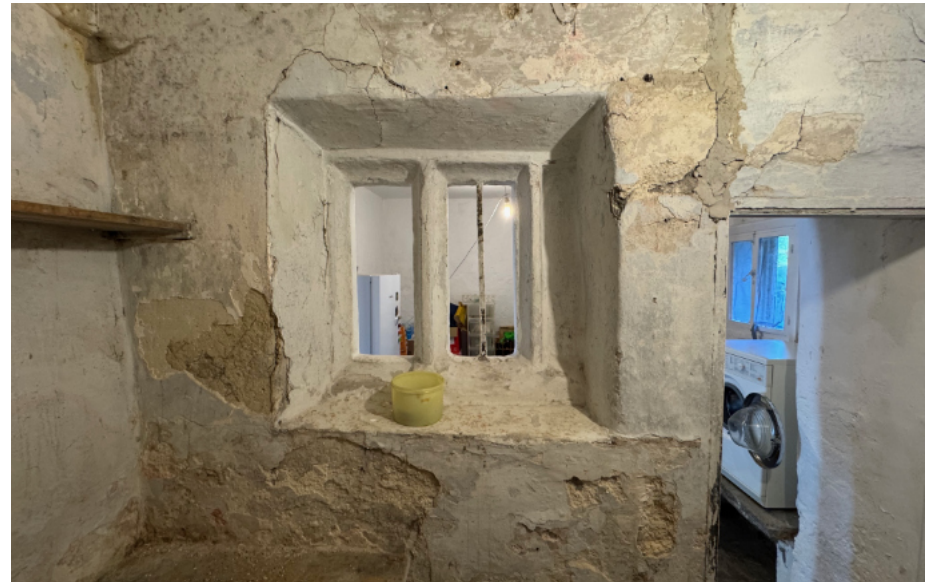
The house is built of sandstone and has a stone slate roof. Its earliest feature is a two-light mullioned window, now without glazing, in the wall between the area under the staircase landing and the rear pantry / dairy. It probably dates from the early seventeenth century, but must be re-used or just be a small fragment of an earlier house, as the plan and other architectural features of the existing house are not consistent with a seventeenth century date.

Photograph 16. Mullioned window within the ground-floor store.

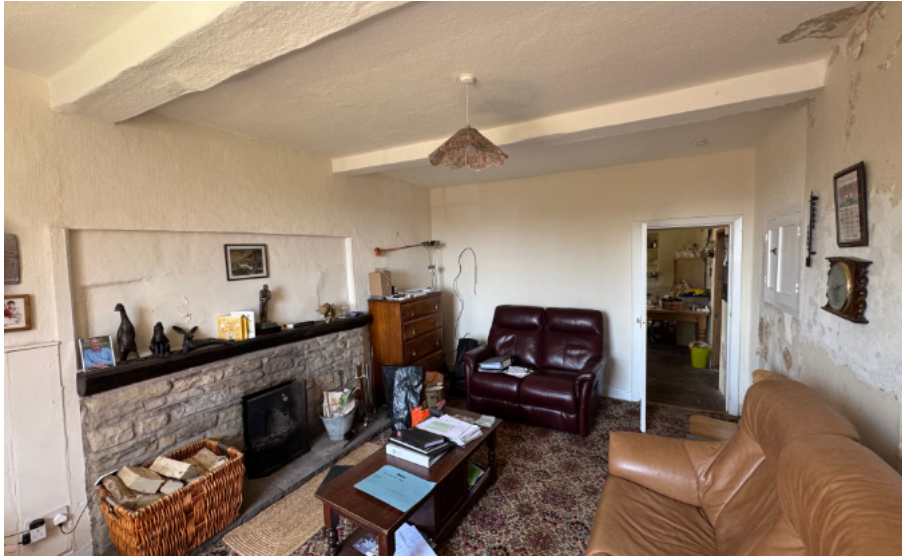
The fireplace in the western ground-floor room is an incongruous late 20th century stone 'feature' fireplace with a redundant back boiler. The projecting chimney breast externally indicates the probable depth of the original fireplace. It is intended to carefully remove the 20th century fireplace and reinstate the original fireplace opening, including any fireplace surround that still exists. The tiled fireplace in the eastern ground-floor room is also incongruous, and it is proposed to remove it while retaining the late 19th century slate surround.

Photograph 17. The sitting room at the west end of the house.

Opening out the two fireplace openings on the ground floor and installing solid fuel stoves.

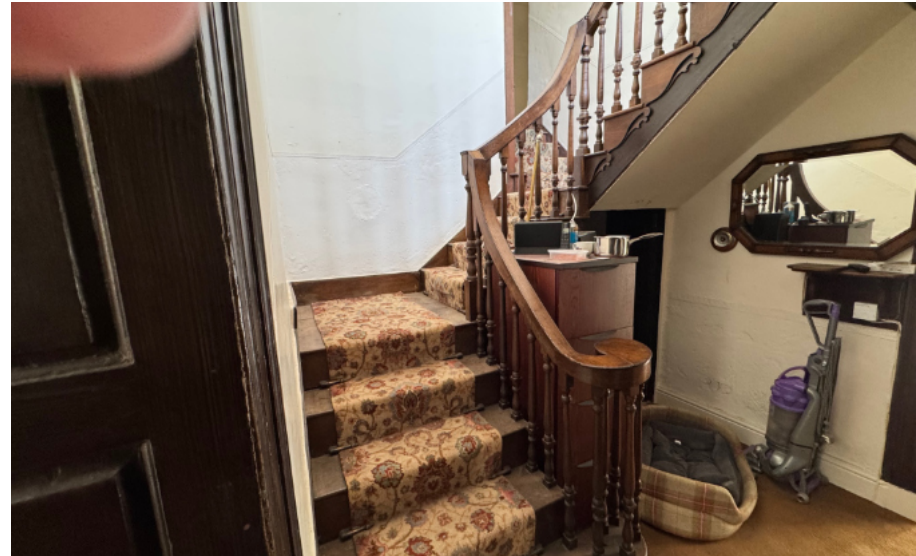
Internally, the main features are the oak staircase and balustrades (Photographs 22, 27 & 28). The tread brackets and turned balusters are

Photograph 22. The staircase.

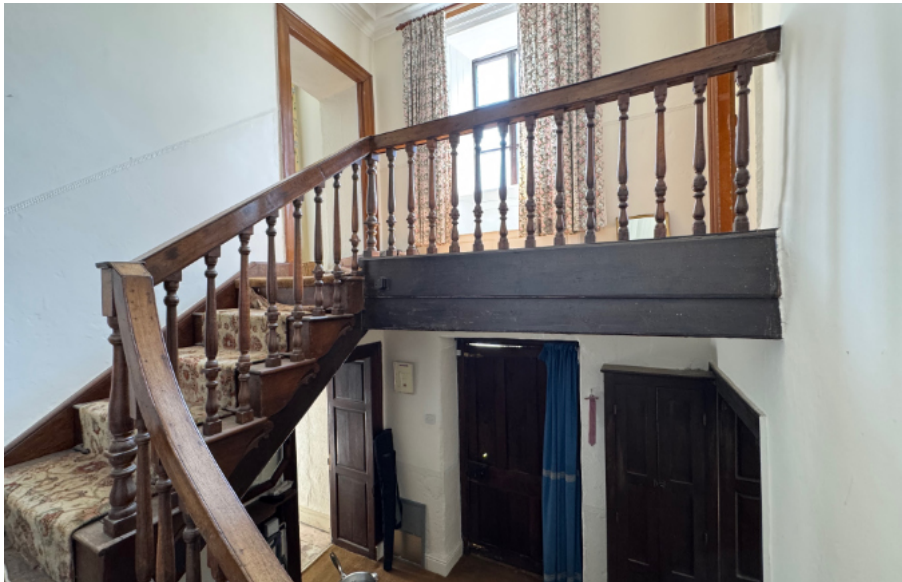
Photograph 27. The staircase and first-floor landing.

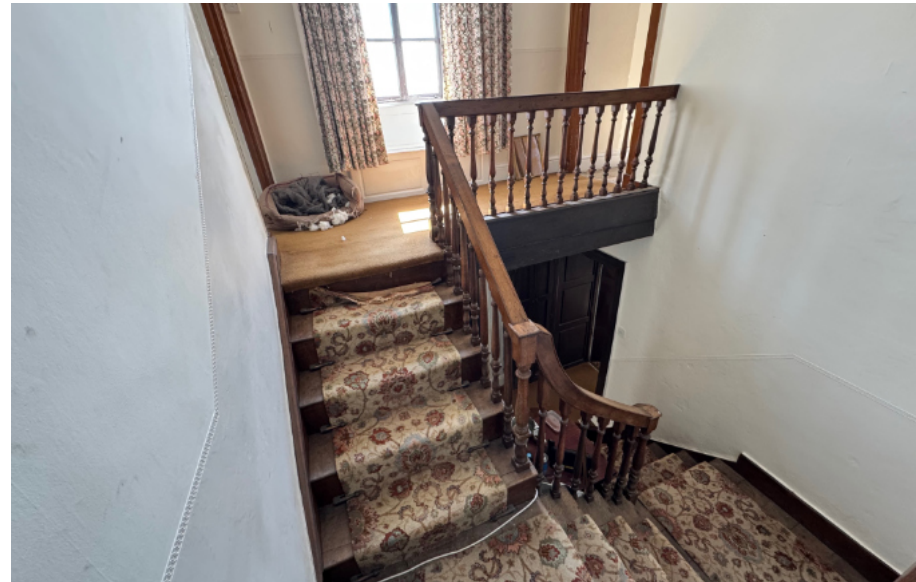
Photograph 28. The staircase and first-floor landing.

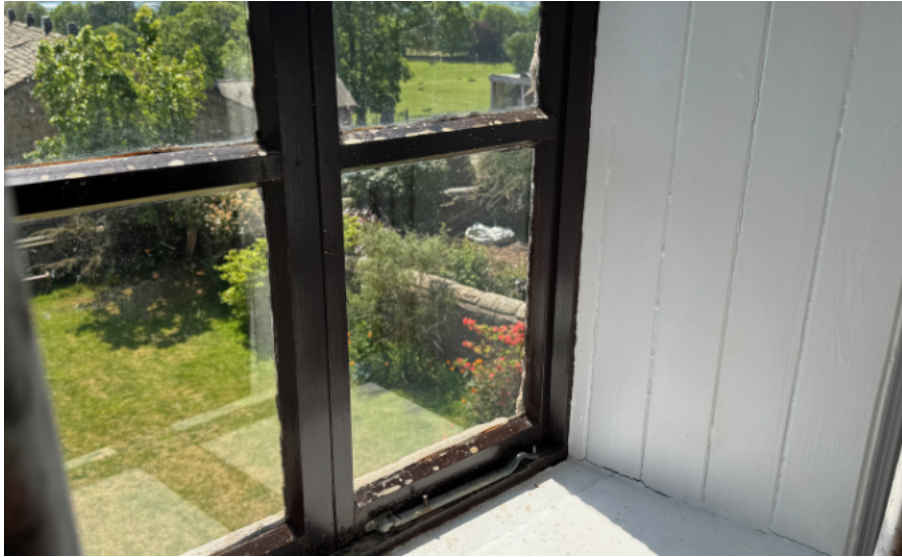
The existing windows are not original, and probably date from the early and mid 20th century. Re-painting has been neglected and there are now areas of wet rot and gaps that cause draughts. It is proposed to replace them with gloss painted timber replicas, with draught seals and low profile double glazing. The existing external appearance of the house will be unaffected.

Photograph 29. A first-floor window at the front.

Replacing the windows with timber windows to match the existing, incorporating slimline double glazing and draughtproofing.
