Written Stone Farmhouse, Longridge

BAT SURVEY REPORT

September 2024

Report Ref: 093_04

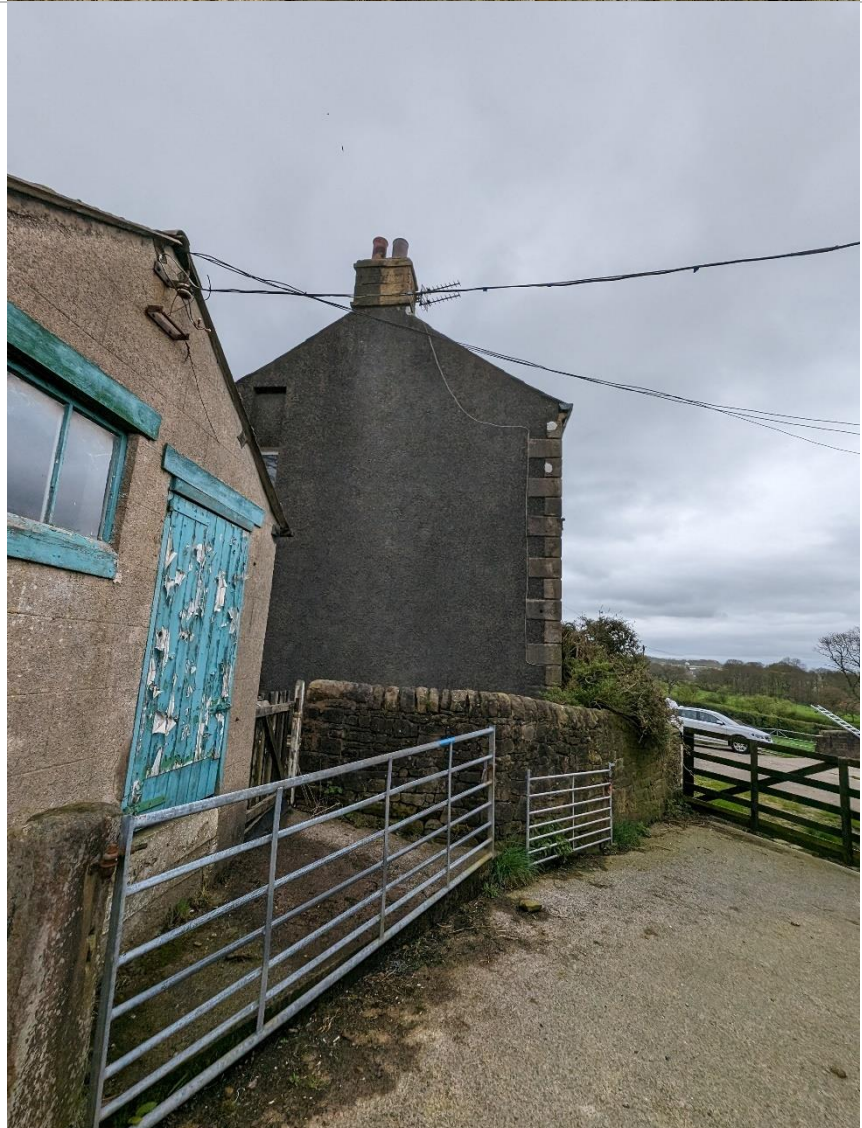
Photo 4.
West gable

The farmhouse is Grade II listed and dates to late C18th. It is a two-storey, sandstone construction and forms an L-plan shape. The west facing side elevation is rendered. Due to the rendering, no potential roost features were observed on this elevation including at the roof ridge. The south elevation (front) and the east side elevation of the gable appeared in good repair with all mortar joints and roof verge pointing in good condition. The north facing gable was of a stone rubble type wall. The stonework pointing appeared in good repair overall; however, there was a slight crack in the wall just below the chimney and there was a noticeable gap in the wall at the top of the crack. The depth of this gap was unknown.
