STRUCTURAL INSPECTION

45 & 47 WHALLEY ROAD, CLITHEROE

STANTON ANDREWS

Project No.: 12175				
Issue Date	Revision	Status	Issued By	Checked By
10.07.2025	---	First Issue	SJ Reid	T Fryars

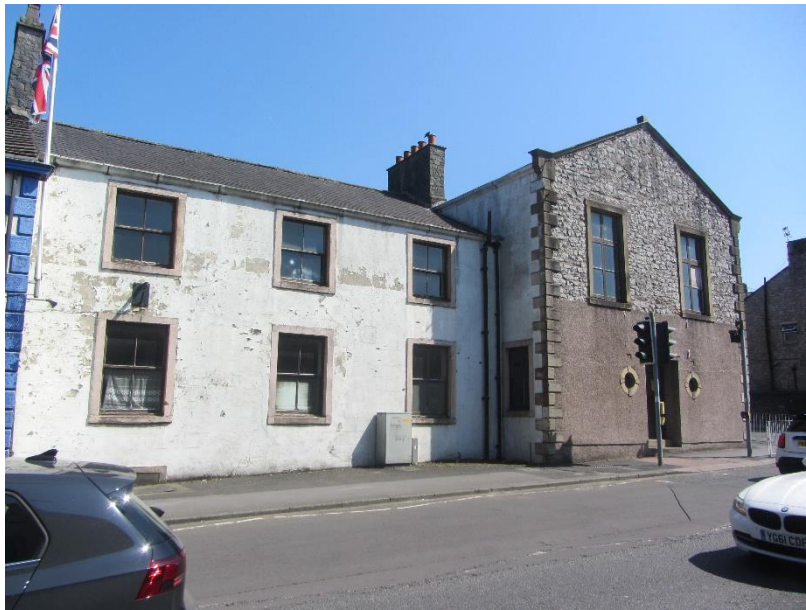
Photo 1 – View from west

The two parts of the building are of traditional stone construction, two storeys high, both dating from the early to mid-1800s (photos 1, 2, & 3). The building is Grade II listed.
