# **Barn at Holmes Farm, Higher Commons Lane, Balderstone BB2 7LR**

## Structural Condition Survey for Conversion to Dwellings

PSC-949 Rev A

July 2025

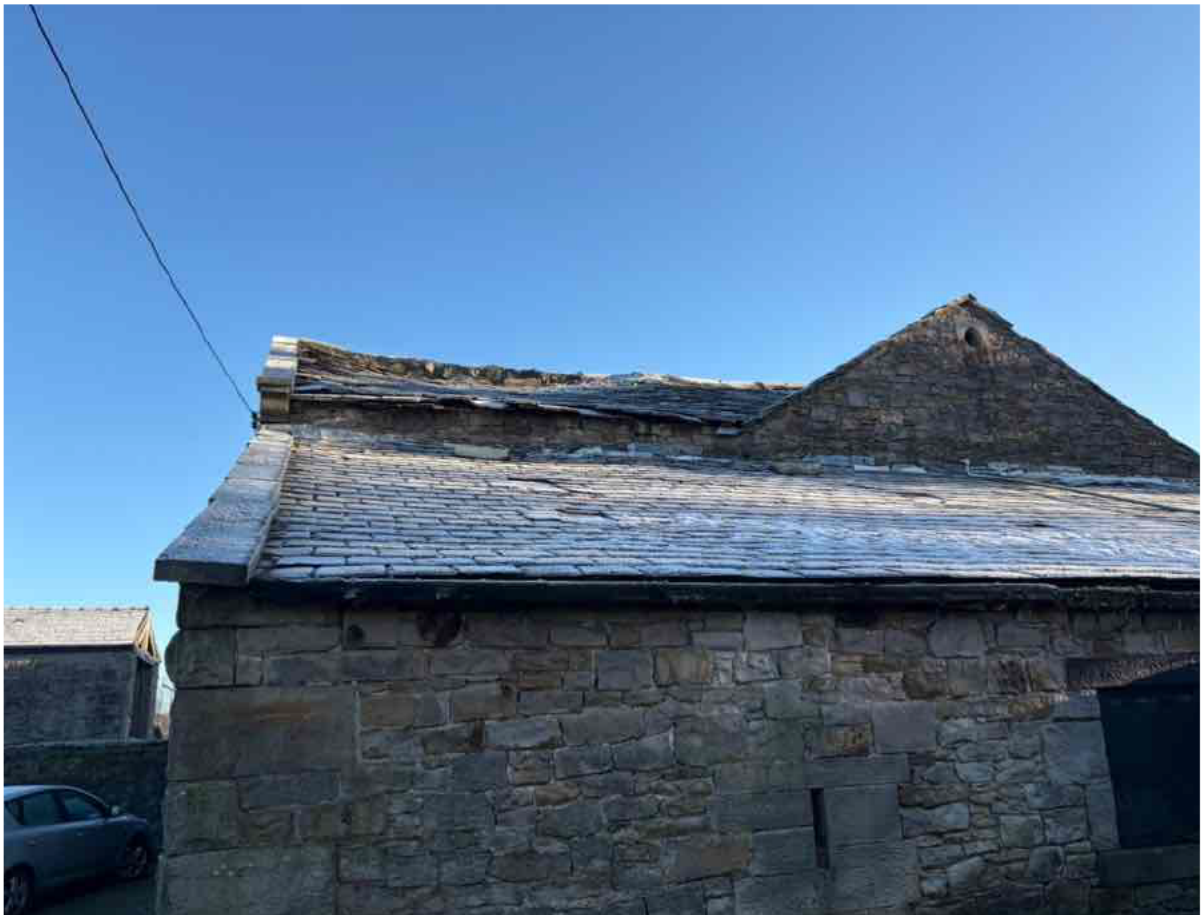
Photo 3- South West Elevation

This single storey wall to the stable area is built in random sandstone and there is a small two room storage area at the south end (photos 9 & 10). Part of the elevation is obscured by a large, rendered tank (photo 8). The gable of the main barn is visible above the roof (photos 6 & 7). The walls are all in good condition. They are plumb and reasonably pointed with a mixture of mainly lime and some cement mortar. There are no signs of previous or ongoing movement. Photo 7 indicates some slight movement to the gable copings on the roof. There are 3 door openings and 3 window openings and the timber to these is in poor condition. This elevation has some sections of gutter but they are in poor condition with no downspouts.

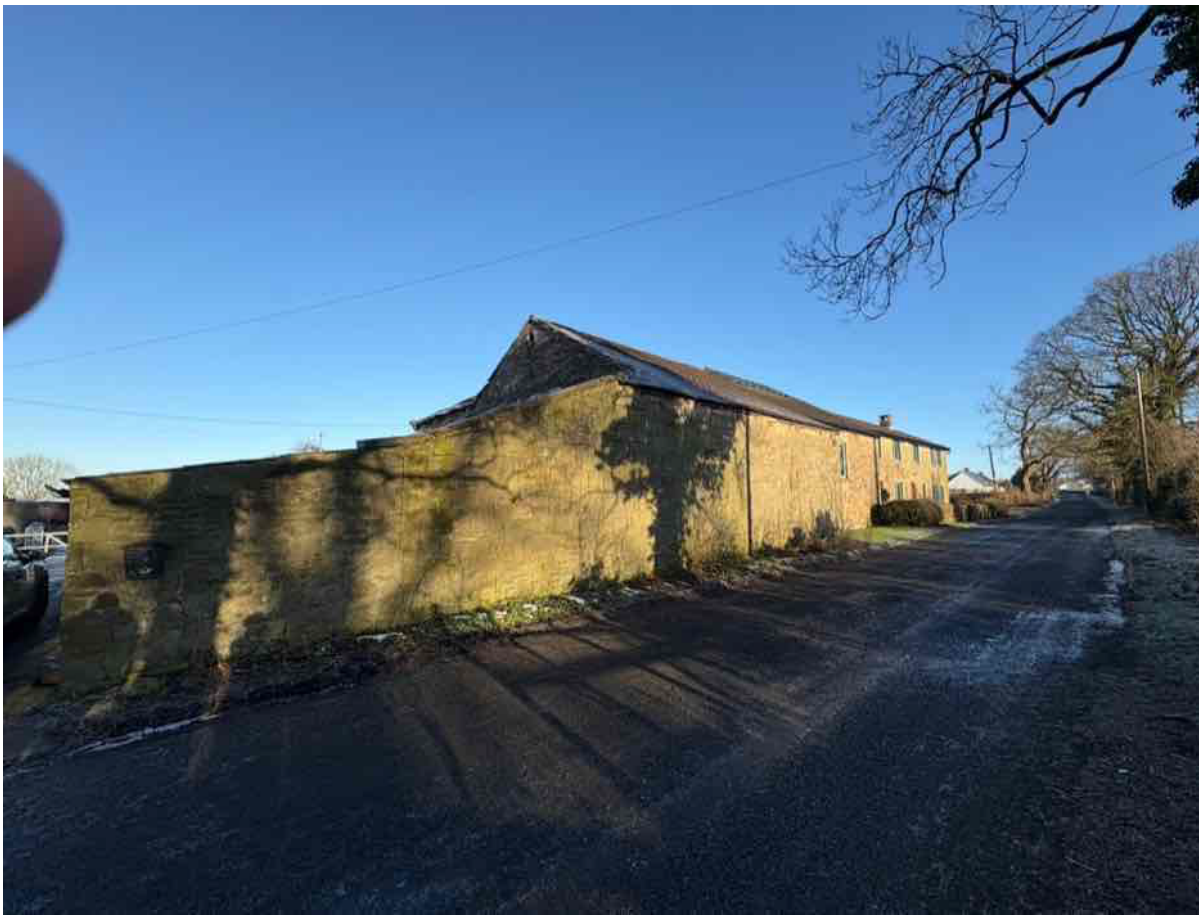
Photo 11 - South East Elevation

This elevation runs along Higher Commons Lane and is built in dressed, randomly coursed sandstone. This elevation has no openings except for a small circular vent at a high level (photo 13). The wall is in good condition. It is plumb and reasonably pointed with a mixture of mainly lime and some cement mortar. There are no signs of previous or ongoing movement. The guttering is missing from this elevation with only brackets remaining.

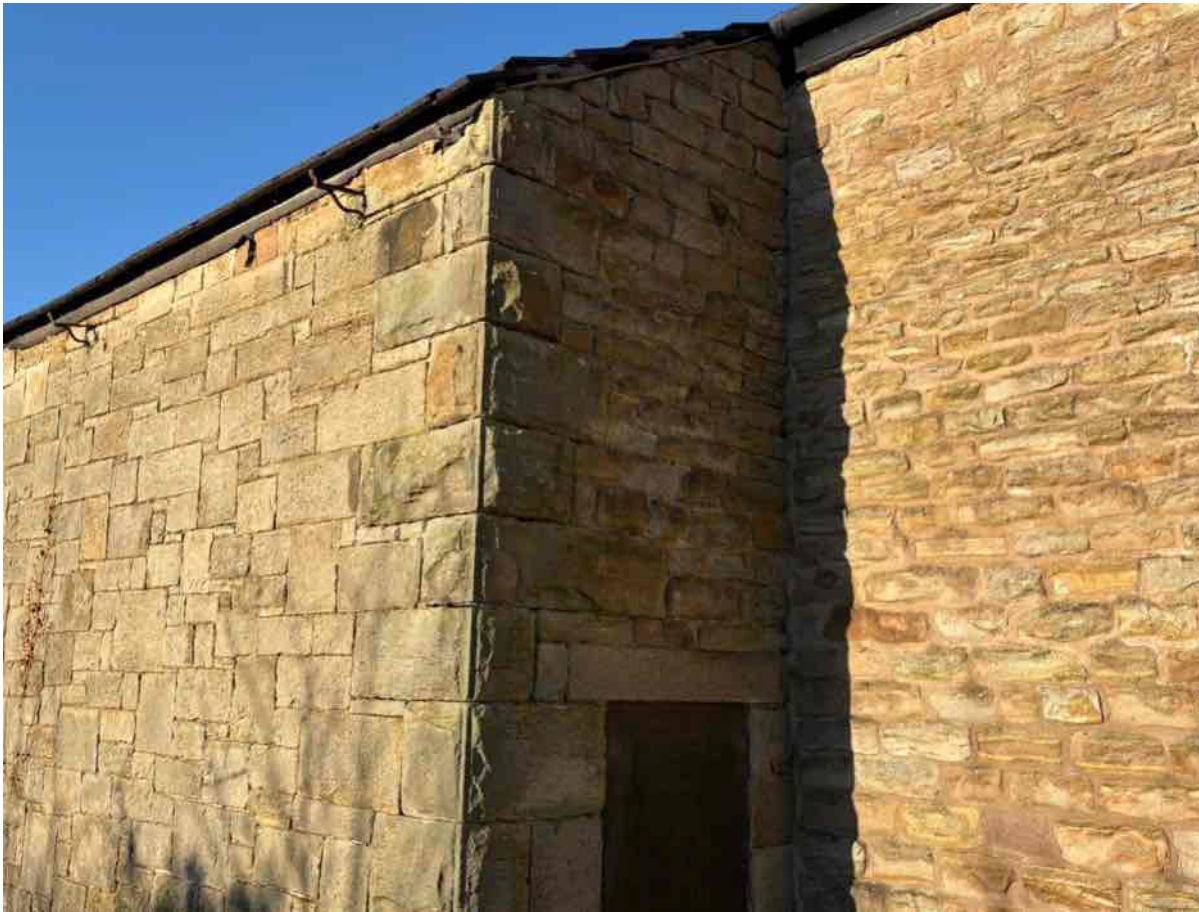
Photo 14 - South East Elevation and return on North East Elevation

This short return is built in dressed, randomly coursed sandstone. There is single window opening at ground floor level (photo 15). The wall is in good condition. It is plumb and reasonably pointed with a mixture of mainly lime and some cement mortar. There are no signs of previous or ongoing movement. The window is boarded over.

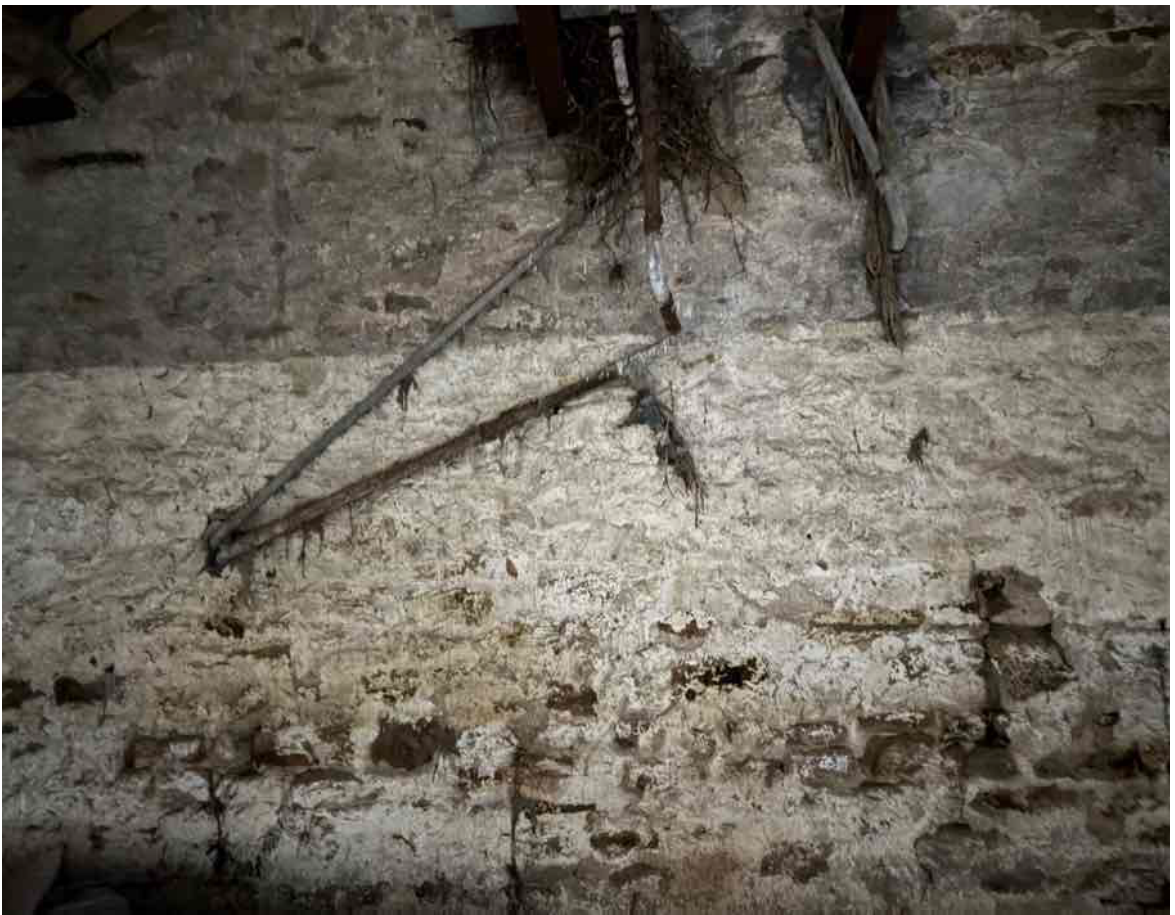
Photo 19 – Internal south east wall

The main section of the barn is split into several rooms as detailed on the plans. Apart from the entrance area, these rooms have loft areas above, supported on timber beams. Internal inspection indicated that all the internal walls were in good condition with no sign of previous or ongoing movement. The walls are well pointed with lime mortar and the majority are lime washed. There are some areas of walls built with red brick (photos 30 & 33). The gable wall to the adjoining property has been re-built in blockwork (photo 29) and this is in excellent condition.

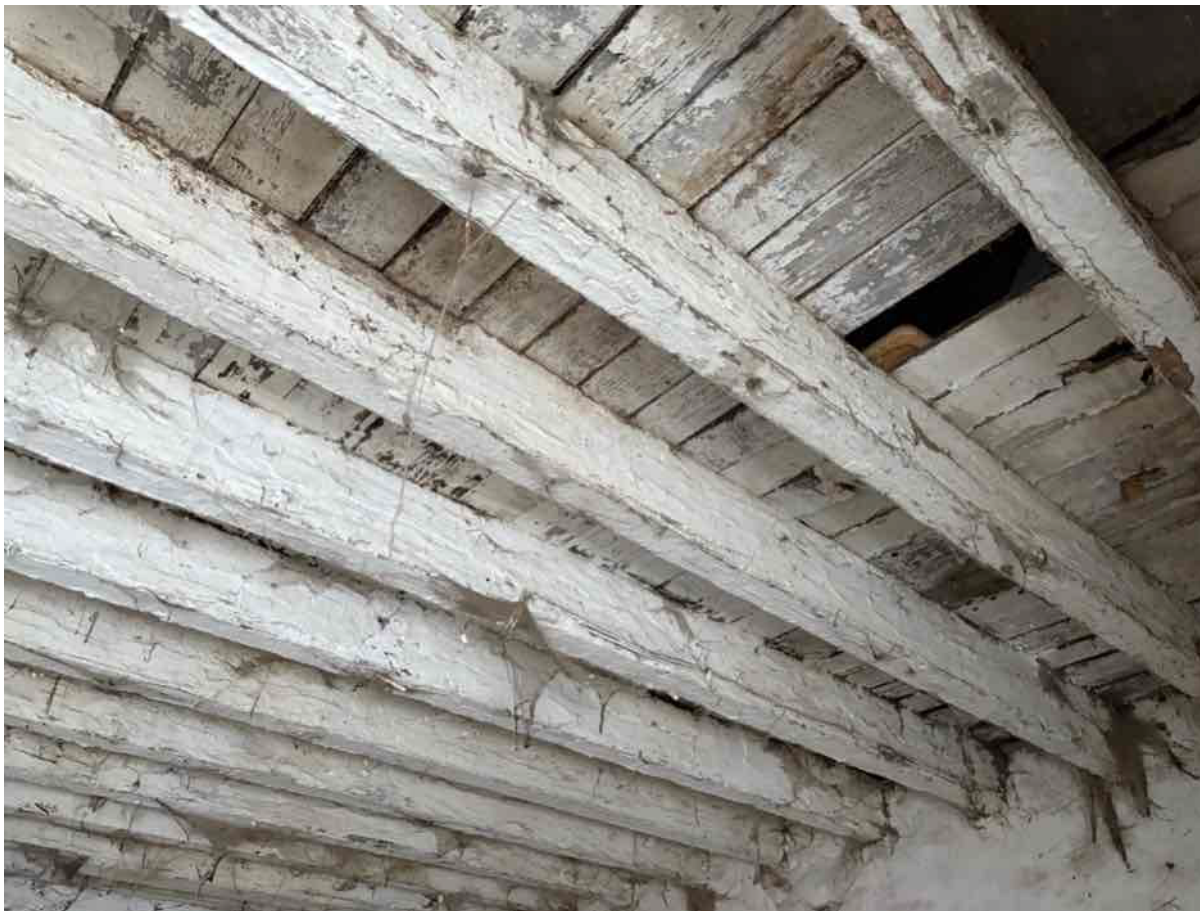
Photo 34 – loft timbers

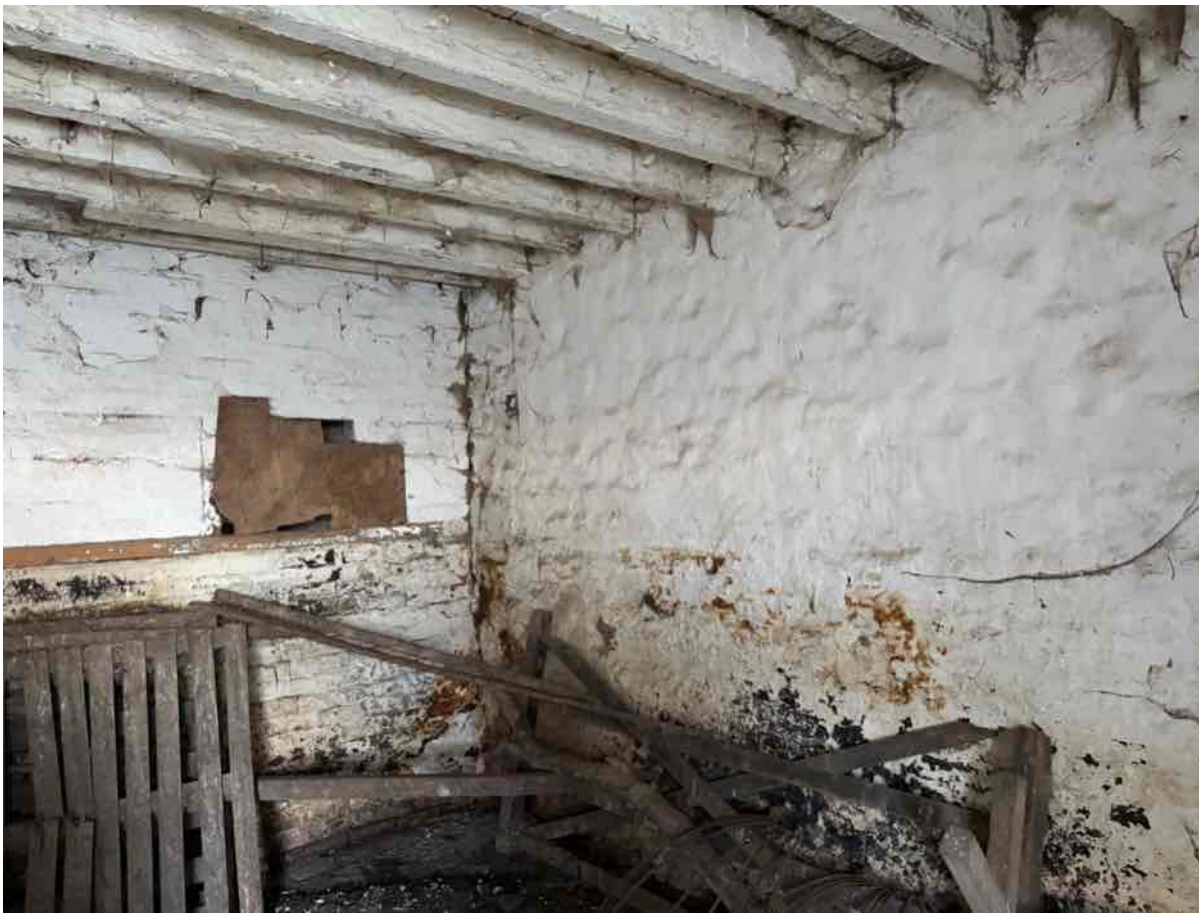
Photo 35 – Small Stable area

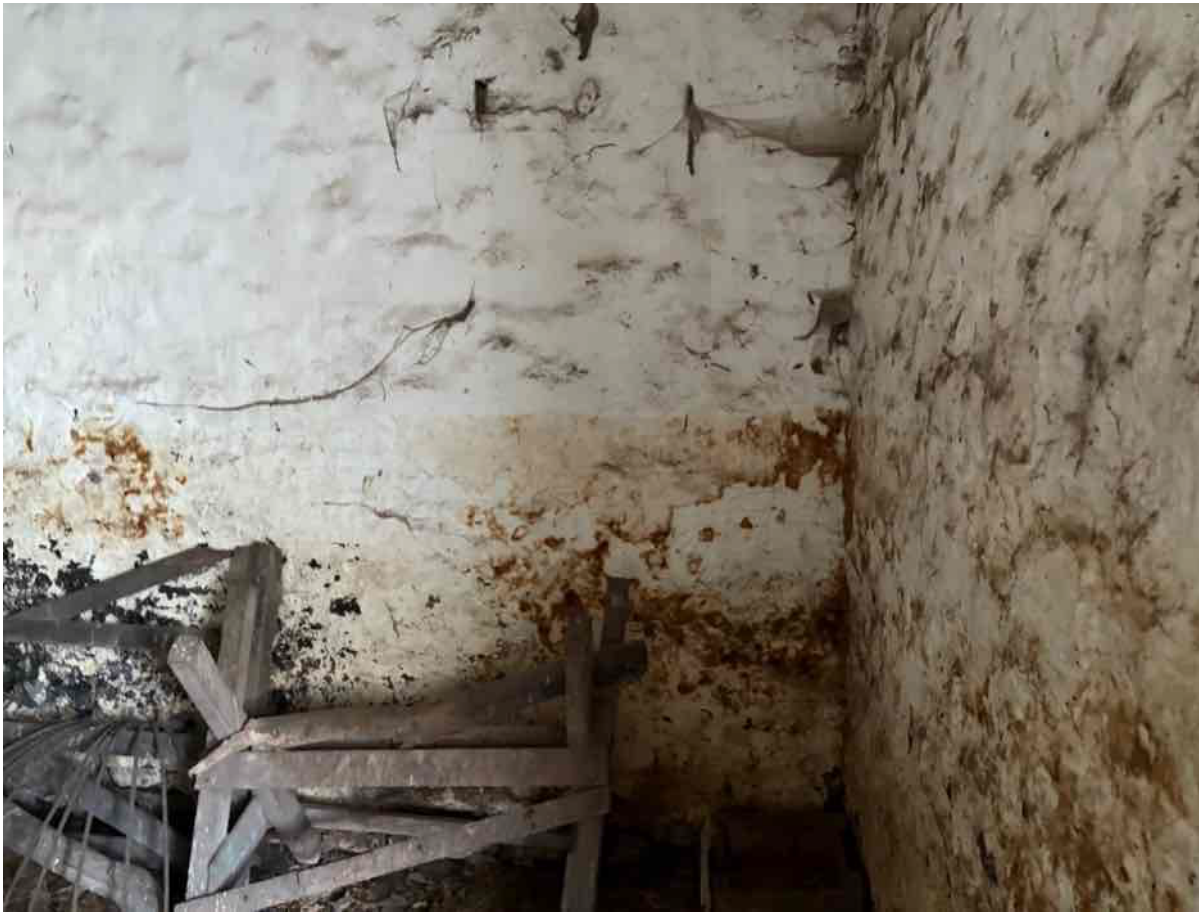
Photo 36 – Small Stable area
