## **Barn 2 at Writtenstone Farm, Writtenstone Lane, Longridge, PR3 2ZN**

### Structural Condition Survey for Conversion to Dwelling

PSC-859 – B2

February 2024

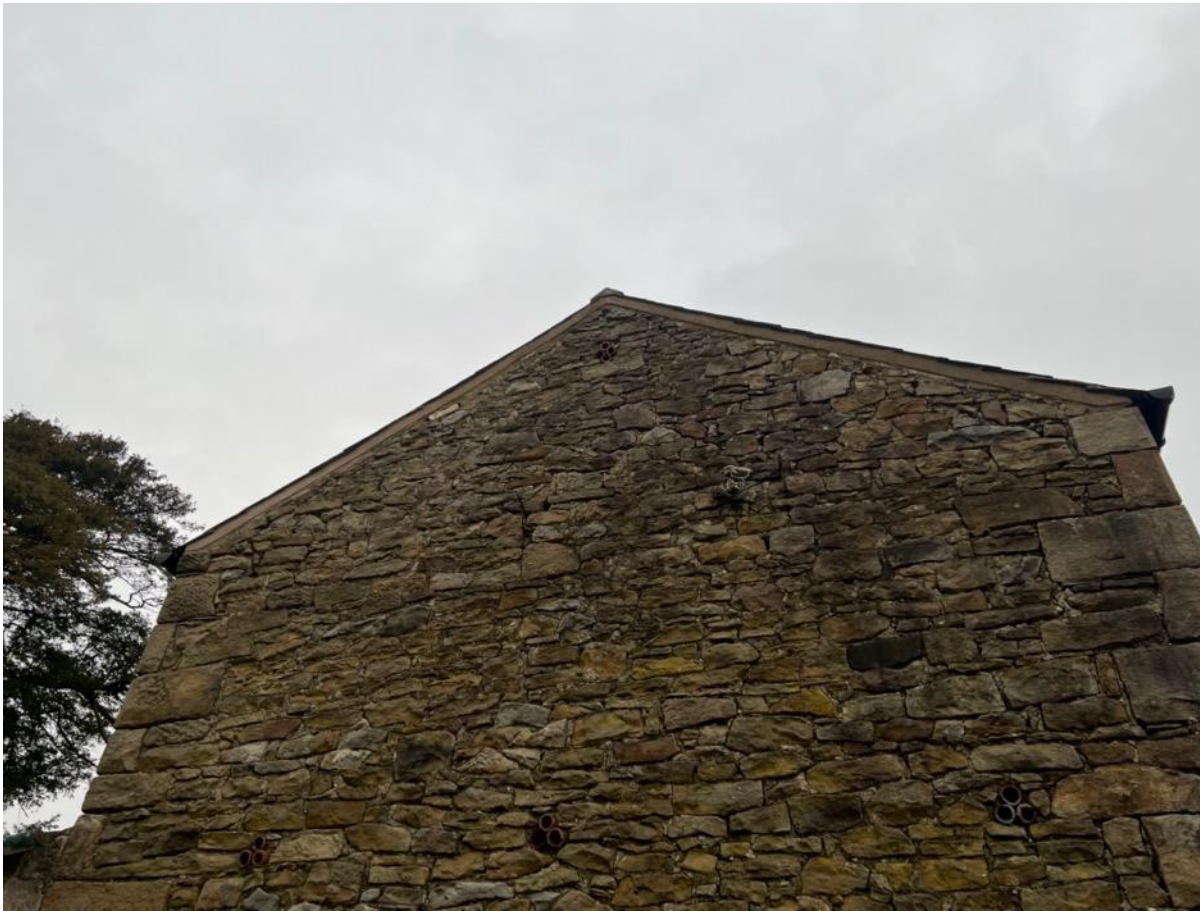
Photo 6 – South West Elevation

This elevation includes the gable to the main barn and the single storey outrigger to the rear of the barn (photo 2). The gable of the main barn is built in random sandstone and the wall is 500mm thick. The wall is in reasonable condition. It is reasonably plumb and reasonably pointed. There are no signs of previous or ongoing movement. There are two door openings at ground floor level with further vents to the building provided by field tiles through the wall (photo 9). The single storey rear elevation wall has sections of sandstone wall, brick wall and an infill of concrete block. The walls to this section are 400mm thick. There are three openings along this length of wall, a doorway and small window (photo 11) and a larger opening for vehicular access (photo 12). When the larger opening was formed a large steel beam was put in place and a section of wall rebuilt in brick (photo 12 & 16). This section of the elevation has the benefit of guttering and downspouts which are in poor condition (photo 13).
