STRUCTURAL INSPECTION REPORT

**ALDER HOUSE FARM,
BOLTON BY BOWLAND,
BB7 4LZ**

REF: 223532 - NOVEMBER 2023

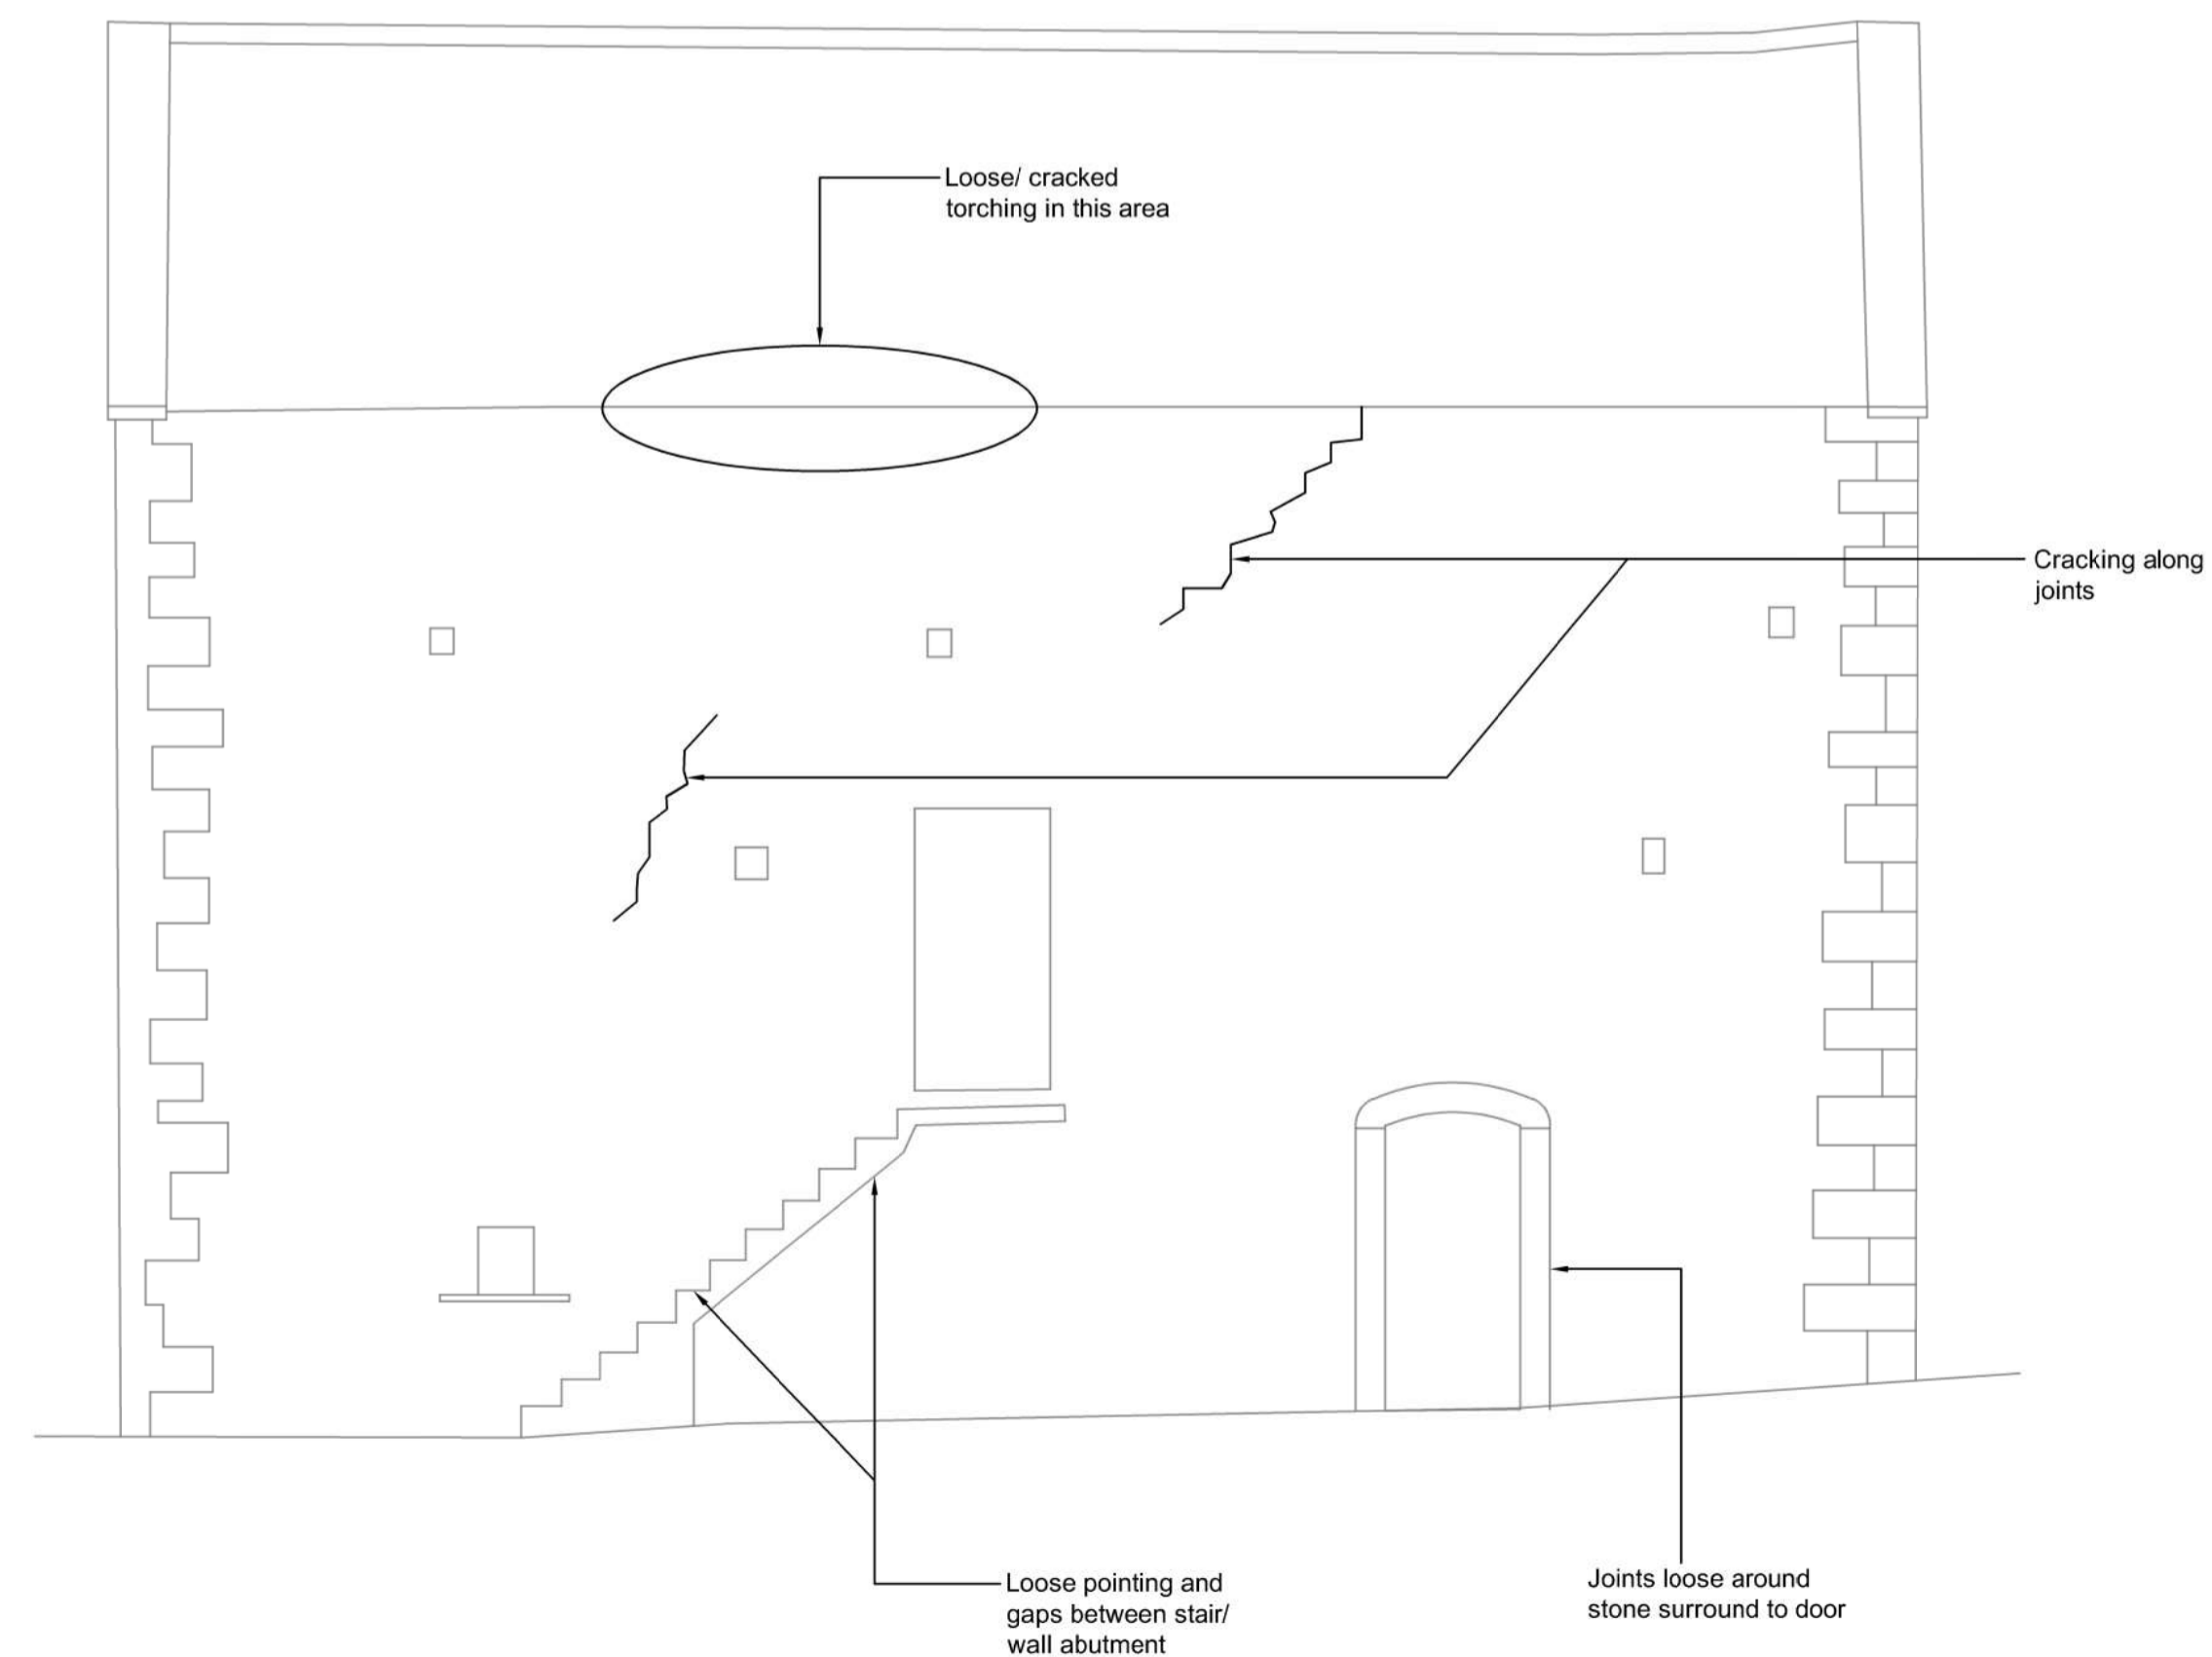
Elevation B

NOTE: Some very loose joints along elevation, majority of wall panel will need re-pointing.

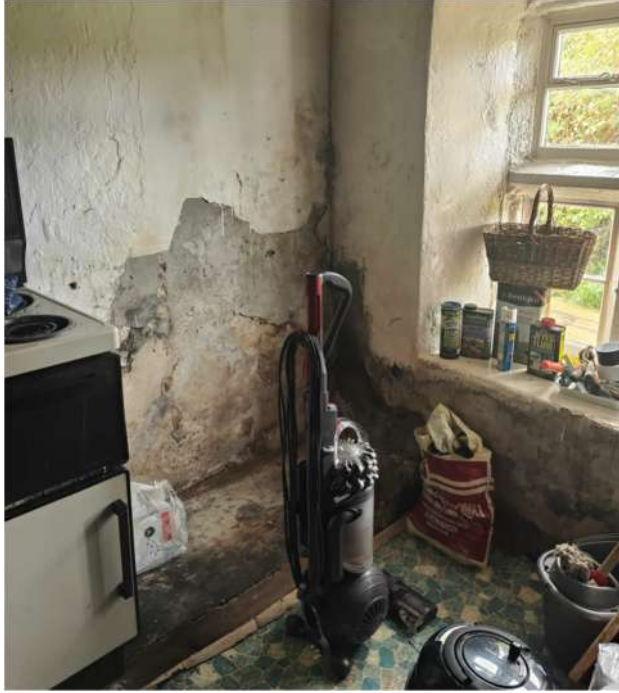
(P-01)

- 3.1.1 Rising damp had started to penetrate through the wall below the window damaging the lime plaster in room 4 (See photograph P-01).
- 3.1.2 A number of the walls were showing signs of damp and water ingress in room 2 (See photographs P-02 & P-03).
- 3.1.3 Crack in the timber beam above living space in room 2. (See photograph P-04).

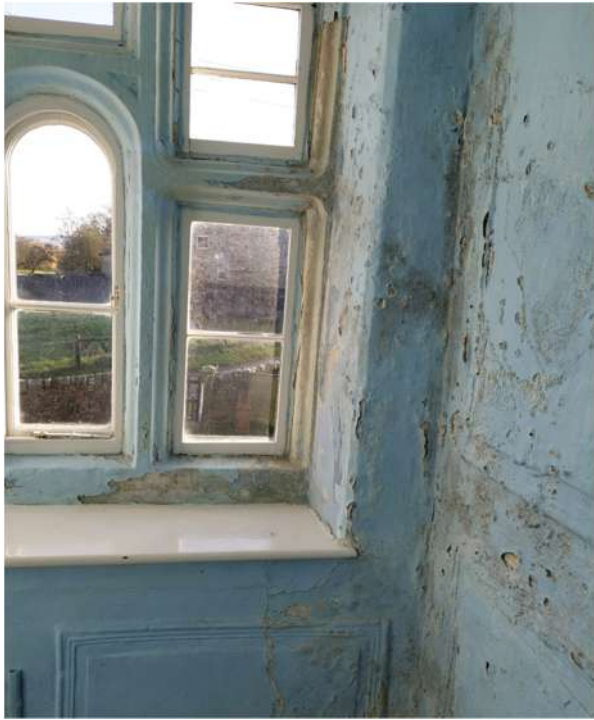
(P-05)

- 3.1.4 Water ingress around window and to side wall panel in room 6 (See photographs P-05 & P-06).
- 3.1.5 Corroded window surround due to water ingress in room 7 (See photograph P-07).
- 3.1.6 Vertical crack in wall under the beam corbel in room 9 (See photograph P-08).
- 3.1.7 Cracking to plaster around beam and mould/ damp indicating signs of water ingress in room 9. (See photograph P-09).
- 3.1.8 Signs of water ingress around window and ceiling in room 9 (See photograph P-10).
- 3.1.9 Cracking under beam/ corbel bearing next to the opening in the wall for the cupboard space in room 8. (See photograph P-11).
- 3.1.10 Damp penetration on the wall above shower in room 10 (See photograph P-12).

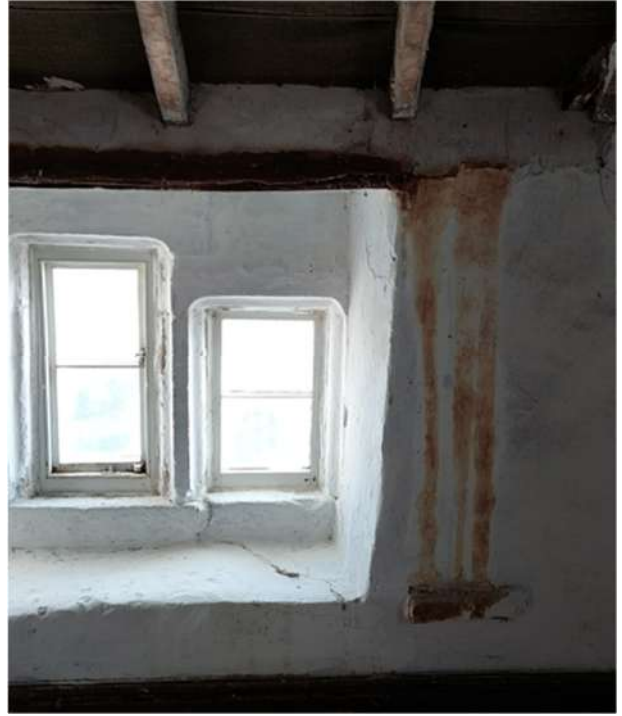
(P-14)

- 3.1.11 Cracking/ de-bonding of plaster around the window in room 11 (See photograph P-13).
- 3.1.12 Water ingress to side of the window and de-bonded plaster to cill in room 12 (See photograph P-14).

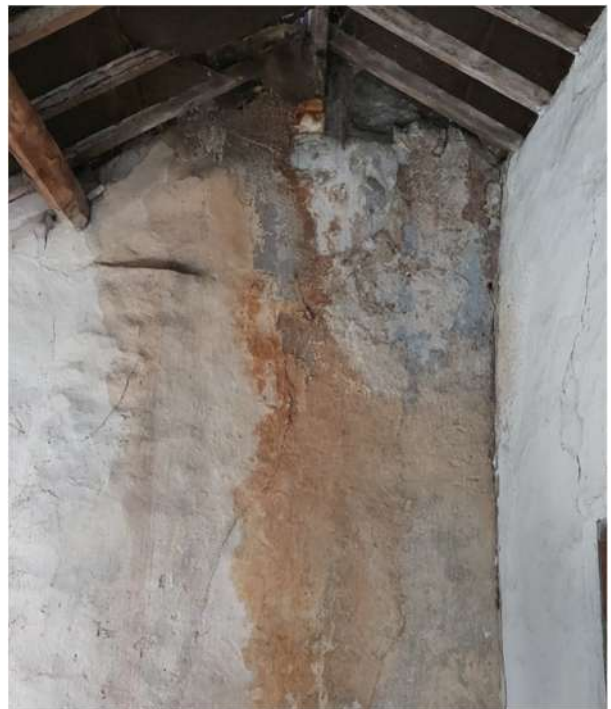
(P-16)

- 3.1.13 Cracking to plaster above the smaller window and signs of water ingress in room 12 (See photograph P-15).
- 3.1.14 Heavy signs of water penetration along the chimney breast in room 12 (See photograph P-16).

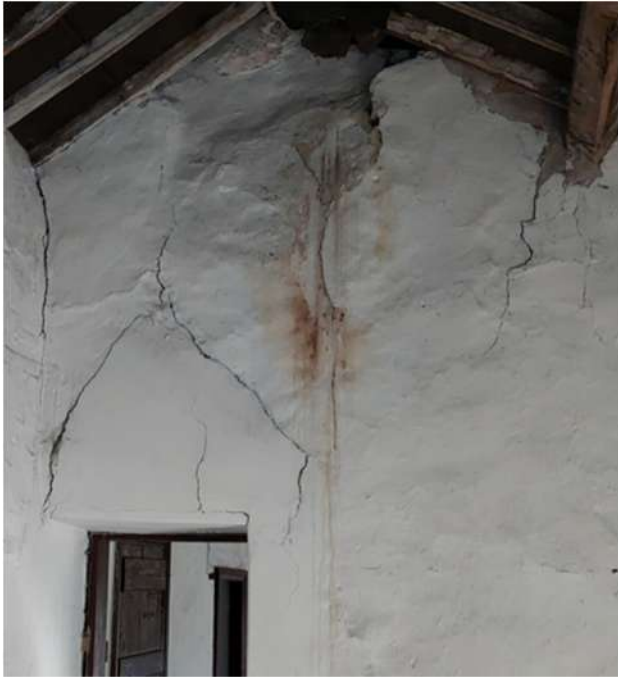
(P-17)

- 3.1.15 Cracking to plaster above door between room 12 & 13 (See photograph P-17).
- 3.1.16 Cracking to plaster around door between landing and room 12 (See photograph P-18).

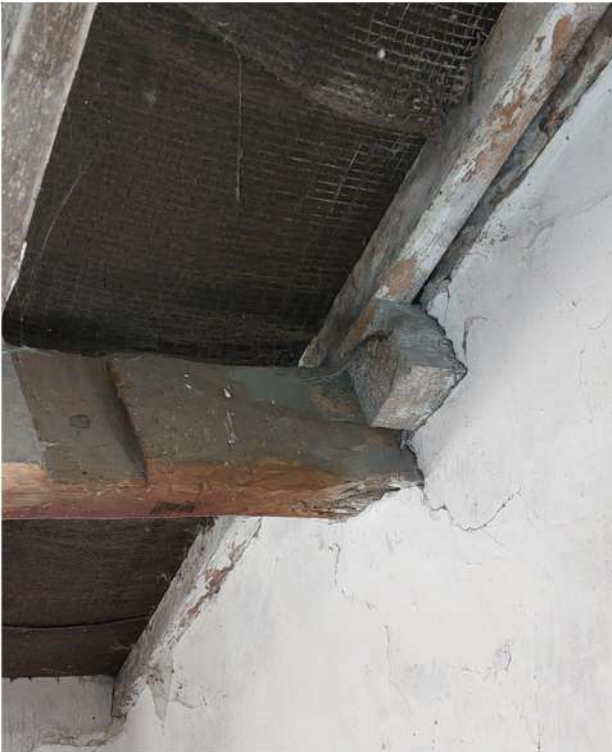
(P-19)

- 3.1.17 Timber purlin rotten at wall bearing in room 12 (See photograph P-19).
- 3.1.18 Cracking under stone corbel supporting purlin in room 13 (See photograph P-20).

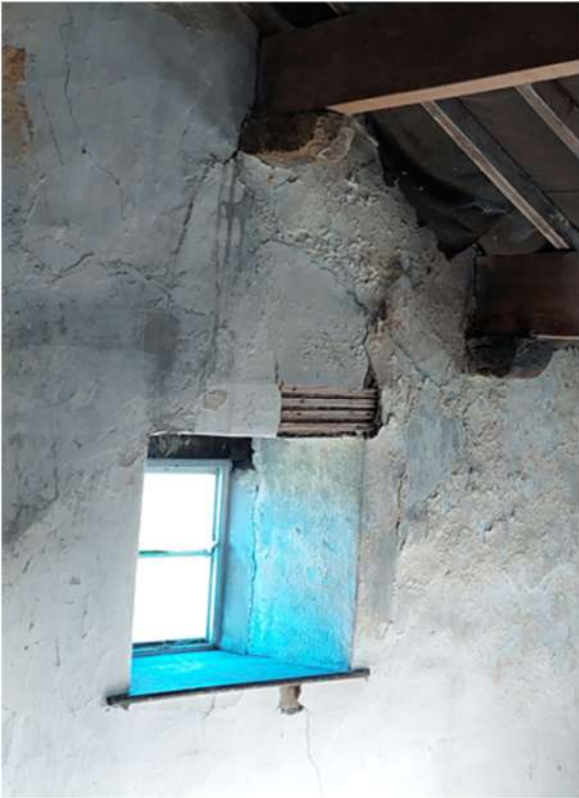
(P-21)

- 3.1.19 Cracked & missing plaster around the window and to the underside of the stone corbels in room 13, plaster was saturated and weakened (See photographs P-21)

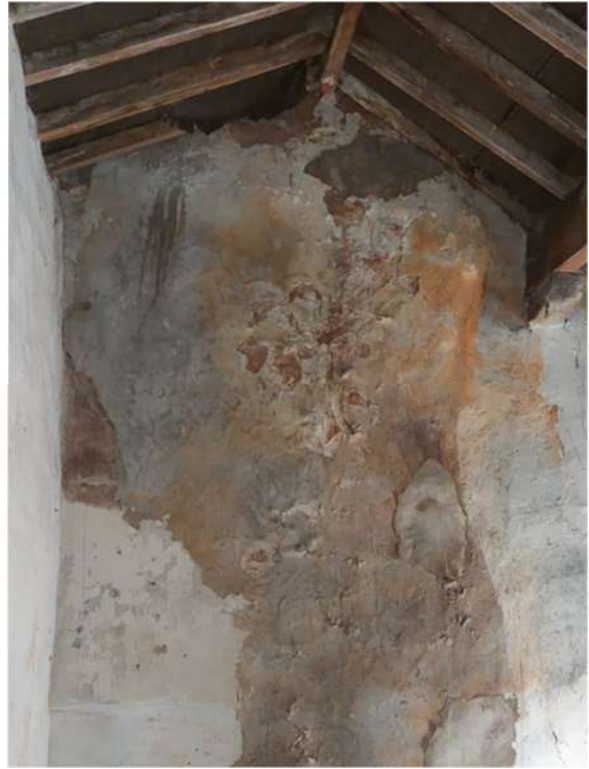
(P-22)

- 3.1.20 Heavy signs of water penetration along chimney breast in room 13, decaying rafter closest to the wall was heavily damaged with section missing at the end (See photograph P-22).

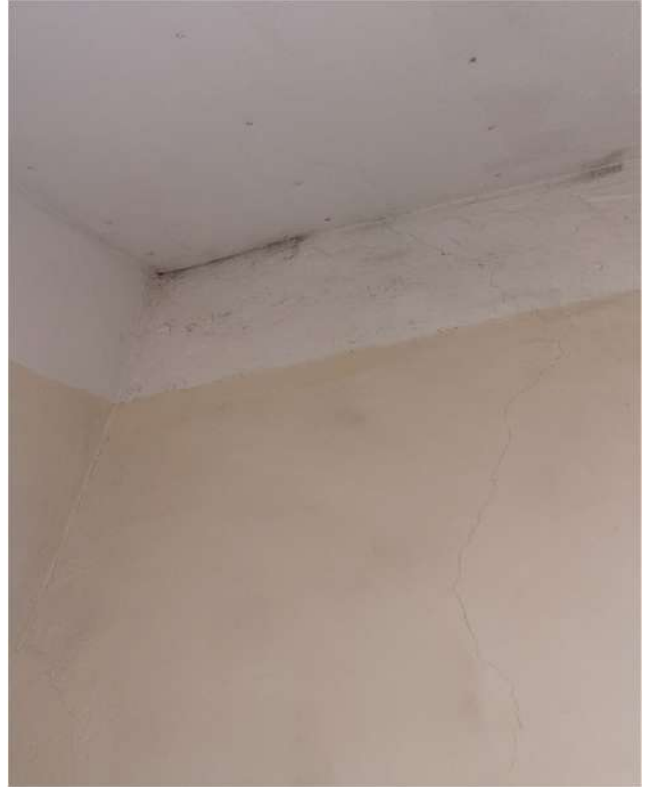
(P-26)

- 3.1.22 Rotting timber purlin ends with damp timber floor boards under, likely due to water ingress in room 14. Plaster damaged and de-bonded along wall panel (See photographs P-24 & P-25).
- 3.1.23 Mould present to top corner of wall and vertical crack along plaster in landing space (See photograph P-26).
- 3.1.24 Water ingress and mould on wall between stair and window (See photograph P-27).
- 3.1.25 Cracking and de-bonding to plaster along all wall panels and end of timber purlin heavily decayed in room 15 (See photograph P-28).
