**HISTORIC BUILDING SURVEY REPORT:**  
**CUCKOO HALL, HIGHER ROAD, LONGRIDGE, LANCASHIRE**

Planning Reference: 3/2024/0121  
NGR: SD 63896 39018  
AAL Site Code: LOHR 25  
OASIS Reference Number: allenarc1-536093

By  
Allen Archaeology Ltd  
Report Number AAL 2025117

August 2025

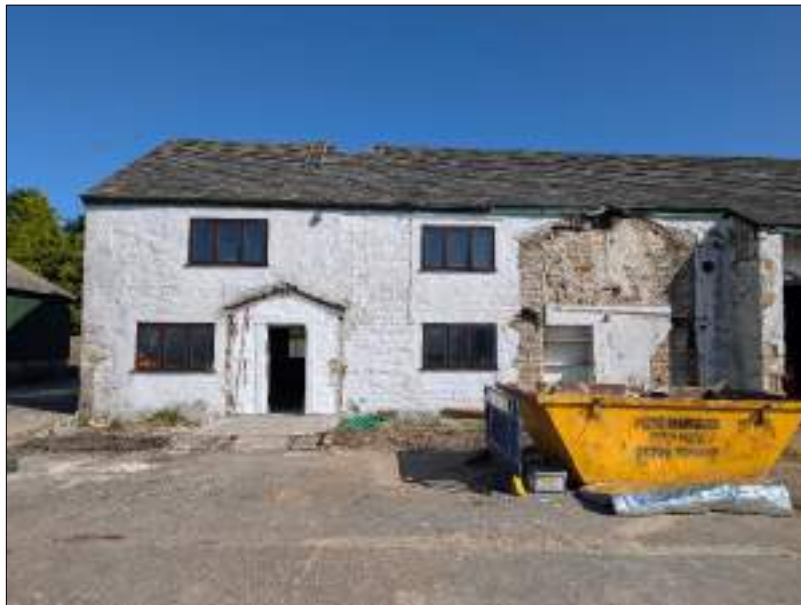
- 6.3 The south east facing façade of the farmhouse (Plate 1; Shot 166) comprised a two storey, two bay elevation with an entrance in the southwestern bay at ground floor level. The misalignment of the ground and first storey windows of the southwestern bay suggests that the ground floor window and entrance represent an alteration to the original fabric of the building. The limewash finish of the façade made details of alterations to the fabric difficult to establish from the exterior of the building. Where visible the masonry comprised roughly squared, random coursed quarry-faced sandstone blocks.

*Plate 1 (shot 166): Southeast-facing elevation of farmhouse, looking northwest, 2m scale*

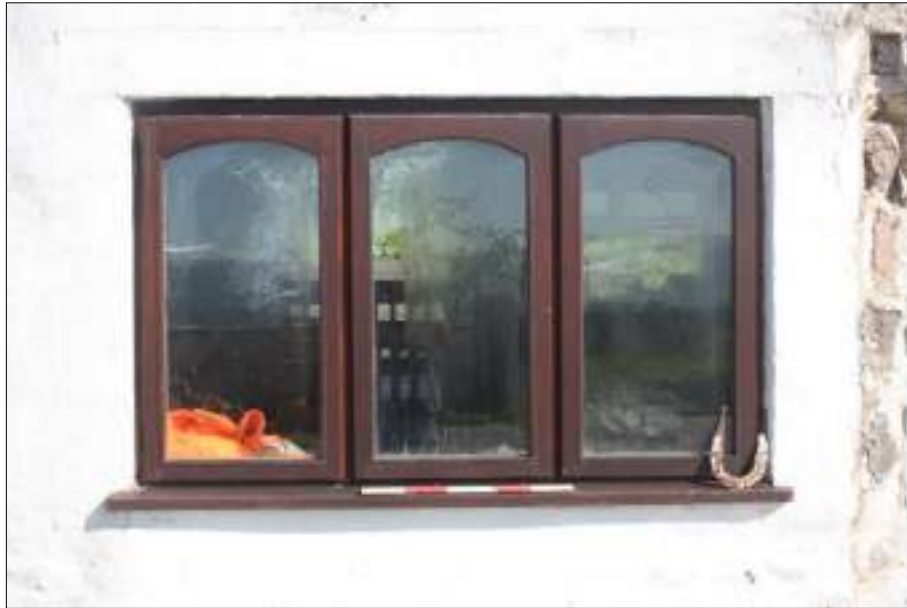
- 6.4 The windows in the southeastern elevation of the farmhouse were rectangular with three rectangular lights with segmental arches at the top (Plate 2: Shot 160). The timber framing and the glazing of the windows is of relatively recent origin.

*Plate 2 (shot 160): Detail of window, southeast elevation of farmhouse, looking northwest, 0.5m scale*

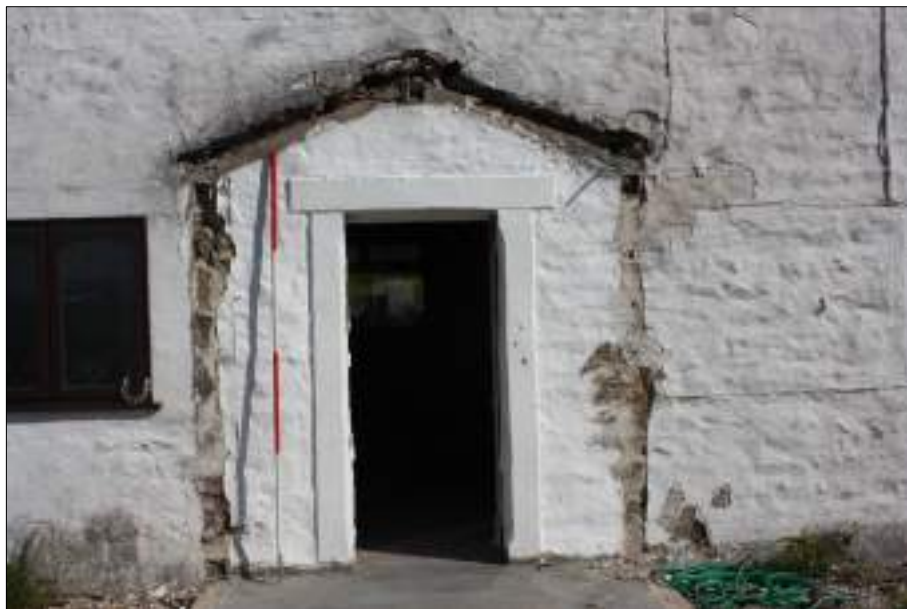
- 6.5 The entrance (Plate 3; Shot 159) comprised masonry jambs and lintel, with the jambs chamfered on the inner corners. Surrounding the entrance there was clear evidence of a porch, likely to have been of brick construction, that has been recently demolished.

*Plate 3 (shot 159): Entrance in southeast elevation of farmhouse, looking northwest, 2m scale*

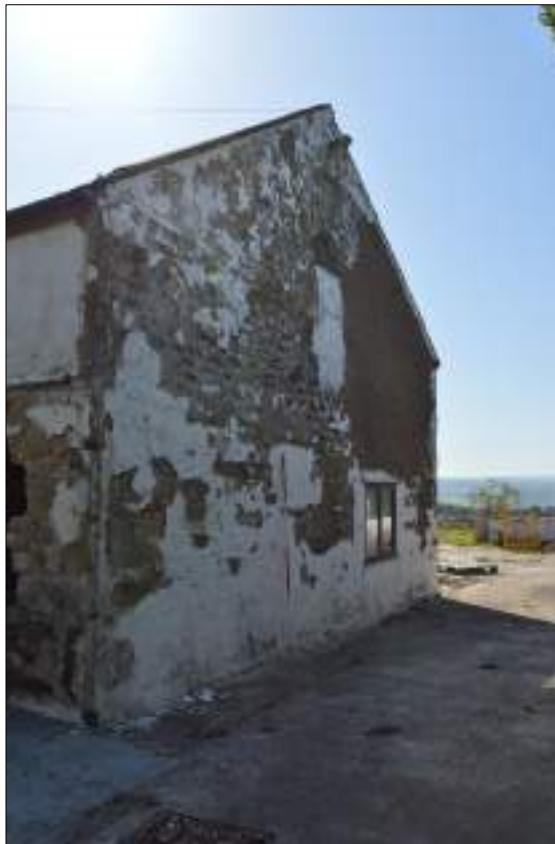
- 6.6 The southwest facing elevation of the farmhouse (Plate 4; Shot 36) as largely solid masonry, with a single square window (Plate 5; Shot 39) at ground floor level at the southeastern side of the elevation. The timber frame and glazing of the window were recent insertions in the same style as the windows in the southwestern elevation, although the window had a substantial stone lintel, suggesting that the opening itself may be part of the original fabric. There was also

*Plate 4 (shot 36): Southwest-facing elevation of farmhouse, looking southeast, 2m scale*

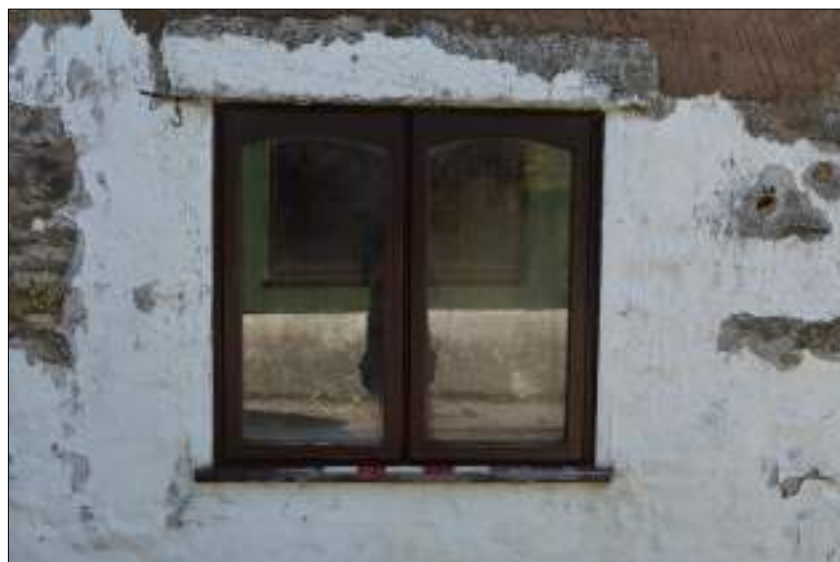
*Plate 5 (shot 39): Detail of ground floor window in southwest facing elevation of farmhouse, looking northeast, 0.5m scale*

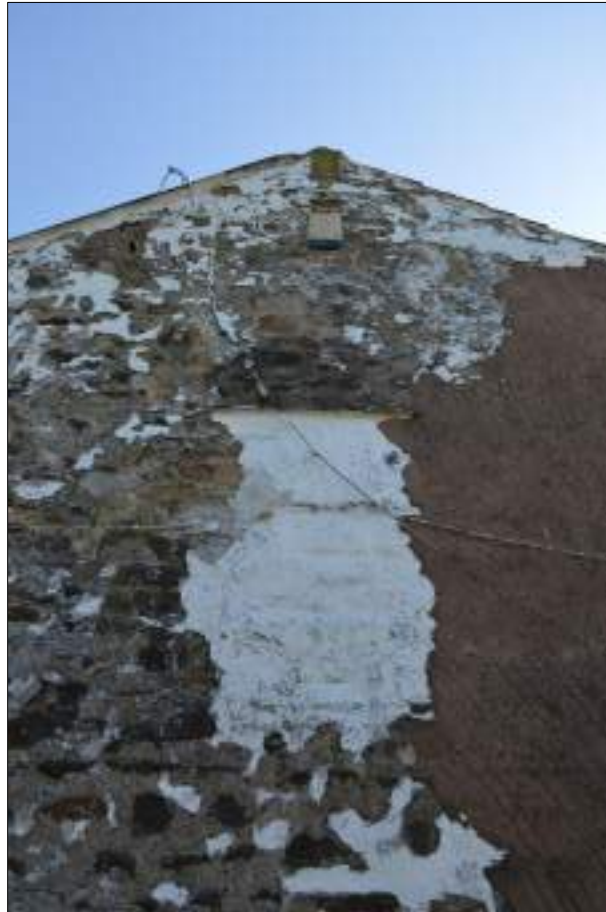
a blocked window (Plate 6; Shot 38) at first floor level, which was clearer internally (see below). To the southeast of the blocked window and above the ground floor window the gable end wall was finished with cement render which appeared to be of relatively modern date.

*Plate 6 (shot 38): Blocked first floor window in southwest-facing elevation of farmhouse, looking northeast, no scale*

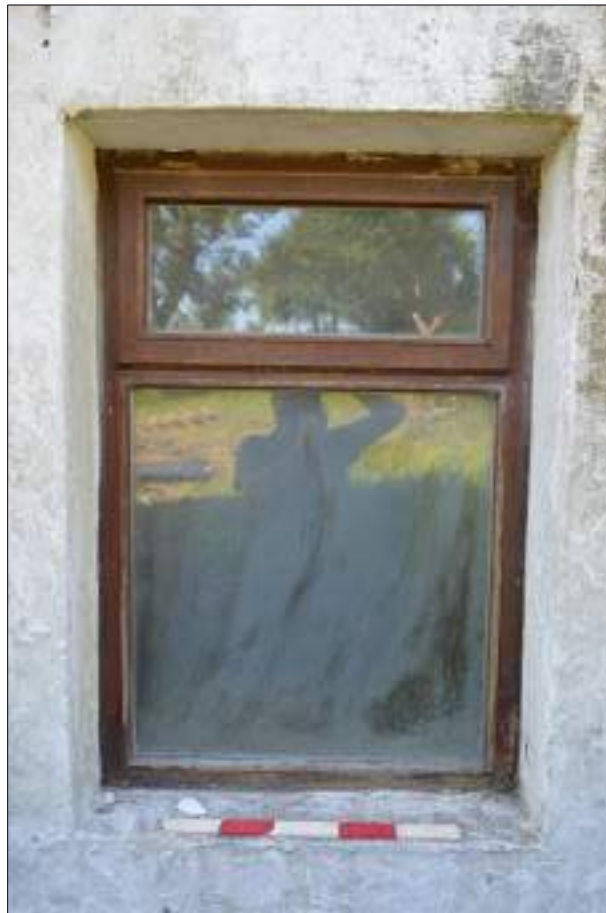
*Plate 11 (shot 30): Detail of ground floor window, northwest elevation of farmhouse, 0.5m scale*

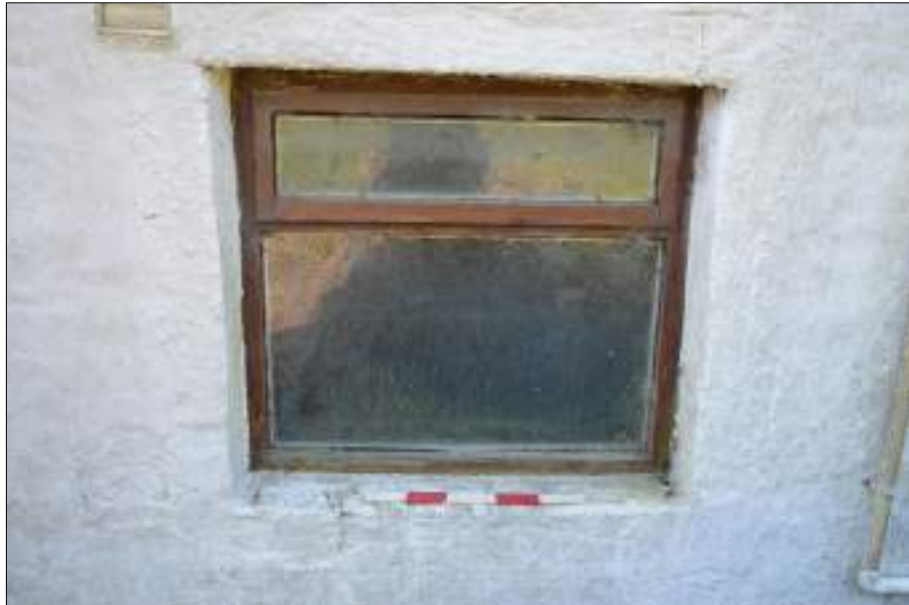
*Plate 12 (shot 28): Detail of ground floor window, northwest elevation of farmhouse, 0.5m scale*

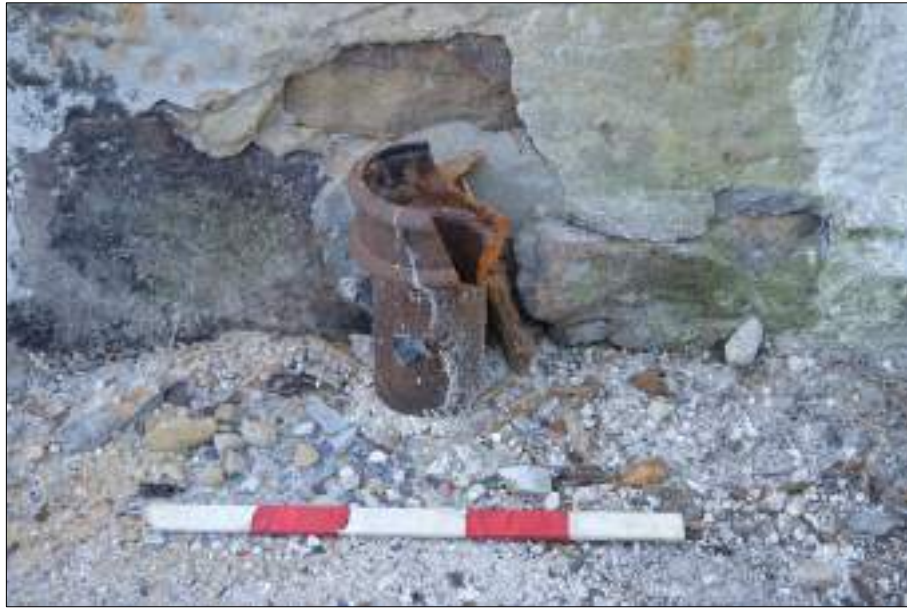
- 6.11 The remnant of a cast iron downpipe (Plate 14; Shot 27) was recorded adjacent to the base of the wall on the northwestern side of the farmhouse.

*Plate 14 (shot 27): Cast iron pipe on northwestern side of farmhouse, 0.5m scale*

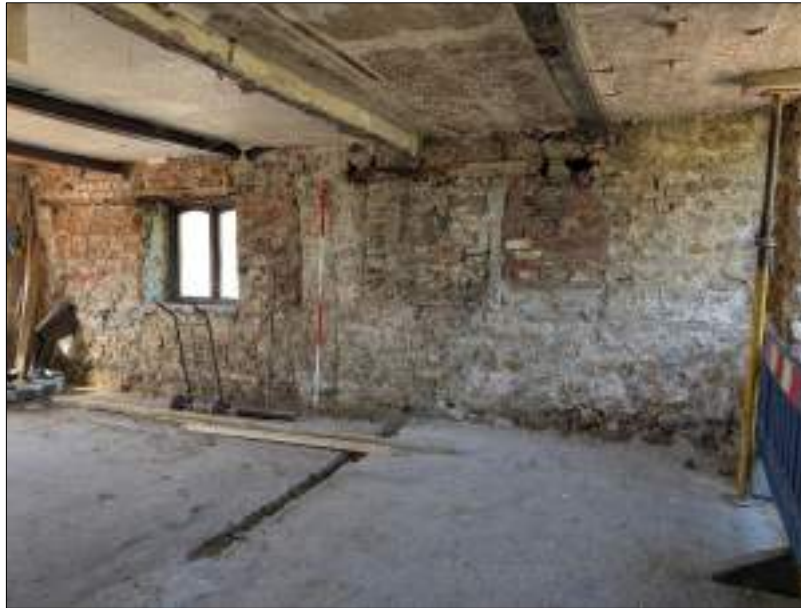
- 6.13 The modern fittings had been stripped out of the interior of the farmhouse buildings, exposing the structural masonry of the walls, which largely comprised random coursed lime mortar bonded sandstone blocks. A removed partition wall was clearly visible toward the northwestern end of the room (Plate 15; Shot 173).

*Plate 15 (shot 173): Interior of Room 1, looking southwest, 2m scale*

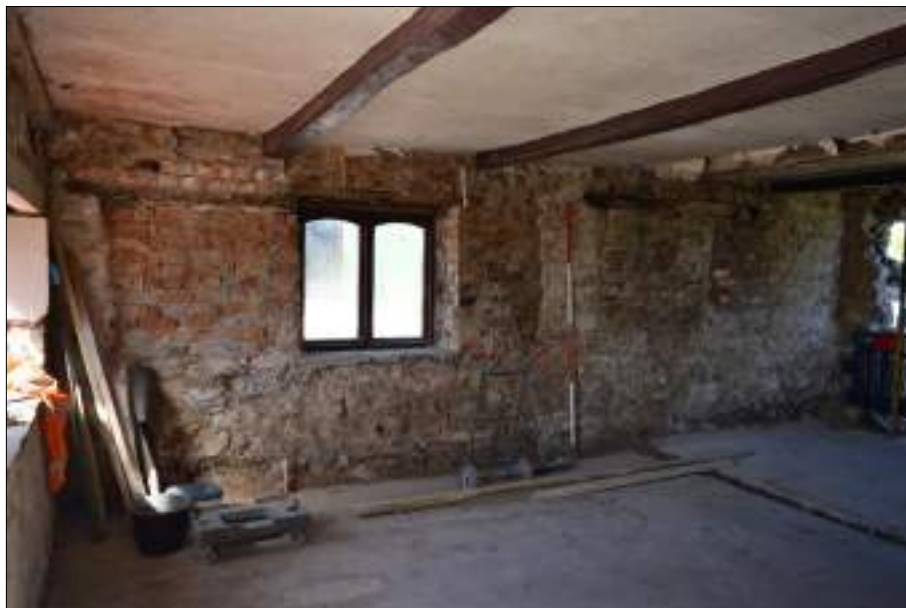
*Plate 16 (shot 43): Interior of Room 1, looking northwest, 2m scale*

- 6.14 On the southwestern wall of Room 1 the window (Plates 16 and 17; Shots 43 and 46) had a double timber lintel above the frame. The masonry to either side of the window and above it comprised hand pressed brick laid in a hybrid English bond with alternately one or two stretcher courses per header course (Plate 18; Shot 40). This suggests that the position of the window is the result of an extensive alteration to the southwestern wall, probably in the first half of the 19<sup>th</sup> century.

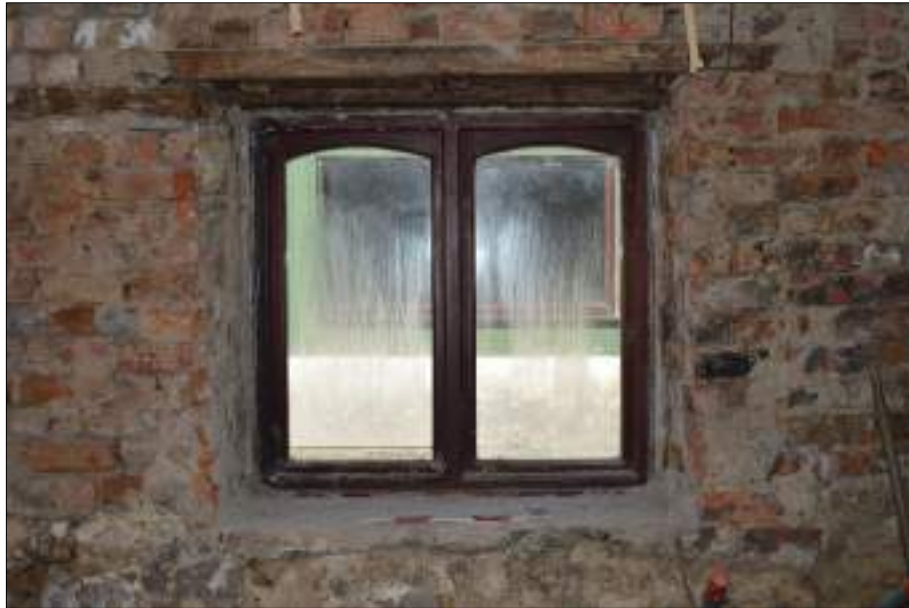
*Plate 17 (shot 46): Detail of window, southwestern wall, Room 1, 0.5m scale*

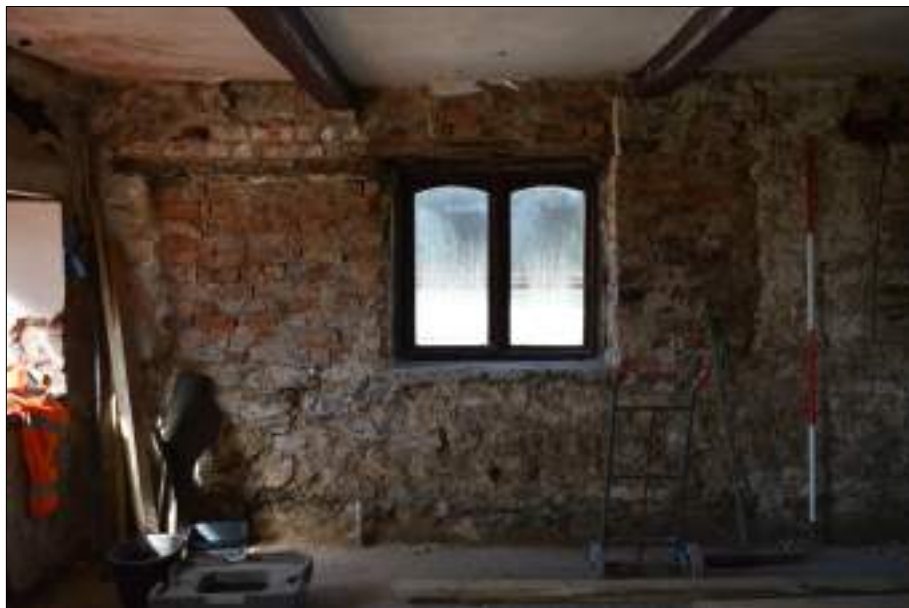
*Plate 18 (shot 40): Southeastern part of southwestern wall, Room 1, 2m scale*

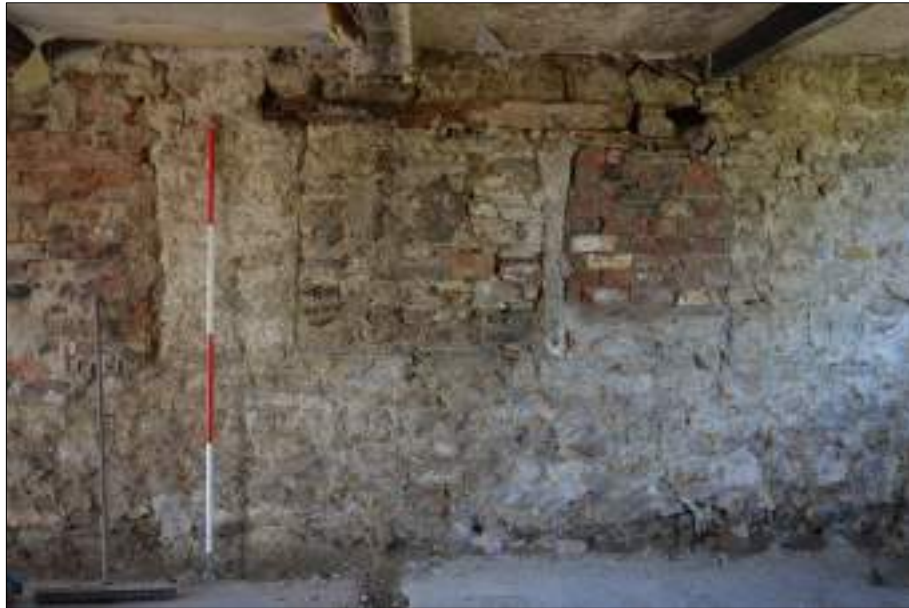
- 6.15 The northwestern part of the southeastern wall (Plate 19; Shot 44) had evidence of two adjacent blocked windows, a larger square opening to the southeast, with a smaller one immediately to the northwest, separated by a vertical timber member. The larger window was largely blocked with sandstone rubble although there was occasional hand pressed brick. The smaller window was blocked with handmade brick, possibly at the same time as the alteration to the southeastern part of the wall described above.

*Plate 19 (shot 44): Detail of blocked windows in southwestern wall, Room 1, 2m scale*

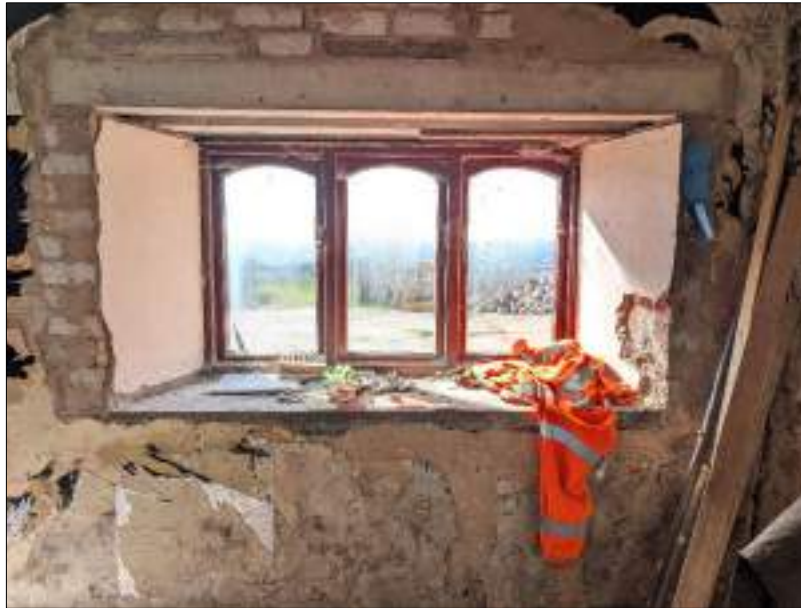
- 6.16 The southeastern wall of Room 1 (Plate 20; Shot 47) largely had the internal render and some wallpaper remaining, so the nature of the fabric was unclear. The rectangular window (Plate 21; Shot 175) had very deep splayed reveals and was surmounted by a concrete lintel with blockwork above, suggesting that the position of the window as well as the glazing represents a relatively late alteration to the fabric of the farmhouse.

*Plate 21 (shot 175): Detail of window, southeastern wall, Room 1, 0.5m scale*

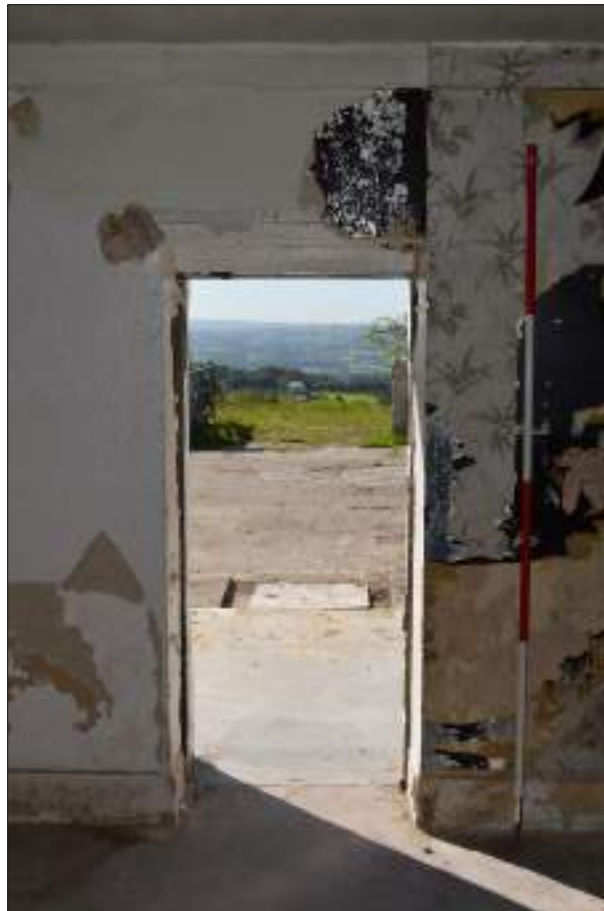
- 6.17 The entranceway in the southeastern wall of Room 1 (Plate 22; Shot 48) was a plain rectangular opening with timber lintel and jambs. The door had been removed.

*Plate 22 (shot 48): Detail of doorway in southeastern wall, Room 1, 2m scale*

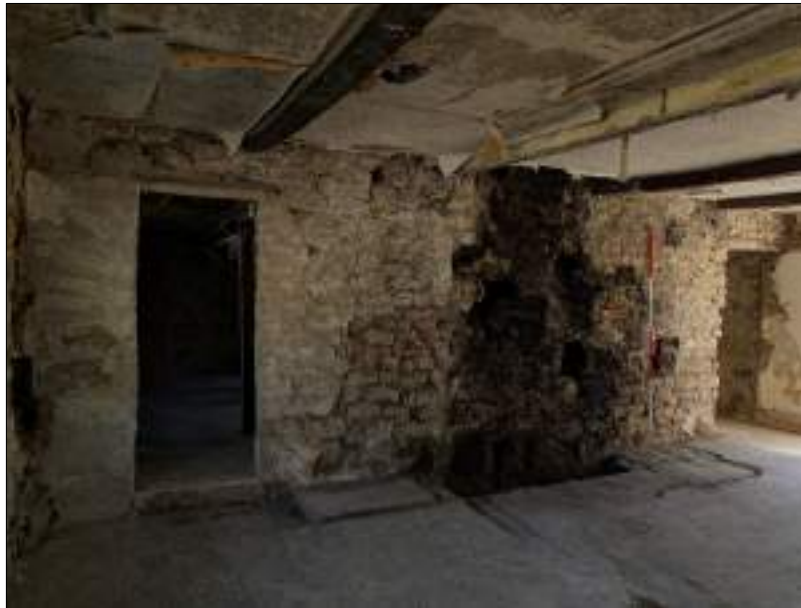
- 6.18 The northeastern wall of Room 1 (Plate 23; Shot 177) was of random coursed sandstone rubble construction, but with a number of later alterations.

*Plate 23 (shot 177): Northeastern wall, Room 1, 2m scale*

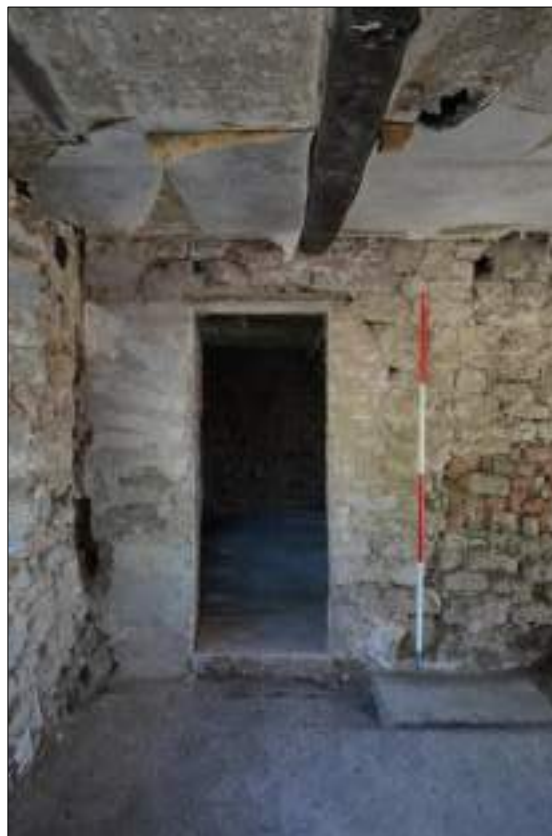
- 6.19 A doorway between Room 1 and Room 3 at the northwestern end of the wall (Plate 24; Shot 52) had a simple timber frame with brickwork to either side, demonstrating that it represents a later alteration to the original fabric of the building.

*Plate 24 (shot 52): Detail of doorway in northeastern wall of Room 1, 2m scale*

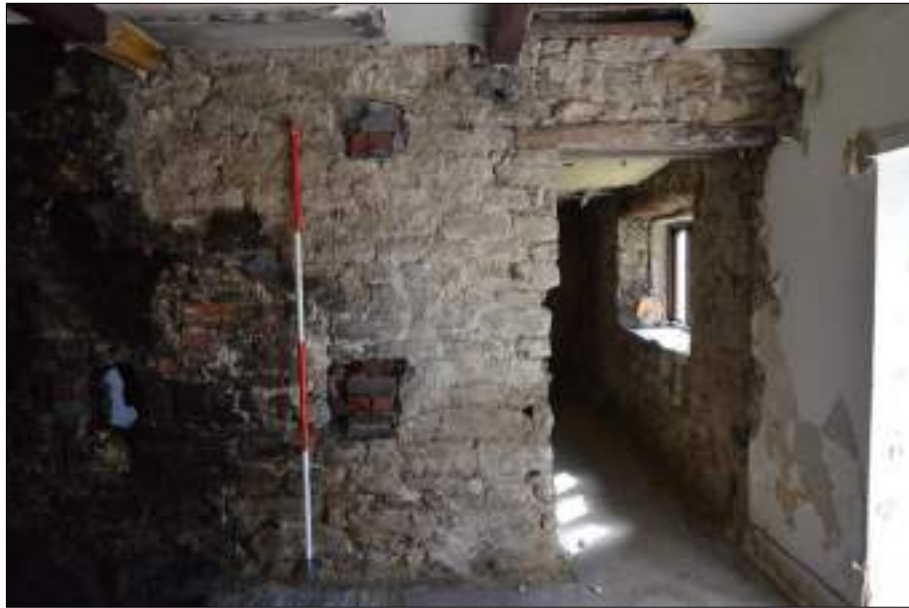
- 6.20 At the southeastern end of the wall a doorway between Room 1 and Room 2 (Plate 25; Shot 51) comprised a rectangular opening with a timber lintel that appeared to represent an original feature of the farmhouse.

*Plate 25 (shot 51): Detail of doorway in northeastern wall of Room 1, 2m scale*

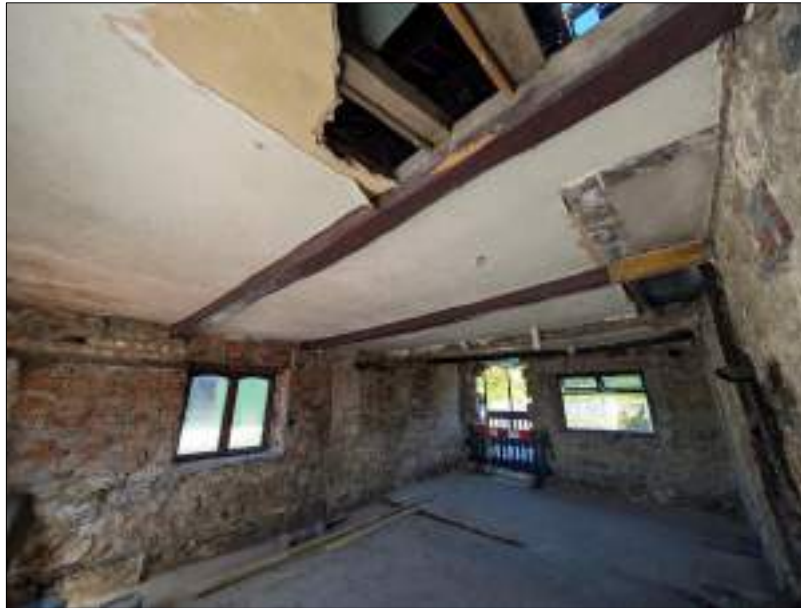
- 6.21 Between the two doorways a fireplace or range in the centre of the northeastern wall had been substantially removed (Plate 26; Shot 50), with evidence of its original extent visible on the floor (Plate 27; Shot 178) and ceiling (Plate 28; Shot 28) of the room, as well as on existing plans of the farmhouse provided by the client. Surrounding the fireplace a number of brick blocked openings in the masonry of the wall are likely to relate to the former presence of a cooking range.

*Plate 27 (shot 178): Interior of Room 1, looking northwest, showing extent of demolished fireplace on ceiling, no scale*

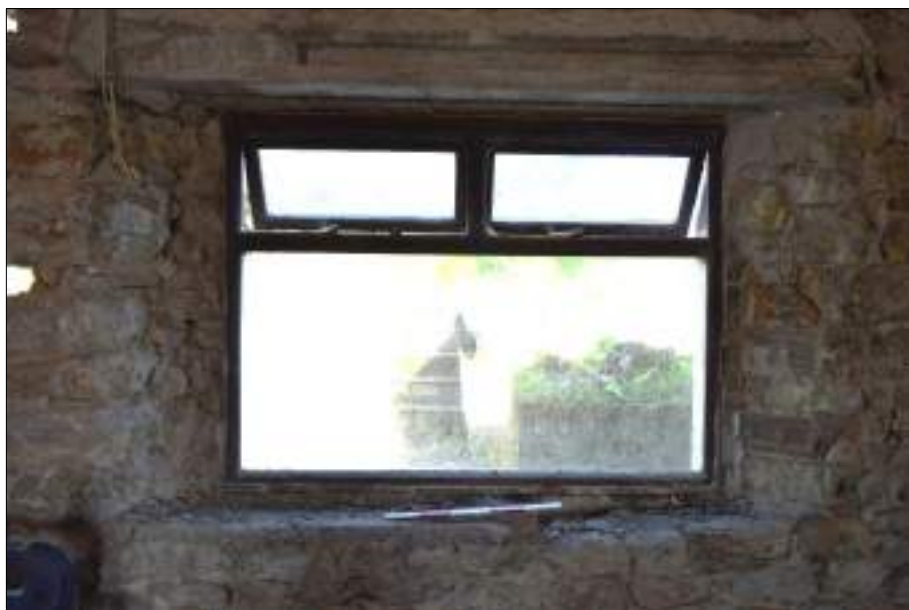
- 6.22 The northwestern wall of Room 1 (Plate 29; Shot 41) was of random coursed sandstone rubble construction, with two openings. That to the southwest was a doorway leading to a demolished modern extension, the doorway had been heavily damaged presumably during the demolition work. To the northeast of the doorway, a rectangular window (Plate 30; Shot 42) with splayed reveals appeared to be in its original position, though some infill above the window suggested that it had been altered later.

*Plate 30 (shot 42): Detail of window, northwestern wall, Room 1, 0.5m scale*

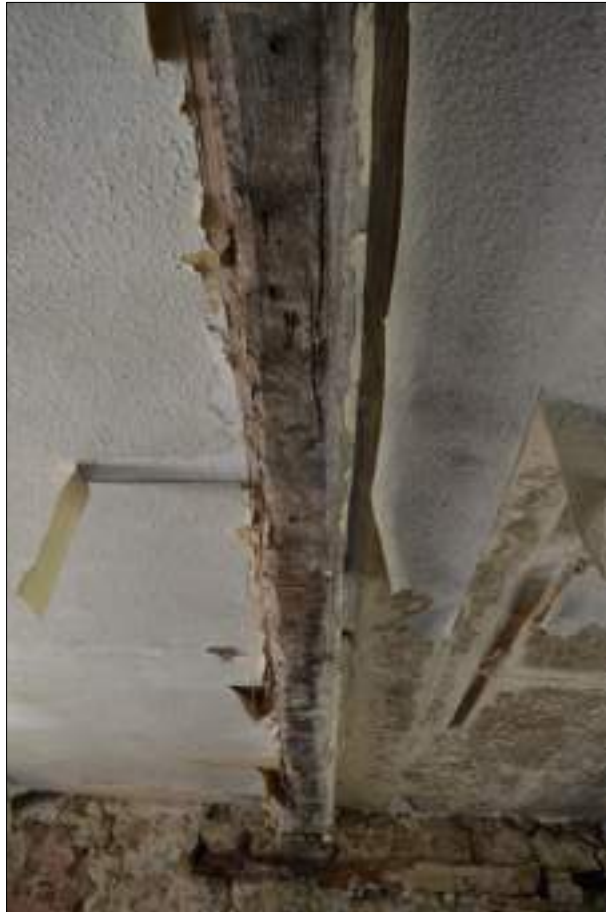
- 6.23 The ceiling (Plate 31; Shot 54) of Room 1 comprised exposed hanging beams parallel with the roof line, with perpendicular joists above. The plasterboard ceiling was hung from battens attached to the sides of the joists (Plate 27; Shot 178).

*Plate 31 (shot 54): Detail of ceiling beam, Room 1, no scale*

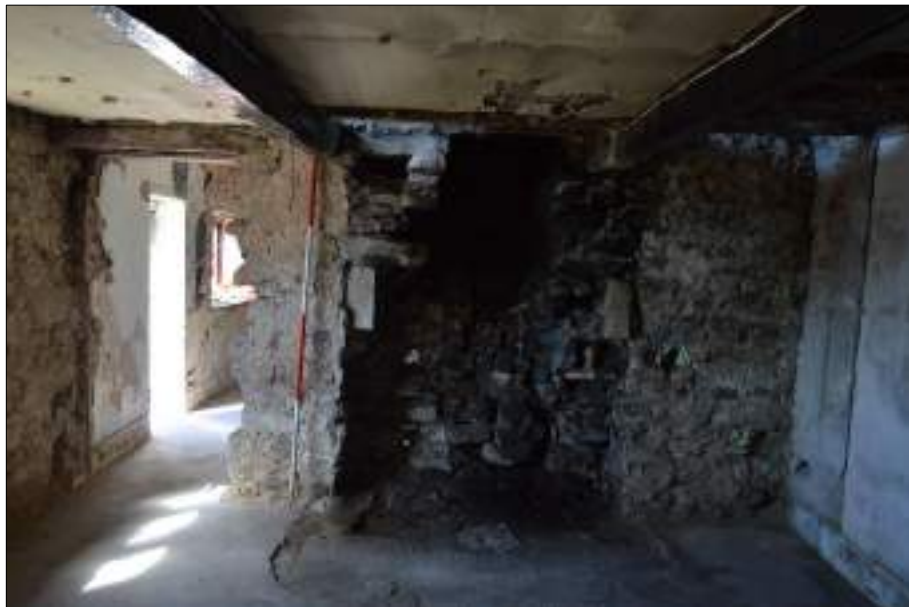
- 6.28 The southwestern wall of Room 2 (Plate 35; Shot 61) had a doorway leading to Room 1 at the southeastern end, and centrally placed demolished fireplace (Plate 36; Shot 62), utilising the same flue as the fireplace in Room 1.

*Plate 35 (shot 61): Southwestern wall of Room 2, 2m scale*

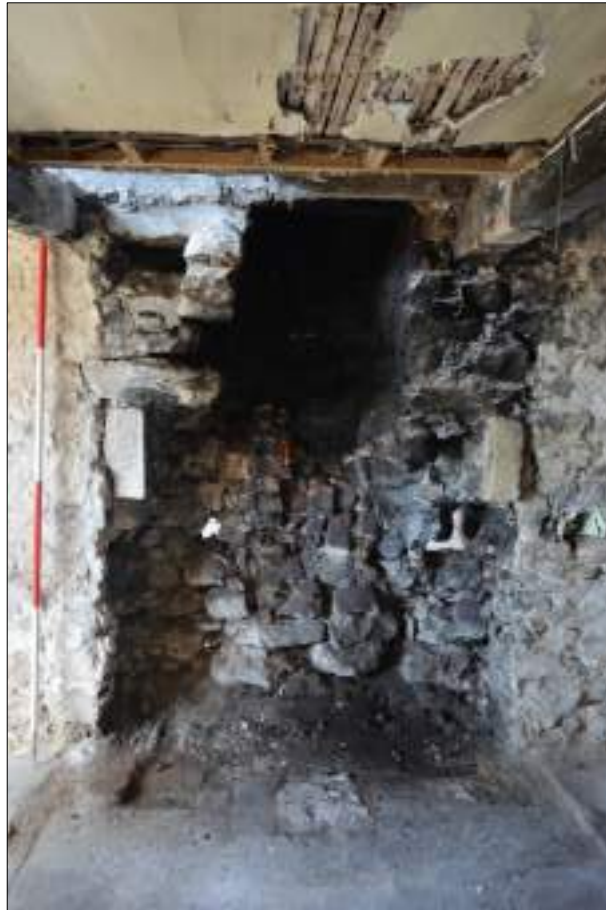
*Plate 36 (shot 62): Detail of demolished fireplace, southwestern wall of Room 2, 2m scale*

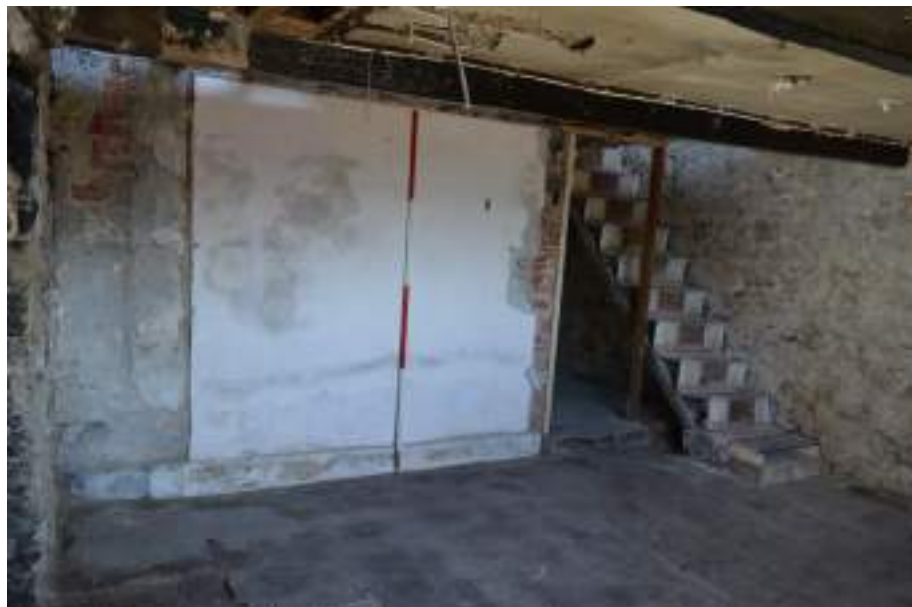
*Plate 37 (shot 65): Northwestern wall of Room 2, 2m scale*

- 6.29 The northwestern wall of Room 2 (Plate 37; Shot 65) comprised a rendered brick partition that did not extend across the full width of the bay, with access to Room 3 and a staircase leading to the first floor to the northeast. The position of the partition was to the northwest of the ridge line of the roof, as represents a later alteration to the original fabric of the farmhouse. It is likely that the removed partition in Room 1, which is on the same line, would have been very similar in character and construction.

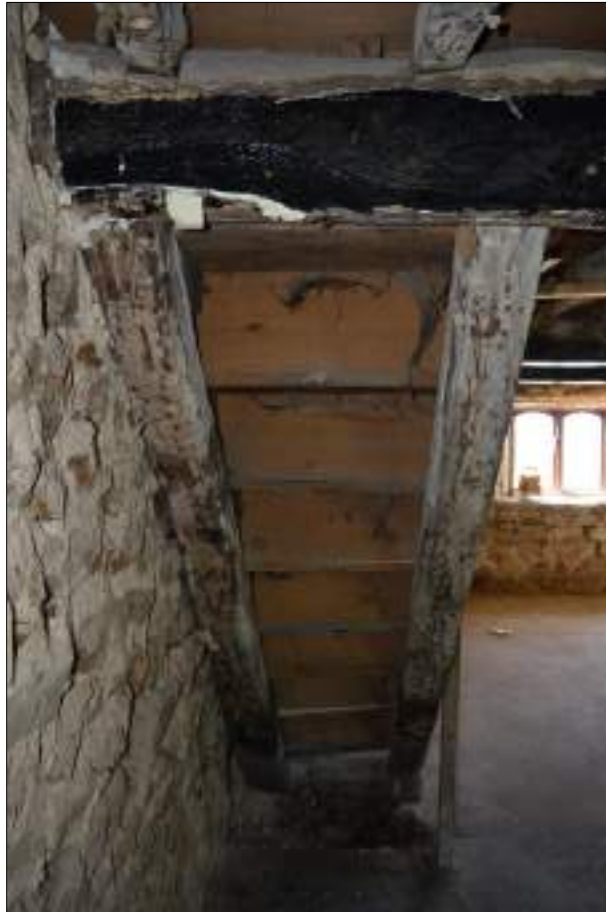
*Plate 39 (shot 70): Detail of staircase, Room 2, 2m scale*

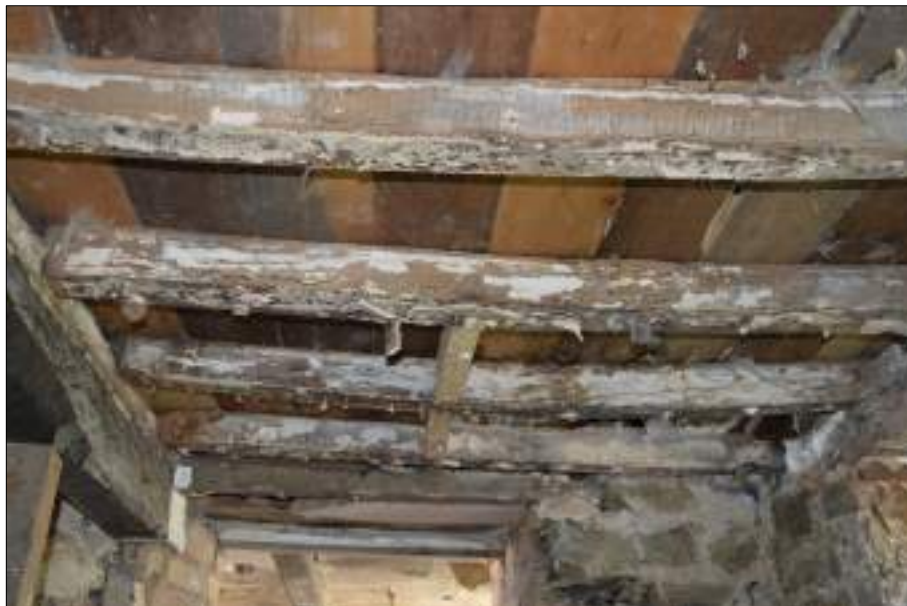
*Plate 42 (shot 75): Detail of ceiling, Room 3, no scale*

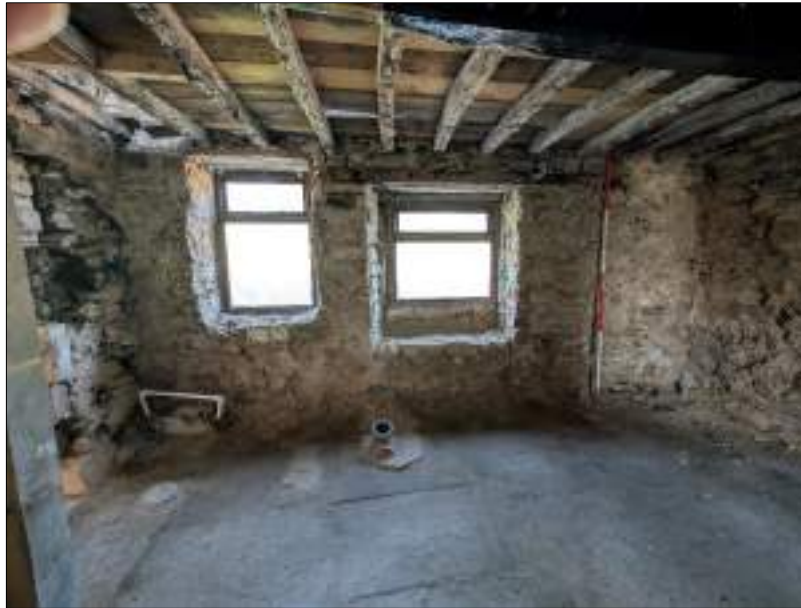
- 6.33 The northwestern wall of Room 3 was of random coursed sandstone rubble construction and was pierced by two windows (Plate 43; Shot 181).

Plate 43 (shot 181): Northwestern wall of Room 3, 2m scale

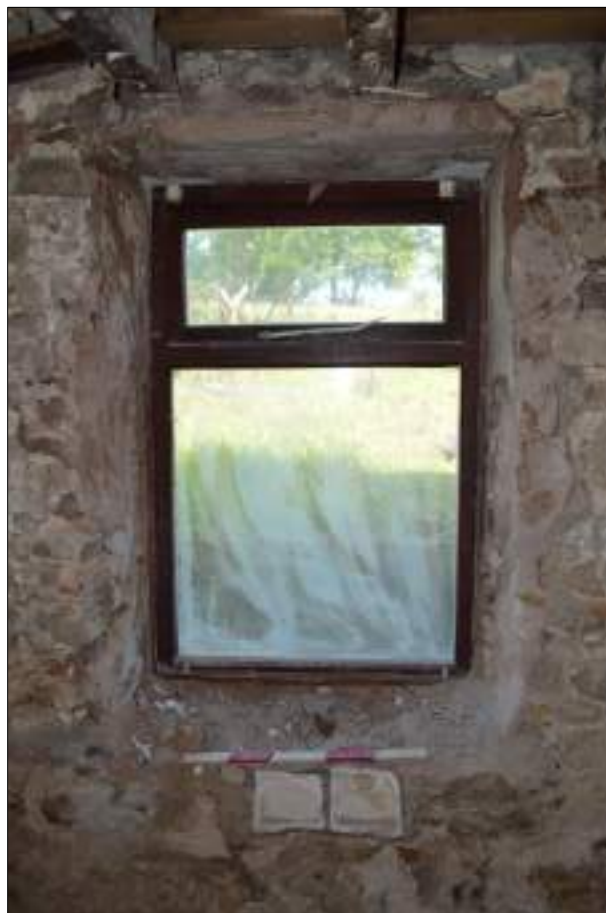
*Plate 44 (shot 73): Detail of window, northwestern wall, Room 3, 0.5m scale*

- 6.34 The southwestern window in the northwestern wall of Room 3 (Plate 44; Shot 73) was a rectangular opening with deep reveals and little evidence of alteration, although the wooden frame and glazing were recent. The window to the northeast (Plate 45; Shot 71) had a patch of brickwork on the northeastern side which suggested that the window opening may have been enlarged, but then subsequently partially blocked when the modern frame was inserted. A timber lintel above, much wider than the window itself, suggests that there may have originally been a substantial entranceway in this part of the farmhouse building.

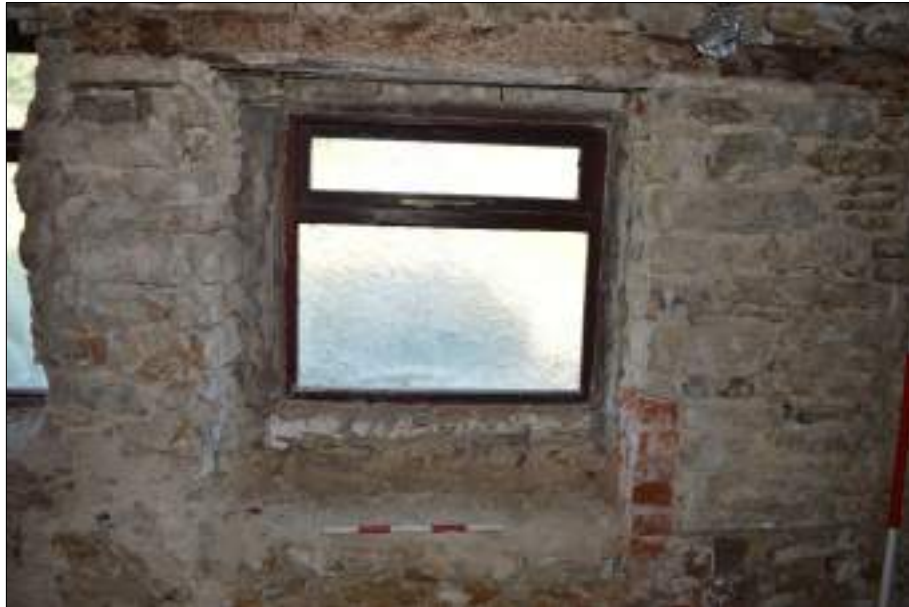
*Plate 45 (shot 71): Detail of window, northwestern wall, Room 3, 0.5m scale*

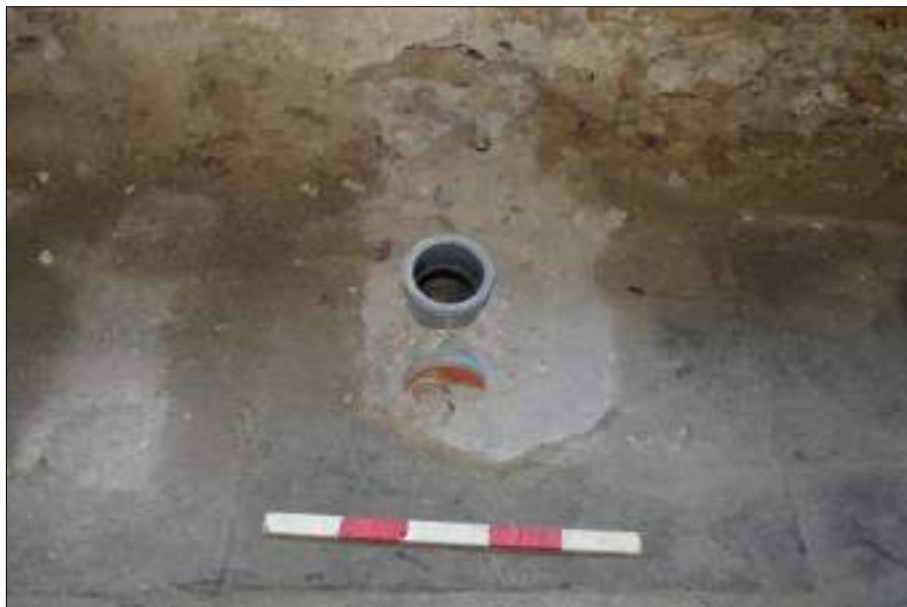
- 6.37 Set into the floor of Room 3 there was a waste pipe (Plate 48; Shot 74) from a removed toilet associated with the recent use of the room as a bathroom. Other elements of the plumbing system also survived in Room 3, all representing modern alterations to the farmhouse building.

*Plate 48 (shot 74): Detail of pipework associated with modern bathroom fittings, Room 3, 0.5m scale*

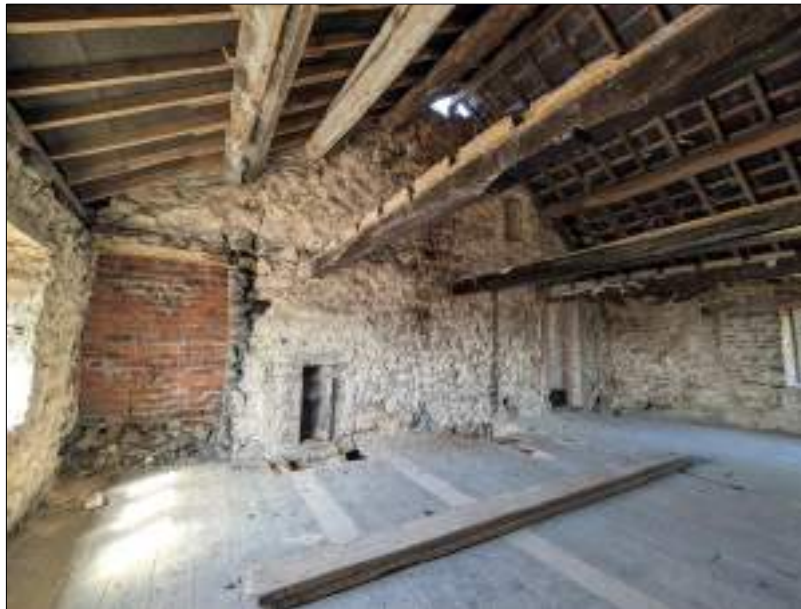
- 6.38 The room designated as Room 4 comprised the northeastern room on the first floor of the farmhouse (Plate 49; Shot 183).

*Plate 49 (shot 183): Interior of Room 4, looking northwest, 2m scale*

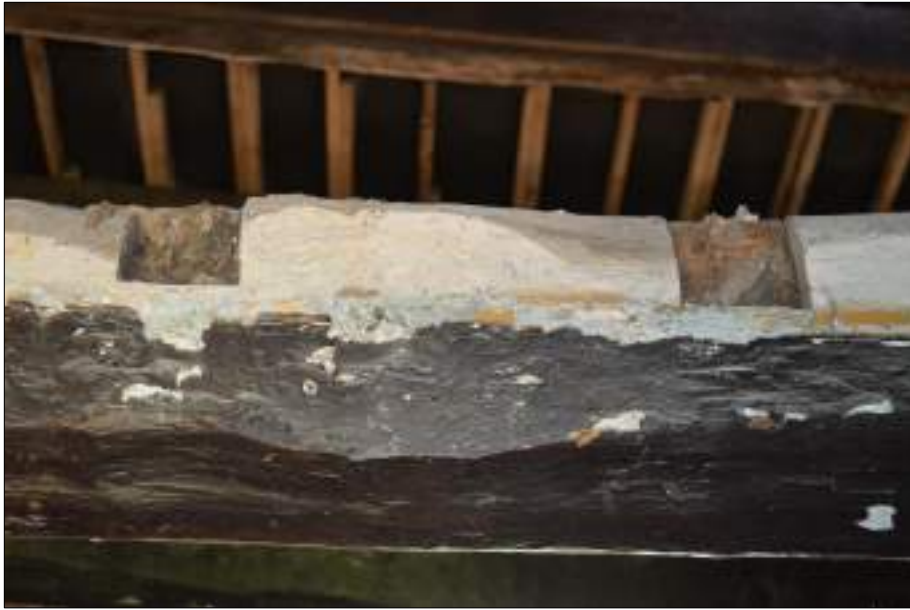
- 6.39 The northeastern wall of Room 4 (Plate 50; Shot 185) was of random coursed sandstone rubble construction, with little sign of alteration. Three beams aligned with the ridge line of the farmhouse were present at the eaves level of the roof, demonstrating that the first-floor rooms had had a ceiling, with a separate loft space above, this floor level having subsequently been removed. Two of the beams were likely to be later replacements, but that to the southeast retained the mortises for the floor joists (Plate 51; Shot 87) and is likely to represent an original member of the building's fabric.

*Plate 51 (shot 87): Detail of mortise joints in ceiling beam, Room 4, no scale*

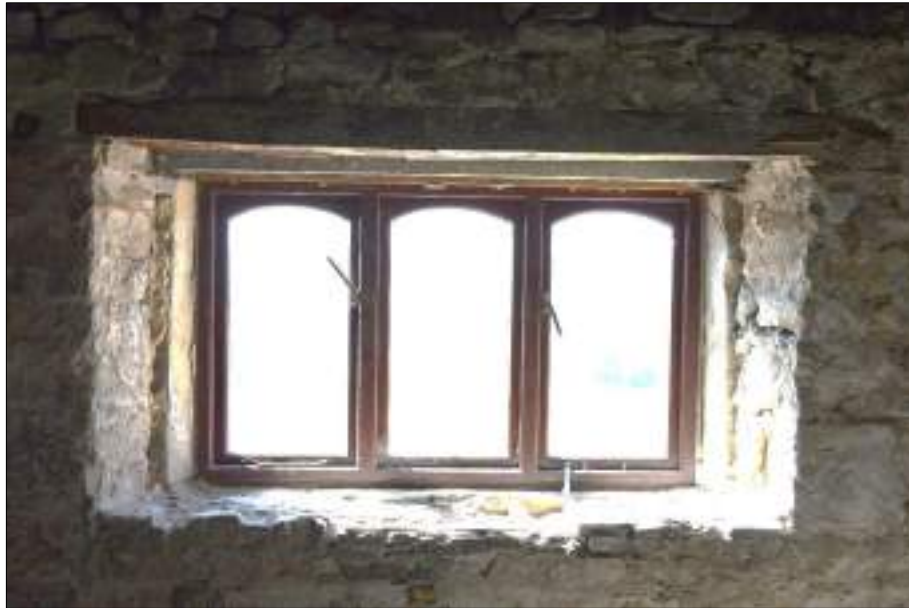
- 6.40 The southeastern wall of Room 4 (Plate 52; Shot 83) was pierced by a landscape rectangular window (Plate 53; Shot 86) with splayed reveals and a timber lintel above. The position of the window opening is likely to be original, although the wooden frame and glazing are later replacements. To the northeast of the window in the corner of the room there was thicker rendering on the wall, although it was not clear whether this was associated with a structural alteration.

*Plate 53 (shot 86): Detail of window, southeastern wall of Room 4, 0.5m scale*

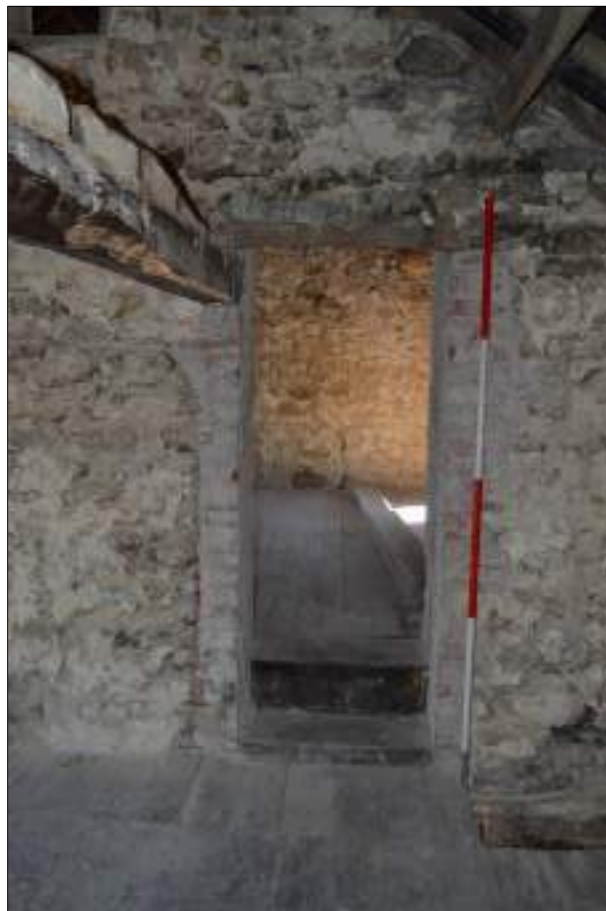
- 6.41 The southwestern wall of Room 4 had a doorway leading to Room 5 (Plate 54; Shot 79) at the northwestern end with a timber lintel and brick jambs, which is likely to represent an alteration to the original fabric of the building. At the southeastern end of the wall a blocked doorway (Plate 55; Shot 82) between Room 4 and Room 5 was blocked with machine made brick, which may have been inserted when the doorway at the northwestern end of the wall was added.

*Plate 54 (shot 79): Detail of doorway, southwestern wall of Room 4, 2m scale*

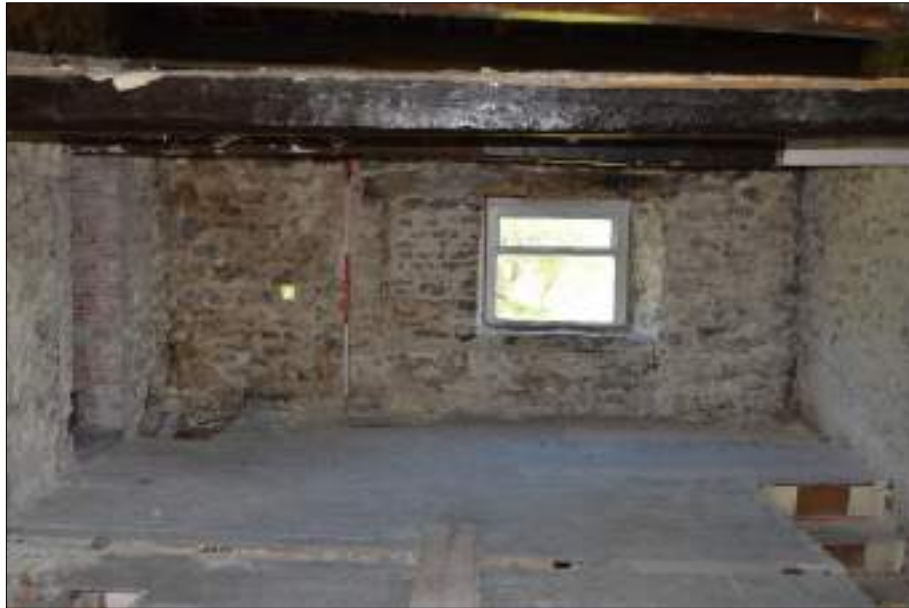
- 6.43 The northwestern wall of Room 4 (Plate 57; Shot 76) was pierced by a window (Plate 58; Shot 78), which represented the altered form of a larger window opening, with a timber lintel above; it had been largely blocked with sandstone rubble when the window was reduced in size. The extant window had a splayed reveal on the northeastern side and a flat reveal on the southwestern side where the blocking had been inserted. The large size of the original window opening and that in the southeastern wall of the room suggests the possibility that there may have been a loom located in the room, with textile manufacture used to supplement the income from farming.

*Plate 57 (shot 76): Northwestern wall of Room 4, 2m scale*
