**HISTORIC BUILDING SURVEY REPORT:**  
**CUCKOO HALL, HIGHER ROAD, LONGRIDGE, LANCASHIRE**

Planning Reference: 3/2024/0121  
NGR: SD 63896 39018  
AAL Site Code: LOHR 25  
OASIS Reference Number: allenarc1-536093

By  
Allen Archaeology Ltd  
Report Number AAL 2025117

August 2025

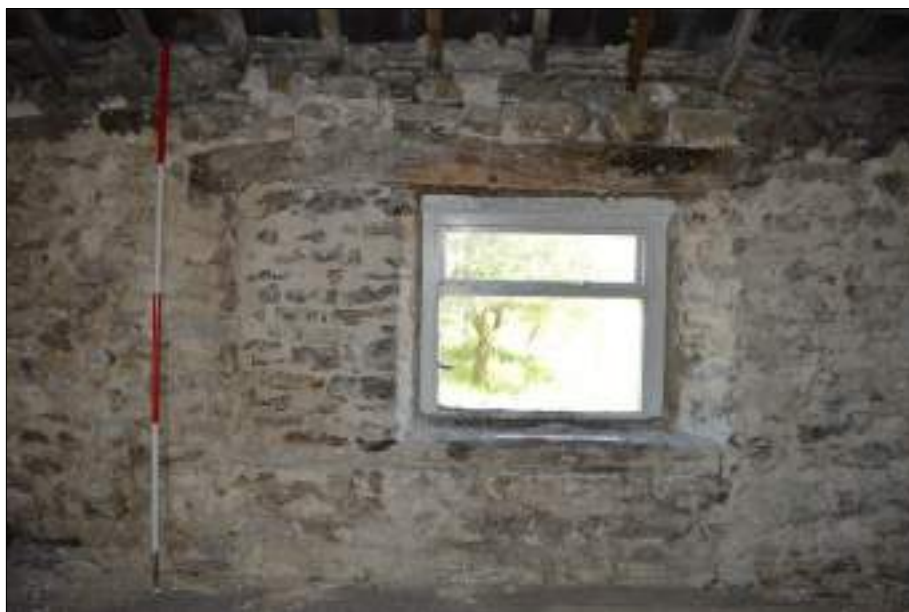
- 6.43 The northwestern wall of Room 4 (Plate 57; Shot 76) was pierced by a window (Plate 58; Shot 78), which represented the altered form of a larger window opening, with a timber lintel above; it had been largely blocked with sandstone rubble when the window was reduced in size. The extant window had a splayed reveal on the northeastern side and a flat reveal on the southwestern side where the blocking had been inserted. The large size of the original window opening and that in the southeastern wall of the room suggests the possibility that there may have been a loom located in the room, with textile manufacture used to supplement the income from farming.

*Plate 58 (shot 78): Detail of window, northwestern wall of Room 4, 2m and 0.5m scales*

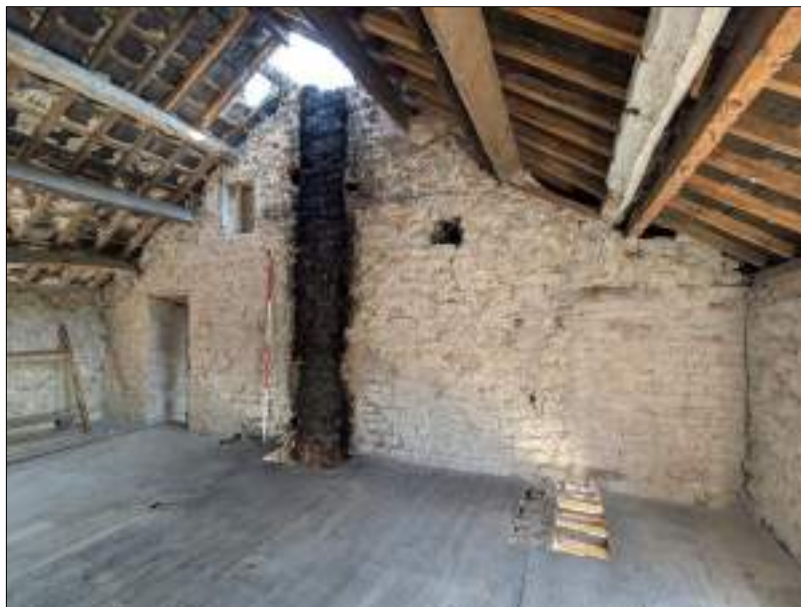
- 6.45 The room designated as Room 5 (Plate 60; Shot 189) was the southwestern room on the first floor of the farmhouse. The floor of Room 5 was at a slightly higher level than that of Room 4, with a single low step in the doorway between the two rooms. The floor was of timber board construction as in Room 4.

*Plate 60 (shot 189): Interior of Room 5, looking northeast, 2m scale*

- 6.47 At the southeastern end of the wall the blocked doorway between the first-floor rooms was visible, with brick blocking as before.
- 6.48 Between the two doorways the northeastern wall of Room 5 was stained with soot at the back of the flue of the fireplaces within the farmhouse (Plate 60; Shot 189). A rectangular gap in the floorboards in Room 5 suggests that a fireplace in this room had been removed. Between the flue and the blocked door, a gap in the masonry of the wall (Plate 63; Shot 91) is likely to represent a socket for a ceiling beam, although no beams were *in situ* in Room 5. Between the flue and the open doorway, a small rectangular opening at loft level with chamfered jambs (Plate 64; Shot 90) suggests that there had been a ceiling present in Room 5 with a separate loft above.

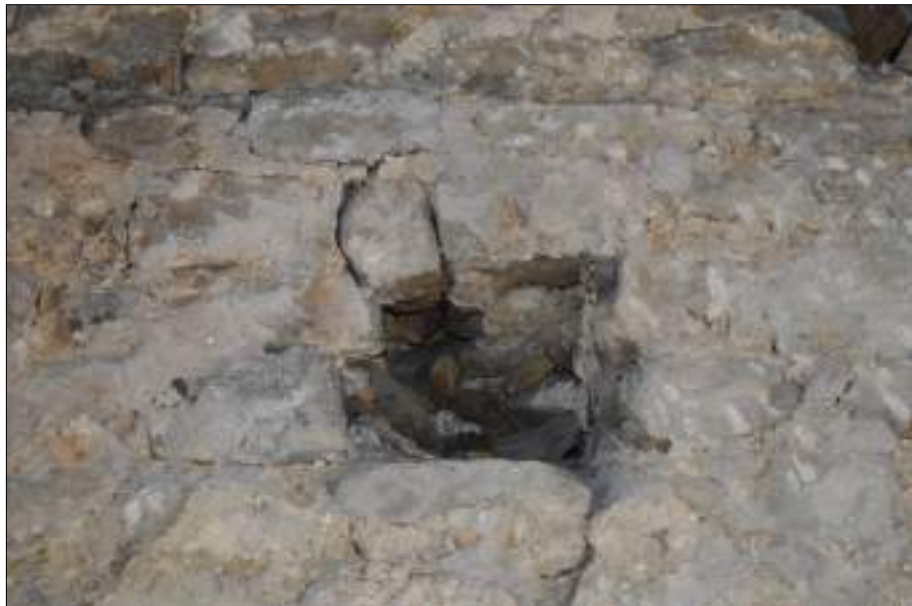
*Plate 63 (shot 91): Detail of possible socket for ceiling beam, northeastern wall of Room 5, no scale*

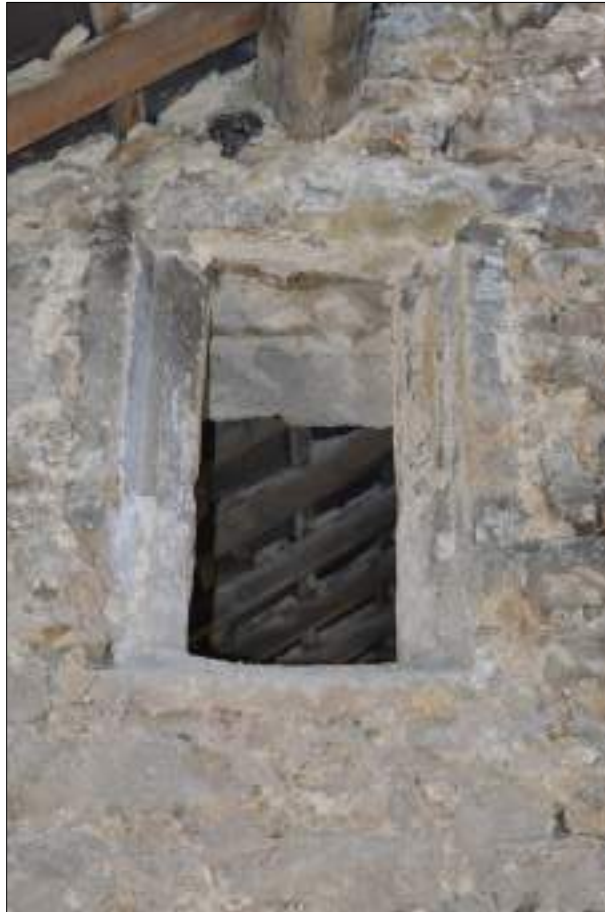
*Plate 64 (shot 90): Detail of loft level opening, northeastern wall of Room 5, no scale*

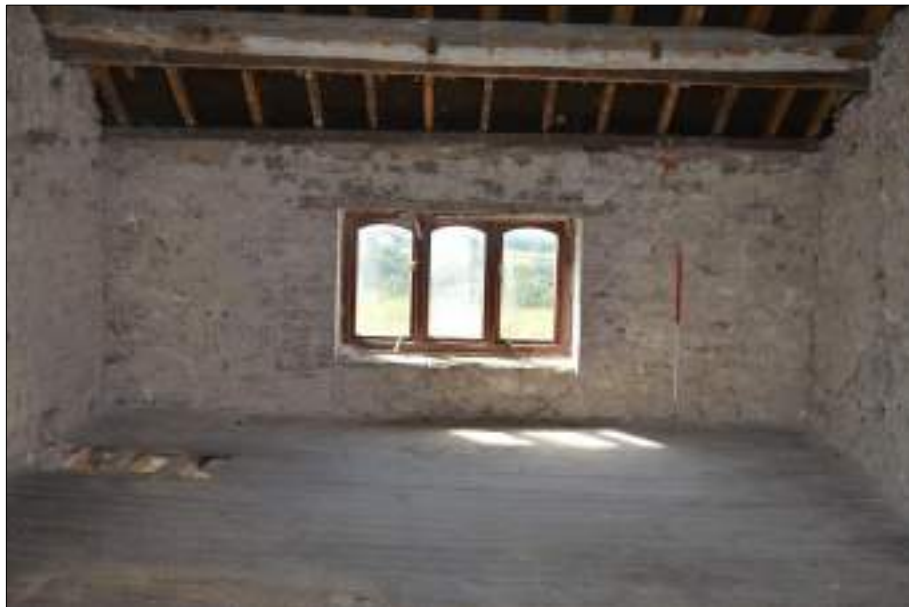
- 6.49 The southeastern wall of Room 5 (Plate 65; Shot 97) was pierced by a window (Plate 66; Shot 98) with a timber lintel above and brick infill to either side, more extensively to the northeast, indicating that the original window opening had been altered to reduce its size.

*Plate 65 (shot 97): Southeastern wall of Room 5, 2m scale*

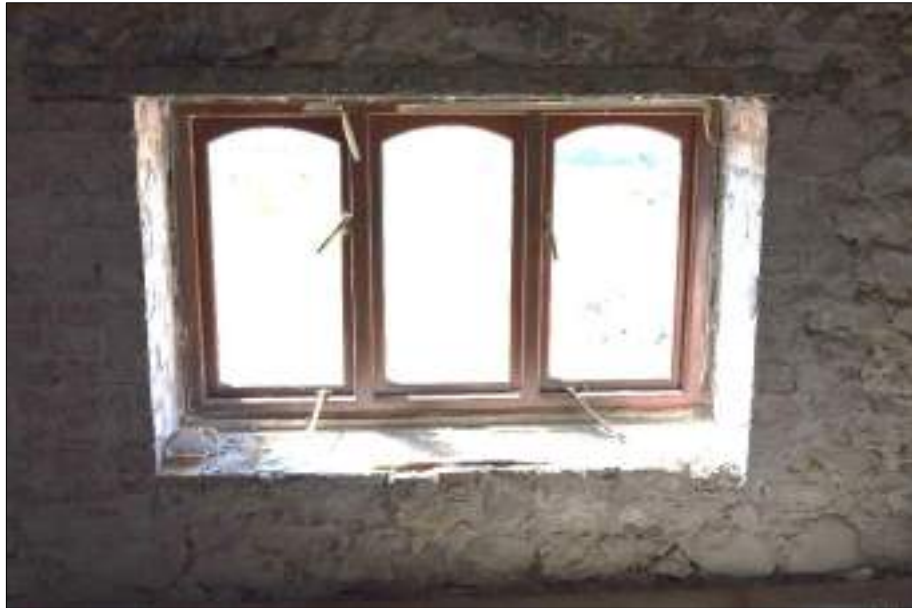
*Plate 66 (shot 98): Detail of window, southeastern wall of Room 5, 0.5m scale*

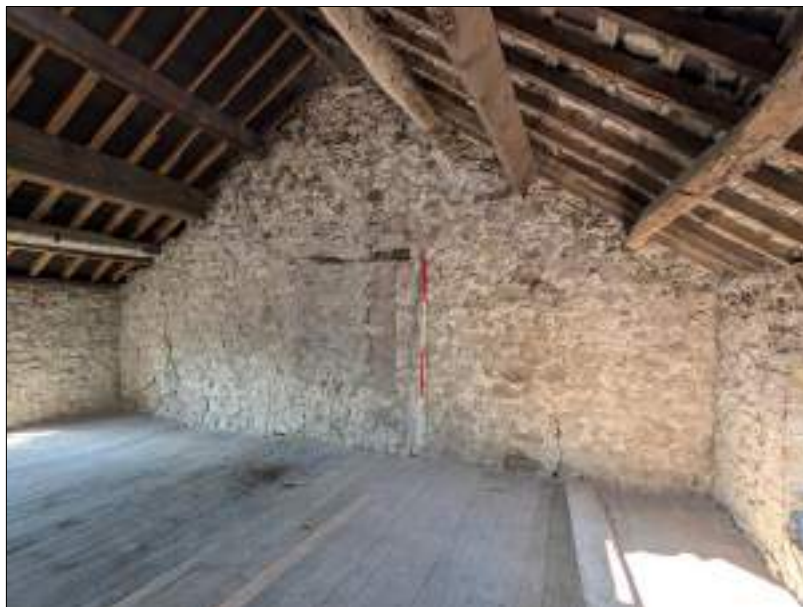
- 6.50 The southwestern wall of Room 5 (Plate 67; Shot 187) was of random coursed sandstone rubble construction, with a blocked opening (Plate 68; Shot 88) in the central part of the wall. The opening comprised a substantial square window that had been blocked with sandstone rubble. It was surmounted by a timber lintel likely to be roughly at the level of the removed ceiling in Room 5, although no sockets for ceiling beams were immediately visible in the southeastern wall.

*Plate 67 (shot 187): Southwestern wall of Room 5, 2m scale*

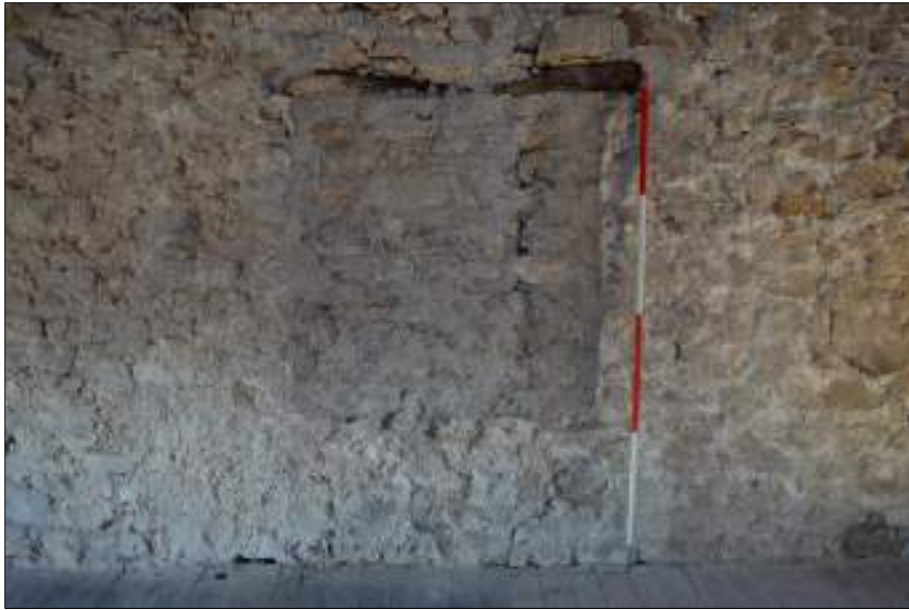
*Plate 68 (shot 88): Detail of blocked window, southwestern wall of Room 5, 2m scale*

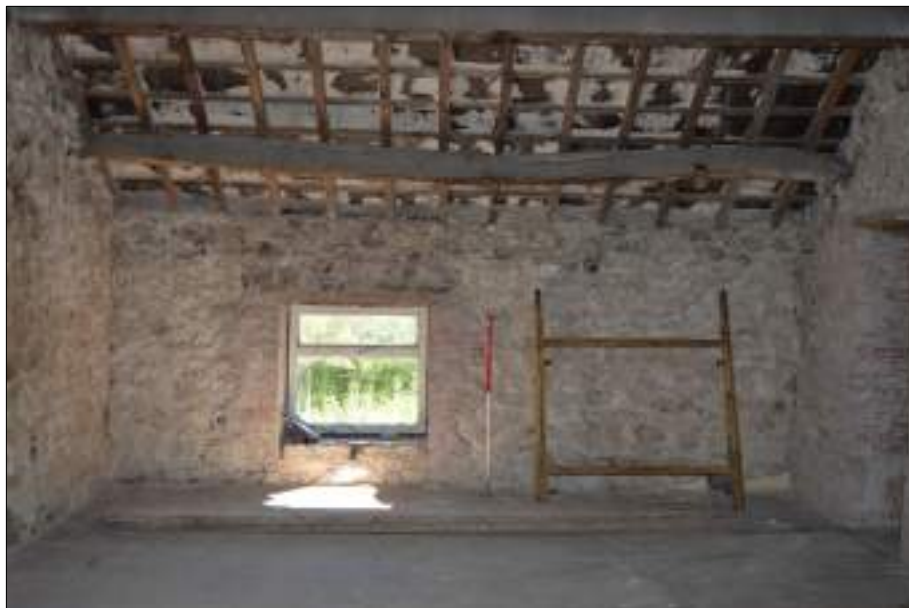
- 6.51 The northwestern wall of Room 5 (Plate 69; Shot 94) was of sandstone rubble construction with a single window (Plate 70; Shot 95). The window was square with a timber lintel and flat reveals formed from brick infill to either side of the window, indicating that the window opening was an alteration to the original fabric of the farmhouse, and that it may have been preceded by a larger window, as noted on other parts of the first floor.

*Plate 69 (shot 94): Northwestern wall of Room 5, 1m and 0.5m scales*

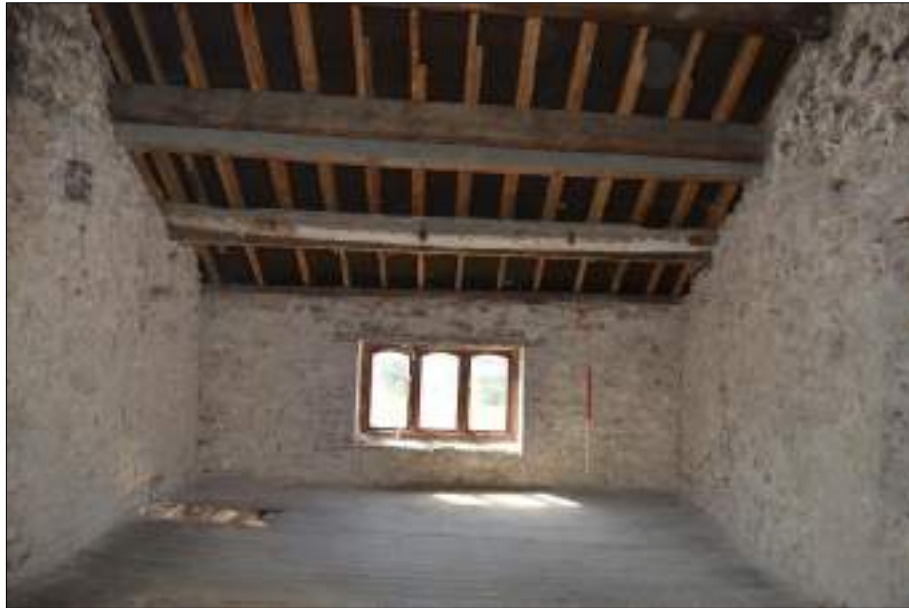
- 6.52 The roof construction was the same as that noted in Room 4, with no trusses and a square grid of rafters and purlins supporting the roof on the northwestern slope (Plate 71; Shot 93), while on the southeastern slope the purlins were not present and the rafters were formed of pairs of overlapping planks (Plate 72; Shot 96). The roof structure showed much alteration, although some of the main beams are probably original.

*Plate 72 (shot 96): Southeast side of Room 5 showing roof construction, 1m and 0.5m scales*

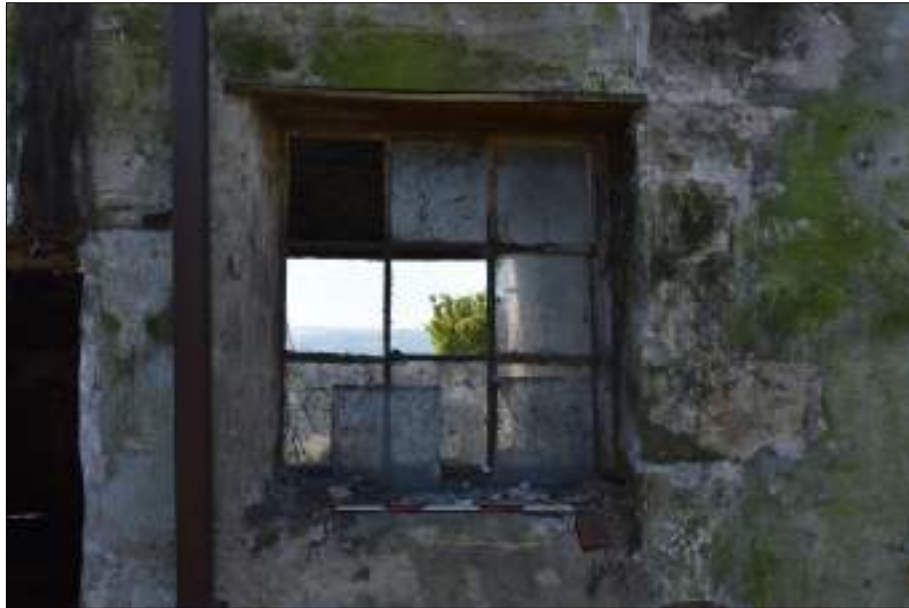
- 6.53 An agricultural building was attached to the farmhouse at the northeastern end. It is likely to be a later addition to the farmhouse, but pre-dates the 1<sup>st</sup> edition OS mapping of 1844.
- 6.54 The northwest-facing elevation of the barn (Plate 73; Shot 23) was of rendered sandstone rubble construction. There were two openings in the elevation, a window (Plate 74; Shot 76) positioned roughly centrally and a doorway immediately to the northeast. The window was square and divided into nine lights in a 3x3 grid by a wooden frame. Three of the panes of glass have fallen from the frame.

*Plate 74 (shot 26): Detail of window in northwest elevation of barn, 0.5m scale*

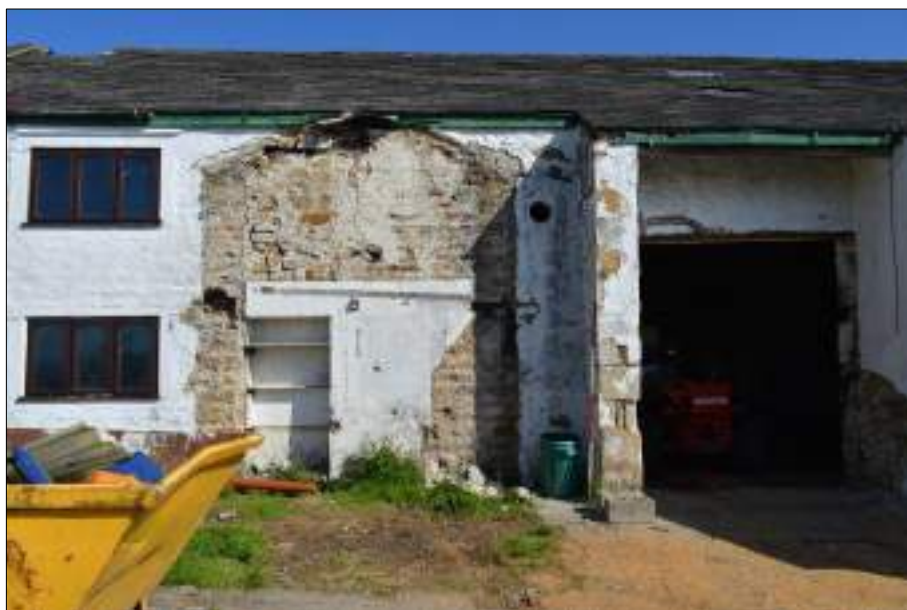
- 6.61 The southeastern elevation of the barn (Plates 82 and 83; Shots 1 and 2) was largely of rendered and limewashed sandstone rubble. At the southwestern end of the elevation the scar could clearly be seen where a southeast projecting extension between the farmhouse and the barn had been recently demolished. An alcove with shelving corresponded to a blocked door in Room 2 of the farmhouse. Above this in the southeast elevation there was evidence of a blocked door at first floor level, indicating that the extension was also a two-storey construction. Beyond the location of the demolished extension there was a projecting wall on one side of a wide rectangular entranceway, the other side of which was formed by the wall of the outshut at the northeastern end of the range. The entranceway had a substantial timber lintel (Plate 84; Shot 11) and lacked any doors.

*Plate 82 (shot 1): Southeast facing elevation of barn, southwest end, 2m scale*

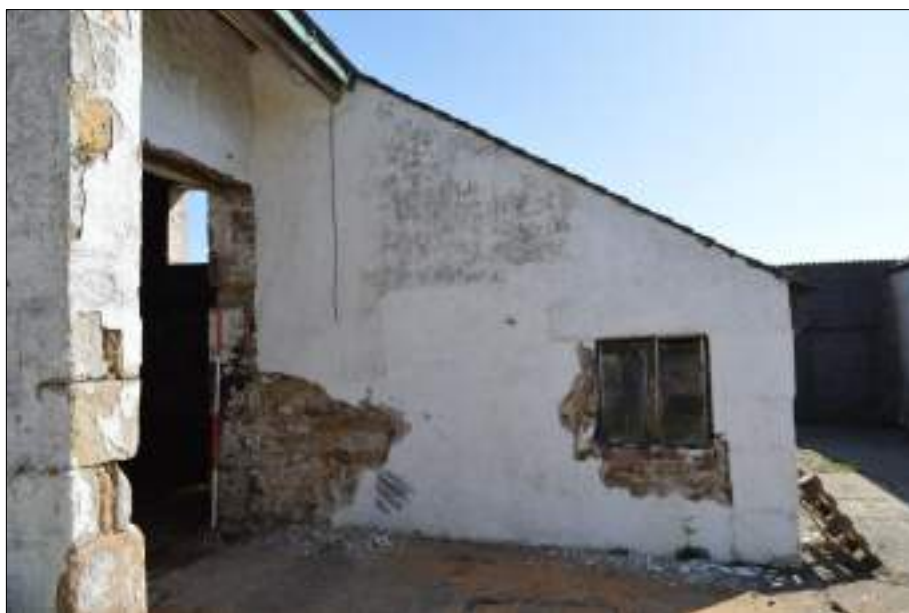
- 6.63 The southwest facing elevation of the outshut (Plate 87; Shot 12) was also rendered and limewashed. A small square timber framed window (Plate 88; Shot 5) with a substantial stone lintel was divided vertically into two lights. A single course of brick below the window frame indicates that it is probably a later alteration to the original fabric.

*Plate 87 (shot 12): Southwest elevation of outshut, northeast end of main range, 2m scale*

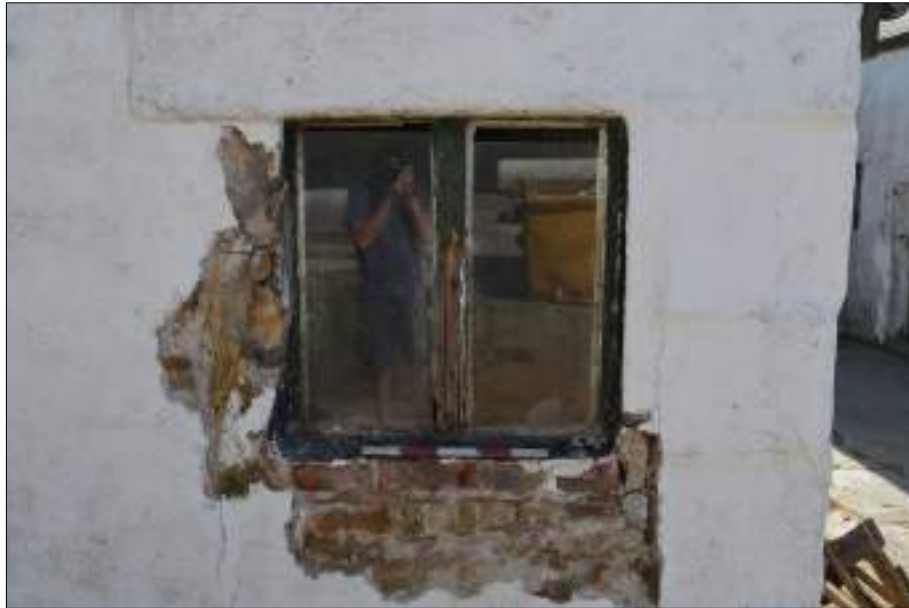
*Plate 88 (shot 5): Detail of window, southwest elevation of outshut, 0.5m scale*

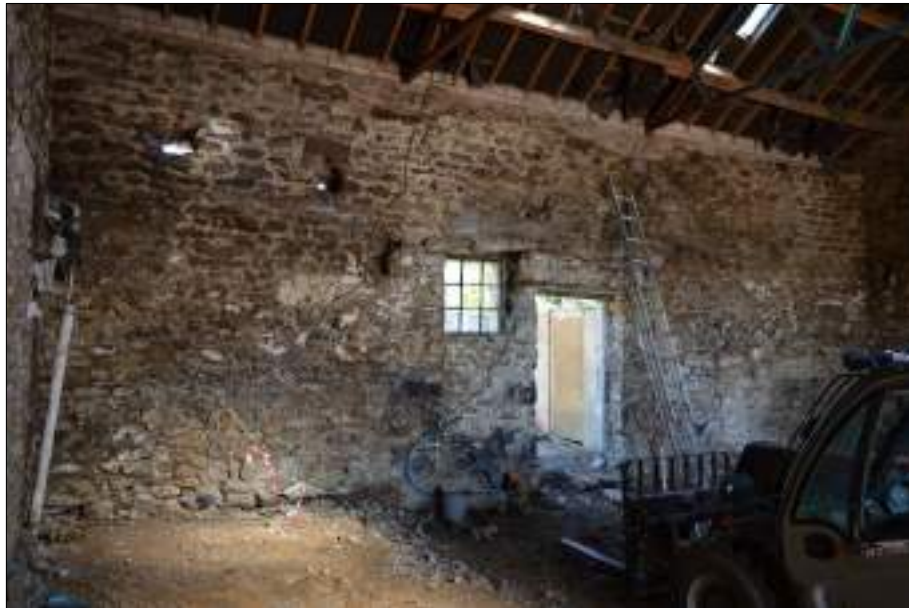
- 6.66 The northwestern wall of Room 6 (Plate 92; Shot 100) was also of sandstone rubble construction. A centrally positioned doorway and adjacent window (Plate 93; Shot 102) had a substantial timber lintel suggesting that the doorway and widow had been inserted into an originally much larger opening, with mixed stone and brick infill adjacent to the doorway and

window, the larger original opening was opposite the large opening in the southeastern wall and may have been originally associated with a cross passage for threshing grain.

*Plate 92 (shot 100): Northwestern wall of Room 6, 2m scale*

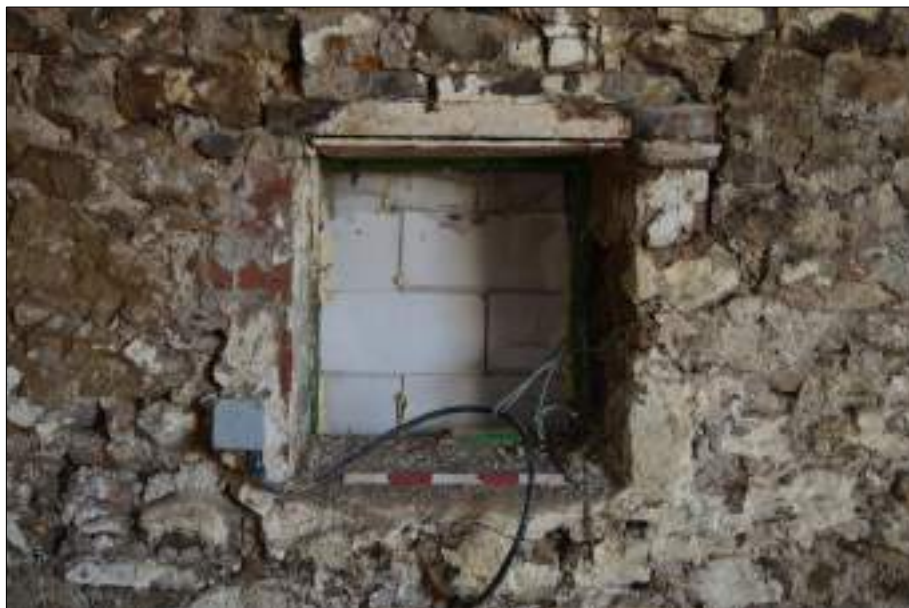
- 6.68 At the northwestern end of the wall a small square window (Plate 95; Shot 108) with a wooden lintel was blocked with cement blocks. Brick infill adjacent to the window suggests that it represents a later alteration to the original fabric of the barn.

*Plate 95 (shot 108): Detail of window, northeast wall of Room 6, 0.5m scale*

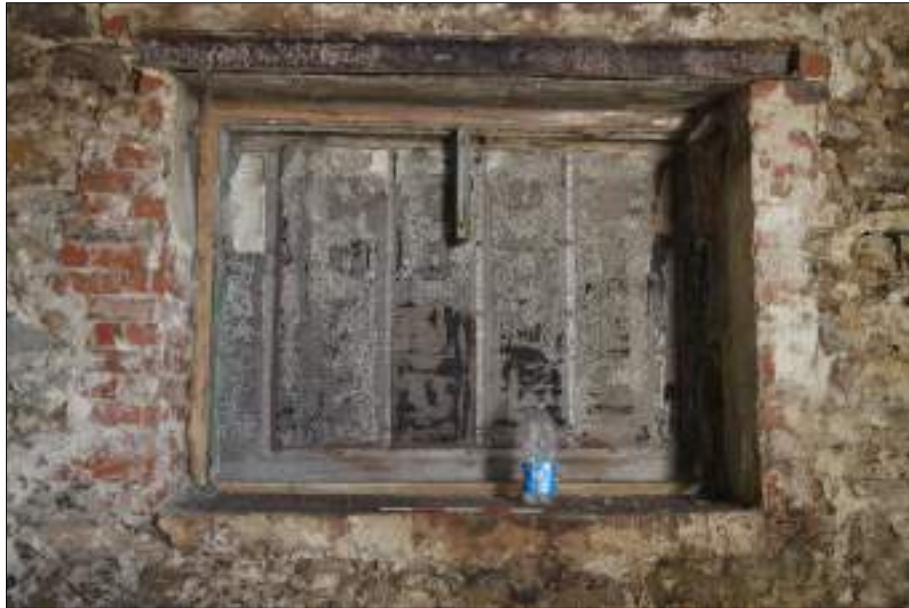
- 6.69 To the southeast a larger rectangular window (Plate 96; Shot 109) had a steel H-beam lintel and a wooden frame. Brick infill to either side of the window indicated that it was a later insertion into the original fabric of the barn.

*Plate 96 (shot 109): Detail of window, northeast wall of Room 6, 0.5m scale*

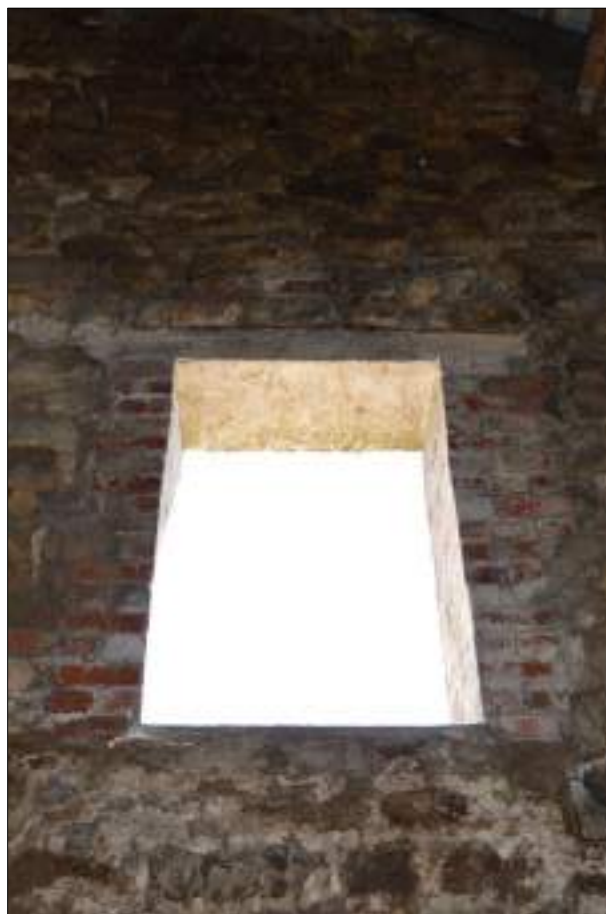
*Plate 99 (shot 110): Detail of doorway, northeast wall of Room 6, no scale*

- 6.71 A row of four beam sockets in the northeastern wall indicated the position of the former floor of the second storey. In the centre of the gable end of the two-storey barn, above the rectangular window, a doorway (Plate 99; Shot 110) with a timber lintel and brick jambs,

presumably a loading door for a grain store or hayloft, probably also represented a later alteration to the original fabric of the barn.

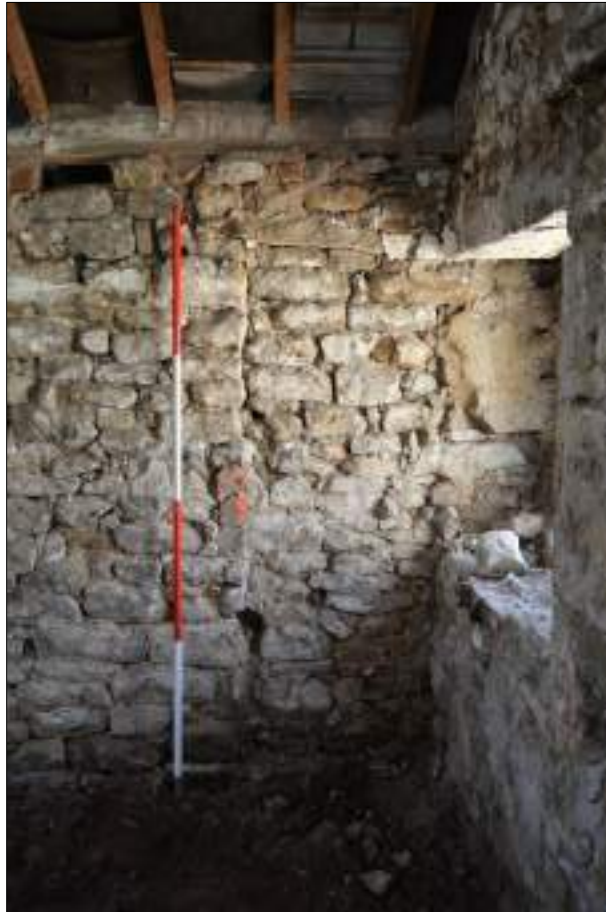
- 6.72 The southeast wall of the single storey outshut to the southeast of the barn (Plate 100; Shot 113) had a doorway with a timber lintel at the northeast end, with a solid door of plank construction (Plate 101). At the southwest end of the wall there was evidence of another blocked doorway (Plate 102; Shot 114)

*Plate 102 (shot 114): Detail of blocked doorway in southeastern wall of outshut, Room 6, 2m scale*

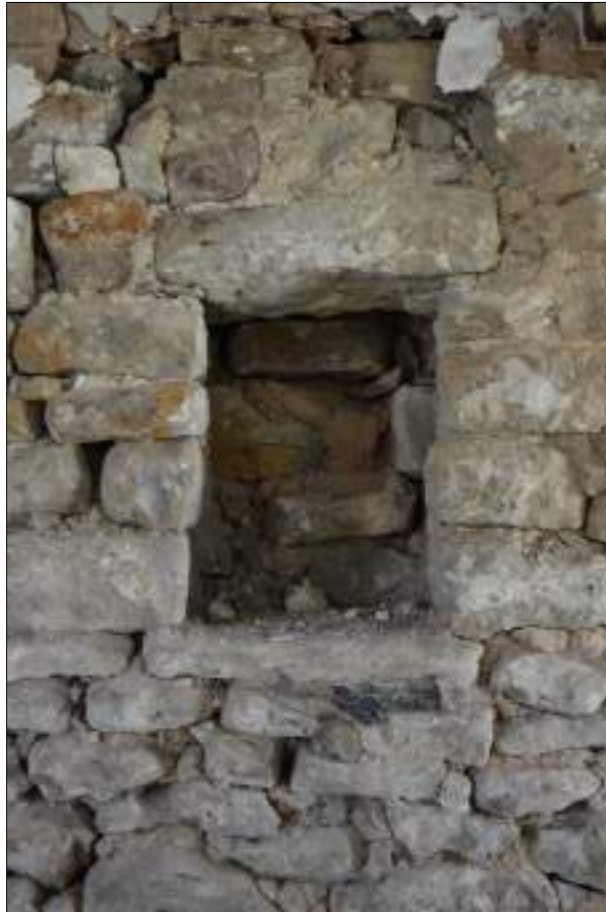
- 6.73 Between the existing doorway and the blocked doorway there was a blocked opening (Plate 103; Shot 115) adjacent to the existing doorway comprising a rectangular opening with blocking behind, possibly representing a former window or vent. There was no evidence of frame or glazing having been fitted

*Plate 103 (shot 115): Detail of blocked opening in southeastern wall of outshut, Room 6, no scale*

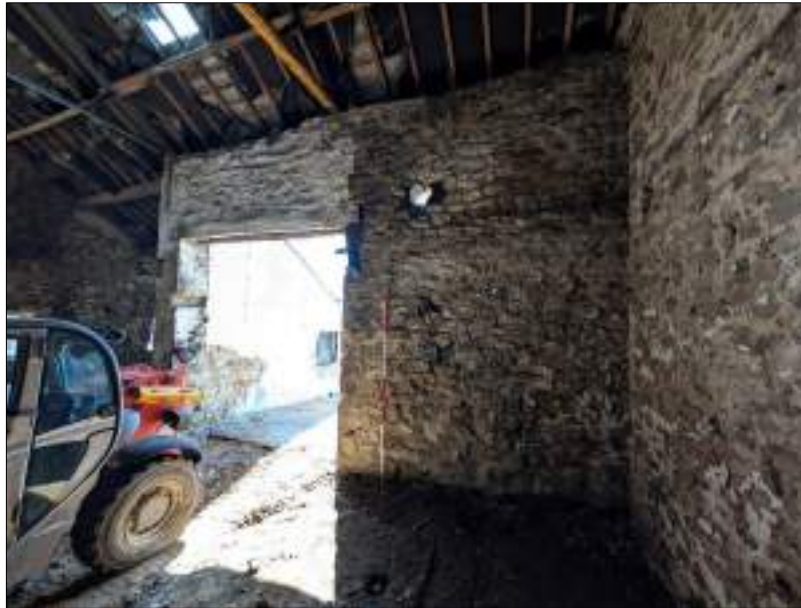
- 6.74 The southeast wall of the main barn building (Plate 104; Shot 196) was of sandstone rubble construction with the northeastern half the position of the large rectangular entranceway into the barn. The wall was limewashed above the timber lintel of the opening, but not to the southwest, perhaps supporting the idea that the large opening had been at one end of a cross passage within the barn.

*Plate 104 (shot 196): Southeastern wall of barn, Room 6, 2m scale*

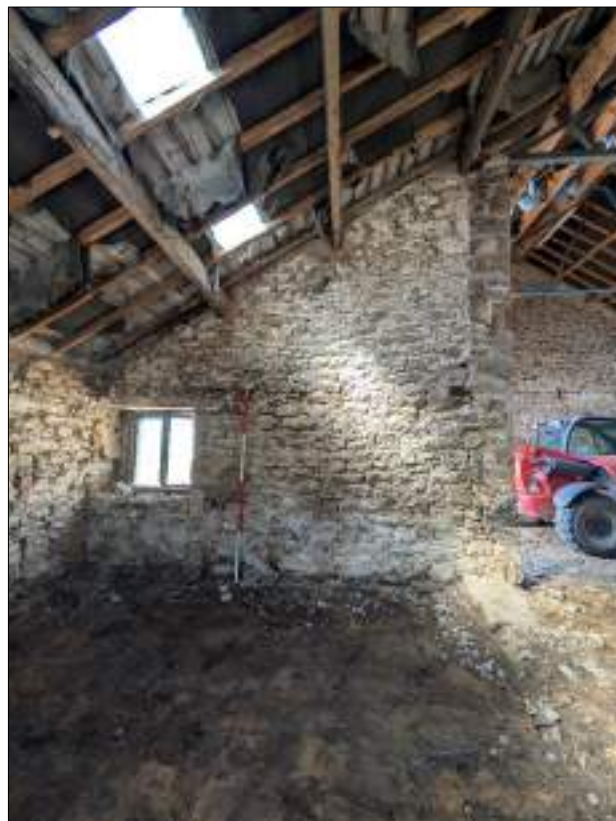
- 6.75 The southwestern wall of the outshut (Plate 105; Shot 195) had a square window at the southeastern end (Plate 106). The window had a stone lintel and rubble blocking below, suggesting that it may have been reduced in size from an original doorway.

*Plate 105 (shot 195): Southwestern wall of outshut, Room 6, 2m scale*

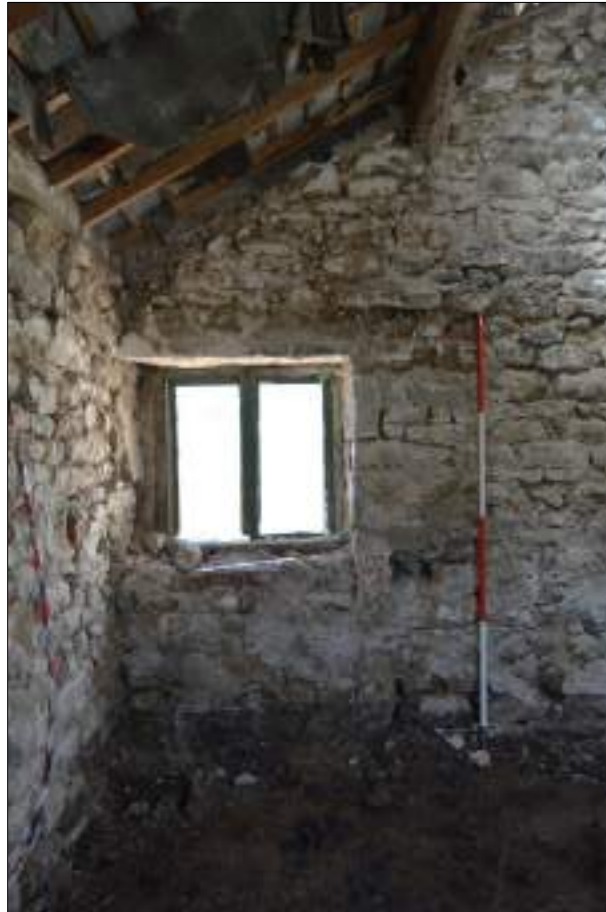
*Plate 106 (shot 118): Detail of window in southwestern wall of outshut, Room 6, 2m scale*

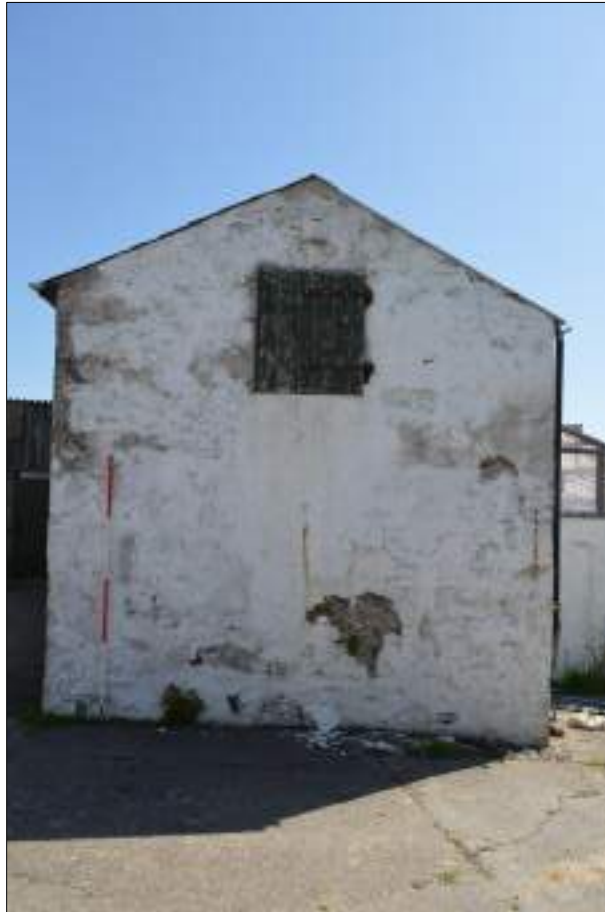
*Plate 107 (shot 122): Southwestern elevation of outbuilding, 2m scale*

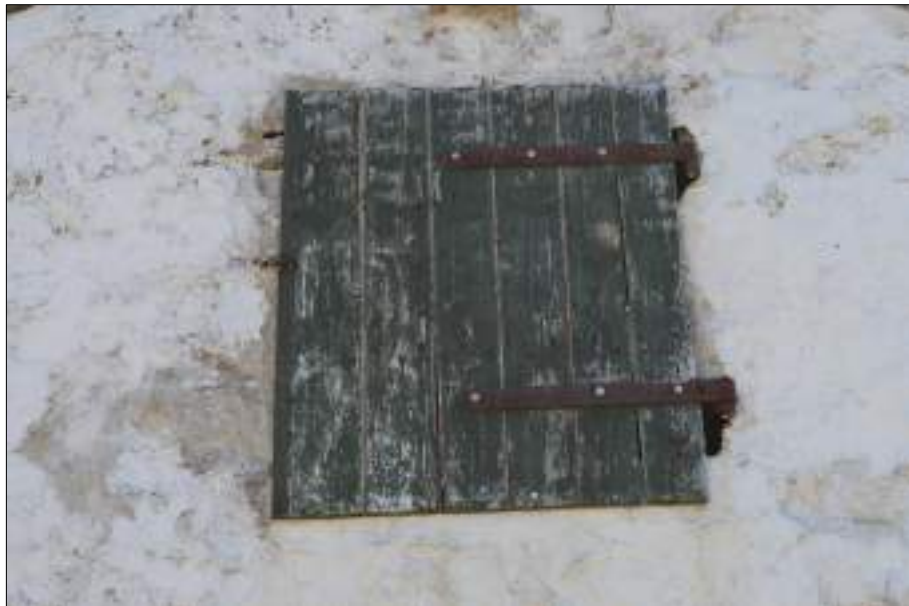
*Plate 108 (shot 124): Detail of door in southwestern wall of outbuilding, 2m scale*

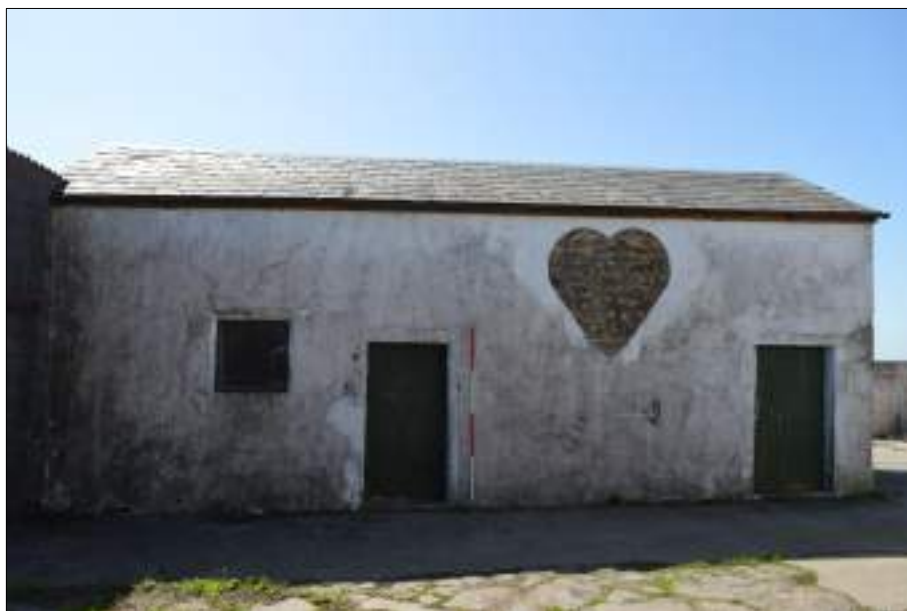
- 6.78 The northwestern elevation of the outbuilding (Plate 109) was rendered with the exception of a heart-shaped patch (Plate 110; Shot 136) at first floor level between the two ground floor doorways, where the render had been removed to expose the random coursed sandstone

*Plate 109 (shot 133): Northwestern elevation of outbuilding, 2m scale*

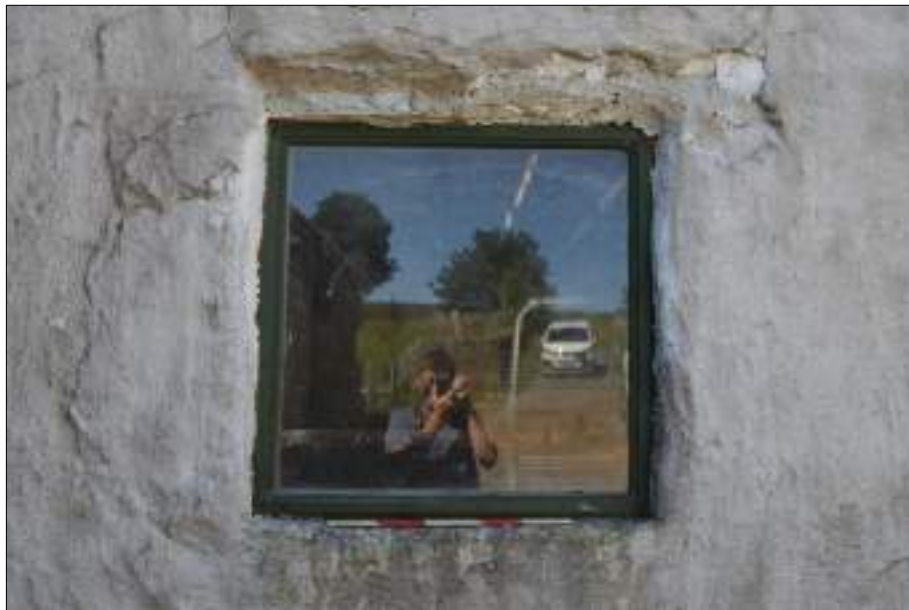
- 6.79 At the northeastern end of the elevation a square window (Plate 111; Shot 135) had a timber frame with a single pane of glass. To the southwest of the window a doorway (Plate 112; Shot 134) was fitted with a solid stable door with the top third comprising a separate door.

*Plate 111 (shot 135): Detail of window in northwestern elevation of outbuilding, 0.5m scale*

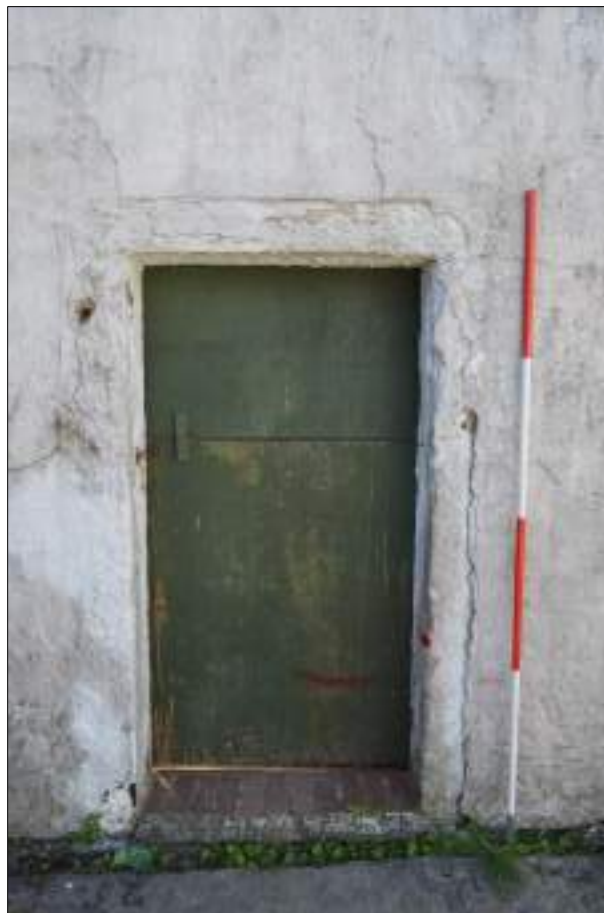
*Plate 112 (shot 134): Detail of door in northwestern elevation of outbuilding, 2m scale*

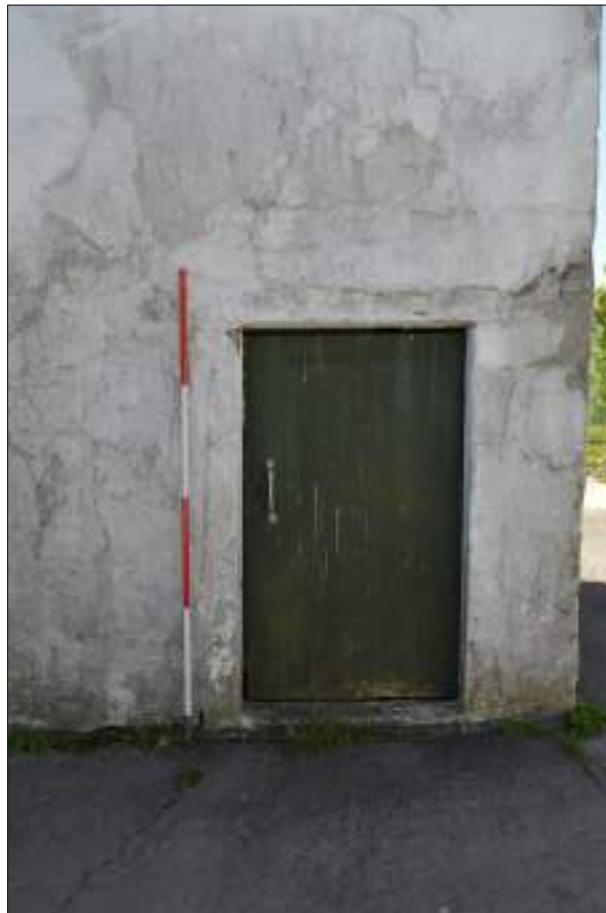
- 6.80 At the southwestern end of the elevation another doorway (Plate 113; Shot 137) had a solid, plank-built door with a timber lintel and concrete threshold.

*Plate 113 (shot 137): Detail of door in northwestern elevation of outbuilding, 2m scale*

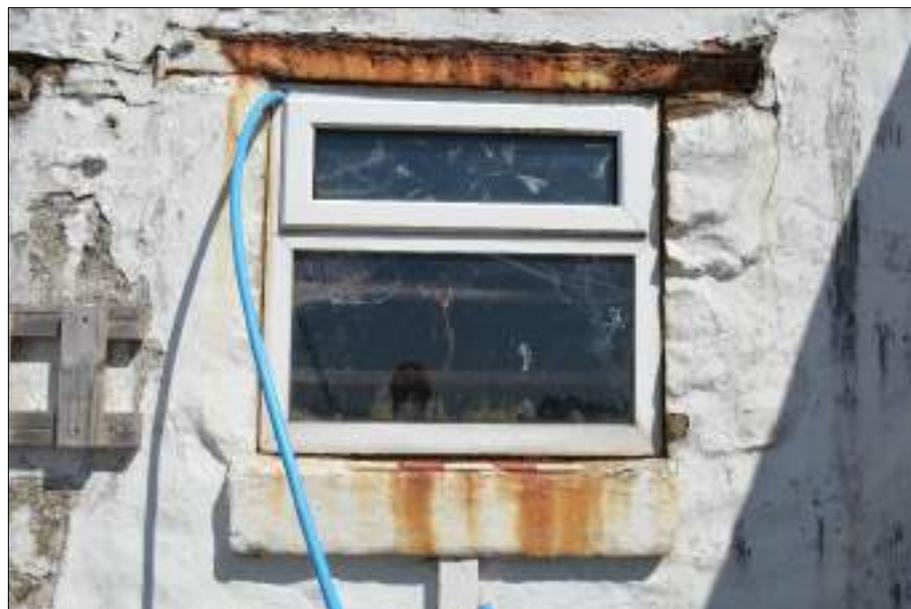
- 6.81 The southeastern elevation of the outbuilding, at the southwestern end (Plate 114; Shot 127) was rendered and limewashed, with a single rectangular window (Plate 115) with a steel joist for a lintel and a concrete sill, representing a later alteration to the original fabric of the outbuilding. The window comprised a uPVC frame with patterned frosted glass in the awning hung casement and plain glass in the lower light.

*Plate 115 (shot 128): Detail of window in southeastern elevation of outbuilding, 0.5m scale*

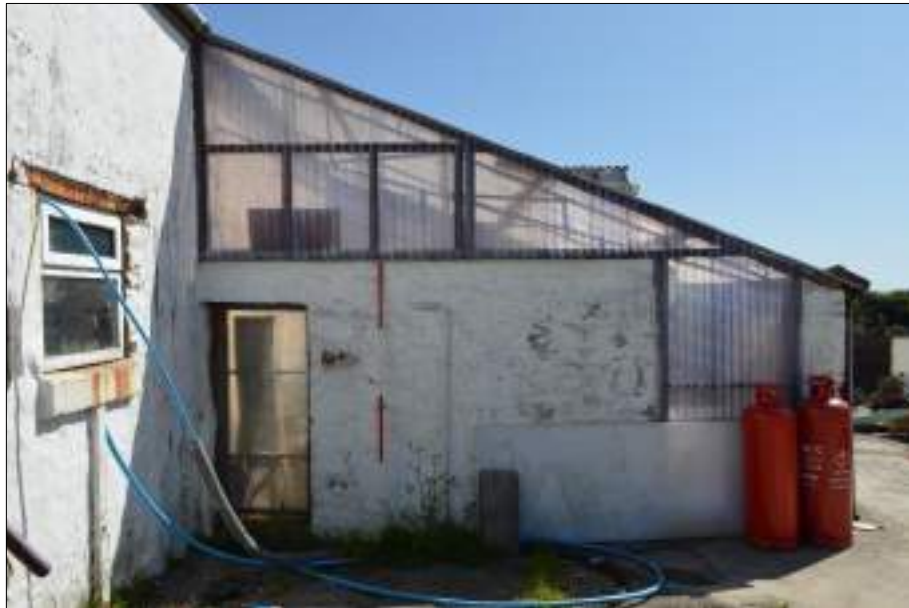
- 6.82 The southwestern elevation of the southeast projecting extension to the outbuilding (Plate 116; Shot 125). was of sandstone rubble construction, with areas of timber framing with corrugated plastic sheeting. The extension is depicted on historic mapping from 1910, although it has been extended to the southeast latterly. A single doorway (Plate 117; Shot 126) at the northwestern

*Plate 116 (shot 125): Southwestern elevation of extension to outbuilding, 2m scale*

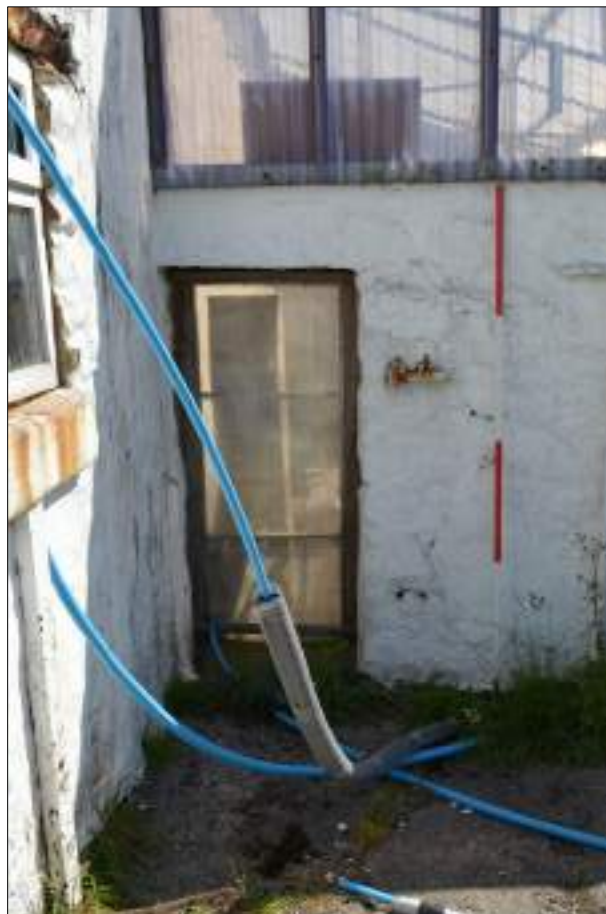
end of the elevation had a timber frame with a timber and plastic door. Cast iron pintles affixed to the wall to the southeast of the existing door may relate to an earlier access arrangement.

*Plate 117 (shot 126): Detail of door in southwestern elevation of extension to outbuilding, 2m scale*

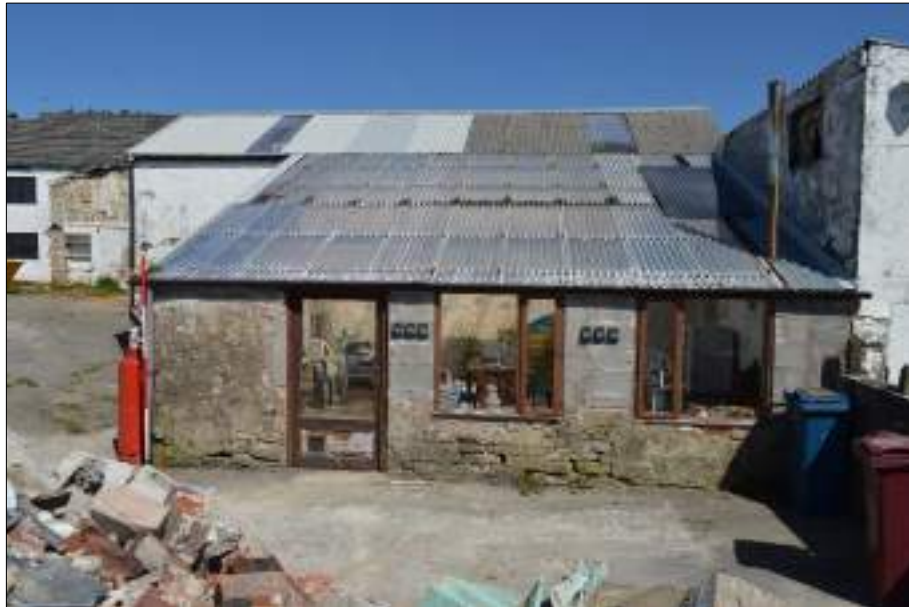
- 6.83 The southeastern elevation of the extension (Plate 118; Shot 131) was of mixed sandstone rubble and cement block construction, with a corrugated steel sheet roof. There were two timber framed windows (Plate 119; Shot 132) and a door in the elevation, all representing recent additions.

*Plate 118 (shot 131): Southeastern elevation of extension to outbuilding, 2m scale*

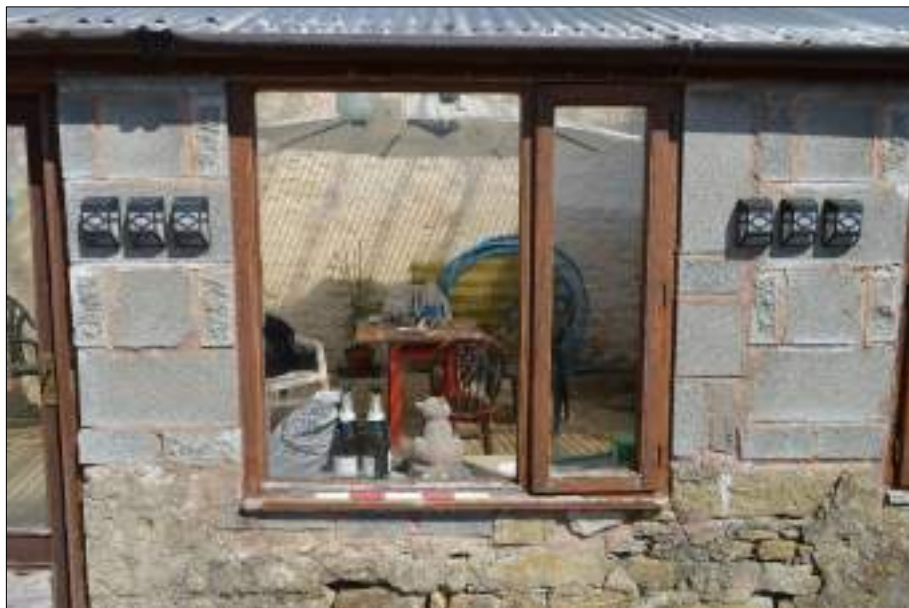
*Plate 119 (shot 132): Detail of window in southeastern elevation of extension to outbuilding, 0.5m scale*

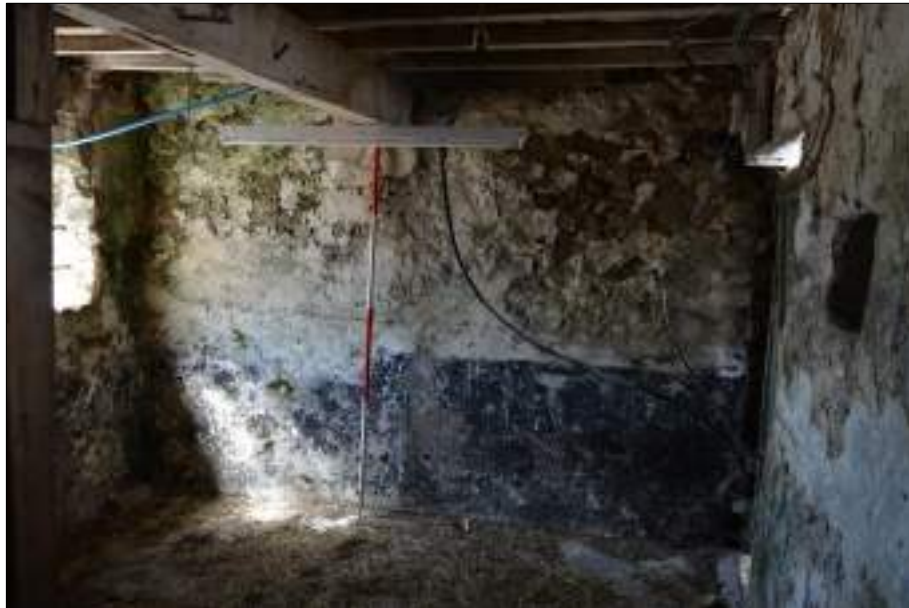
- 6.85 The southwest wall of Room 7 (Plate 120; Shot 144) was of sandstone rubble construction and was rendered and limewashed on the upper part and painted black on the lower, possibly with bitumen paint. There were no openings in the southwestern wall.

*Plate 120 (shot 144): Southwest wall of Room 7, 2m scale*
