**HISTORIC BUILDING SURVEY REPORT:**  
**CUCKOO HALL, HIGHER ROAD, LONGRIDGE, LANCASHIRE**

Planning Reference: 3/2024/0121  
NGR: SD 63896 39018  
AAL Site Code: LOHR 25  
OASIS Reference Number: allenarc1-536093

By  
Allen Archaeology Ltd  
Report Number AAL 2025117

August 2025

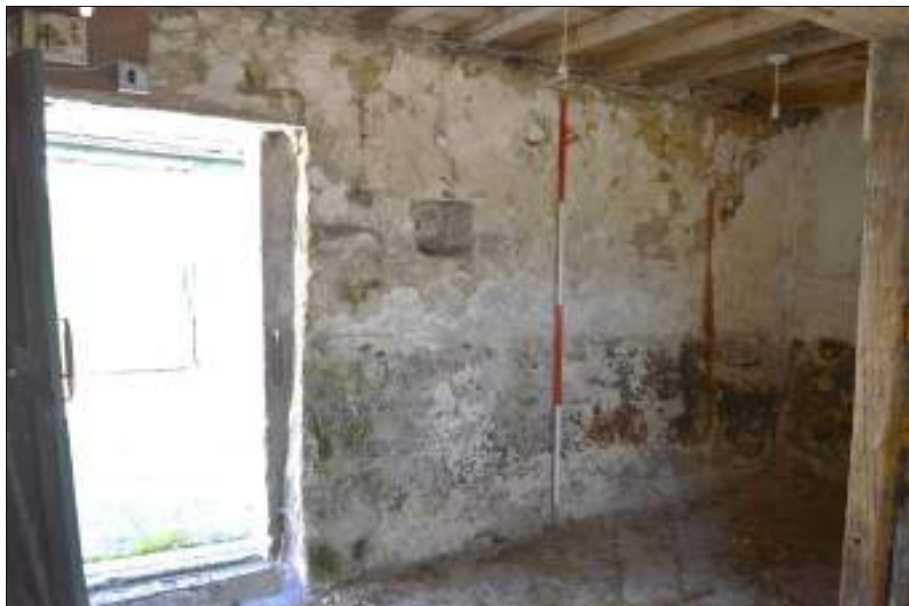
- 6.86 The northwestern wall of Room 7 (Plate 121; Shot 142) was of similar construction and finish to the southwestern wall. At the southwestern end there was a rectangular doorway with timber lintel and jambs. To the northeast of the door there was a recess in the masonry of the wall (Plate 122; Shot 143).

*Plate 121 (shot 142): Northwestern wall of Room 7, 2m scale*

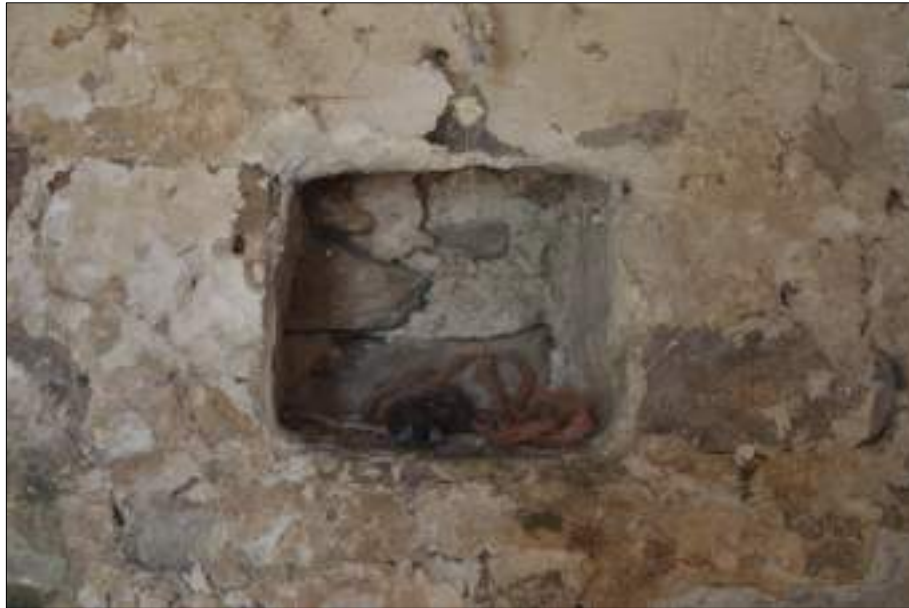
*Plate 122 (shot 143): Detail of recess in northwestern wall of Room 7, no scale*

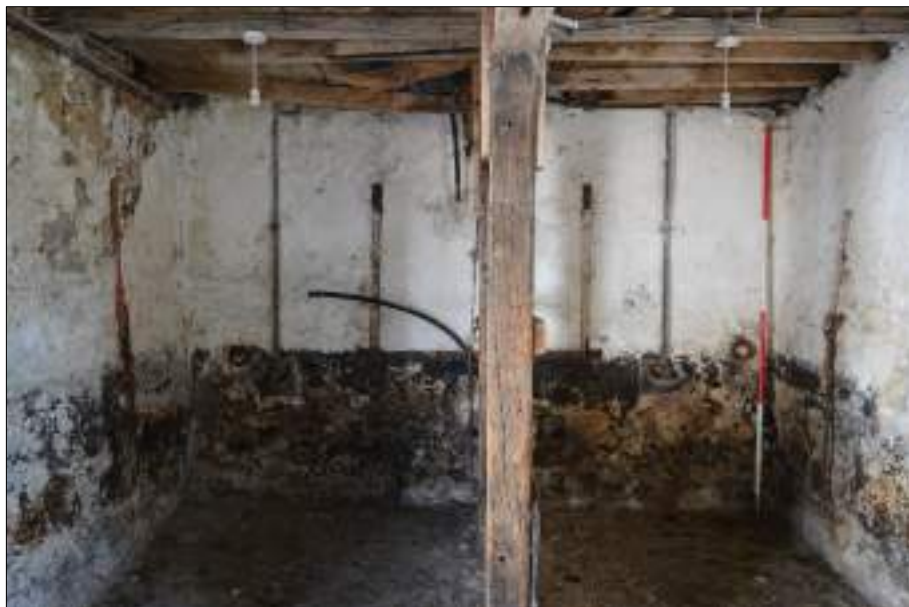
- 6.87 The northeastern wall of the room (Plate 123; Shot 140) was similar in construction and finish to the other walls within Room 7. The northeastern part of the room was divided into two stalls by a timber partition (Plate 124; Shot 197), and the concrete floor had drainage channels in the surface (Plate 125; Shot 145). Water pipes and troughs were attached to the northeastern wall in the centre of each of the two stalls (Plate 126; Shot 141).

*Plate 123 (shot 140): Northeastern wall of Room 7, 2m scale*

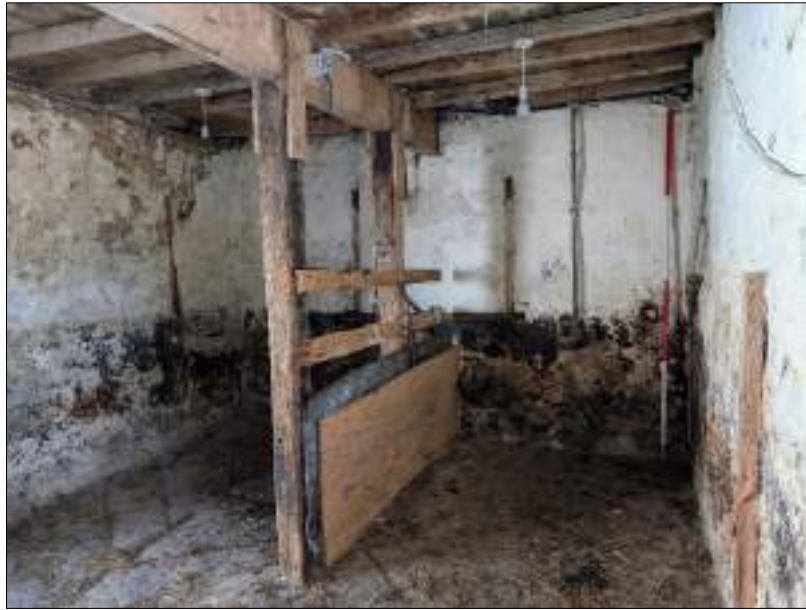
*Plate 124 (shot 197): Stalls at northeastern end of Room 7, 2m scale*

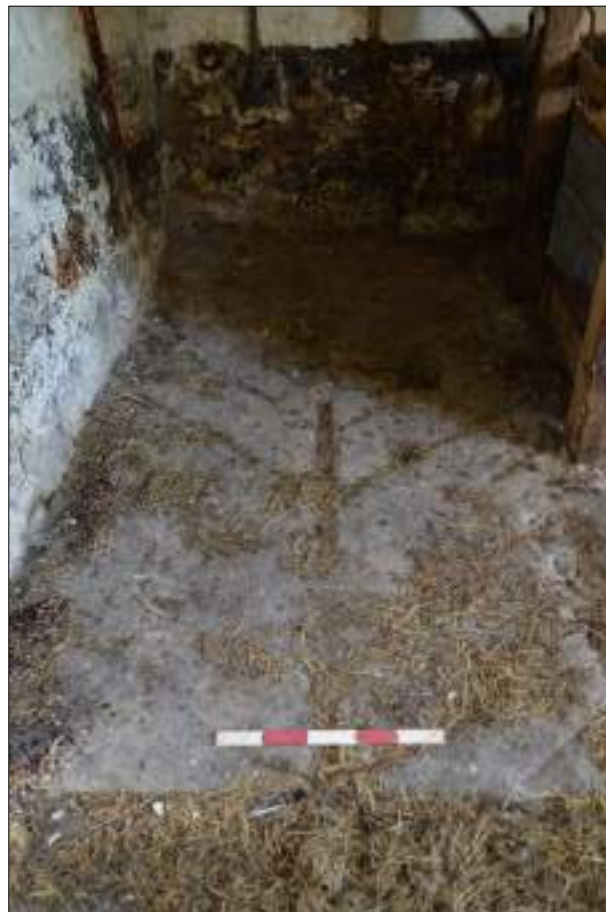
*Plate 125 (shot 145): Detail of floor, northwestern stall at northeastern end of Room 7, 0.5m scale*

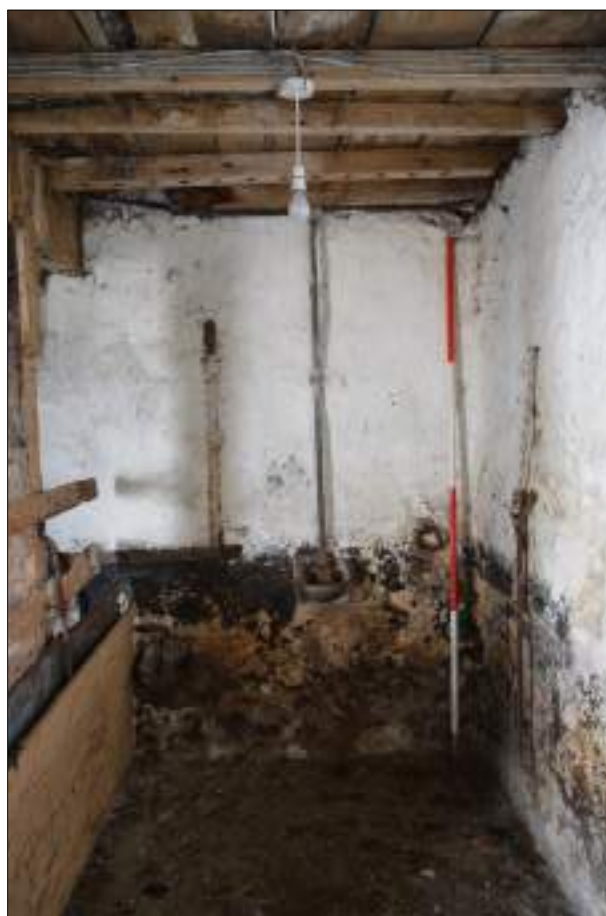
*Plate 126 (shot 141): Southeastern stall at northeastern end of Room 7, 2m scale*

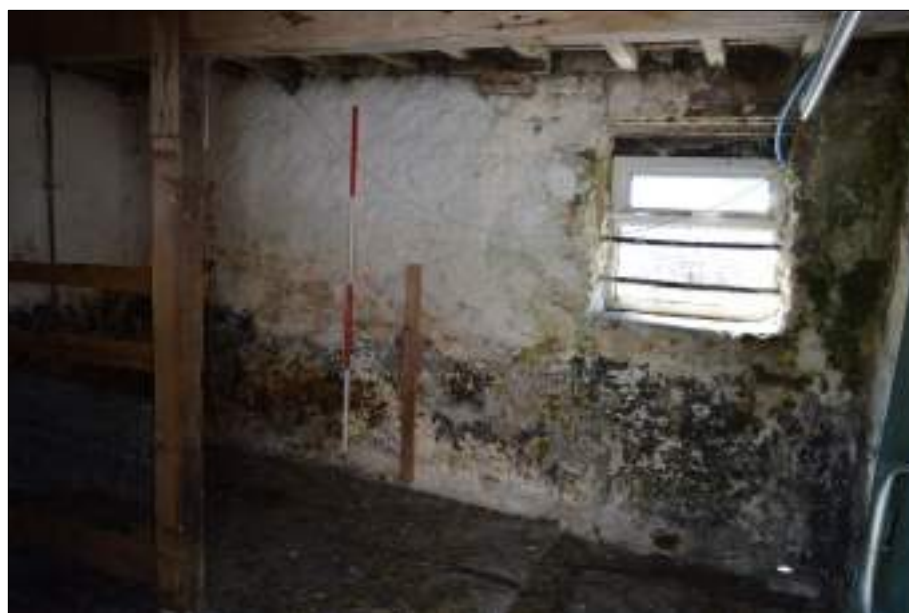
- 6.88 The southeastern wall of Room 7 (Plate 127; Shot 138) was of rendered and limewashed/black painted sandstone rubble as before. A single rectangular window (Plate 128) with an iron or steel lintel and two horizontal bars had been retrofitted with a uPVC frame and glazing. Blocking

*Plate 127 (shot 138): Southeastern wall of Room 7, 2m scale*

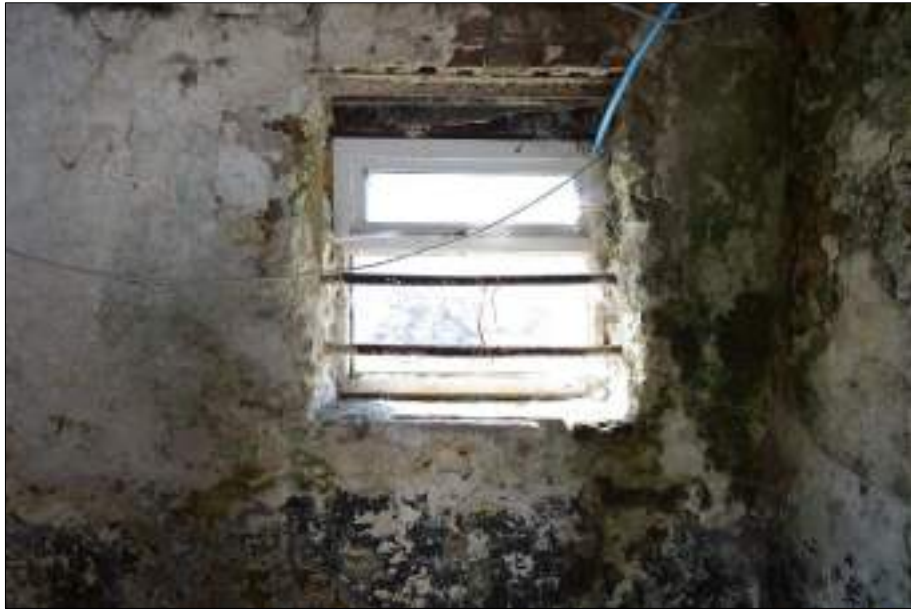
above the frame comprising machine pressed brick is likely to have been inserted at the time of this alteration.

*Plate 128 (shot 139): Detail of window in southeastern wall of Room 7, 0.5m scale*

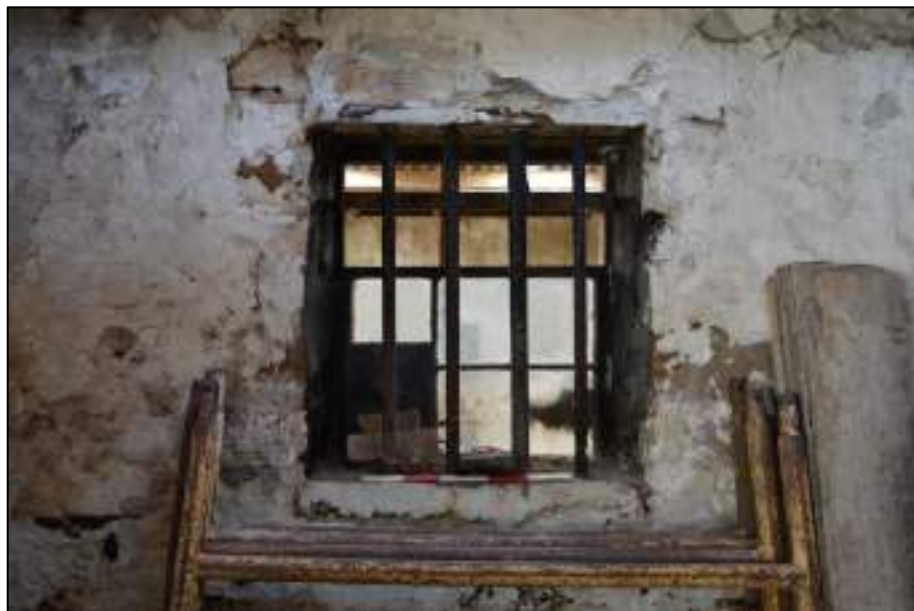
- 6.89 The ceiling within Room 7 comprised timber joists laid perpendicular to the ridge line of the roof, supporting plank floorboards.
- 6.90 Room 8 was in use as a storage area, and consequently internal details were difficult to determine, although it is likely that two stalls were originally located against the southwestern wall, back-to-back with those in Room 7. A timber framed sash window (Plate 129; Shot 147) in the northeastern wall of the room had a timber lintel and stone sill, with four vertical iron bars on the inside.

*Plate 129 (shot 147): Detail of window in northeastern wall of Room 8, 0.5m scale*

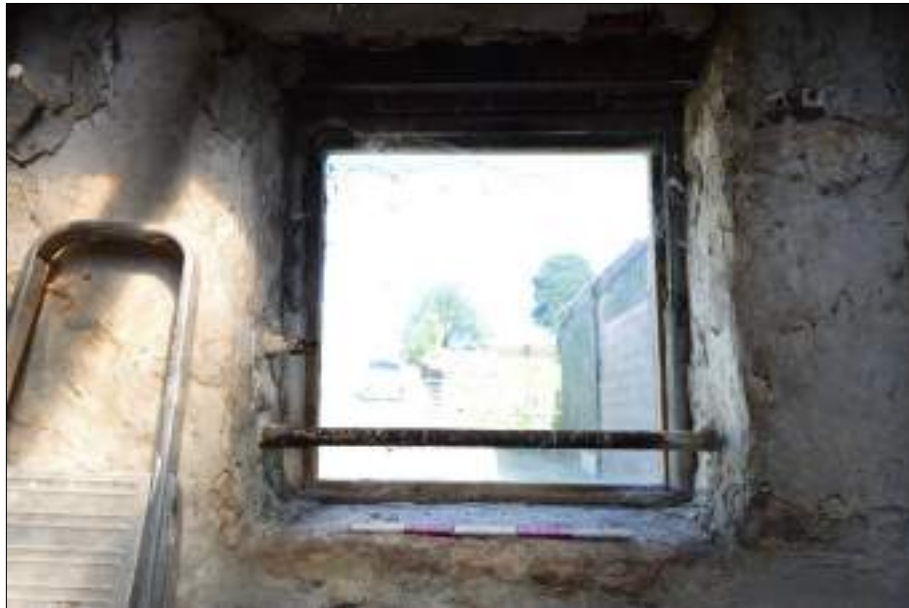
- 6.91 In the northwestern wall of the room a square window (Plate 130; Shot 150) had the remnants of two horizontal bars and thus resembled the window in the southeastern wall of Room 7,

lacking, however, the late insertion of a uPVC frame. Rather it retained a timber frame with a single pane of glass.

*Plate 130 (shot 150): Detail of window in northwestern wall of Room 8, 0.5m scale*

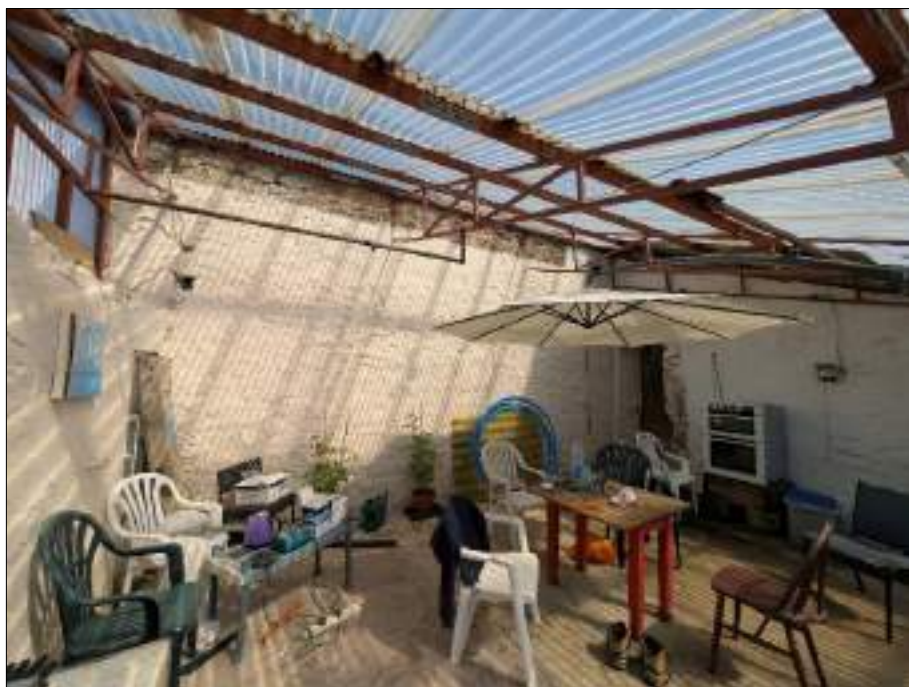
- 6.92 Room 11 (Plate 131; Shot 204) refers to the single storey southeast projecting extension at the northeastern end of the outbuilding. Historic mapping suggests that part of this extension originates in the early 20<sup>th</sup> century, as it does not appear on the 1898 OS mapping, but is depicted on that of 1910.

*Plate 131 (shot 204): Interior of Room 11, 2m scale*

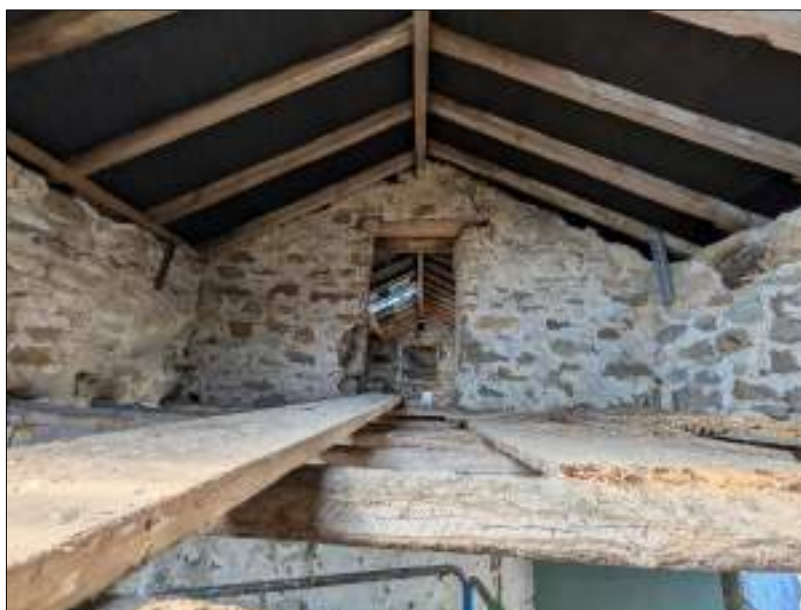
- 6.97 In Room 10 the roof structure was the same, and again the roof is likely to represent a fairly modern replacement. The masonry (Plate 133; Shot 202) was of very similar character and form to that observed in Room 9. Near the apex of the gable at the northeastern end of the room there was a metal fixing, the function of which could not be ascertained, as the exterior of the gable at this end could not be observed.
- 6.98 In the gable of the partition wall between Room 9 and Room 10 there was a rectangular doorway with a lintel formed by two large pieces of timber (Plate 134; Shot 199). There was no door fitted to the opening, nor any evidence that there ever had been.

*Plate 134 (shot 199): Southwestern wall of Room 10, no scale*
