Re; Application number 3/2025/0738

# HERITAGE STATEMENT

33 & 33a King Street, Whalley, BB7 9SP  
Grade II Listed Building within Whalley Conservation Area

Property: First Floor, 33 King Street, Whalley  
Client: Julie Macfarlane  
Survey Date: 09 June 2026  
Report Reference: Whalley shop first floor

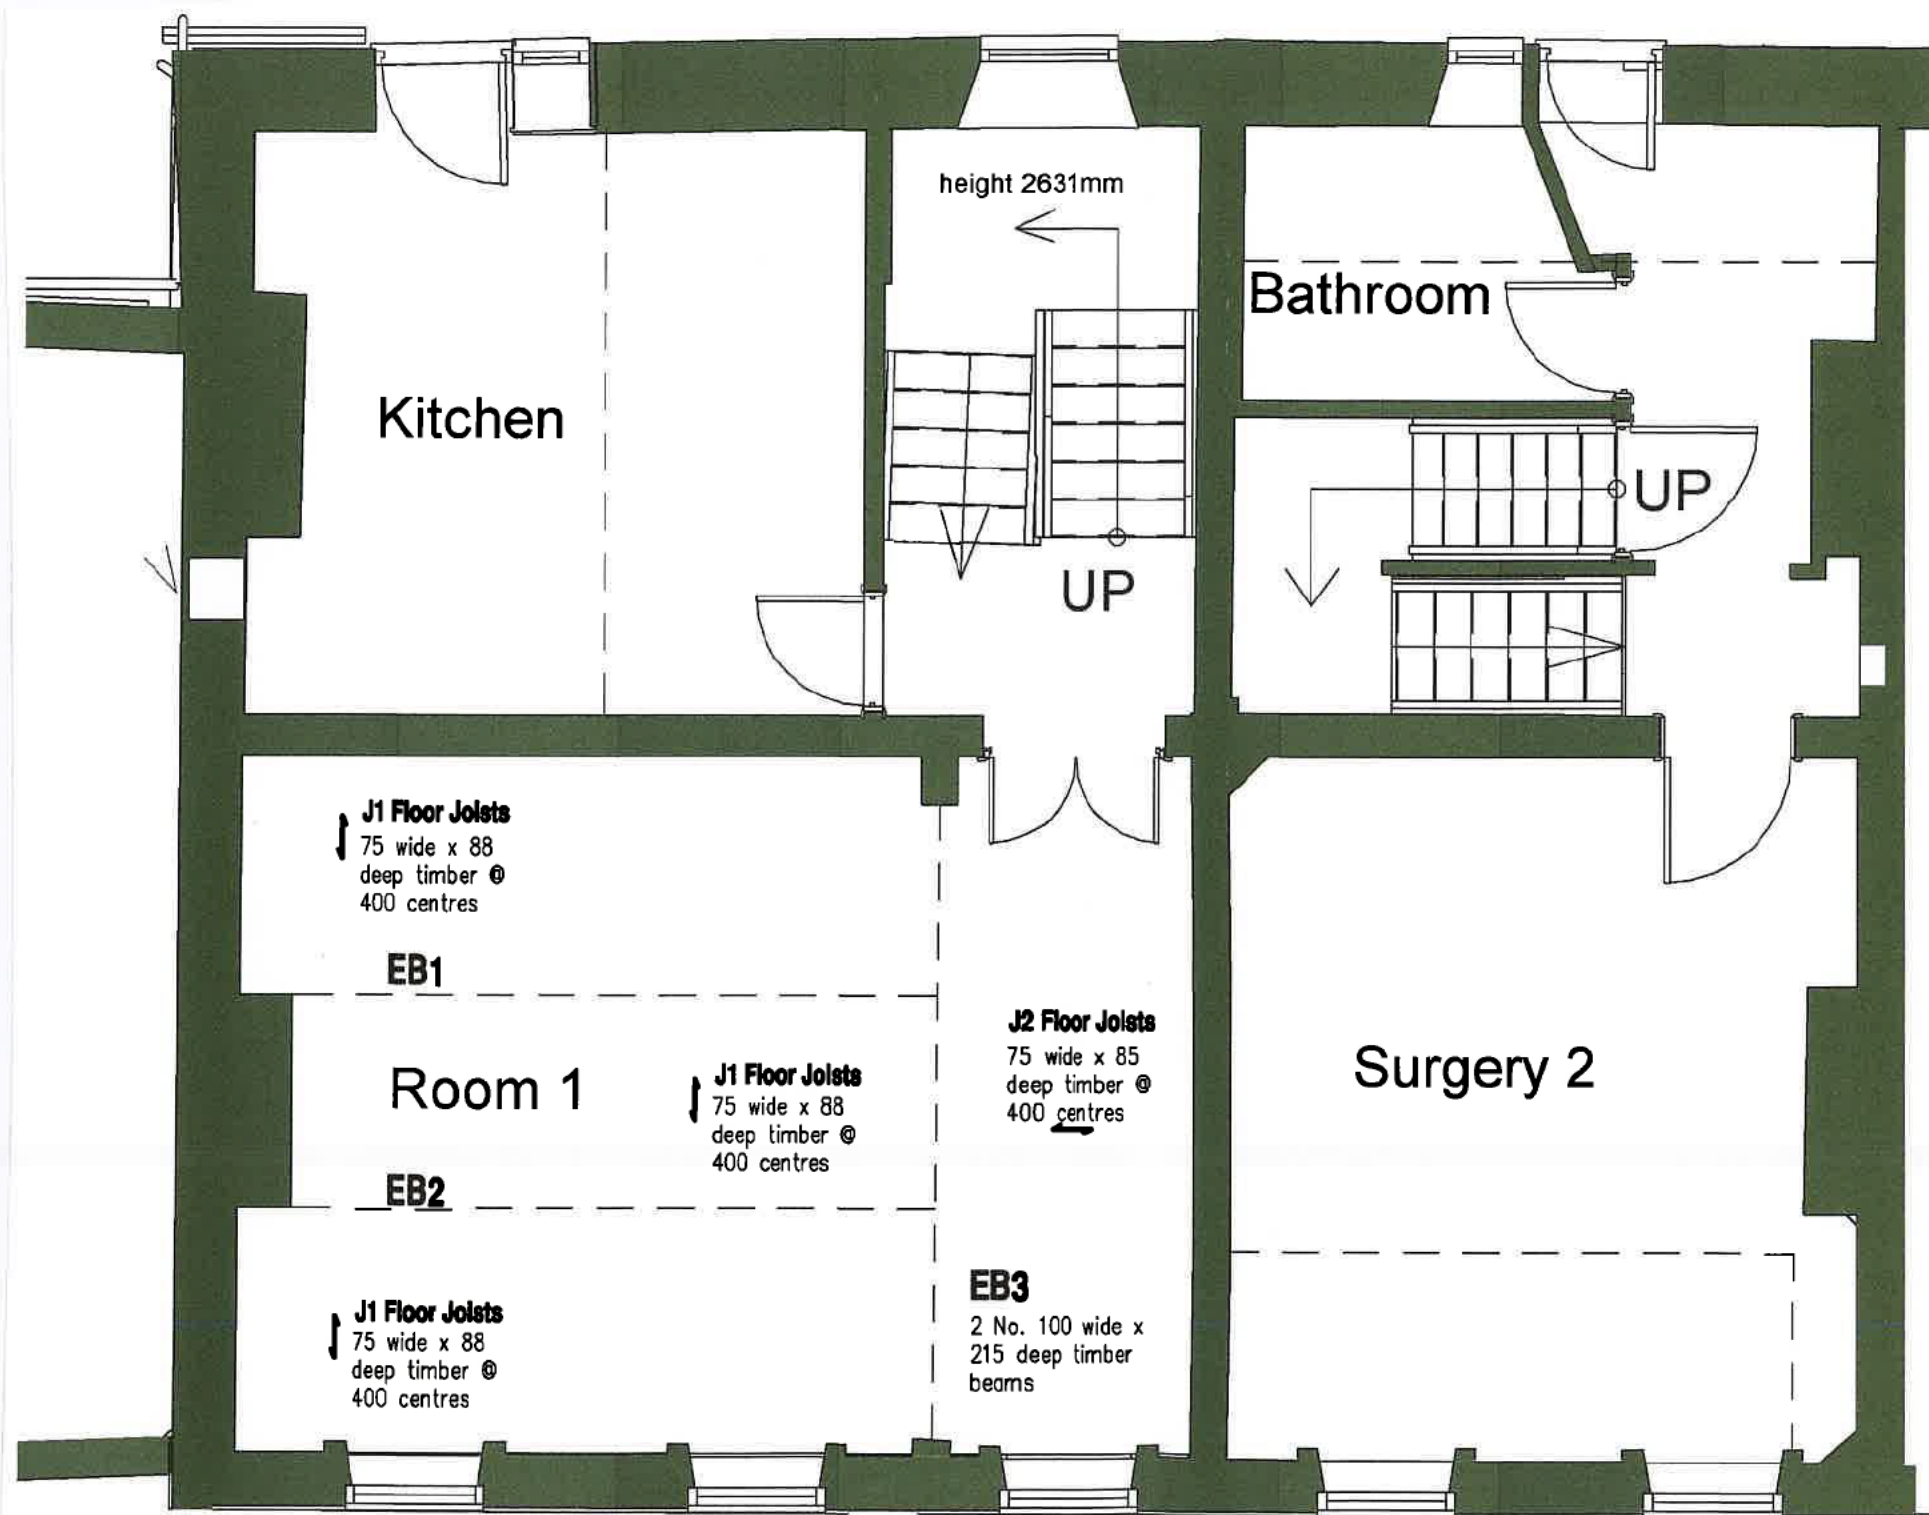
**EXISTING FIRST FLOOR PLAN**  
**(Showing structure over)**

Total deflection =  $27.28 + 1.00 = 28.28 \text{ mm}$  ( $0.0064 L$ )  $> 0.003L$  FAIL

Member fails in bending and deflection

EXISTING TIMBER BEAM INADEQUATE

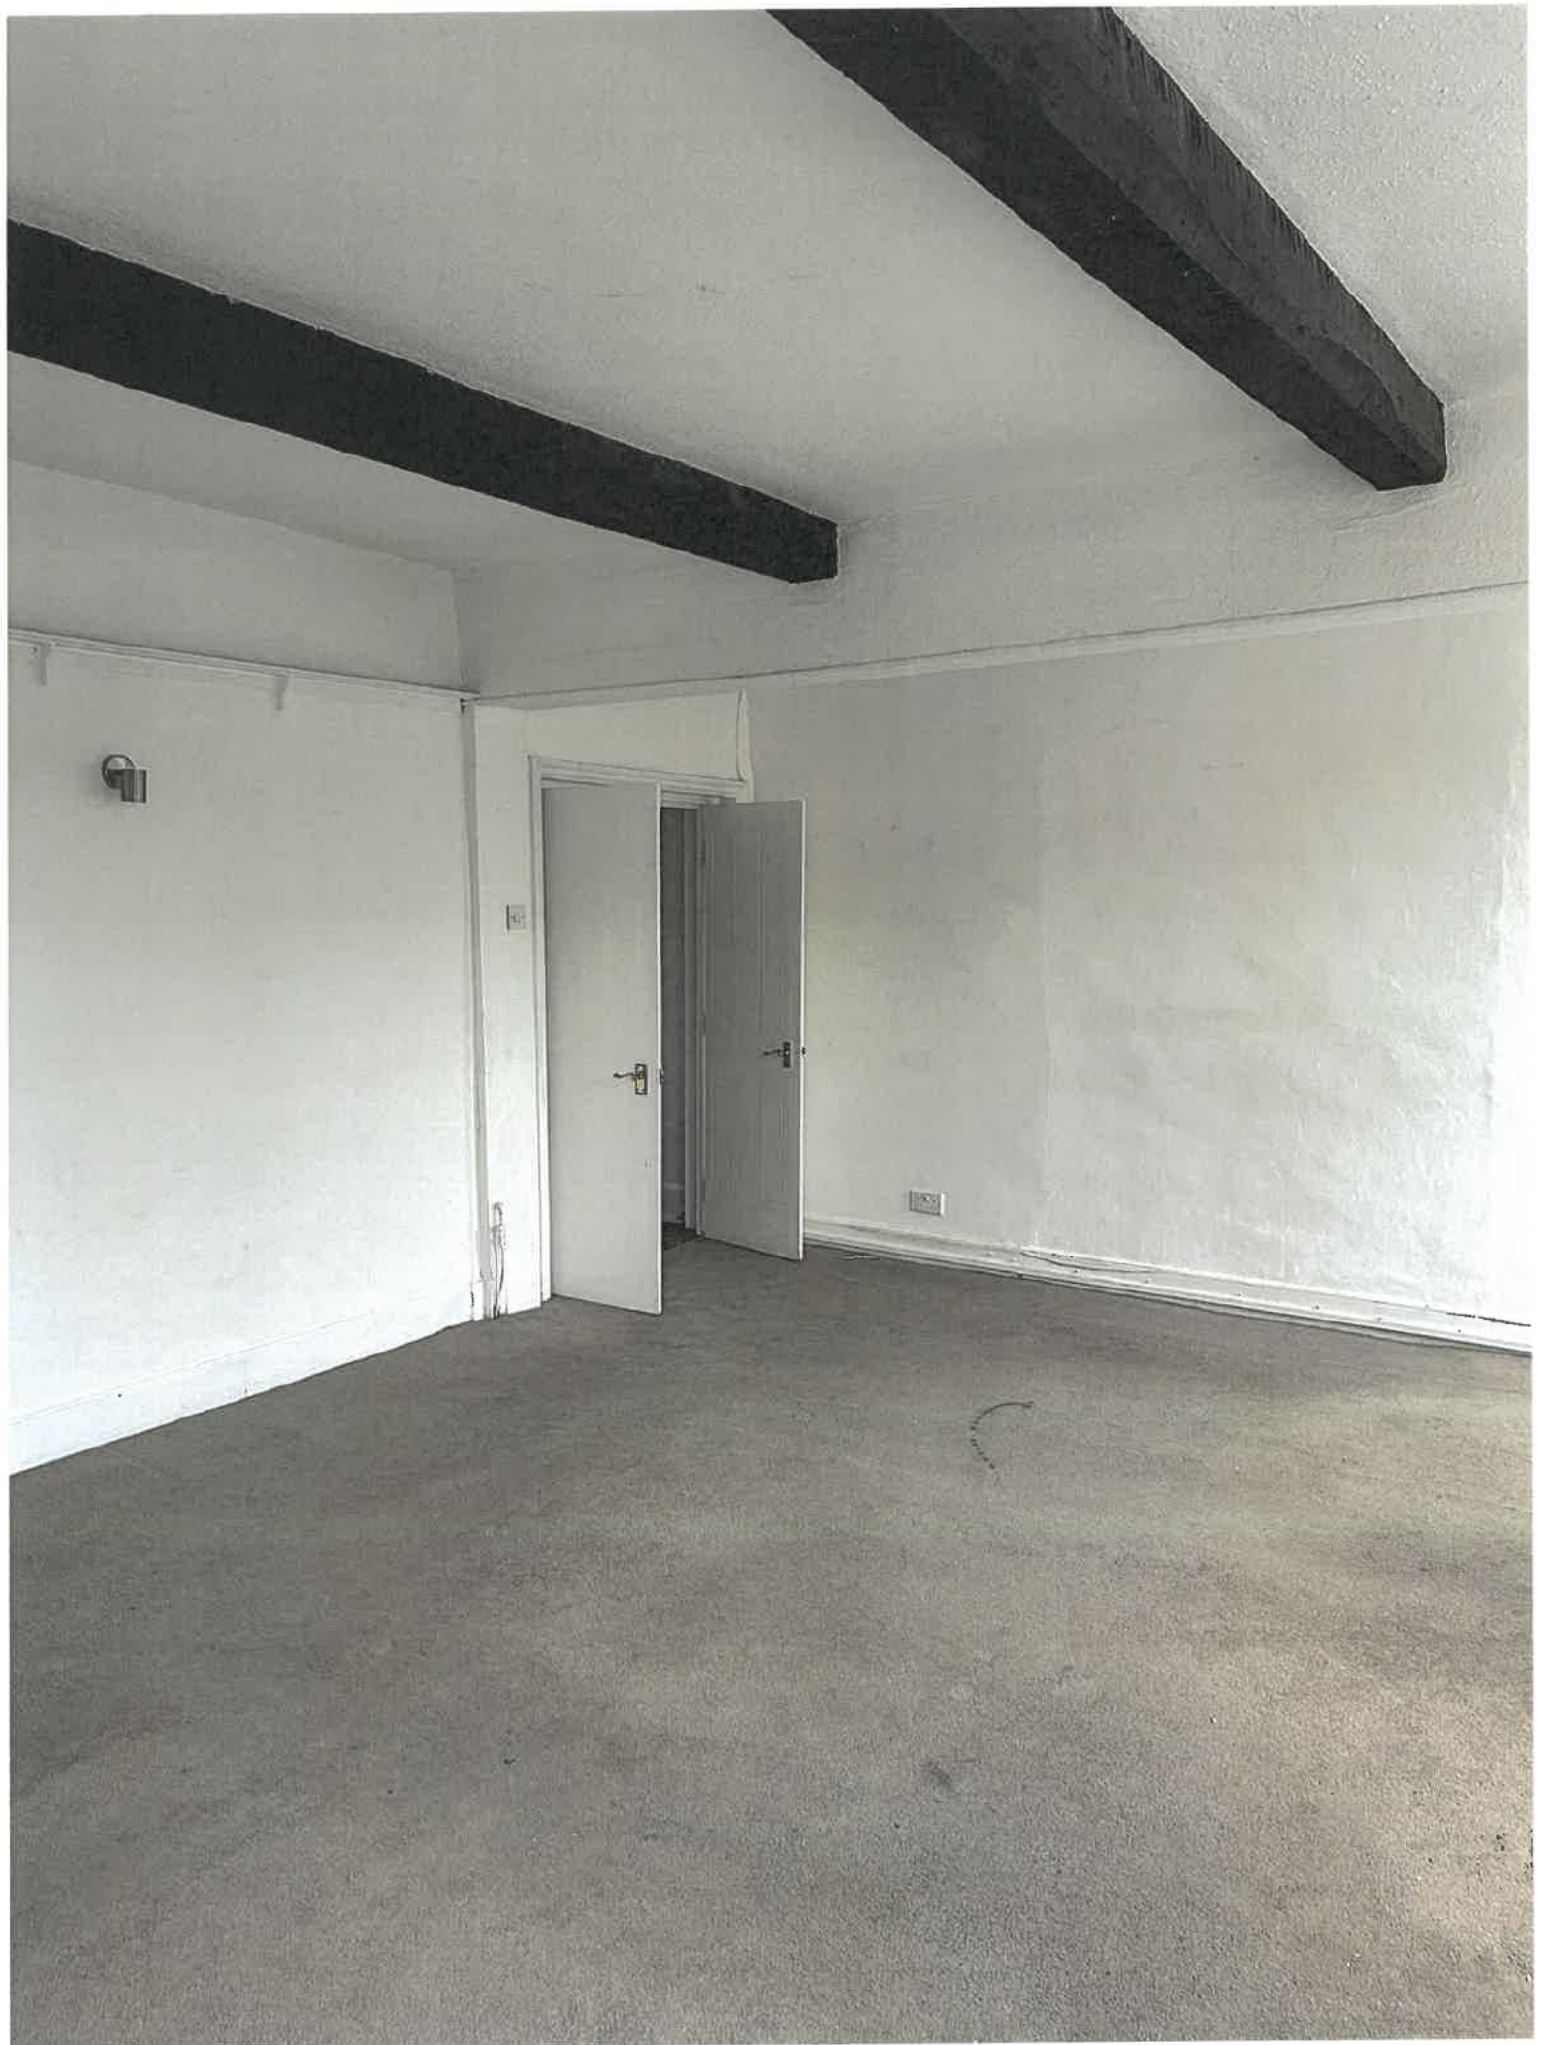
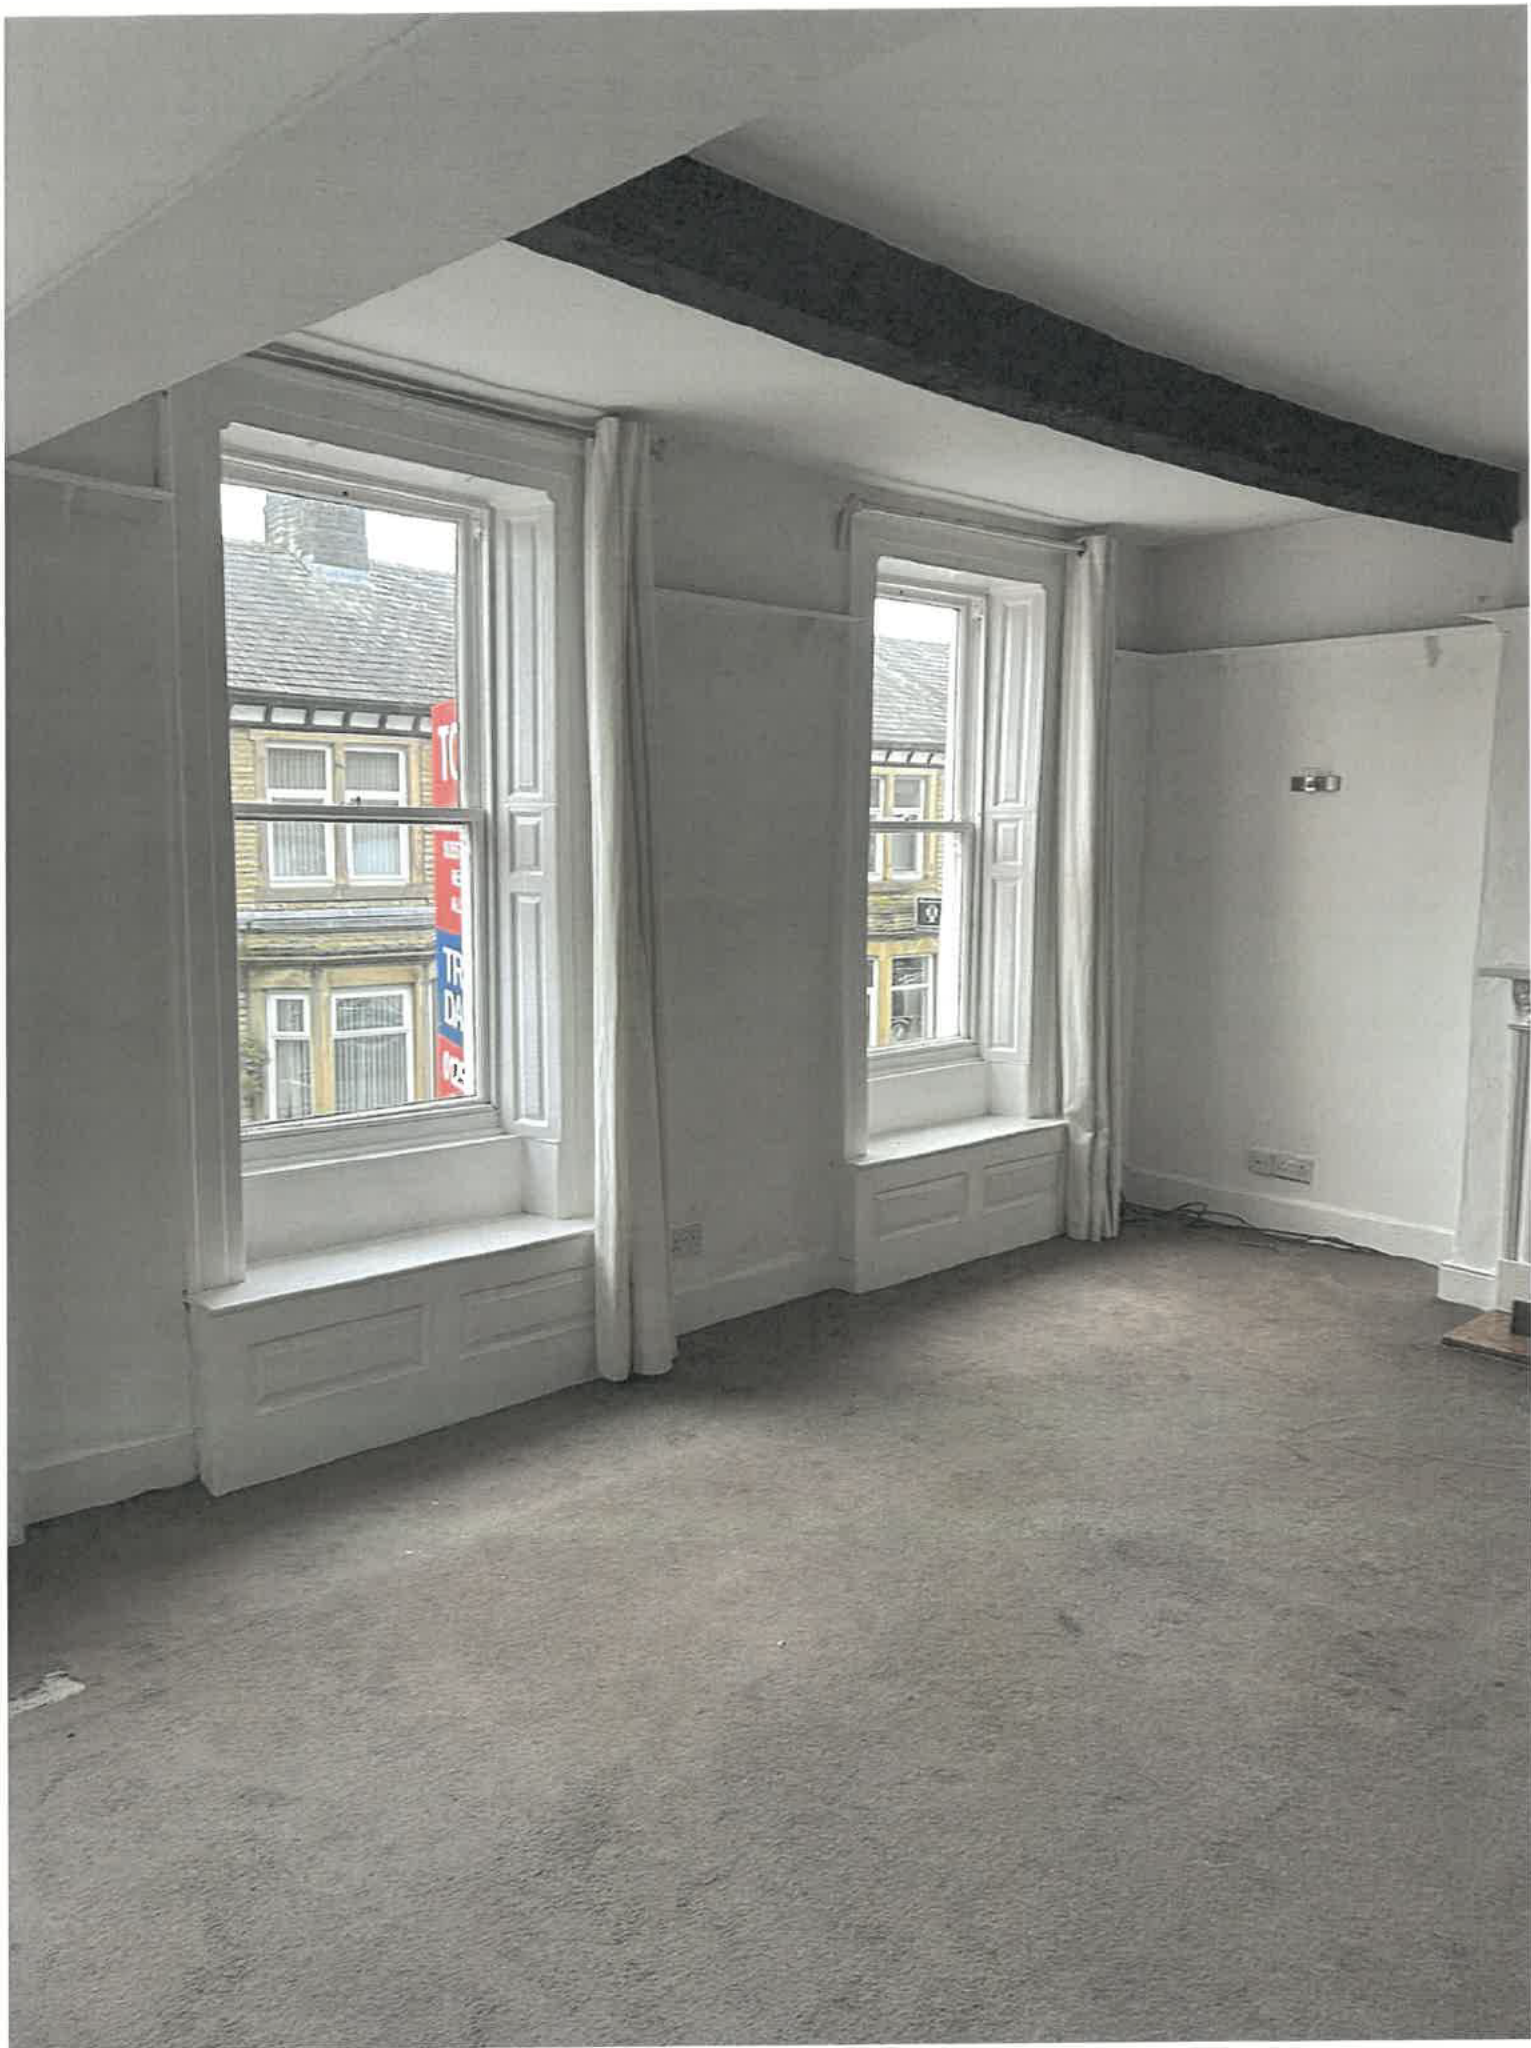
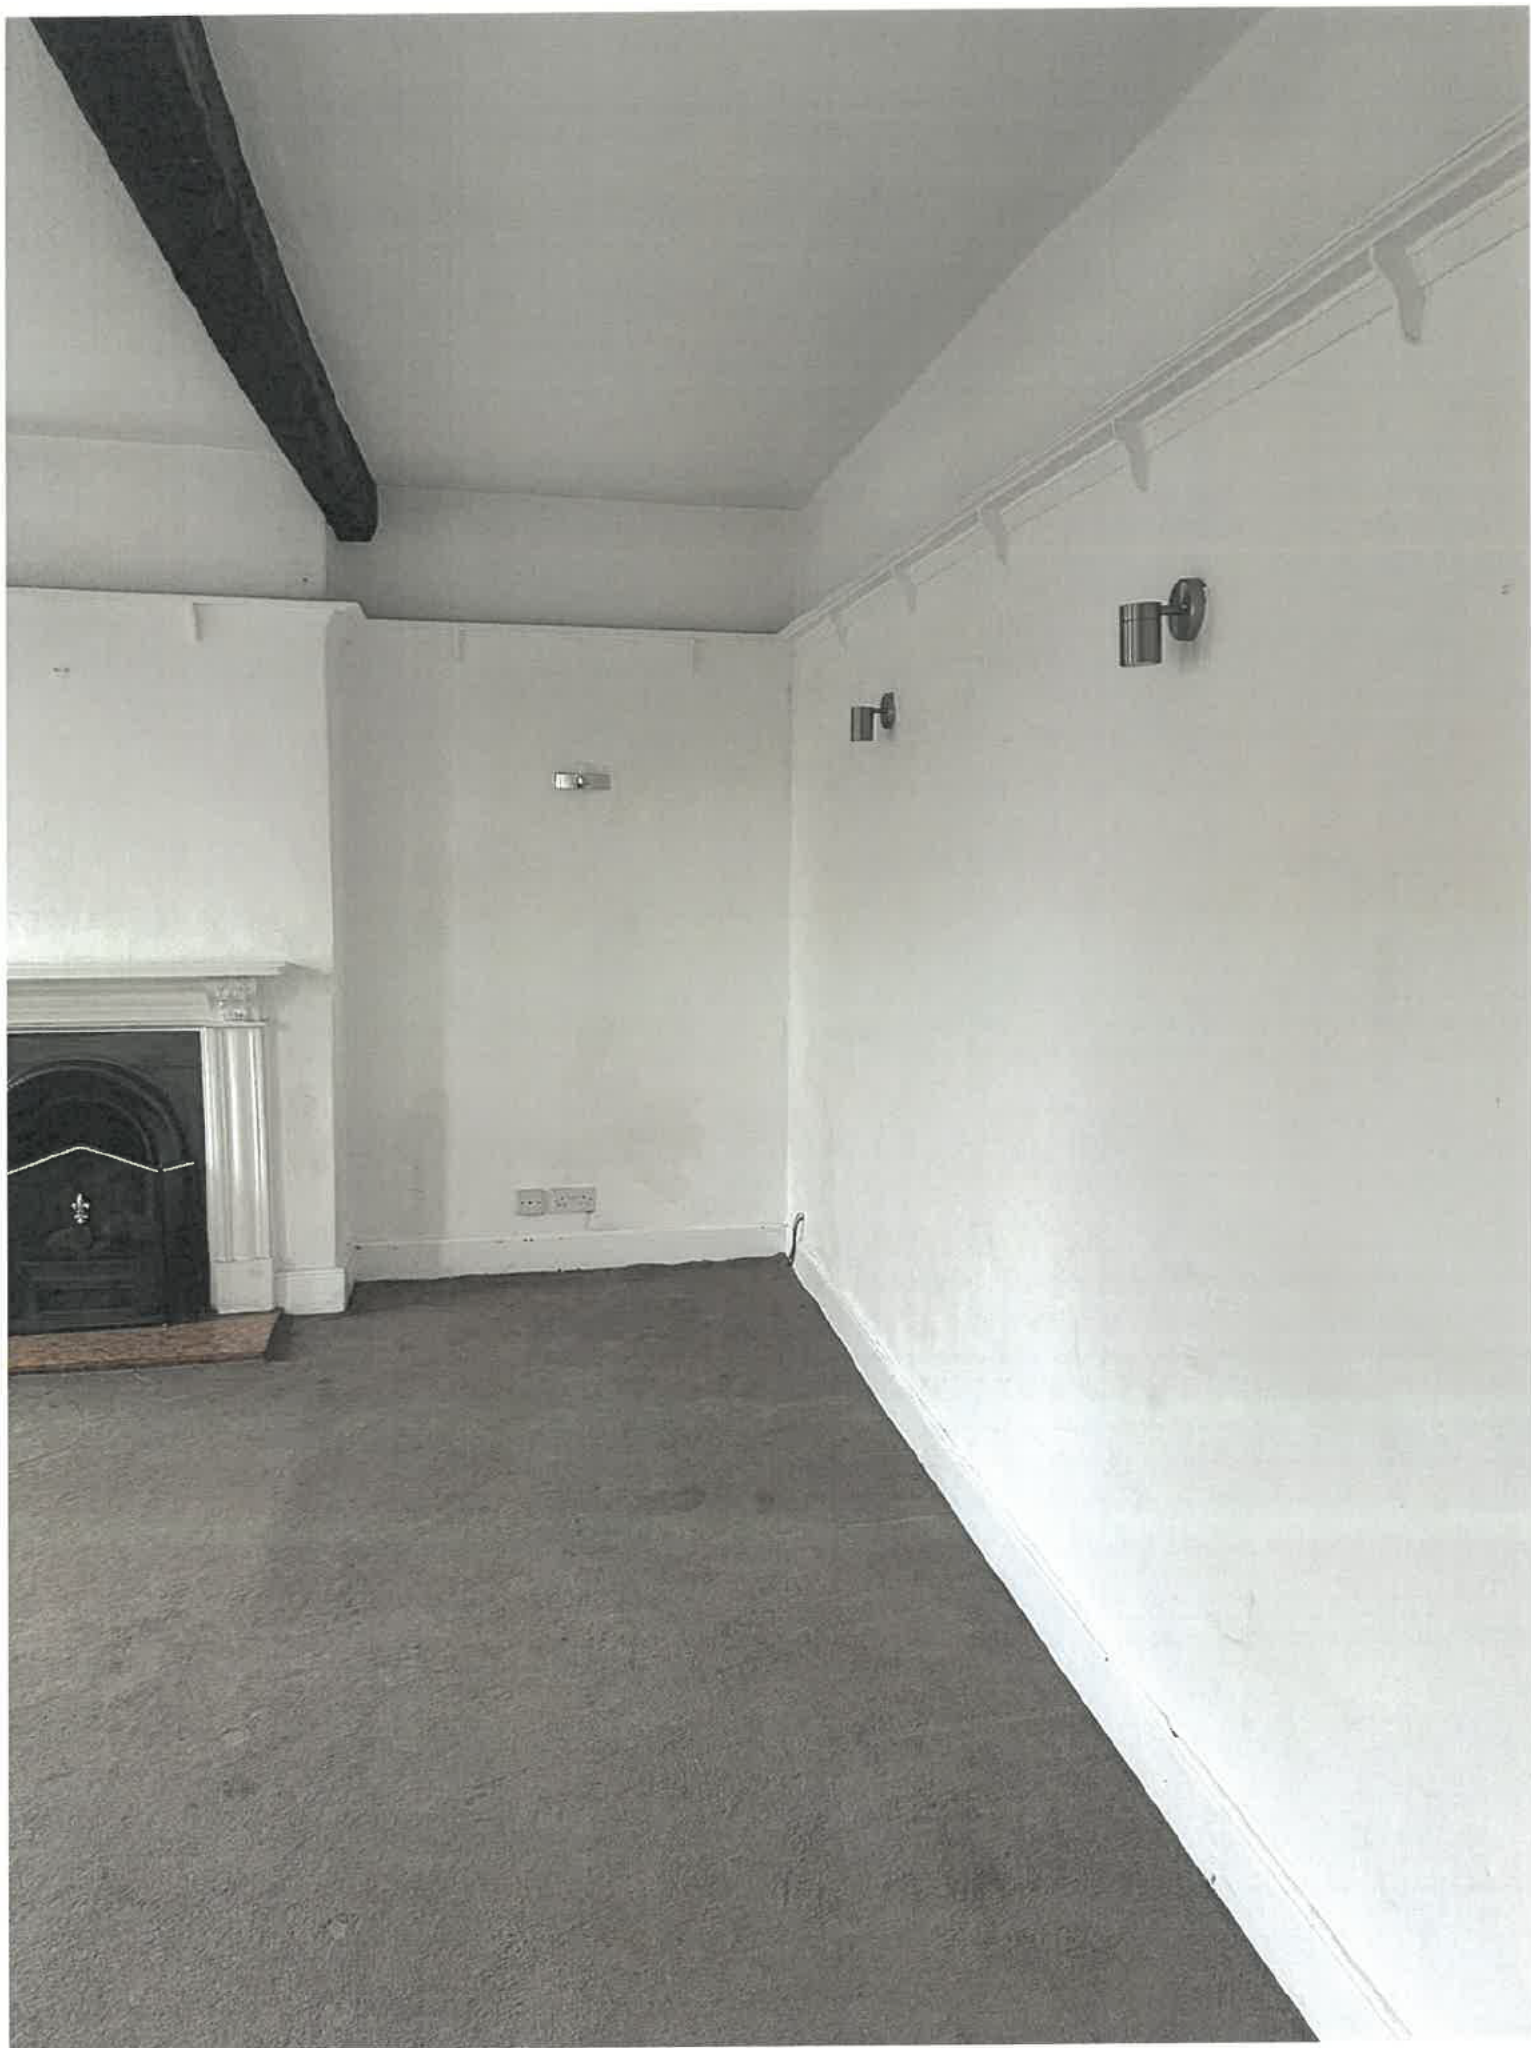
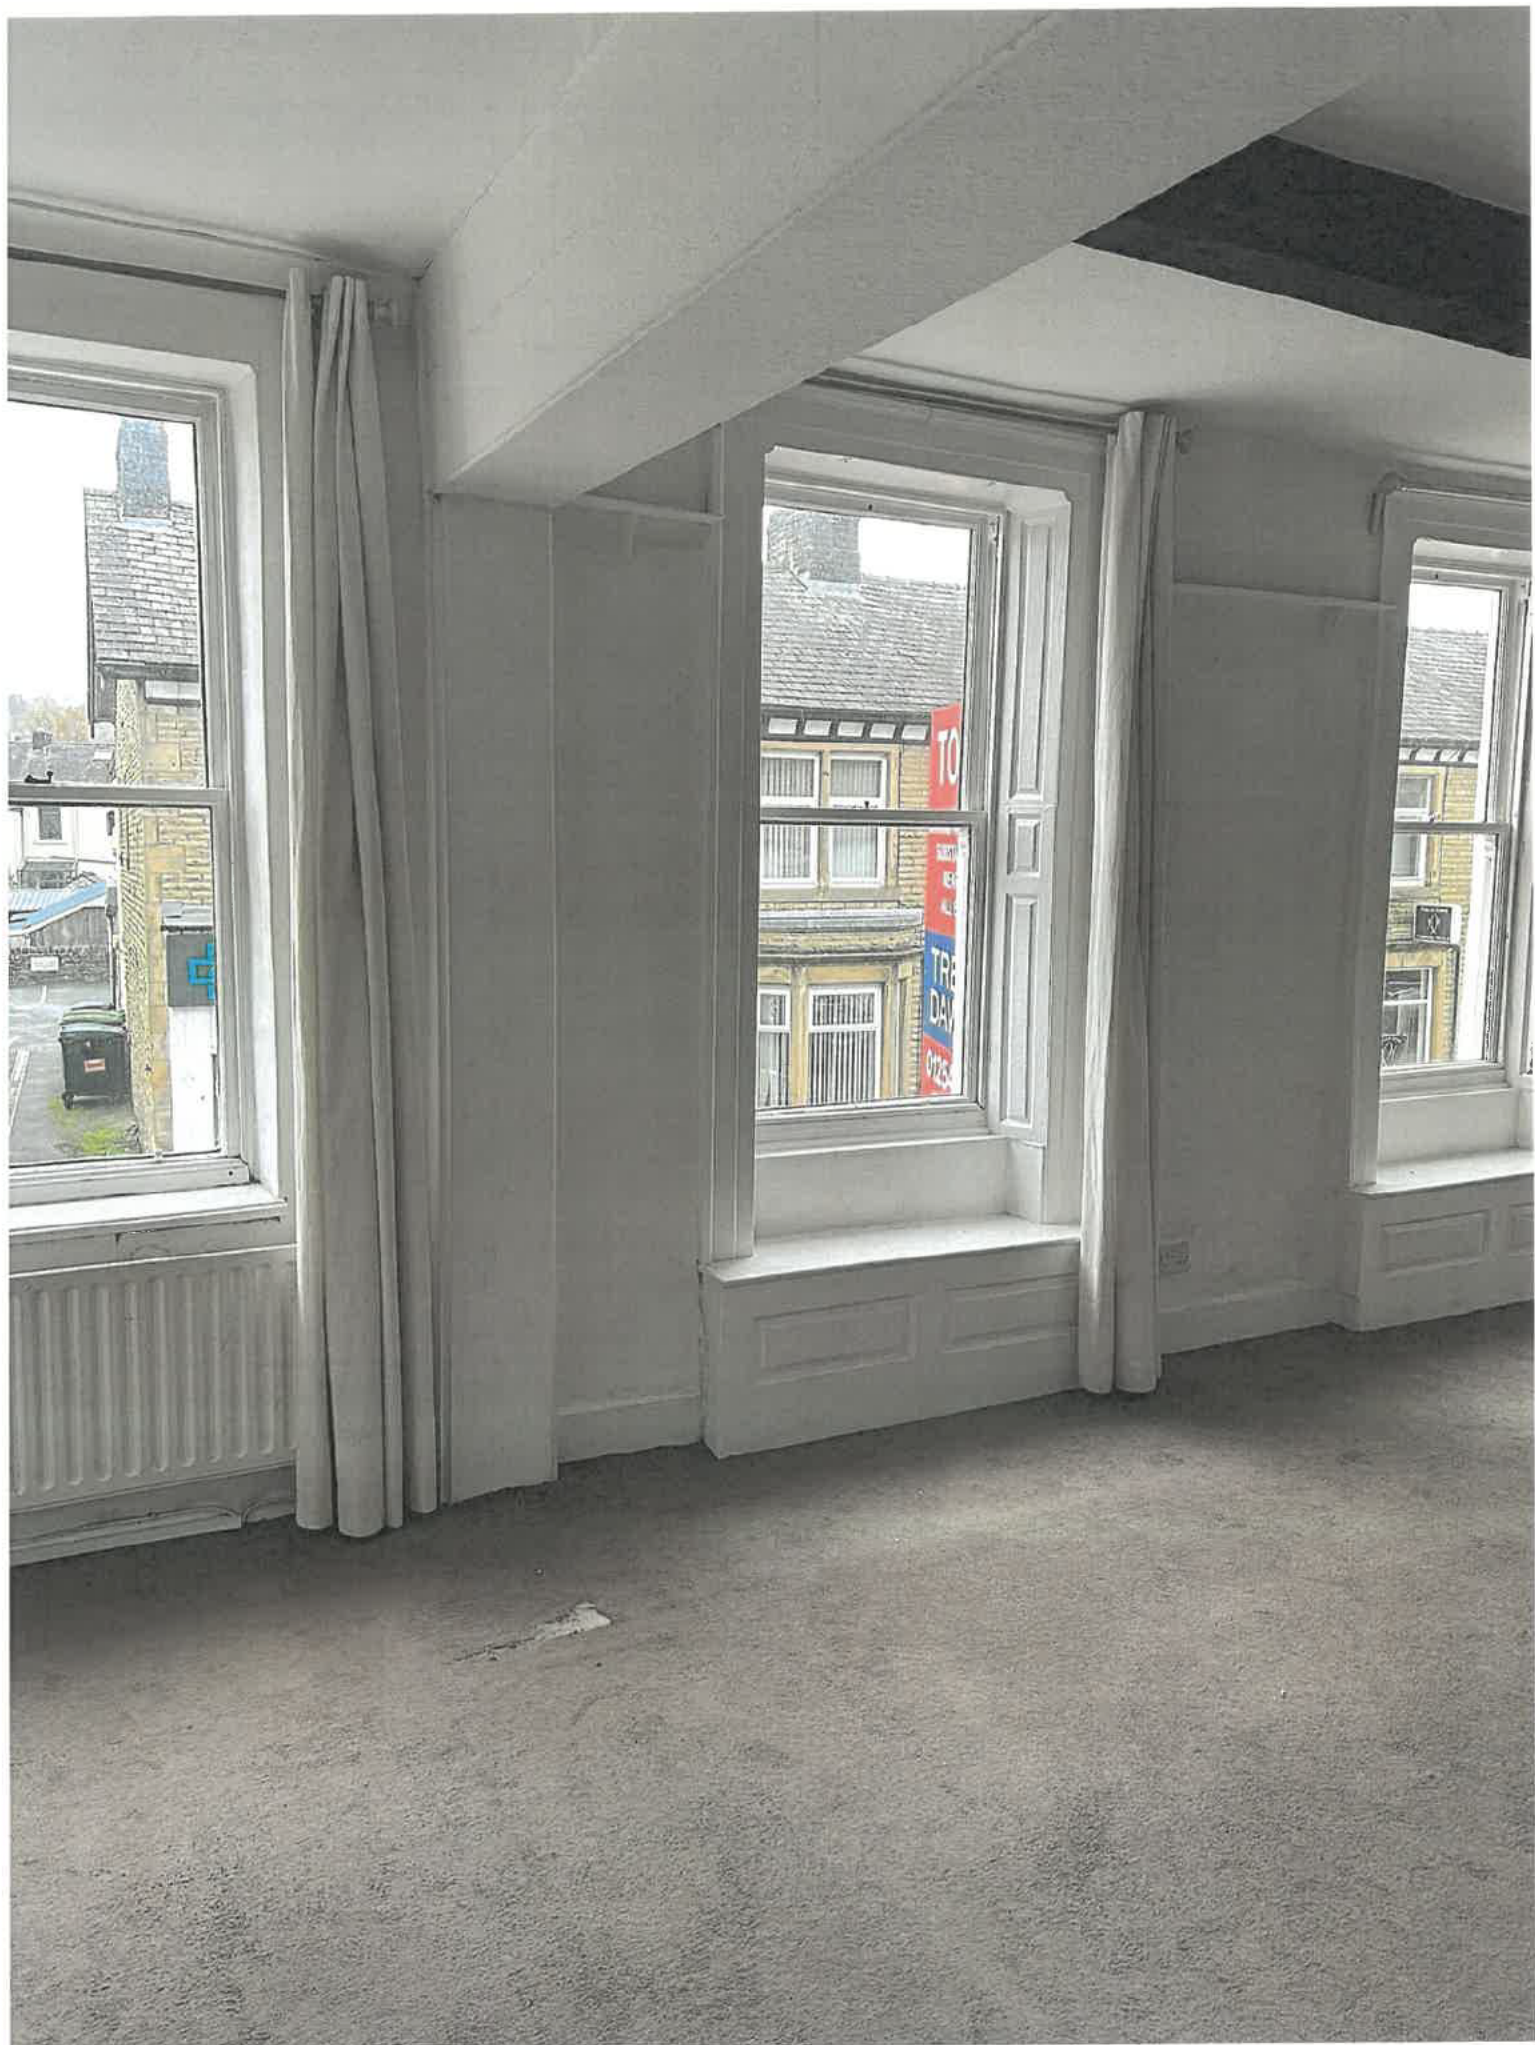
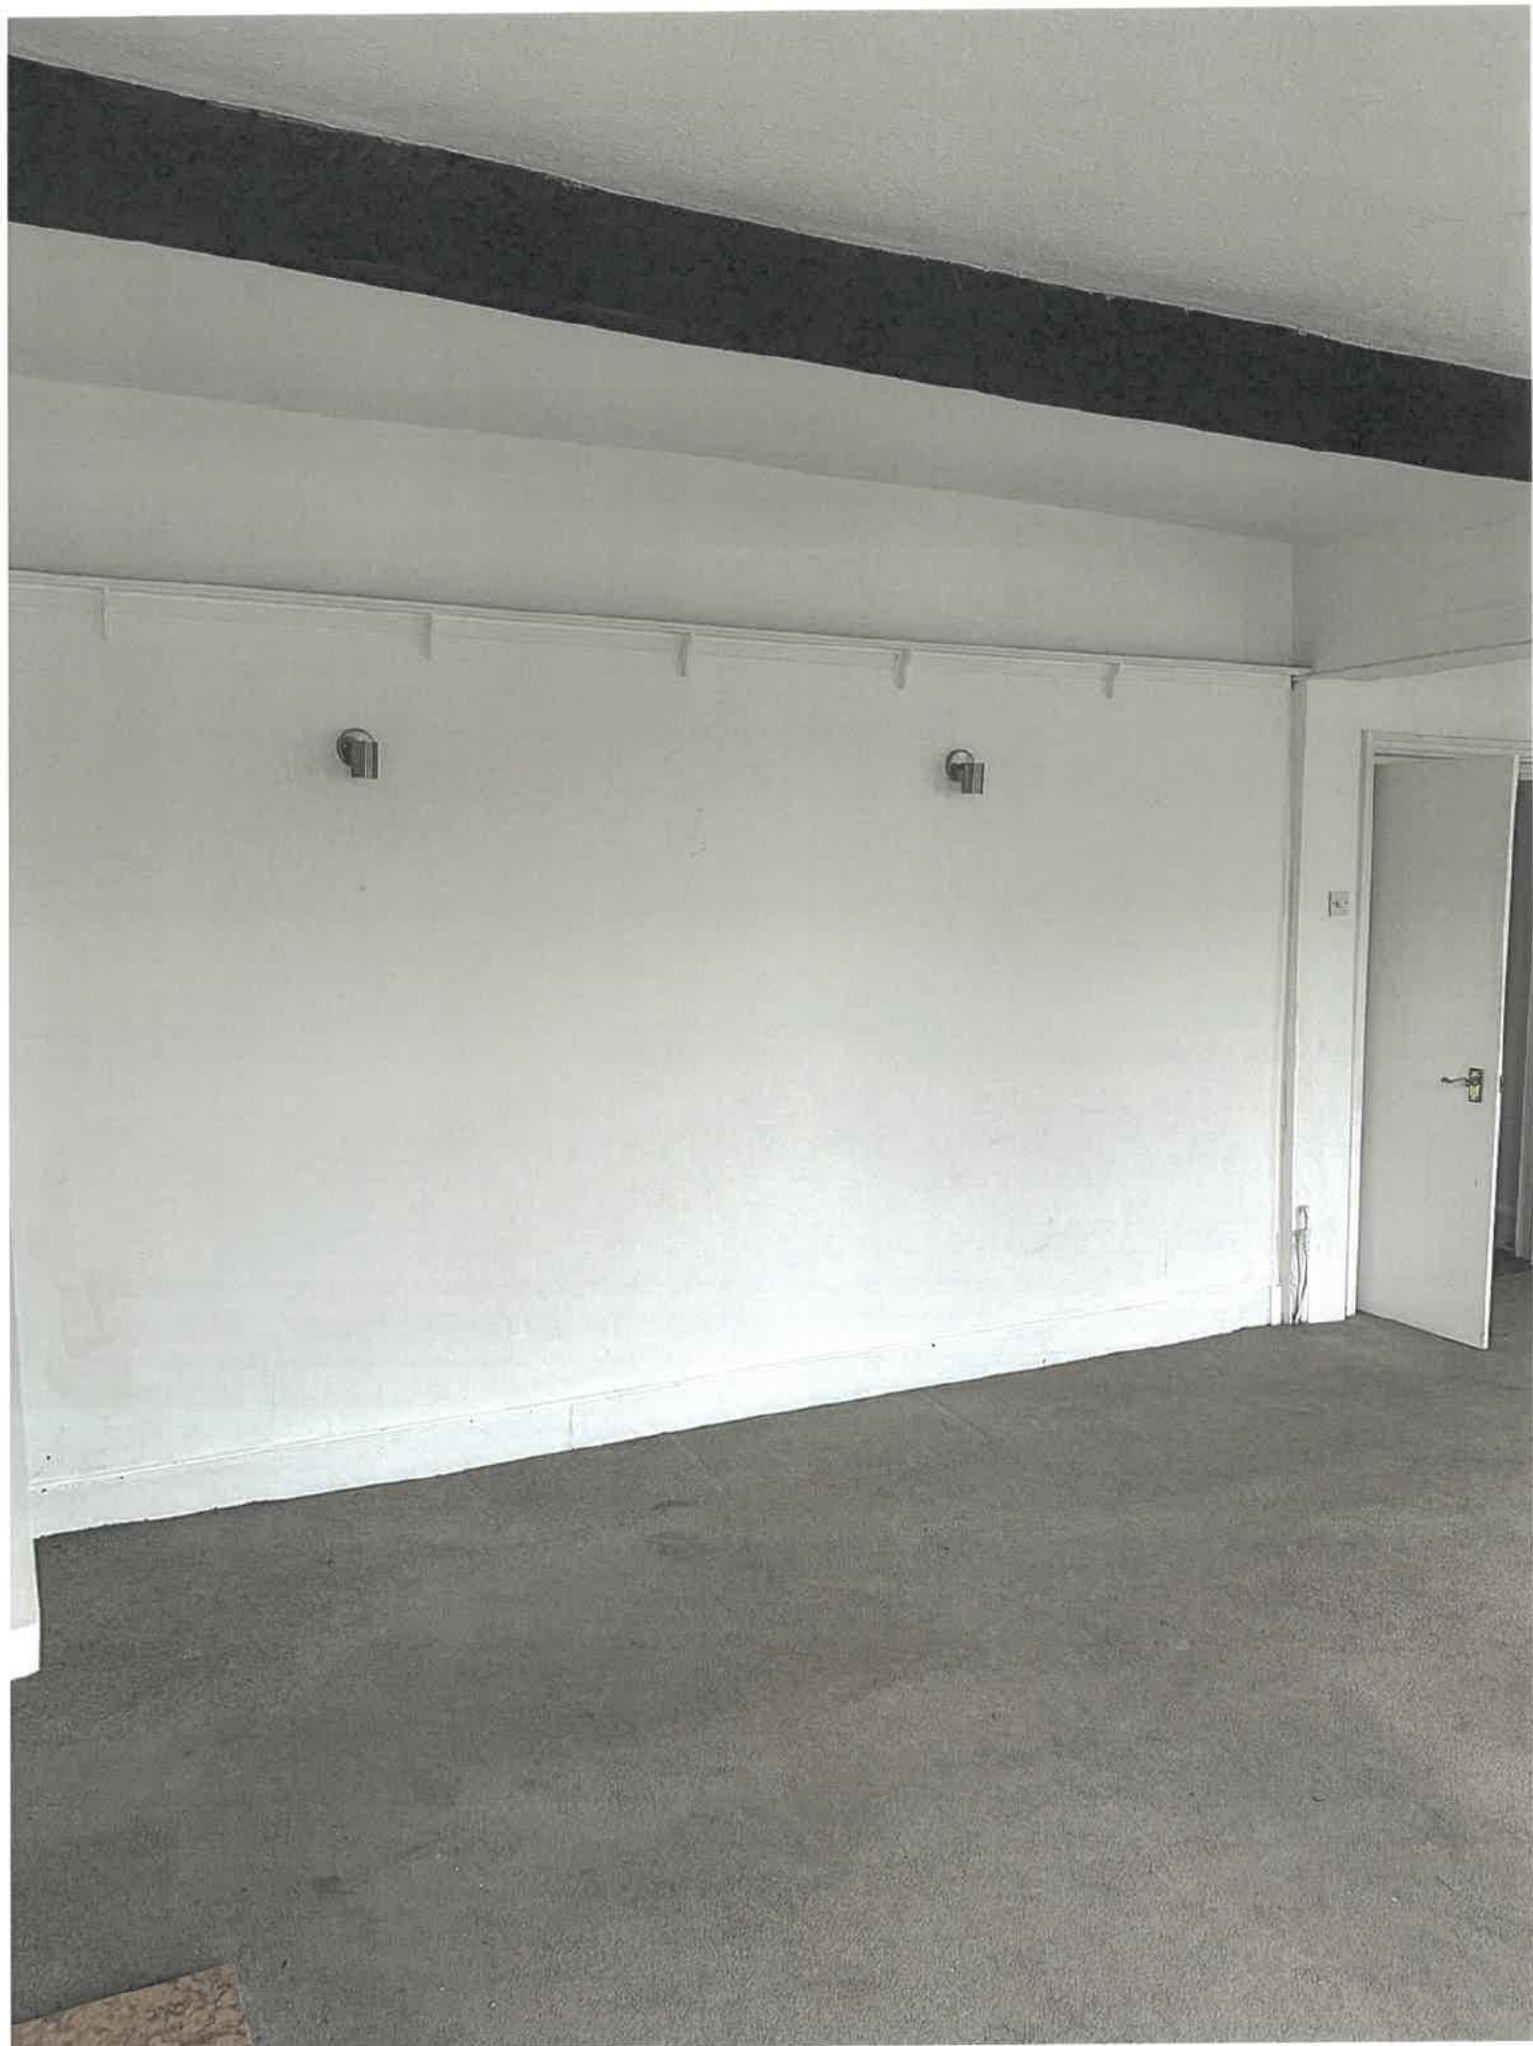
- A revised Heritage Statement
- The structural engineers report
- Several photographs to demonstrate how the beams were bowed on the 1<sup>st</sup> floor.
- The floor survey for the 1<sup>st</sup> floor
