Document name: 19310-EDGE-XX-XX-CO-C-0003_DRAINAGE VERIFICATION AND MAINTENANCE[P01]

Re: 19310 – VERIFICATION REPORT & OPERATION AND MAINTENANCE PLAN FOR SURFACE WATER DRAINAGE SYSTEM

Project**Project Name:** 2023-06-20463 Persimmon Hawthorne Clitheroe**Project Date:** 17/07/2023**Inspection Standard:** MSCC5 Sewers & Drainage GB (SRM5 Scoring)

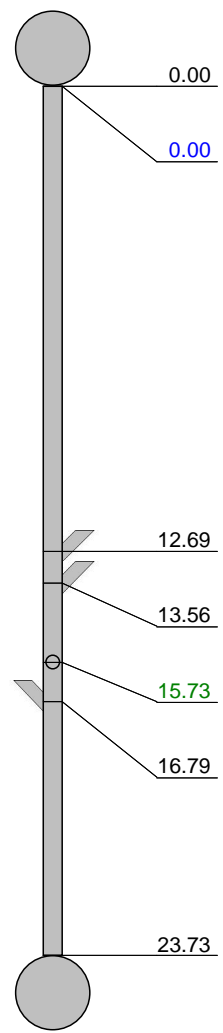
<table><tr> <td>0.00</td> <td>MH</td> <td>Start node, manhole, reference: S15</td> <td>00:00:00</td> <td></td> <td></td> </tr><tr> <td>15.73</td> <td>CXI</td> <td>Connection defective, connecting pipe is intruding at 12 o'clock, 150mm dia, intrusion: 10%</td> <td>00:01:12</td> <td>S15X_83803eba-5f3c-427b-a5</td> <td>3</td> </tr></table>

S15X_83803eba-5f3c-427b-a586-ab6f81f50a07_20230719_083737_463.jpg, 00:01:12, 15.73 m
 Connection defective, connecting pipe is intruding at 12 o'clock, 150mm dia, intrusion: 10%
