Tree Condition Report

St Mary's Church,
A59, Gisburn
BB7 4HB

Ribble Valley Borough Council

Job Ref: 2060

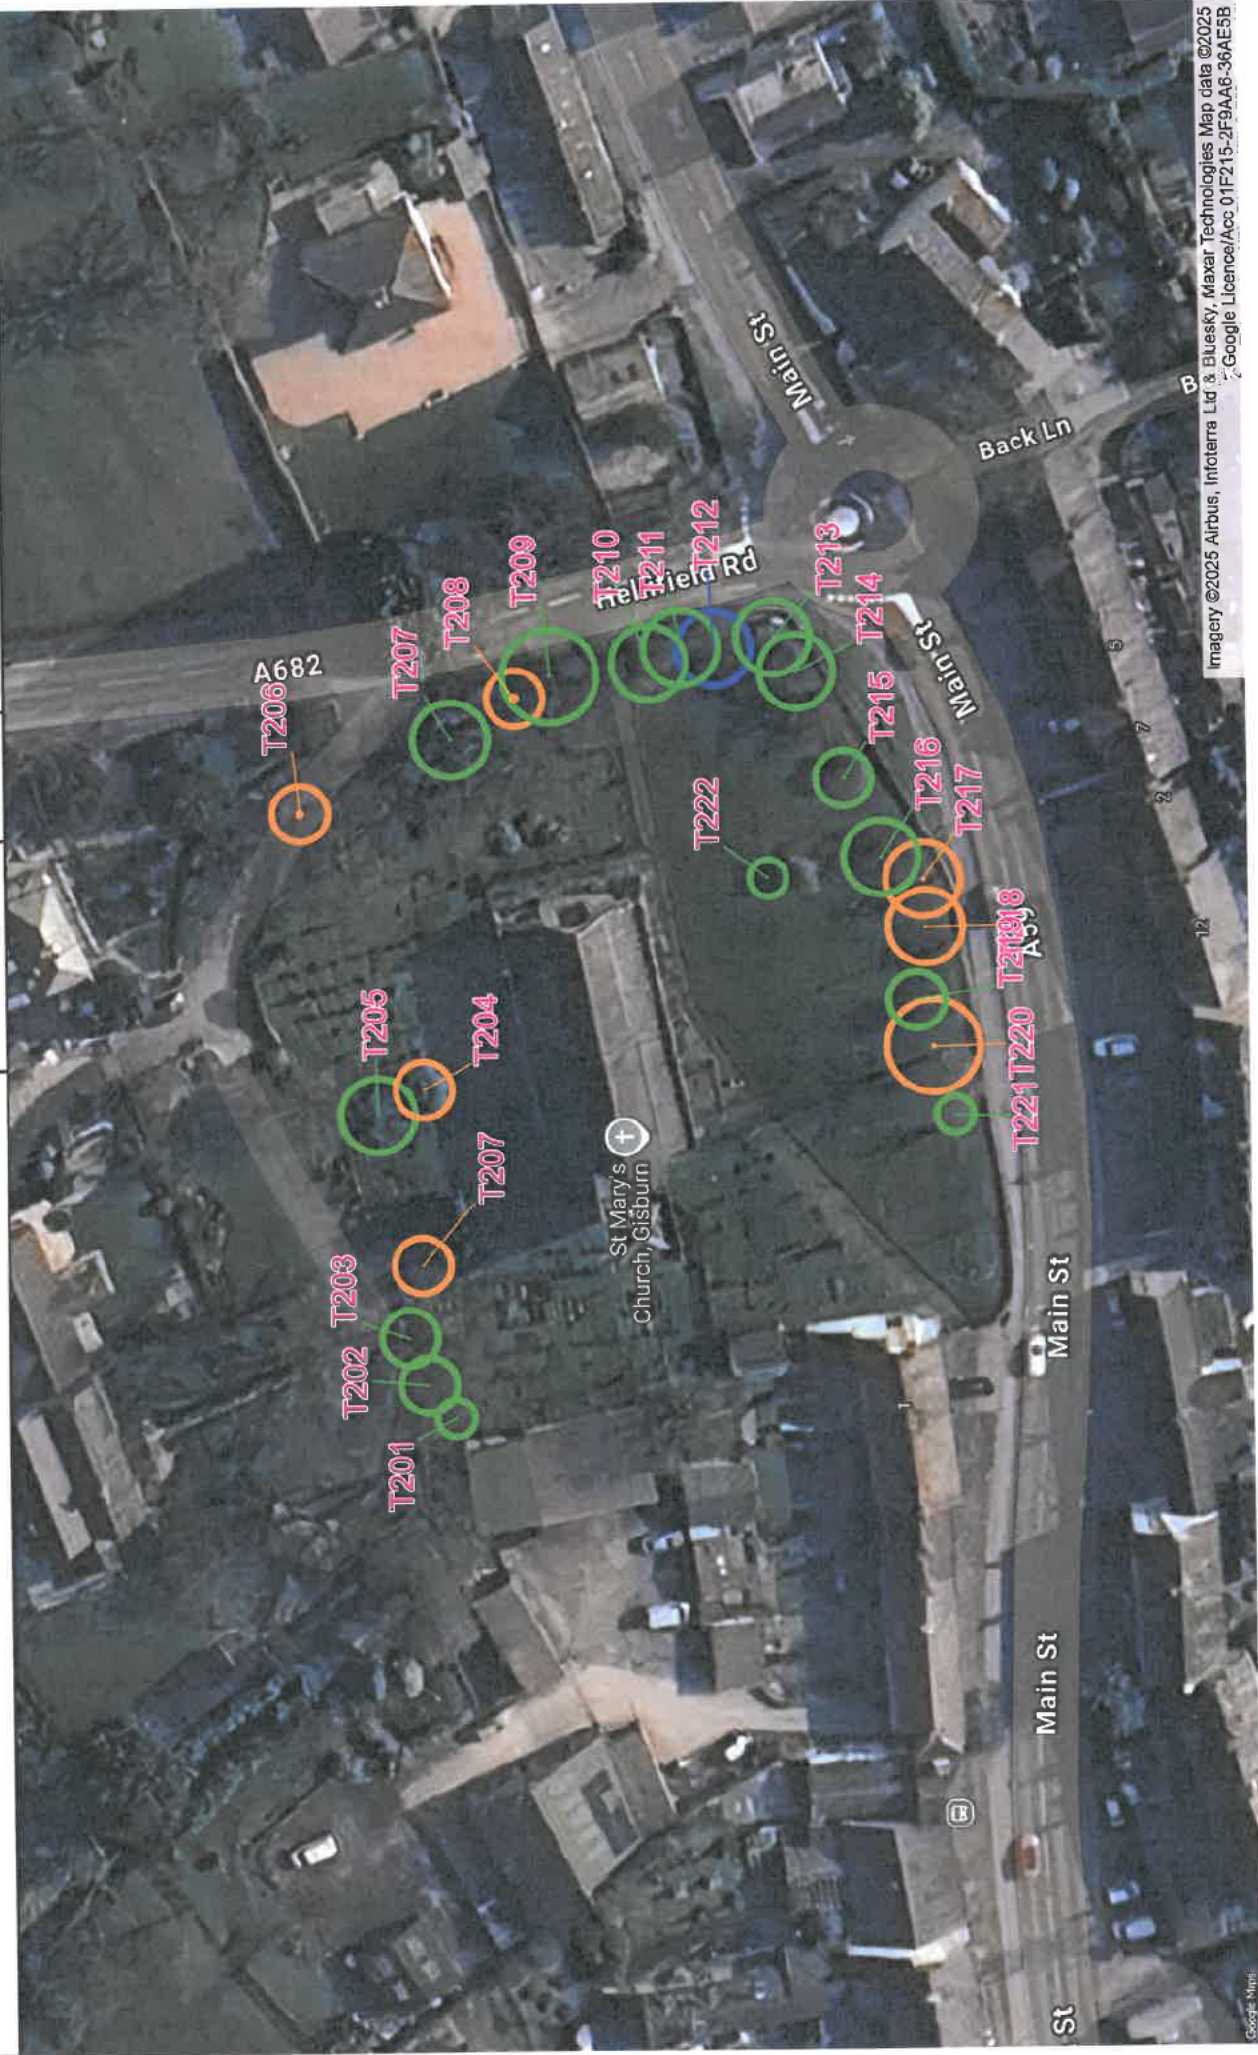
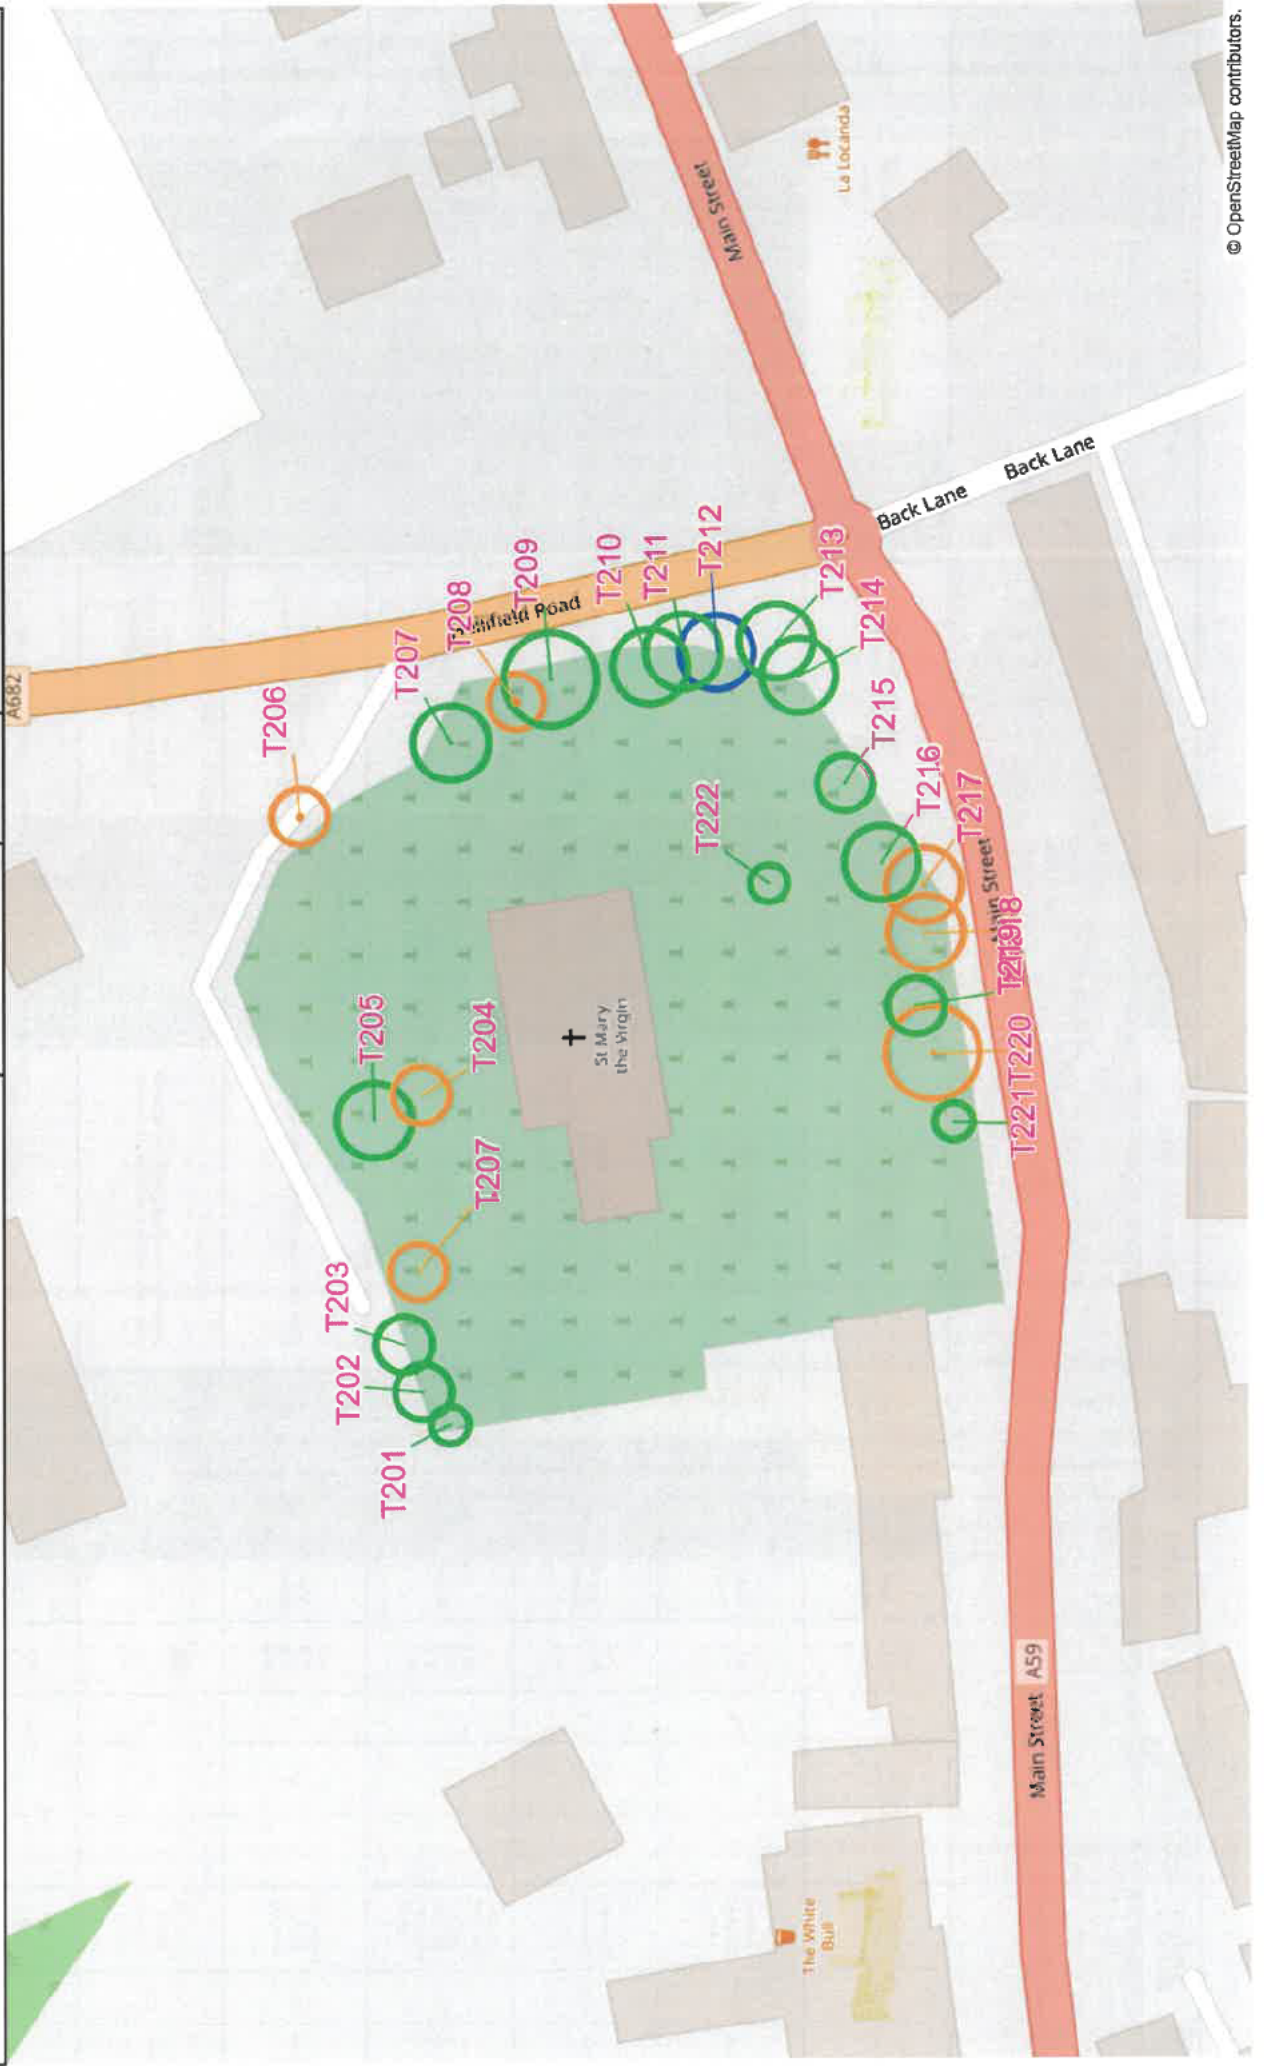
Job Ref:	2060		Survey Date: 11 December 2025				Surveyor: Gary Marsden		Site Address: St Marys Church Gisburn		VTA site survey			EMIRIE CONSULTANTS				
Type	Ref.	Species	Number of stems	Stem diameter @ 1.5m (cm)	Height	Spread	Life Stage	Physiological Condition	Structural Condition	Life Expectancy	Survey Notes	Fungus	Pests and Diseases	Description	Is RISK 'ALARP' As Low As Reasonably Practicable	Recommendations	Timescale for recommended works	Re-inspect within
Tree	T201	Cherry (<i>Prunus sp.</i> 'Cherry')	1	20	6	N:2 E:2 S:2 W:2	Semi Mature	Good	Fair	20+ Years	<ul style="list-style-type: none"> Stem decay. Canopy encroaching phone wires. 	No significant visible fungus present at the time of inspection.	No significant visible Pests or Diseases present at the time of inspection.	Owned by the client. Target # - Garage Target # - graveslones / statue	YES	Prune to clear utilities by 2 m.	11-Dec-2026 (1 Year)	1 Year

Tree	T202	Hawthorn (<i>Crataegus sp.</i>)	4	20	6	N:3 E:3 S:3 W:3	Semi Mature	Good	Good	20+ Years	<ul style="list-style-type: none"> Suppressed canopy. Unbalanced canopy. Seasonal leaf drop has occurred (normal). 	No significant visible fungus present at the time of inspection.	No significant visible Pests or Diseases present at the time of inspection.	Owned by the client. Target # - graveslones / statue	YES	No work required at time of inspection.	No Action	1 Year
Tree	T203	Hawthorn (<i>Crataegus sp.</i>)	4	20	5	N:3 E:3 S:3 W:3	Semi Mature	Good	Good	20+ Years	<ul style="list-style-type: none"> Suppressed canopy. Unbalanced canopy. Seasonal leaf drop has occurred (normal). 	No significant visible fungus present at the time of inspection.	No significant visible Pests or Diseases present at the time of inspection.	Owned by the client. Target # - graveslones / statue	YES	No work required at time of inspection.	No Action	1 Year
