# **BUILDING (STRUCTURAL) CONDITION SURVEY**

PROPOSED CONVERSION OF EXISTING BARN AT

FOODEN HALL FARM

GISBURN ROAD

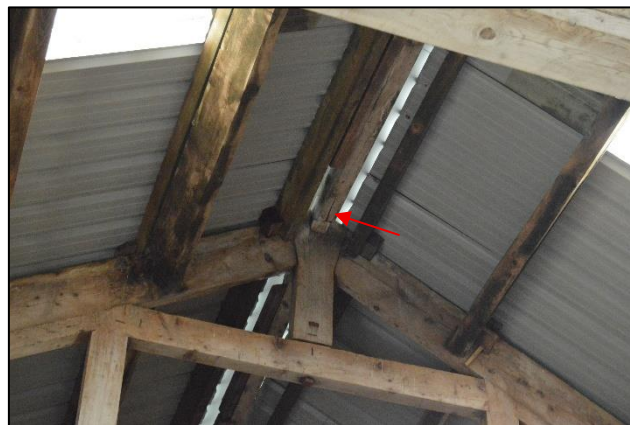
PLI 8: A shake / split was noted to the ridge at a location of a joint to the ridge beam of the roof to the main core of the barn. A closer assessment of this area is recommended on erection of a safe working platform to confirm the structural integrity of the ridge beam at this location. This being said, no obvious specific issues were identified at the time of inspection to suggest any immediate cause for concern, however a closer assessment is recommended to confirm.

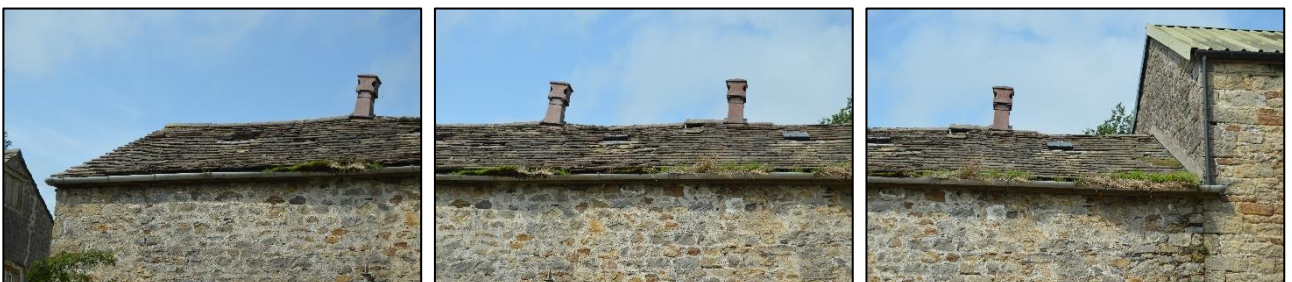
The roof to the south addition was in poor condition at the time of inspection. The roof covering had numerous broken, dislodged and missing slates. Obvious undulations were noted to the roof slopes and ridge at the time of inspection, in between the locations of the stonewalling and roof trusses, however no evidence of roof spread was noted at the time of inspection. All ridge tiles were present but breaches were noted. On inspection of the roof structure appeared to be in fair to poor condition. Issues of decay were noted to the ridge beam and crude repairs appear to have been undertaken. Some slight curvature / deflection noted to the timber purlins, likely as a result of 'creep' over time as opposed to over a long period of time as opposed to a more recent significant structural issue / defect. Again, the trusses and purlins were built into the existing external walls and is considered to be traditional

PL20: View of the stone flag roof covering to the east roof slope of the south addition.

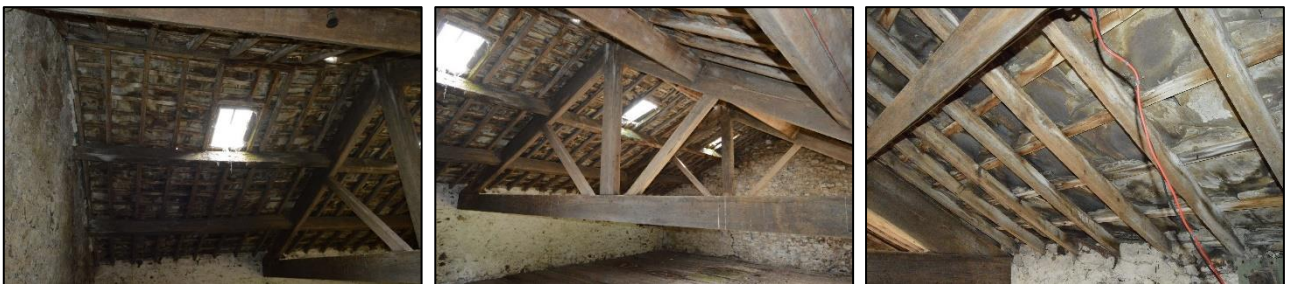
PL21: View of the roof structure to the south addition of the barn.

Our inspection of the roof structure was limited due to the hayloft below appearing unsafe. A closer inspection of the roof structure is recommended on erection of a safe working platform to confirm the exact condition of the roof structure and its suitability for retention. This should also provide an opportunity to assess for the extent of any decay present not visible from ground level and any evidence of wood boring insect attack to the roof timbers. It is also recommended that all elements of the existing timber roof structures which are to be retained are treated to ensure their longevity.

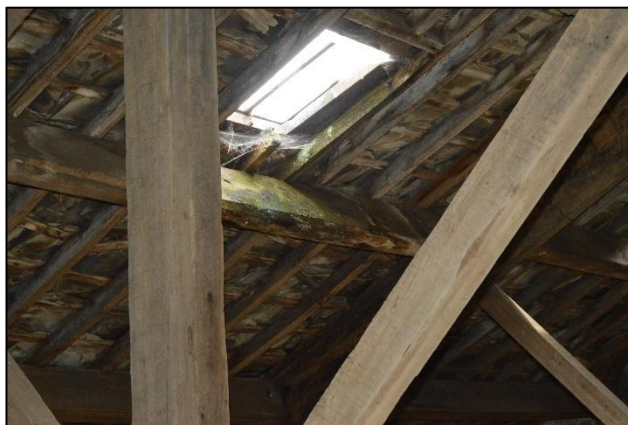
Decay was noted to the timber purlins directly below the roof lights to the east roof slope of the south addition, with associated staining and algal growth suggesting water ingress at the roof light locations. A number of the timber battens to the roof were broken.

PL22: Staining noted to the timber purlins located beneath the roof lights to the east roof slope of the south addition, suggesting potential water ingress at these locations. This has led to some decay of the timbers below the roof light locations and it is recommended that these areas are closely inspected on erection of a safe working platform to confirm condition and full extent of decay.

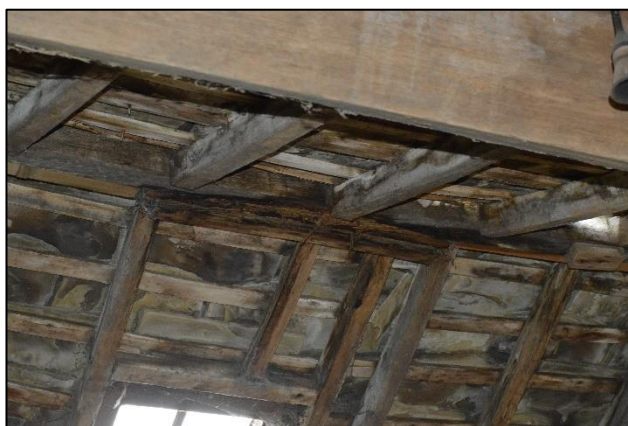
PL23: View of decay and repairs undertaken the ridge beam of the roof to the south addition. It is recommended that these areas are closely inspected on erection of a safe working platform to confirm condition.

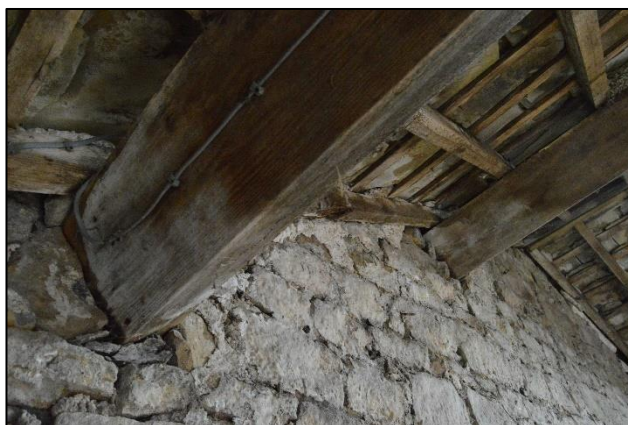
PL24: View of staining noted to the roof timbers of the south addition where the timbers are built into the stone wall fabric.

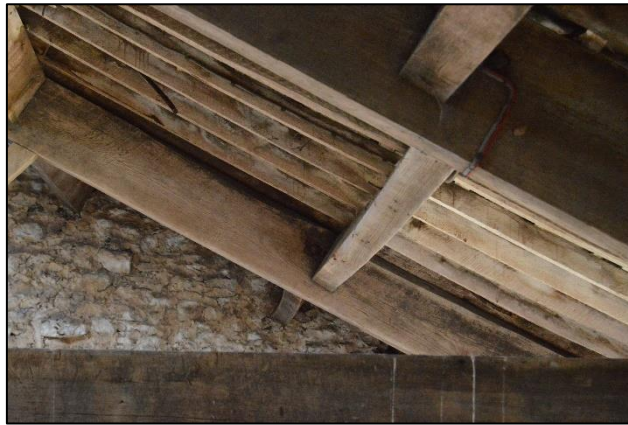
*PL25: View of timber purlins to the west roof slope of the south addition which were noted as having a slight curvature, possibly caused by 'creep' as opposed to any serious defect, however it is recommended that the purlins are closely assessed on erection of a safe working platform to confirm condition.*

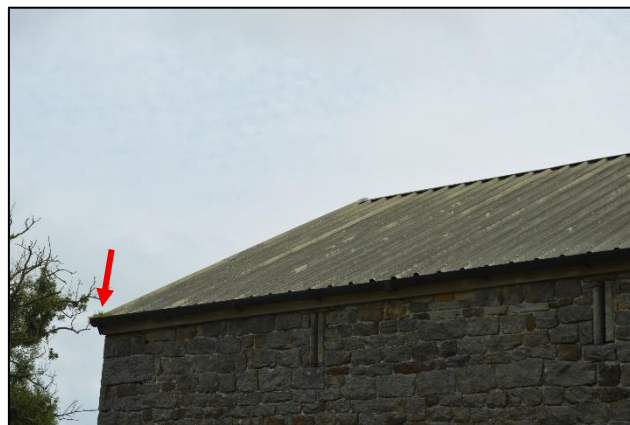
PL28: Plant growth noted to the west gutter to the main core of the barn.

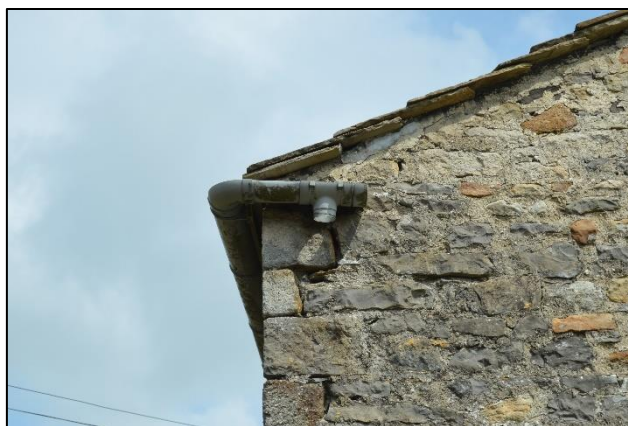
PL30: View of missing down spout to the south west corner of the south addition.

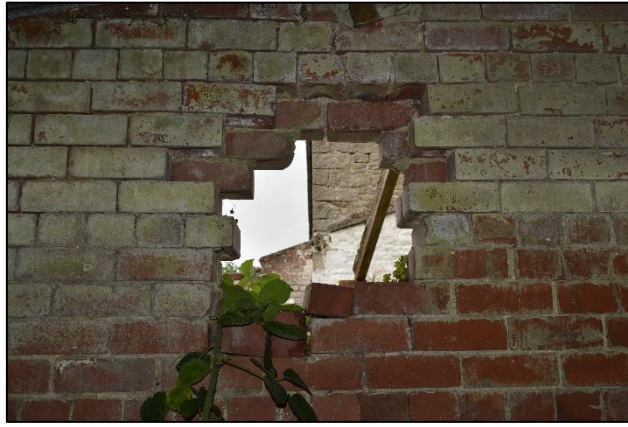
*PL33: A hole was noted in the brickwork to the south wall of the north lean-to structure.*

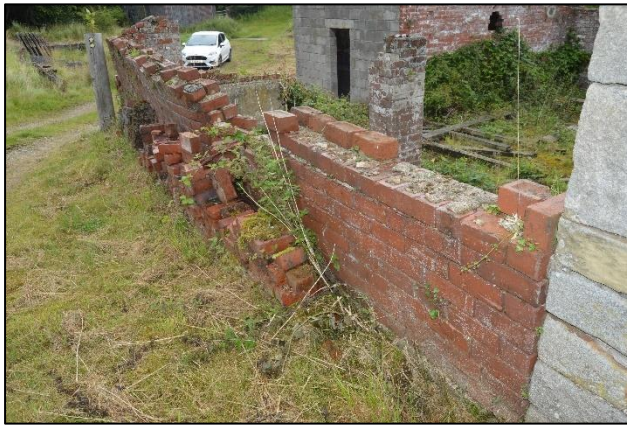
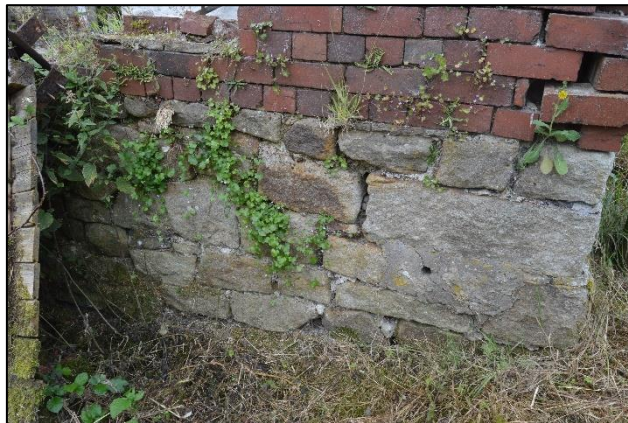
The north addition of the barn is built in solid wall construction comprising of red brick. The majority of the walling has now collapsed, with what remains to the east and west walls now leaning and with areas of loose / unconsolidated masonry present. This masonry over the south east doorway of the addition is at risk of collapse due to the poor support of the lintel over the opening and the presence of loose / unconsolidated masonry. The mortar throughout the remains of the red brick built north addition is largely perished throughout. The remains of the red brick built north addition are considered to be unsafe and the full demolition of what now remains is recommended.

*PL34: The remains of the west wall of the brick built north addition was leaning towards the west at the time of inspection. The masonry was largely loose and unconsolidated and is considered to be unsafe. The pointing to the masonry was largely perished.*

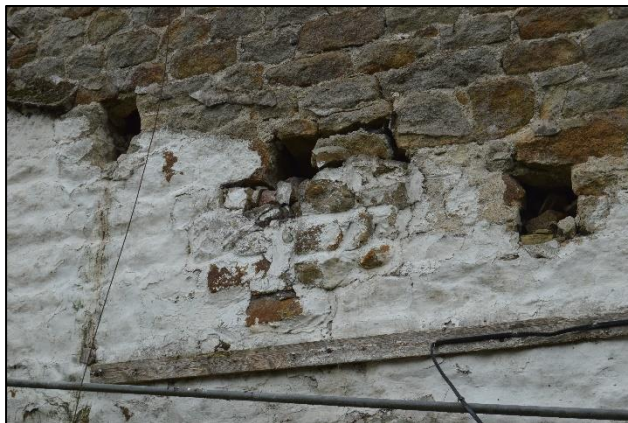
*PL40: Loose / unconsolidated masonry noted to the now relict purlin sockets to the north gable of the main core of the barn. Making good is recommended and the sockets infilled with matching stonework.*

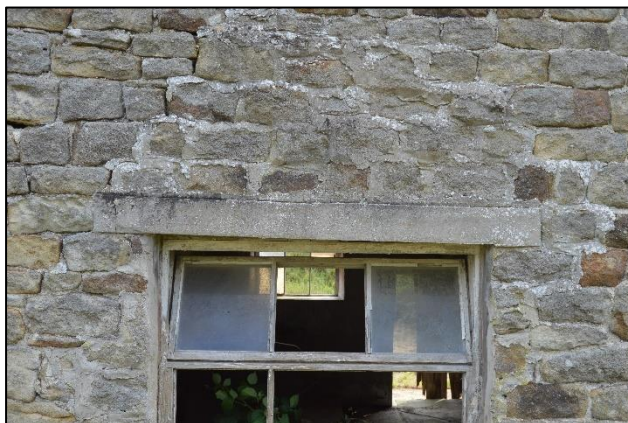
*PL41: A crack noted to the lintel to a window to the ground floor of the west elevation of the main core of the barn. The front of the lintel appeared to be comprised of a cement veneer and it could not be confirmed if it was only the veneer was cracked or if the crack was also present the underlying structural support, the type, condition and adequacy of which could not be confirmed at the time of inspection.*

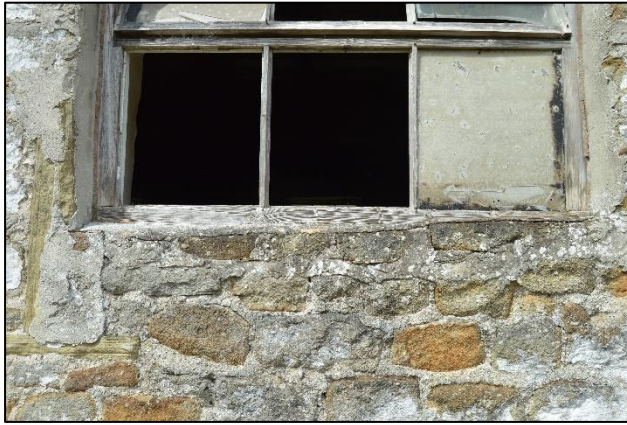
PL44: No cills were largely present to window openings throughout the barn and as a result this will prove to be a poor water shedding detail. It is recommended that all window openings are provided with a throated cill to remove surface water away from the window and wall fabric.

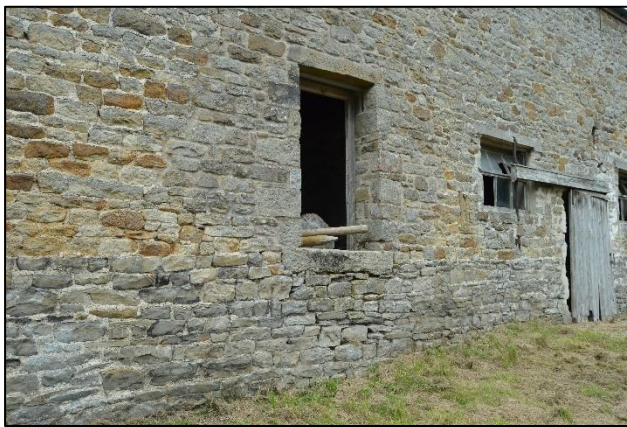
PL45: A lean / bulging was noted around the location of the former winnowing door to the east elevation of the main core of the barn. It was noted that the external walling around the former winnowing door has been rebuilt, however this does not appear to be the case to the walling directly below the opening, likely as the wall is retaining the floor behind. No obvious structural cracking was noted at this location at the time of inspection to suggest any recent / ongoing movement to this location, however it is recommended that this area is regularly monitored for any evidence of recent movement / cracking. Should any further movement / cracking occur then this will require assessment by a Structural Engineer and structural repairs undertaken as required. The stonework beneath the former winnowing door should be repointed / consolidated using a lime mortar.

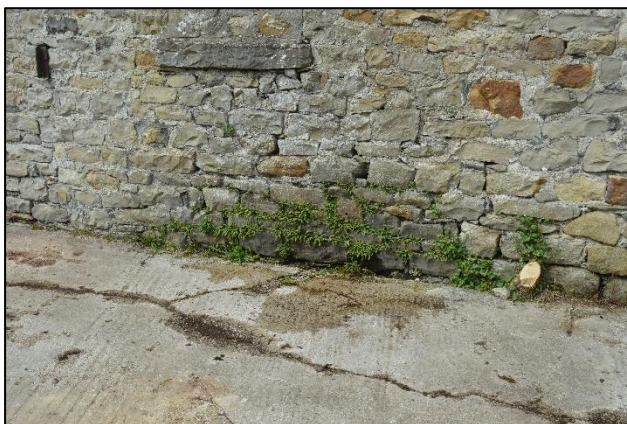
PL46: Areas of plant growth were noted throughout the building and should be removed to prevent further growth.

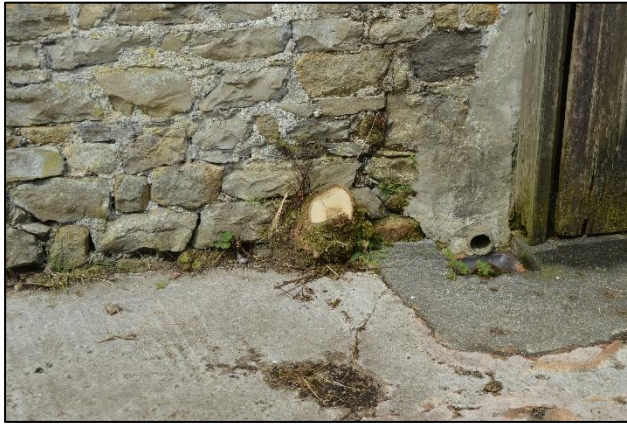
PL47: A number of tree / sapling stumps were noted to the wall base of the east elevation. It is recommended that stumps are fully removed as well as the underlying root matrices.

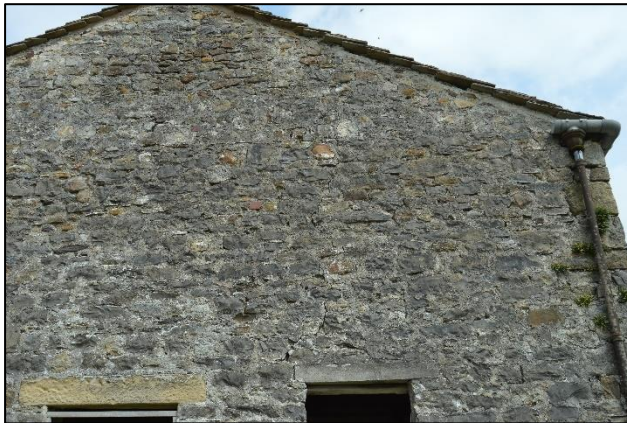
PL48: Isolated vertical cracking was noted over the east window opening to the south gable end of the south addition. The cracking was deemed to be slight (between 1mm and 5mm) to moderate (between 5mm and 15mm). A fall was also noted to the window head at this location. It is recommended that bed joint reinforcement is installed where coursing will allow i.e. stainless steel helical bars and the affected area then repointed using a lime mortar. This should then be monitored for any further evidence / re-occurrence of cracking or movement. Should any further movement / cracking occur then this will require assessment by a Structural Engineer and structural repairs undertaken as required.

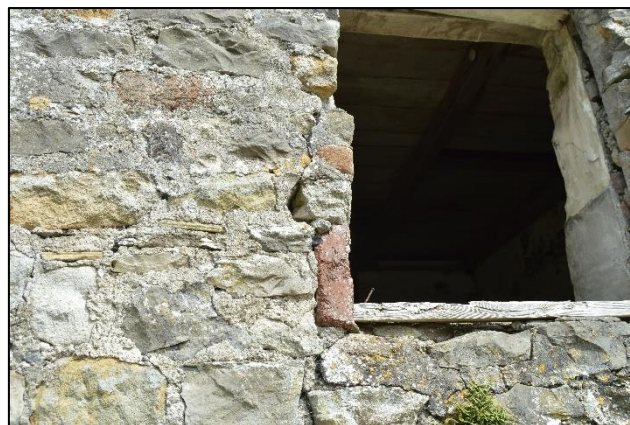
PL49: Loose / poorly consolidated masonry noted to the LHS jamb of the east window to the east window opening to the south gable end of the south addition. Making good is recommended.

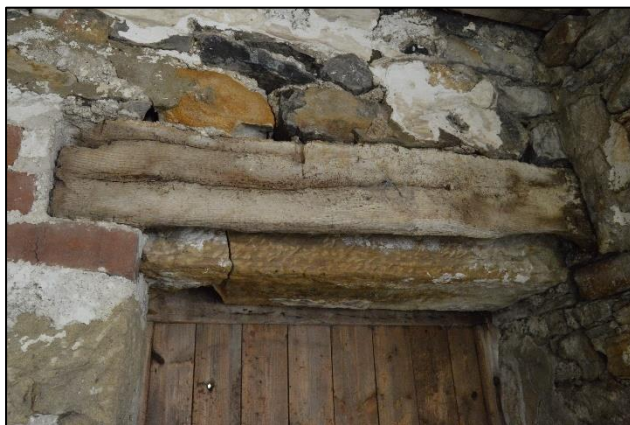
The stone lintel to the doorway at the south end of the east elevation was cracked and replacement will be required.

PL50: The stone lintel to the doorway at the south end of the east elevation was cracked and replacement will be required. The internal timber safe lintel was also noted as being slender in profile and was decayed. It also contained evidence of wood-boring insect attack and replacement of the timber lintel is also required.

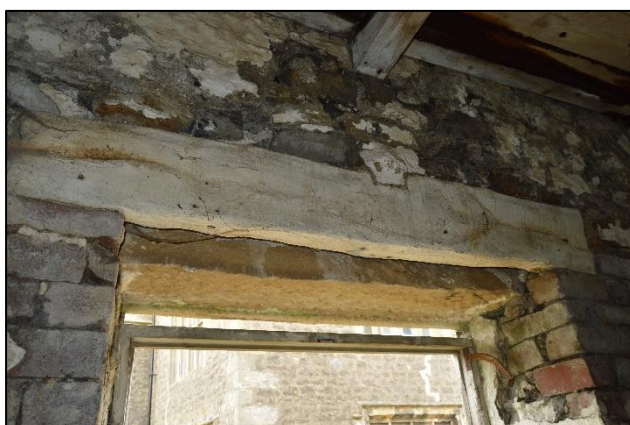
PL52: The timber safe lintel over the west opening to the opening to the ground floor of the south gable end of the south addition was noted as being slender in profile. Evidence of wood-boring insect attack was also noted, i.e. insect flight holes. It is recommended that the timber lintel is replaced.

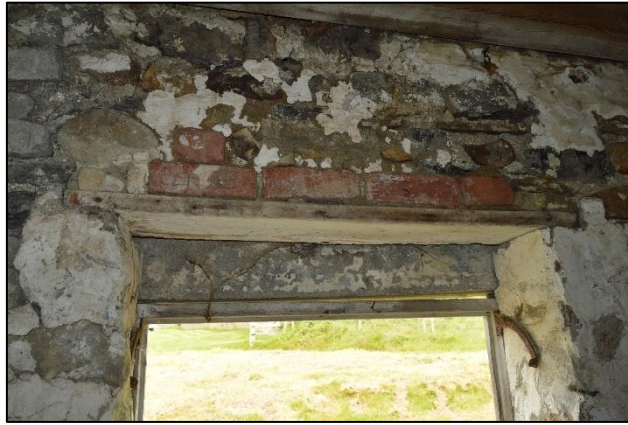
PL53: The lintel over the west opening present to the south end of the west elevation was noted as being slender with a minimal end bearing. It is recommended that the lintels are replaced with new lintels with a minimum end bearing of 150mm – 200mm.

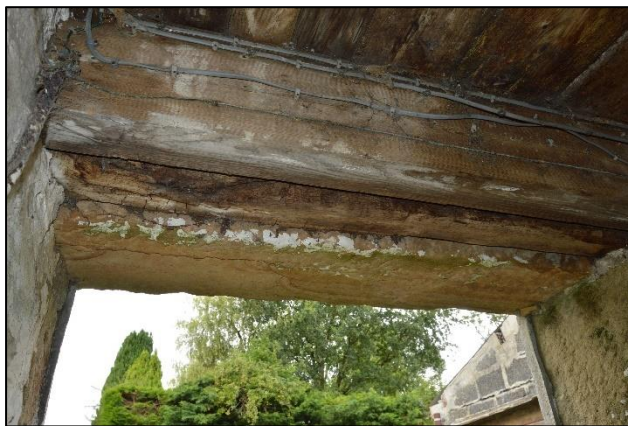
PL54: Decay was noted to the timber safe lintel located over the west elevation personnel door to the south addition. Replacement is recommended.

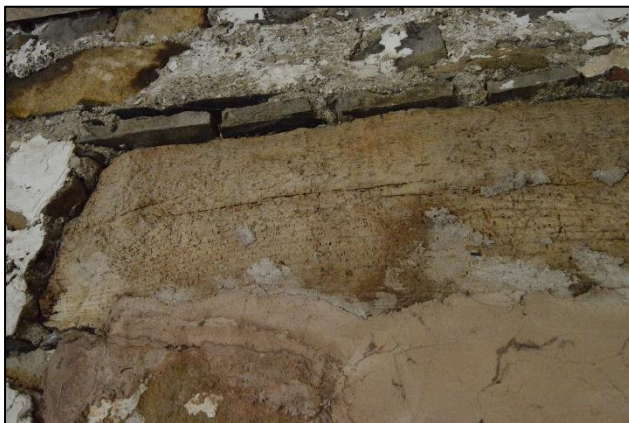
PL55: Evidence of wood-boring insect attack was noted to the internal timber safe lintel over the blocked-up door opening to the west side of the south addition, i.e. insect flight holes. It is recommended that the timber lintel is replaced.

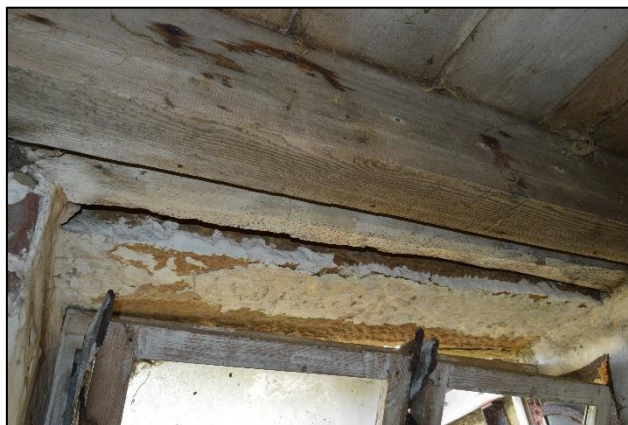
PL56: Evidence of wood-boring insect attack was noted, i.e. insect flight holes, to the timber lintel over the east elevation ground floor window of the south addition, adjacent to the west lean-to structure. It is recommended that the lintel is replaced.

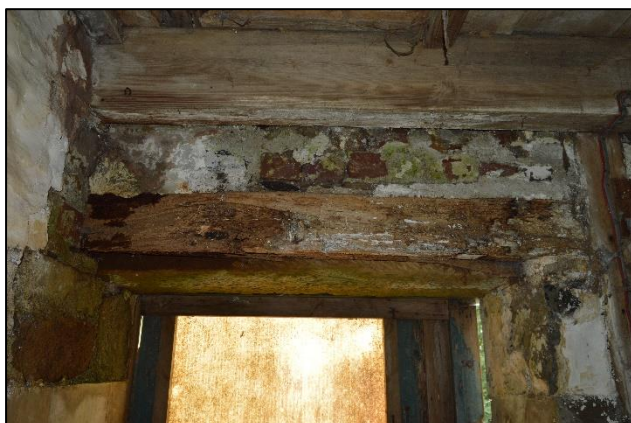
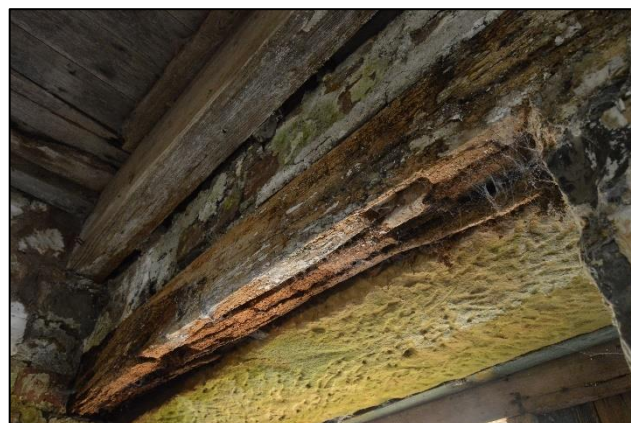
PL57: Decay was noted to the internal timber safe lintel over the external doorway to the north end of the east elevation of the south addition. It is recommended that the lintel is replaced.

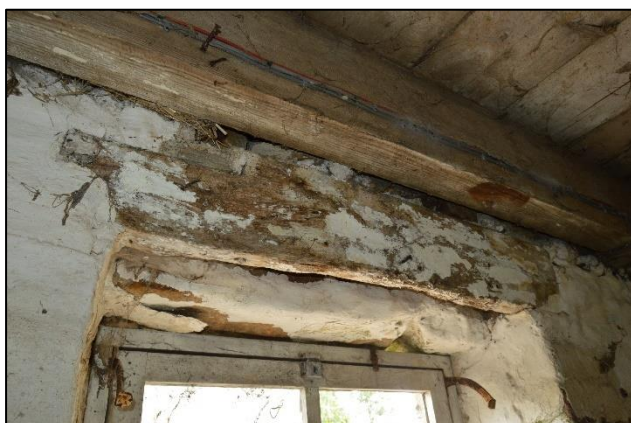
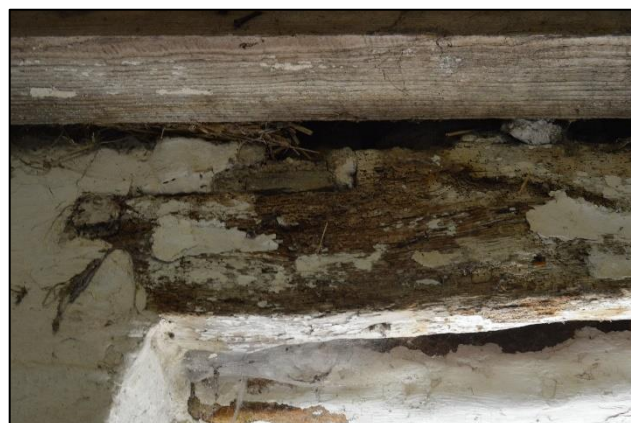
PL58: Minor decay and evidence of wood-boring insect attack was noted, i.e. insect flight holes, to the timber lintel over the ground floor window to the north end of the east elevation of the south addition, adjacent to the west lean-to structure. It is recommended that the lintel is replaced.

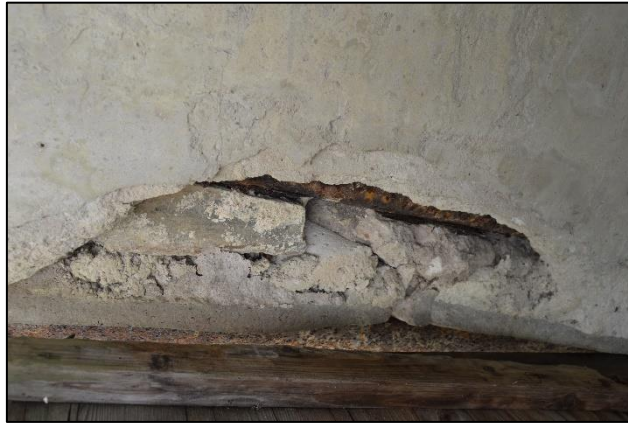
*PL59: Perished plaster was noted to the underside of the door head to the east elevation external door to the north end of the south addition. Corroded metalwork was also noted to the door head, but the nature and purpose of the metalwork could not be confirmed at the time of inspection. It is recommended that the metalwork is exposed to confirm its purpose and condition followed by remedial works.*

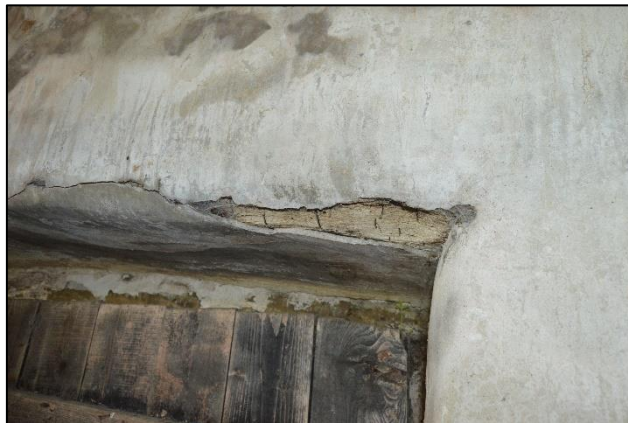
*PL60: An exposed area of timber safe lintel was noted above the external doorway to the north side of the main core of the barn. Decay was noted to the exposed area of the timber lintel and it is recommended that the lintel is exposed to assess its full condition, followed by its replacement if required.*

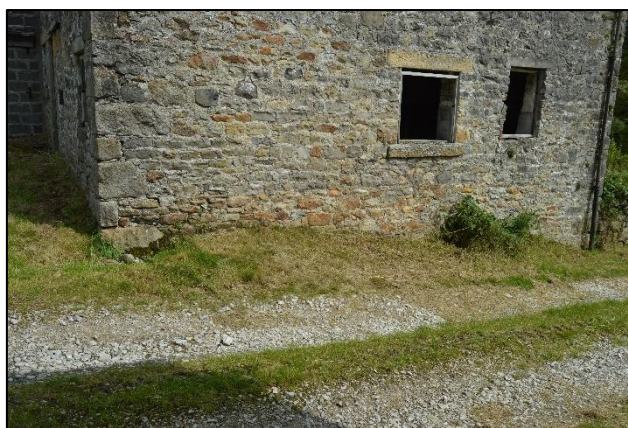
*PL62: View of raised external ground levels to the south end of the building.*

Areas where the external ground level was higher than the internal floor level were noted around the perimeter of the building. This increases the risk of penetrating dampness as was noted at the time of inspection. It is recommended that the external ground levels around the perimeter of the building are reduced to a minimum of 150mm – 200mm below the level of the proposed internal floor level to reduce the risk of penetrating dampness. This should also be combined with the addition of drainage i.e. channel drains or French / land drains to redirect surface water away from the building further reducing the risk of penetrating dampness.

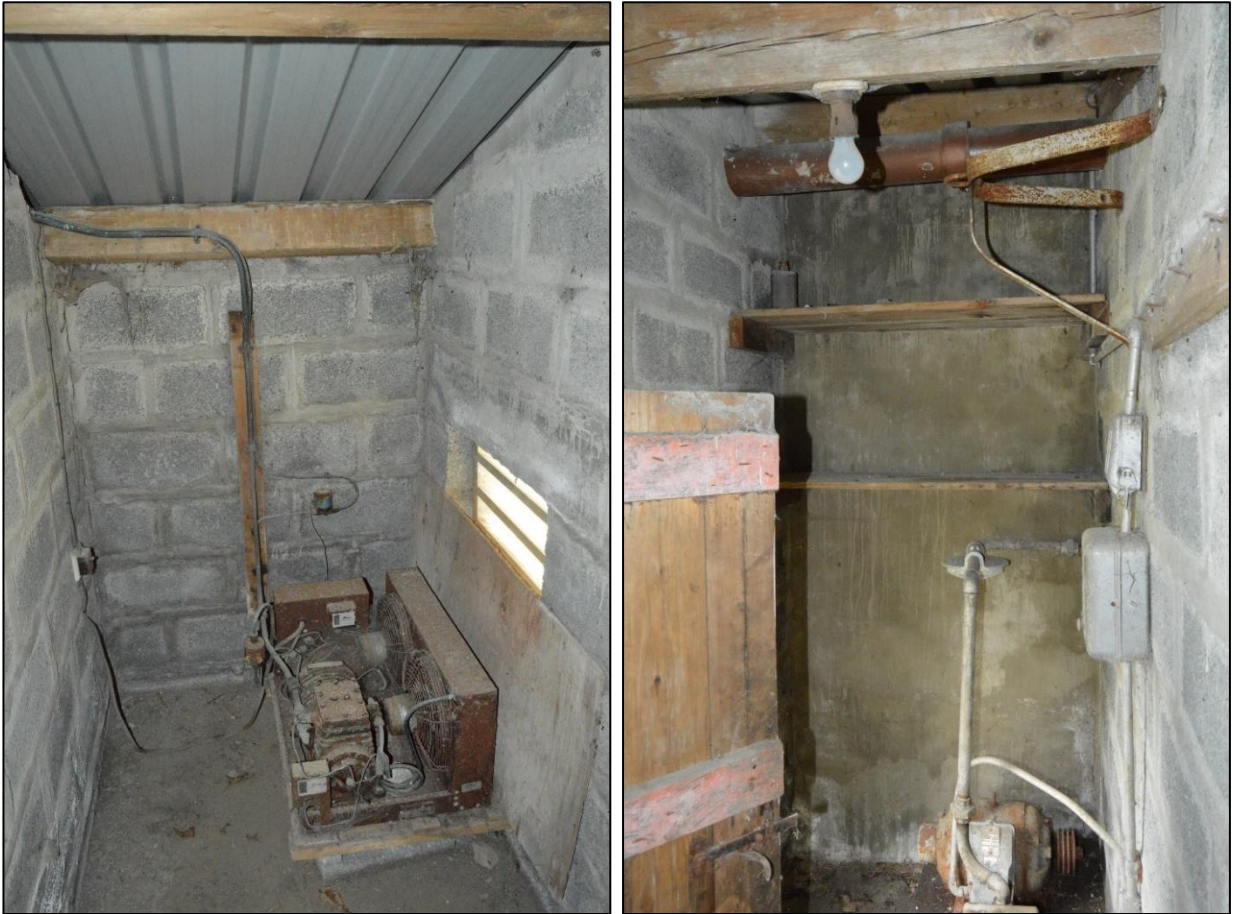
PL64: Internal views within the north unit of the west lean-to.

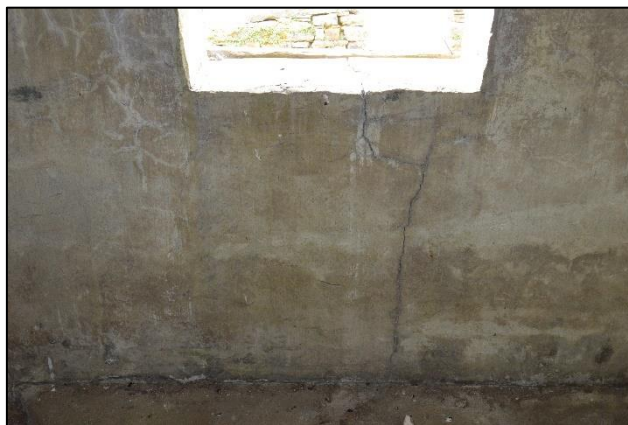
PL68: An isolated crack was noted to and below the cill to the east window of the south gable to the south addition. The cracking was deemed to be slight (between 1mm and 5mm). Cracking was also noted externally to the gable end above this particular window opening, however it could not be confirmed if this internal cracking was related at the time of inspection or if it is just superficial. Further investigations are recommended to confirm.

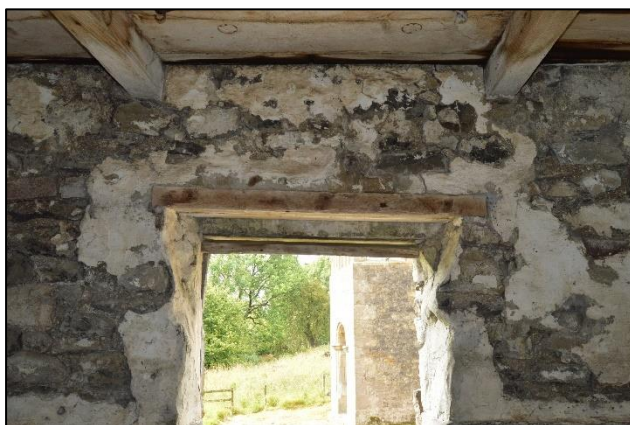
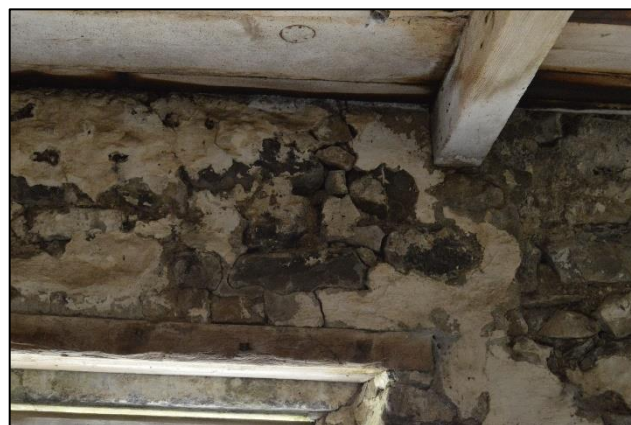
PL69: Poorly consolidated masonry was noted over the head of the east window to the south gable of the south addition. Making good is recommended to consolidate the masonry.

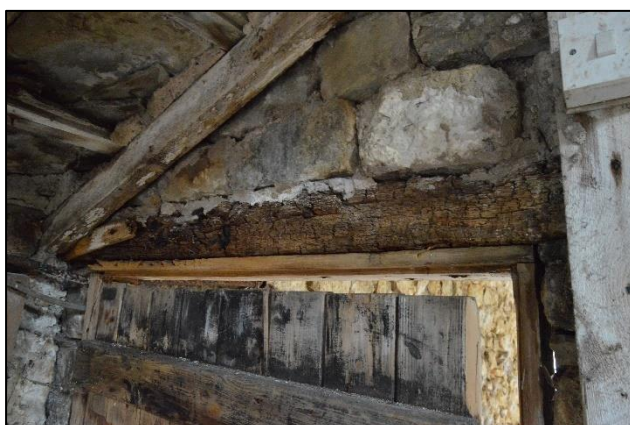
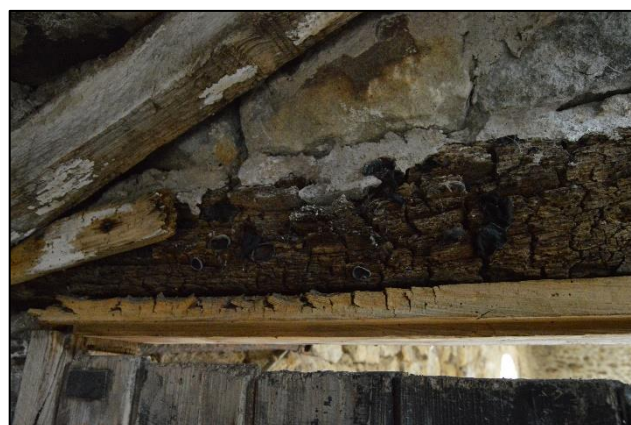
PL70: Decay and fungal growth were noted to the south timber lintel over the internal door opening between the main core of the barn and the hayloft to the south addition. Replacement is recommended.

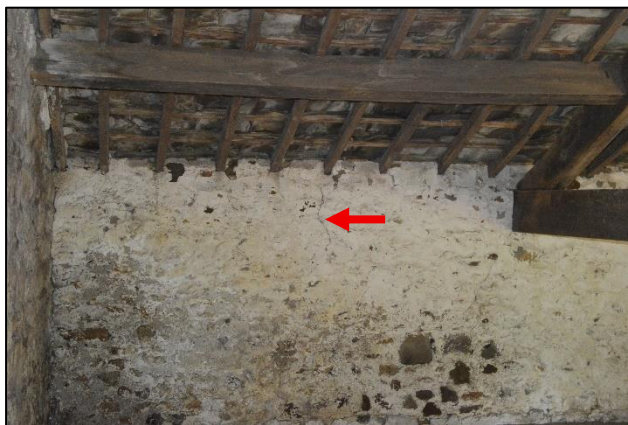
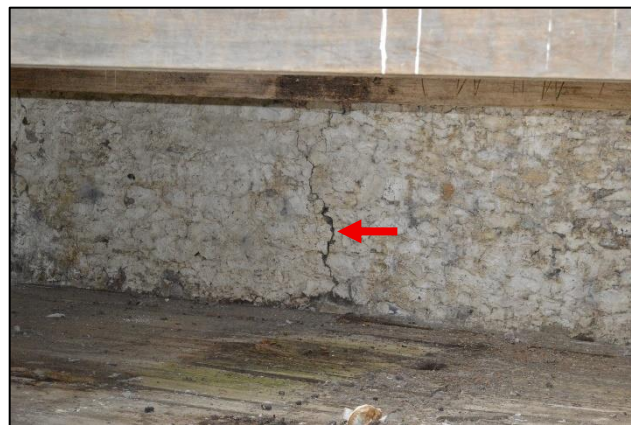
PL71: Cracking was noted at first floor level to the east wall of the south addition (left) as well as to the south gable (right). The cracking was deemed to be slight (between 1mm and 5mm) to moderate between 5mm and 15mm). Cracking was also noted externally to the gable end, however it could not be confirmed if this internal cracking was related at the time of inspection or if it is just superficial. Further investigations are recommended to confirm followed by appropriate remedial works i.e. crack stitching.

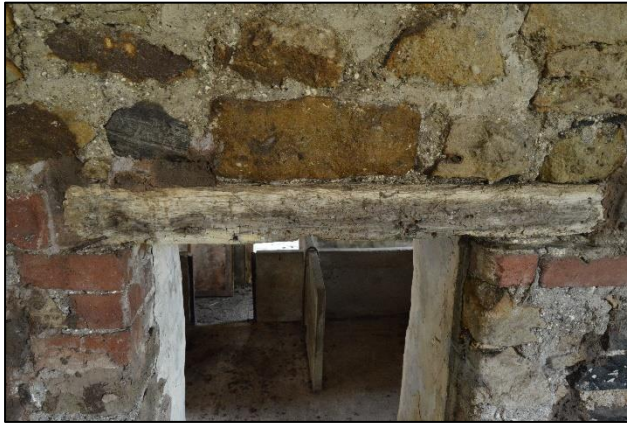
PL73: Decay and evidence of wood-boring insect attack i.e. flight holes, noted to the timber lintels over the wall opening to the north side of the main core of the barn. Replacement of the lintels is recommended.

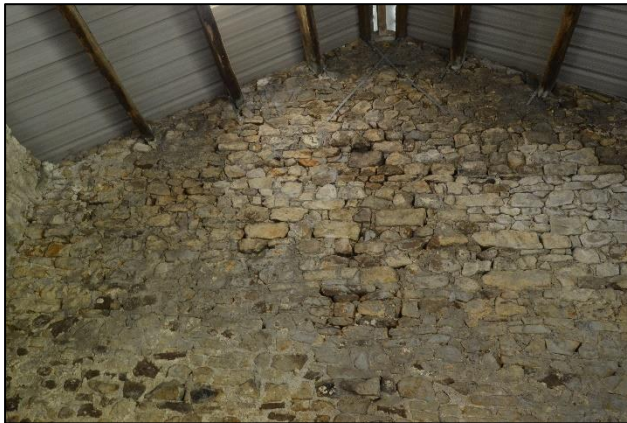
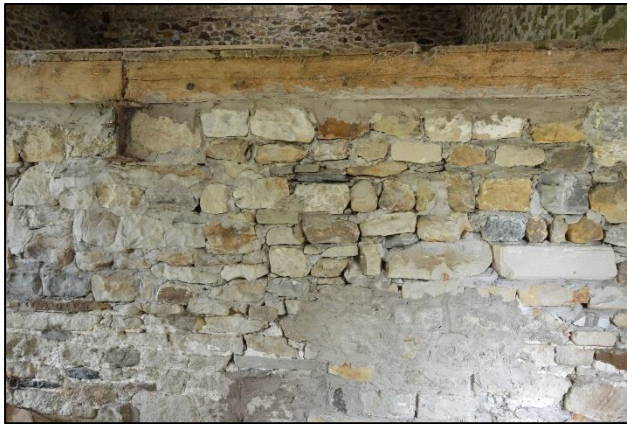
PL74: Areas of perished mortar were widely noted throughout the building and repointing using a lime based mortar is recommended. Any larger voids should be packed with mortar and gallet stones and then repointed.

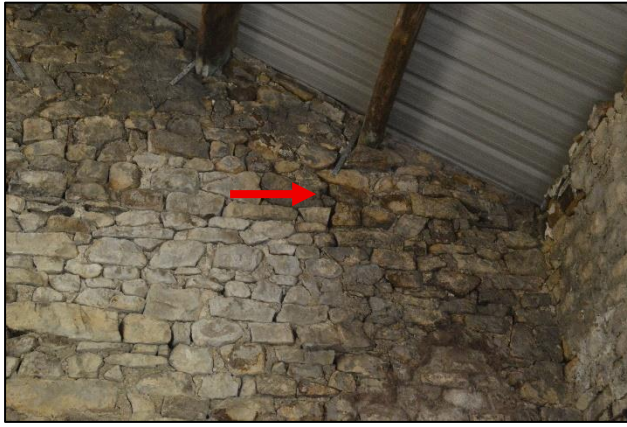
PL75: Cracking was noted internally to the south wall of the main core of the barn, above the doorway to the south hayloft and extending down the LHS of the doorway. The cracking was deemed to be slight (between 1mm and 5mm) to moderate (between 5mm and 15mm). It is recommended that bed joint reinforcement is installed where coursing will allow i.e. stainless steel helical bars, and the affected area then repointed using a lime mortar. This should then be monitored for any further evidence / re-occurrence of cracking or movement. Should any further movement / cracking occur then this will require assessment by a Structural Engineer and structural repairs undertaken as required.

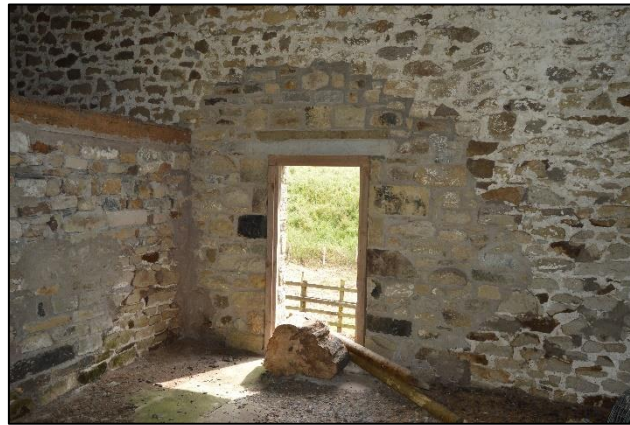
PL76: A lean / bulging was noted around the location of the former winnowing door to the east elevation of the main core of the barn. It was noted that the external walling around the former winnowing door has been rebuilt, however this does not appear to be the case to the walling directly below the opening, likely as the wall is retaining the floor behind. No obvious structural cracking was noted at this location at the time of inspection to suggest any recent / ongoing movement to this location, however it is recommended that this area is regularly monitored for any evidence of recent movement / cracking. Should any further movement / cracking occur then this will require assessment by a Structural Engineer and structural repairs undertaken as required. The stonework beneath the former winnowing door should be repointed / consolidated using a lime mortar.

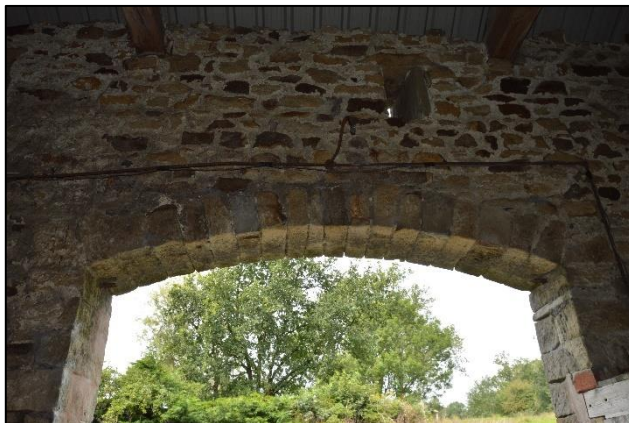
PL77: The internal faces of the stone voussoirs to the west cart entry opening appear to have decayed and have been repaired with a stone / masonry veneer. This was not considered to be significant at the time of inspection.

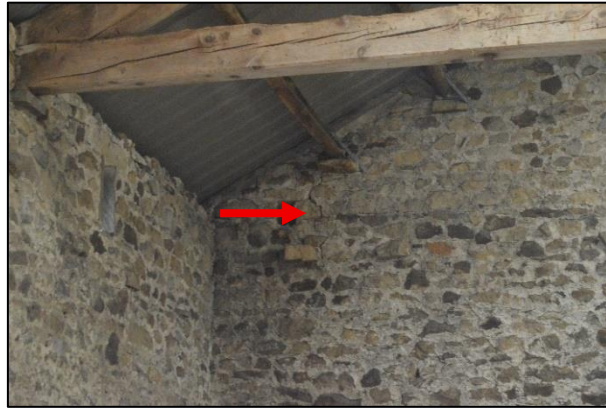
PL78: Cracking was noted internally to the north wall of the main core of the barn, below the bottom west side purlin. The cracking was deemed to be slight (between 1mm and 5mm) to moderate (between 5mm and 15mm). It is recommended that bed joint reinforcement is installed where coursing will allow i.e. stainless steel helical bars, and the affected area then repointed using a lime mortar. This should then be monitored for any further evidence / re-occurrence of cracking or movement. Should any further movement / cracking occur then this will require assessment by a Structural Engineer and structural repairs undertaken as required.

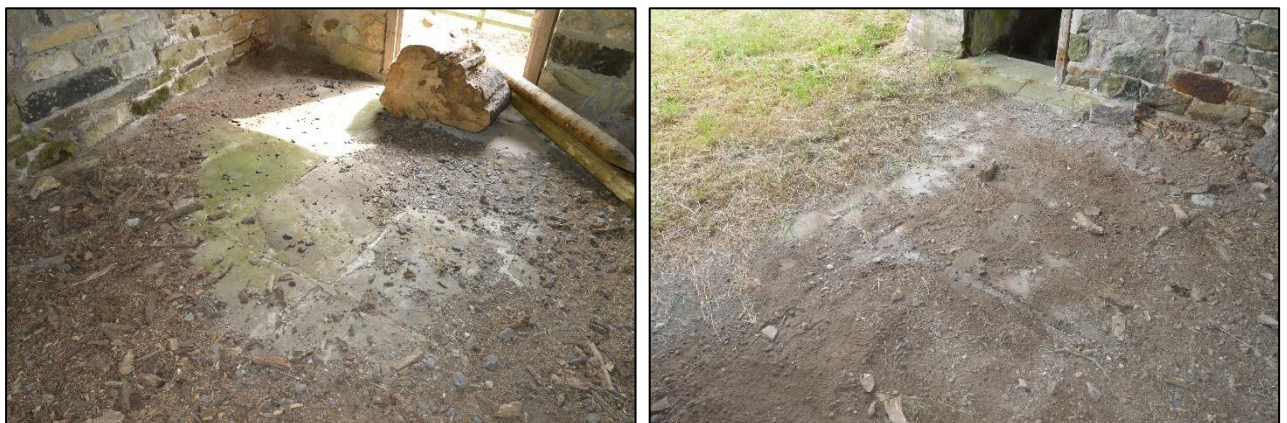
*PL80: Views of the remaining stone flag flooring present to the former threshing floor to the main core of the barn.*

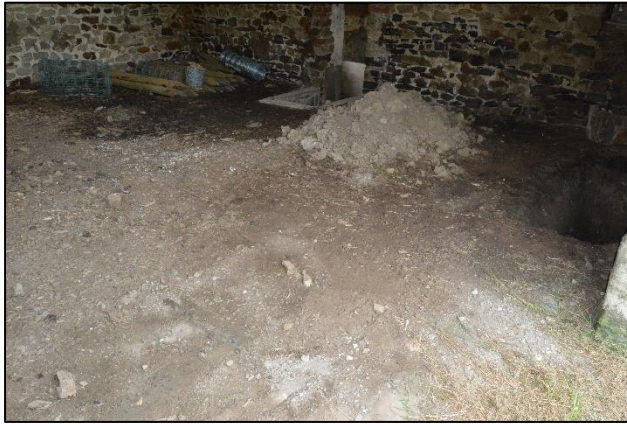
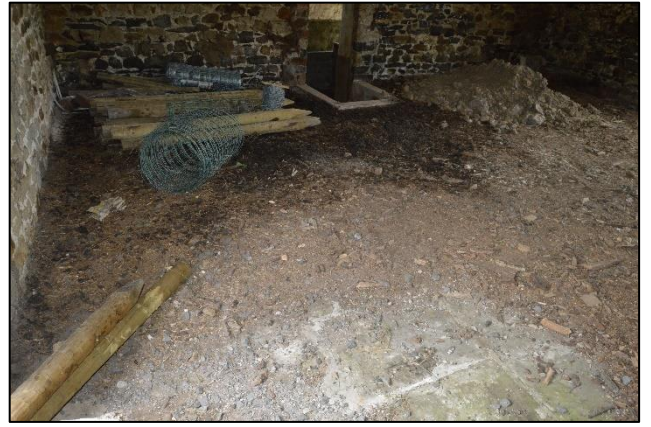
PL81: Views of the earth floor which flanks the former threshing floor to the south side of the main core of the barn.

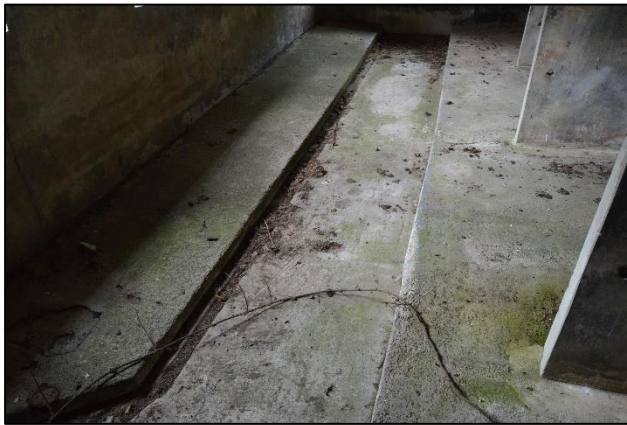
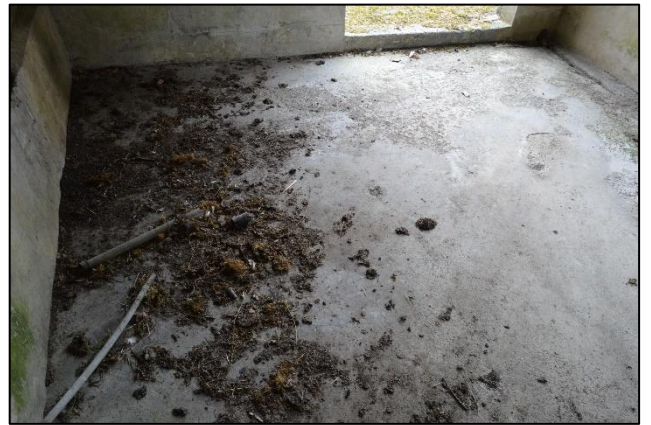
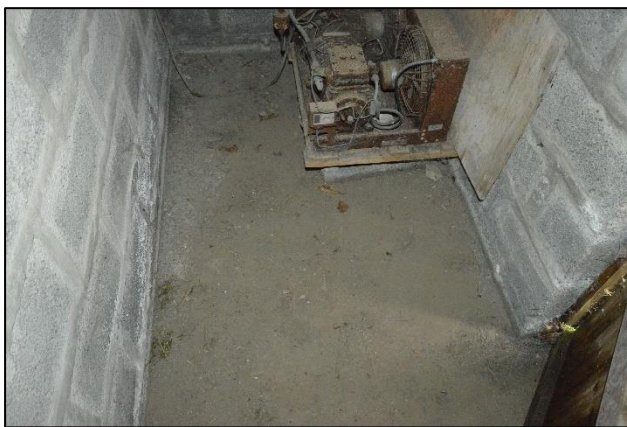
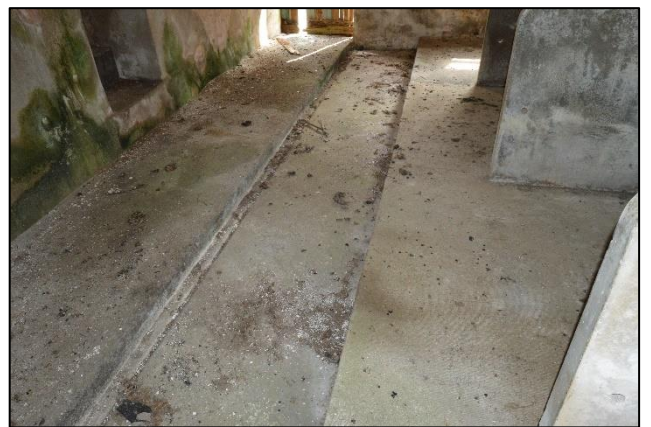
PL82: Views of various modern concrete floors present throughout the building.

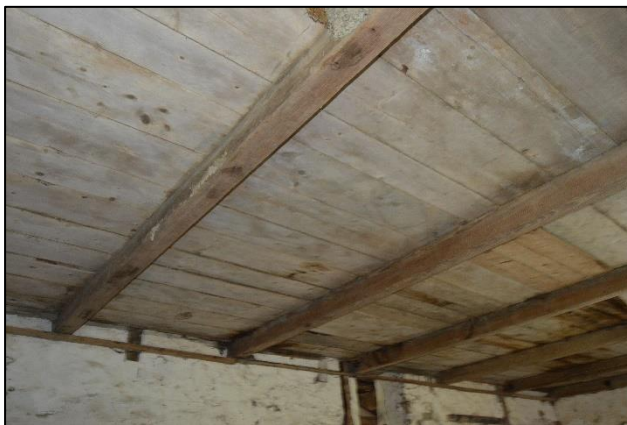
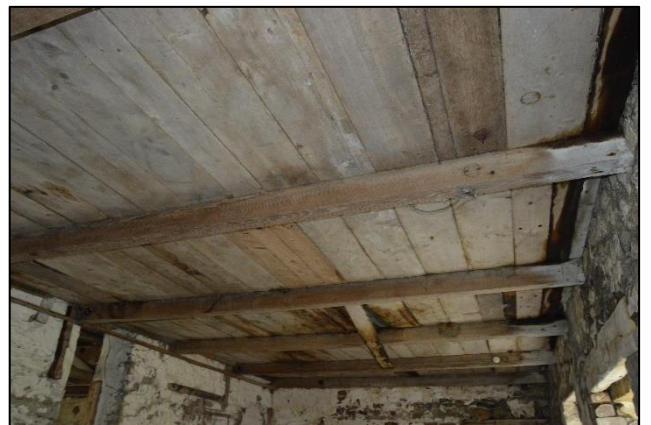
PL83: View of the suspended timber floor structure to the southern half of the south hayloft.

The hayloft structures will require removal and new suspended timber floors will be required comprised of engineered timber floor joists, capable of meeting the required spans and loadings (to the design, details, and specification of a Structural Engineer), with timber floor boarding over.

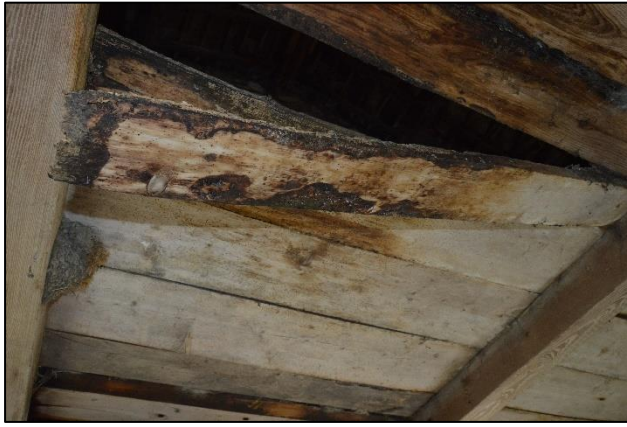
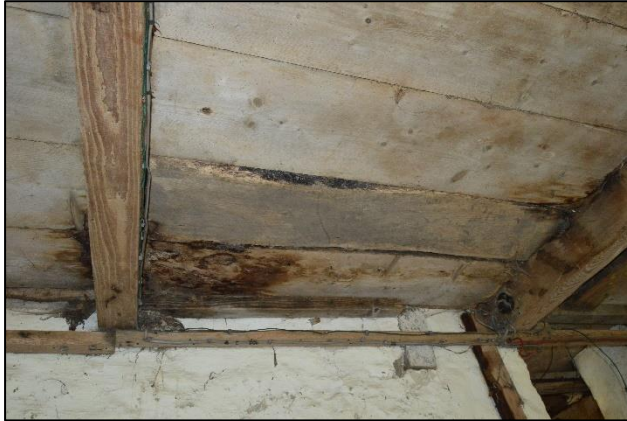
*PL84: View of areas of decayed timber floor boards present to the suspended timber floor to the southern half of the south hayloft, likely caused by past water ingress from the roofing above.*

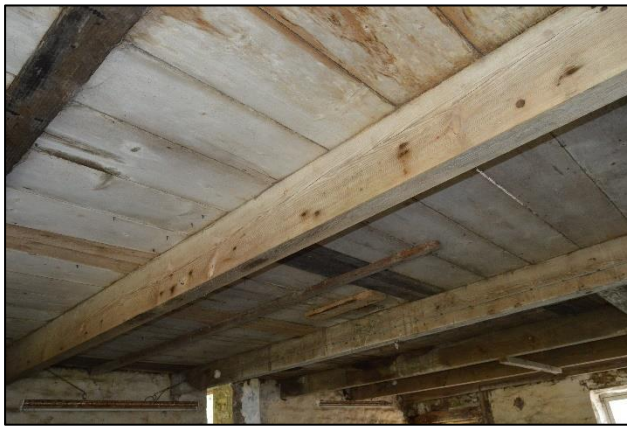
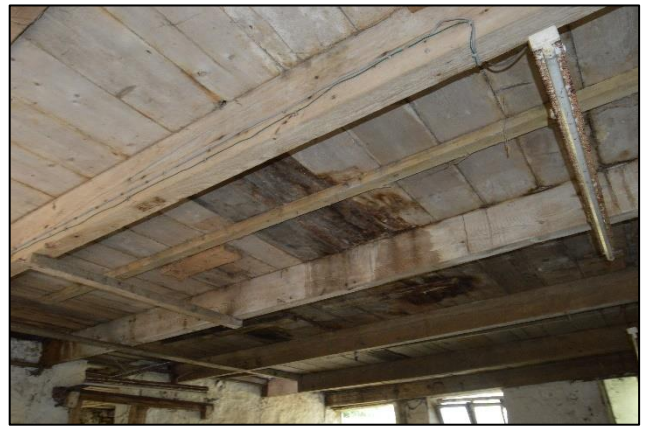
*PL85: View of the suspended timber floor to the north half of the southern hay loft.*
