# **BUILDING (STRUCTURAL) CONDITION SURVEY**

PROPOSED CONVERSION OF EXISTING BARN AT

FOODEN HALL FARM

GISBURN ROAD

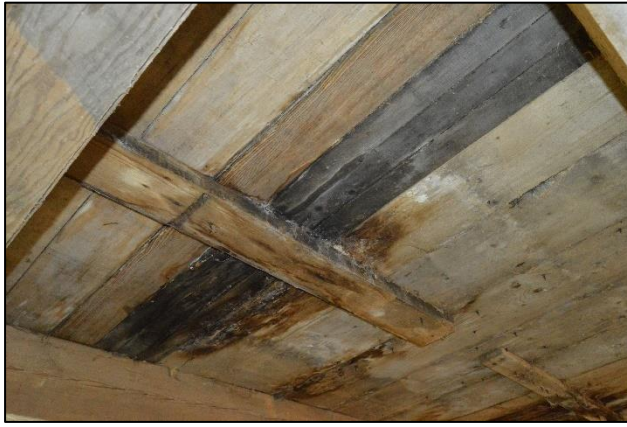
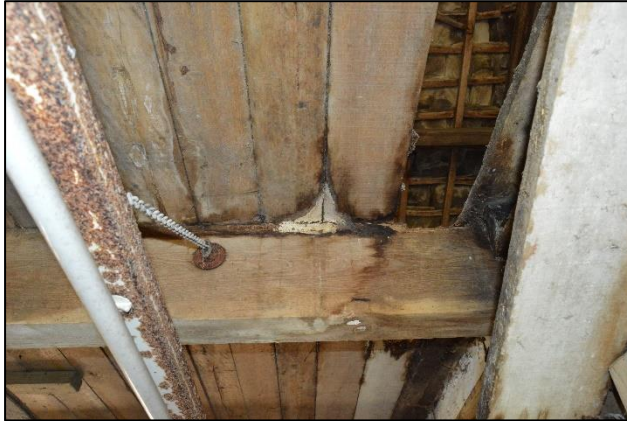
PL86: View of areas of decayed timber floor boards present to the suspended timber floor to the northern half of the south hayloft.

The hayloft structures will require removal and new suspended timber floors will be required comprised of engineered timber floor joists, capable of meeting the required spans and loadings (to the design, details, and specification of a Structural Engineer), with timber floor boarding over.

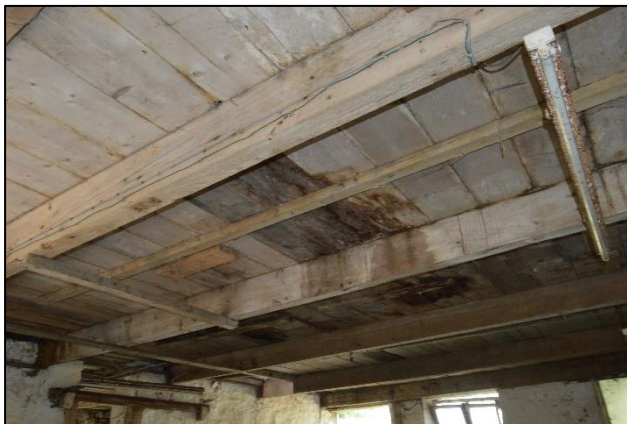
PL87: View of staining noted to isolated floor joists to the northern half of the south hay loft.

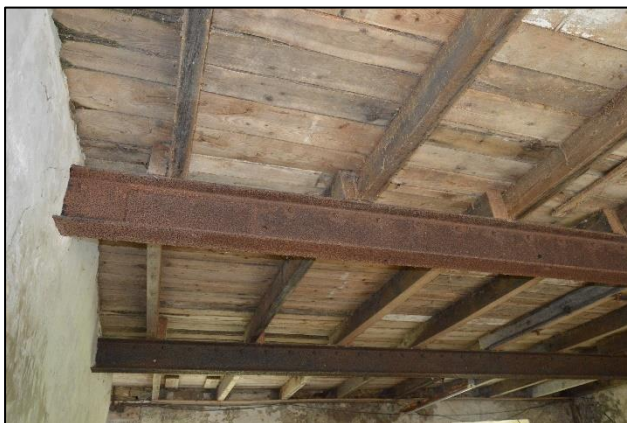
The steel beams to the north hayloft were heavily rusted and will require removal to facility the installation of a new floor structure over the hayloft.

PL88: View of the suspended timber floor structure and steel supporting beams to the north hay loft, likely caused by past water ingress from the roofing above.

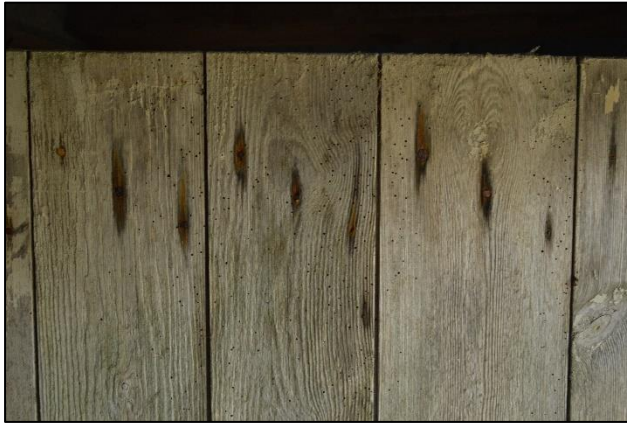
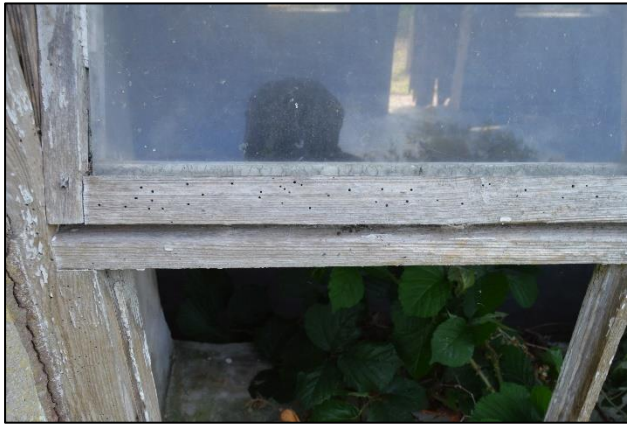
Evidence of woodboring insect attack i.e. insect flight holes, was also widespread throughout the internal and external joinery of the building. However, it could not be confirmed if there was any active infestation to the affected timber items and further investigations are recommended to confirm.

PL90: Evidence of insect attack i.e. insect flight holes and decay noted to joinery items.

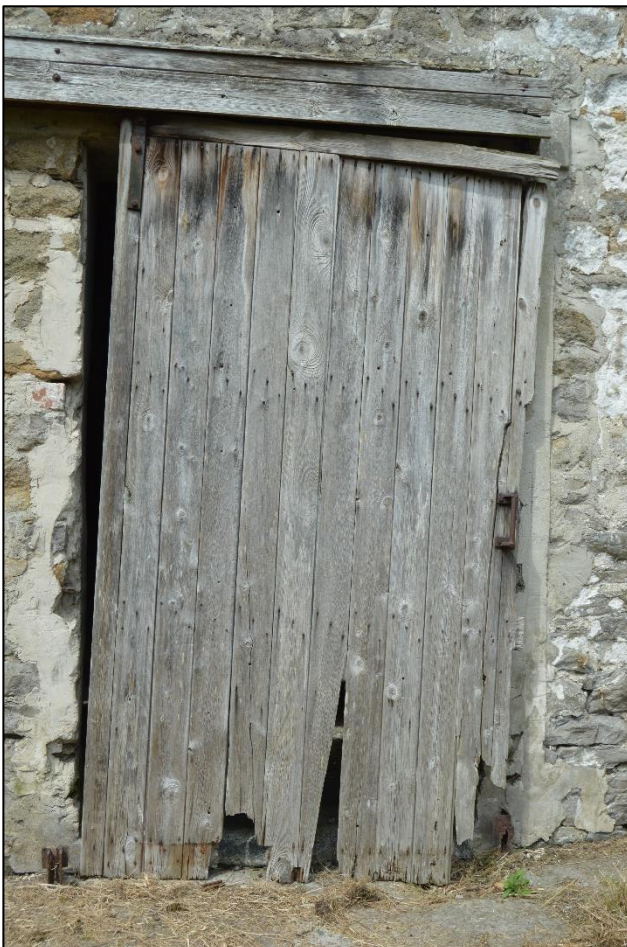
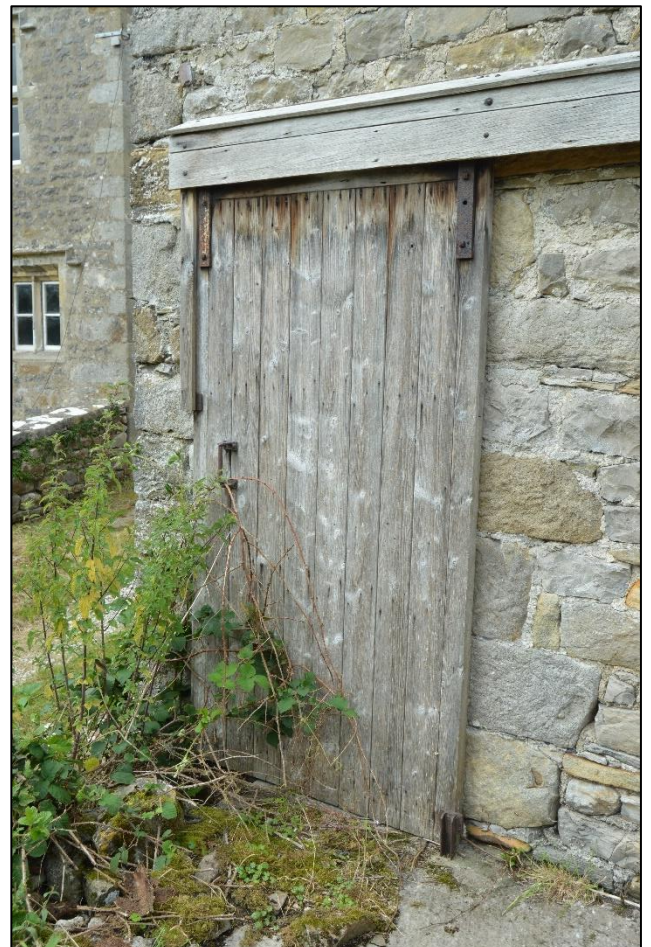
The existing windows and internal / external doors were in poor condition at the time of inspection. Damage and decay to existing joinery appeared to be widespread along with missing and damaged glazing panes to windows.

PL91: Examples of external timber doors present to the building at the time of inspection.

As part of the conversion, it is recommended that new timber windows and doors are installed with double glazing in order to improve the energy efficiency of the building.

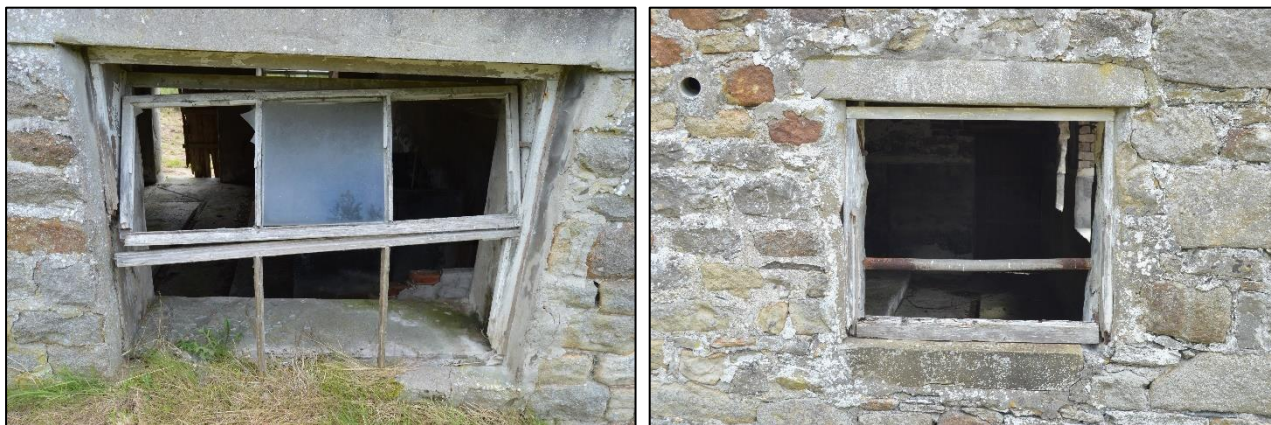
PL92: Examples of windows present to the building at the time of inspection.

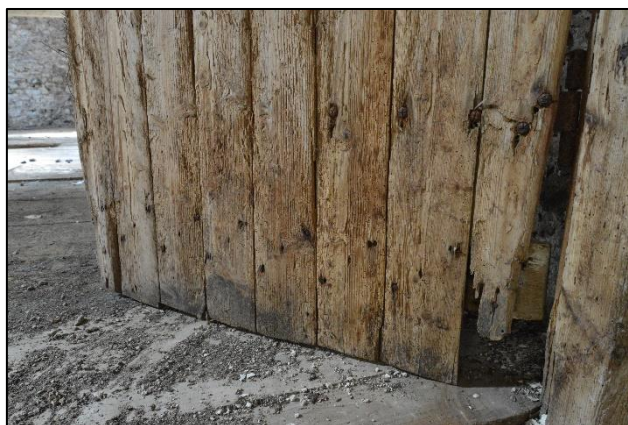
PL93: Evidence of decay and insect attack noted to the internal door to the south hay loft.
