# Preliminary Roost Assessment

13 Brookside  
Old Langho  
Blackburn  
BB6 8AP

## Gritstone Ecology

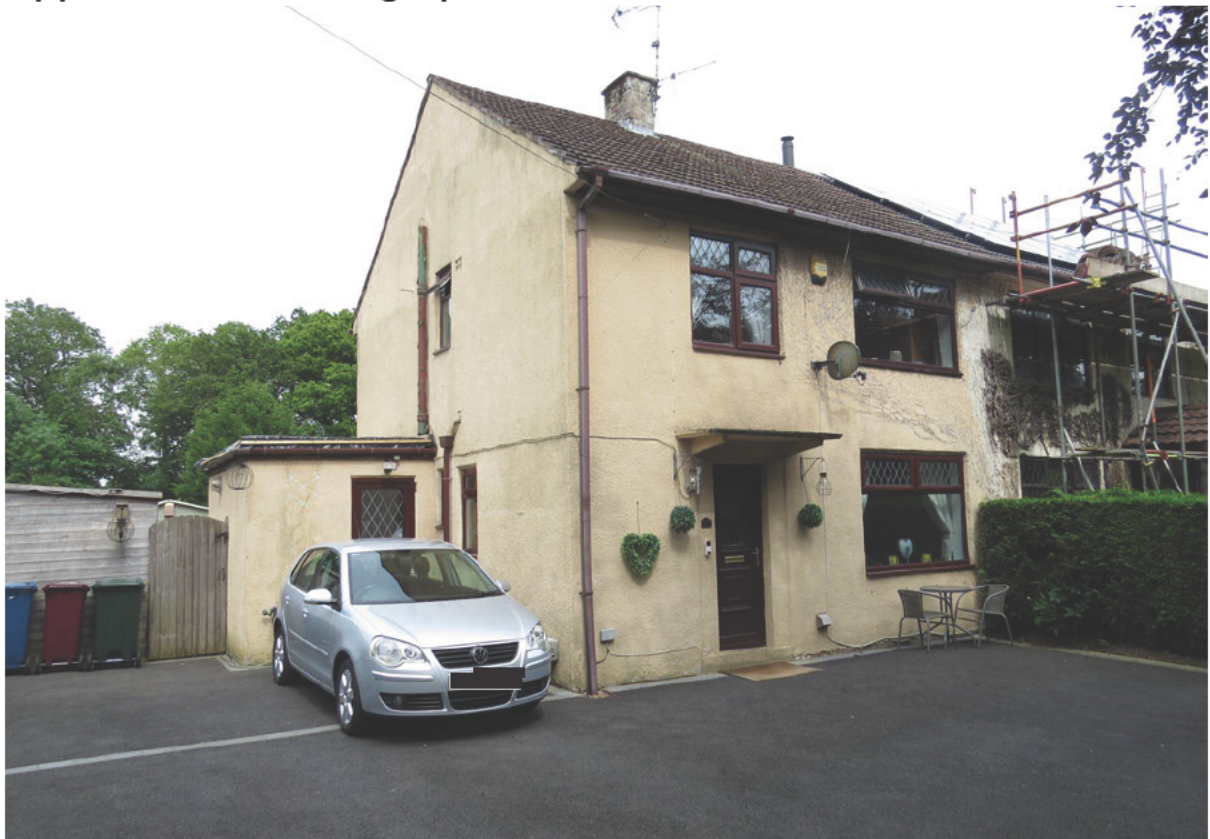
The building is well maintained, and in good condition. Ridge tiles are fixed tightly, there are no damaged or missing ridge tiles. There are no damaged, slipped, or missing roof tiles. Roof tiles are tightly fitted, with no gaps between tiles. End tiles at the verges are sealed with cement. Fascia boards and boxed soffits are fitted tightly against the walls with no viable gaps. Walls and render are in good condition, with no missing mortar or cracks.

Roof and ridge tiles are in good condition; ridge tiles are sealed with cement, end tiles at the verges are sealed with cement. There are no gaps between roofing materials which could be used by roosting bats.

Walls are brick with an insulating cavity, covered with a painted cement render. Walls and render are in good condition, with no cracks, or missing mortar which could be used by crevice dwelling bats.

1 – The front of the house.

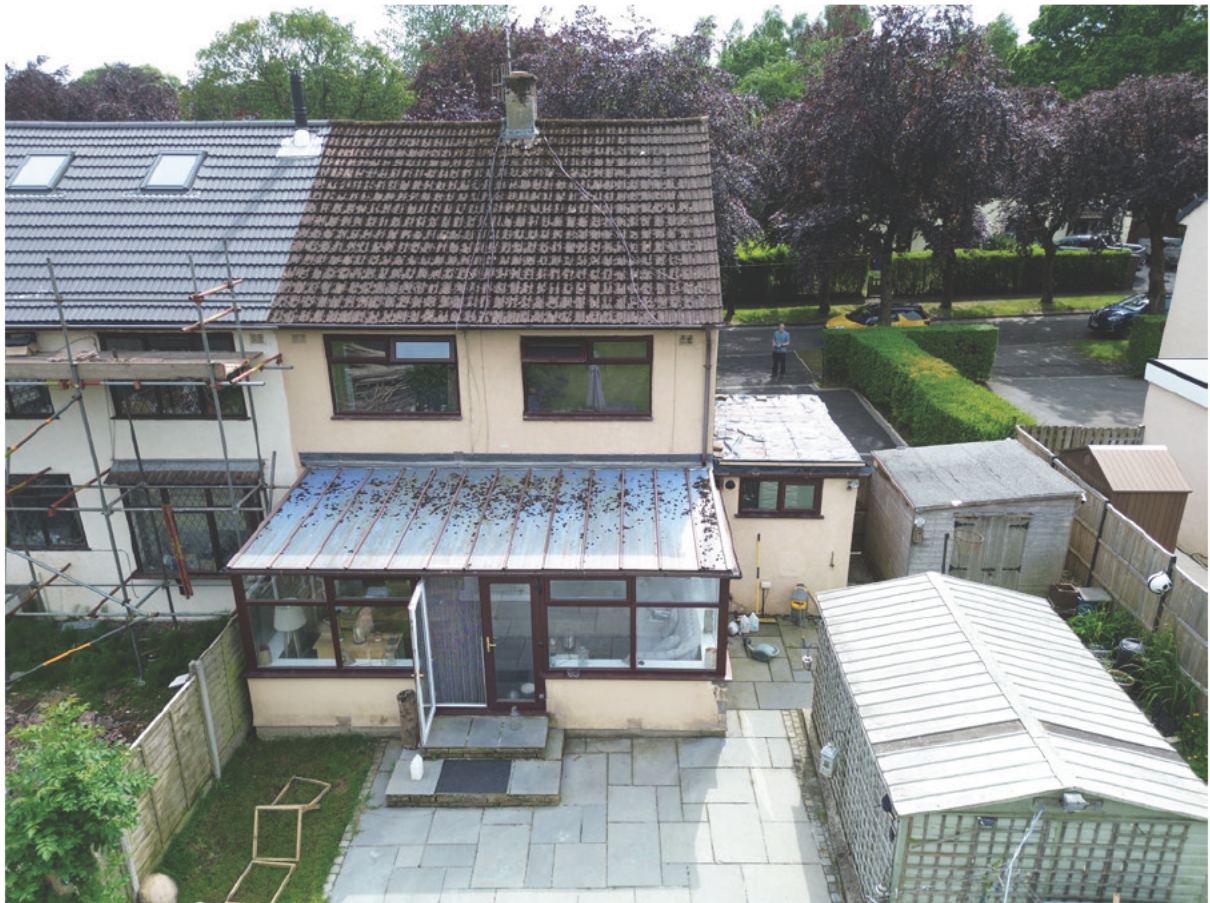
2 – The rear of the house.
