Structural Appraisal

Listed Barn & Outbuildings

Home Farm, Chatburn Road, Downham

Blackett-Ord Conservation Engineering

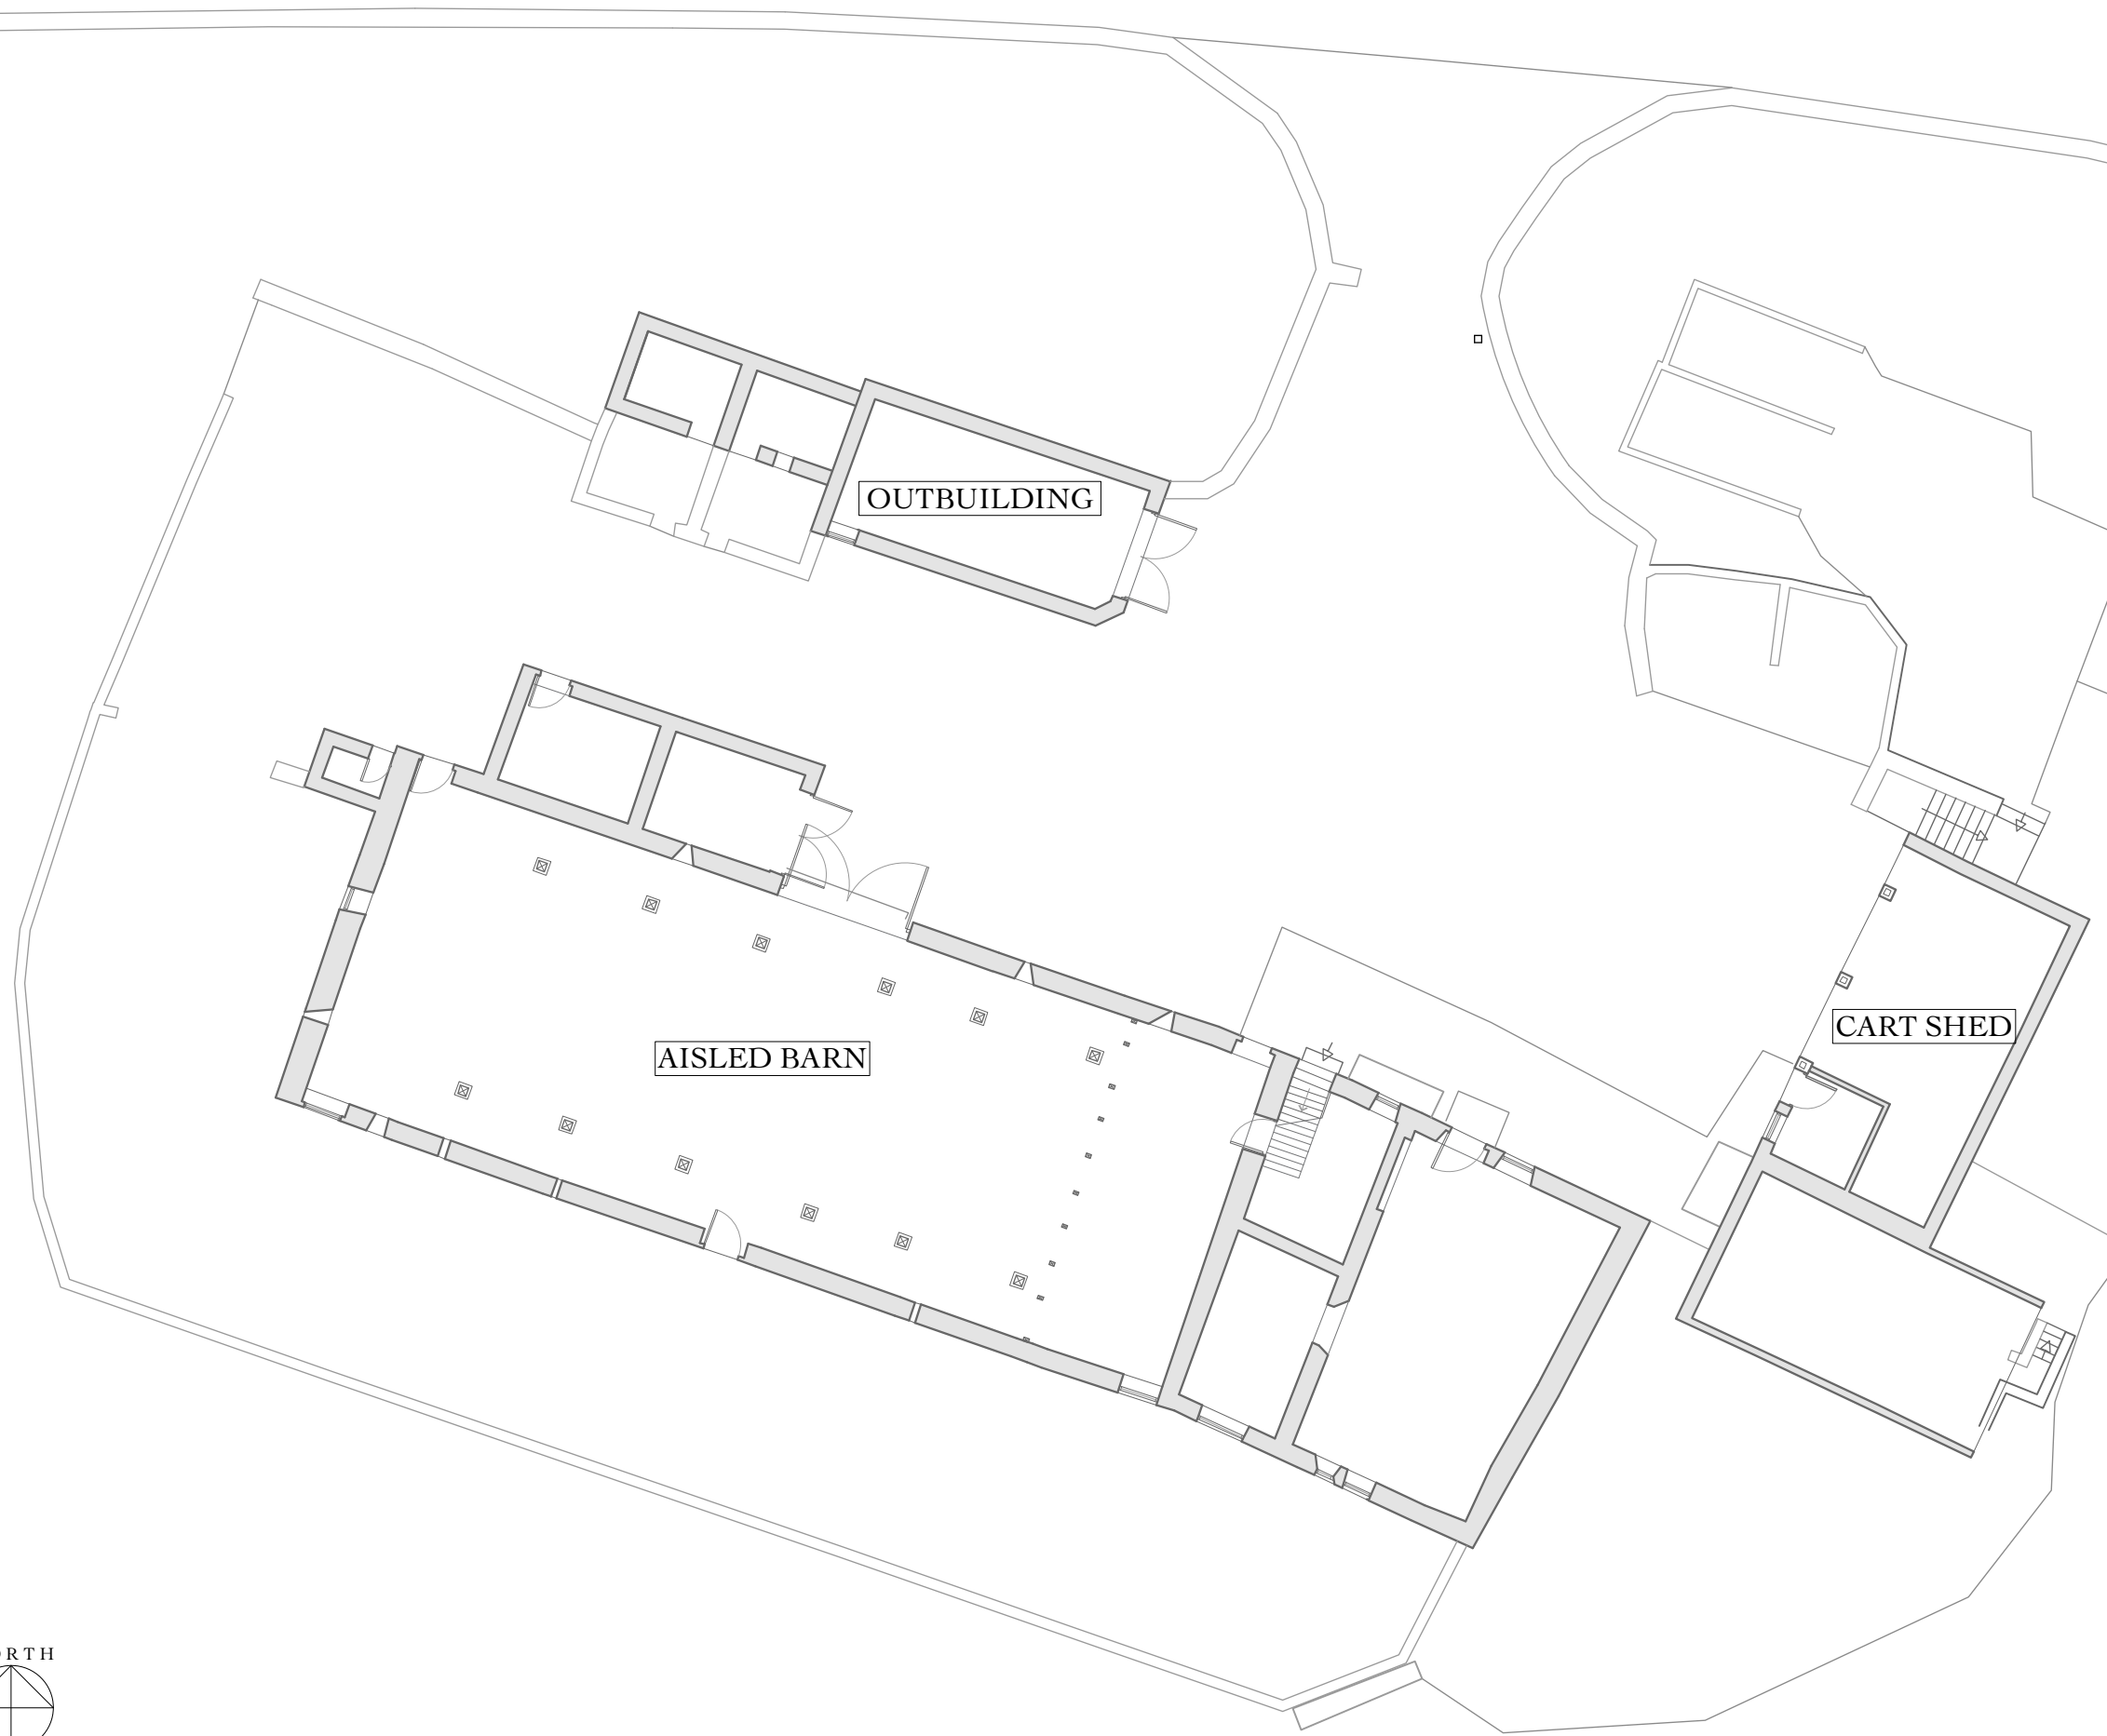
CONDITION SURVEY

1. Additional pieces of timber fixed at top of the frame posts. Condition underneath unknown.
2. Original purlins have previously been replaced with softwood. Lower purlins are double stacked - single purlins only in bays 1, 3 & 4 south side, and bays 1 & 7 north side.
3. Evidence of historic woodworm decay in timber posts, approximate 25mm loss of section.
4. Water ingress on upper purlins under roof lights
5. Majority of rainwater goods are missing.
6. No below ground drainage provision.
