**The Barn, Springwood,  
Hurst Green**

**Level 2-3 Historic  
Building Recording**

AB Heritage Project No: 63086

Date: 27/02/2026

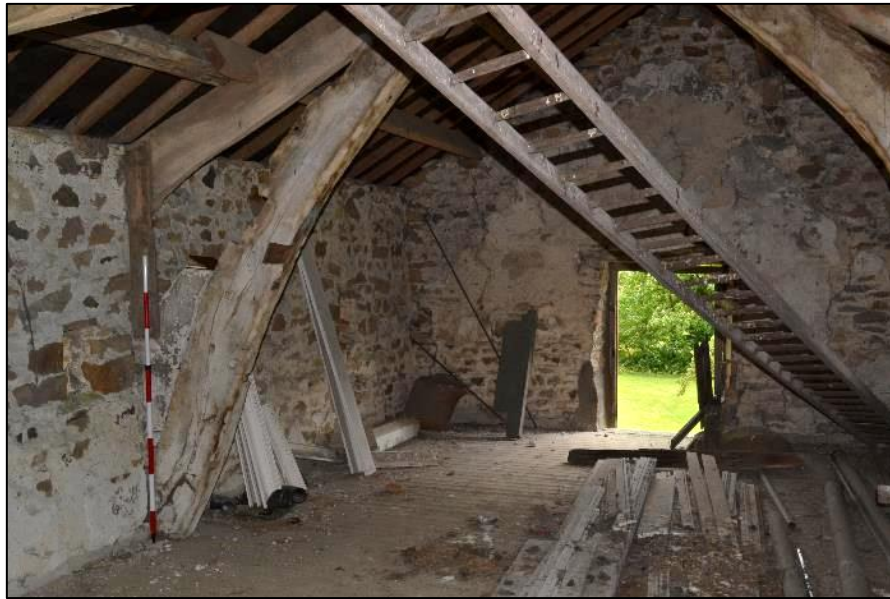
**Plate 18. General shot first floor. Looking east (scale 1.6m)**

- 4.2.31 The floor is close set, regular timber boards, probably of 20<sup>th</sup> century origin.
- 4.2.32 The most remarkable feature on the first floor is the roof structure. This is mainly comprised of substantial, modern, machine cut timbers, but they support two pairs of original timber roof crucks which are in turn supported by the transverse joists seen on the ground floor. With the exception of a single member, the purlins are machine cut modern timbers. Tie beams appear to be modern. Plates 18 to 20 give a broad view of the roof timbers.

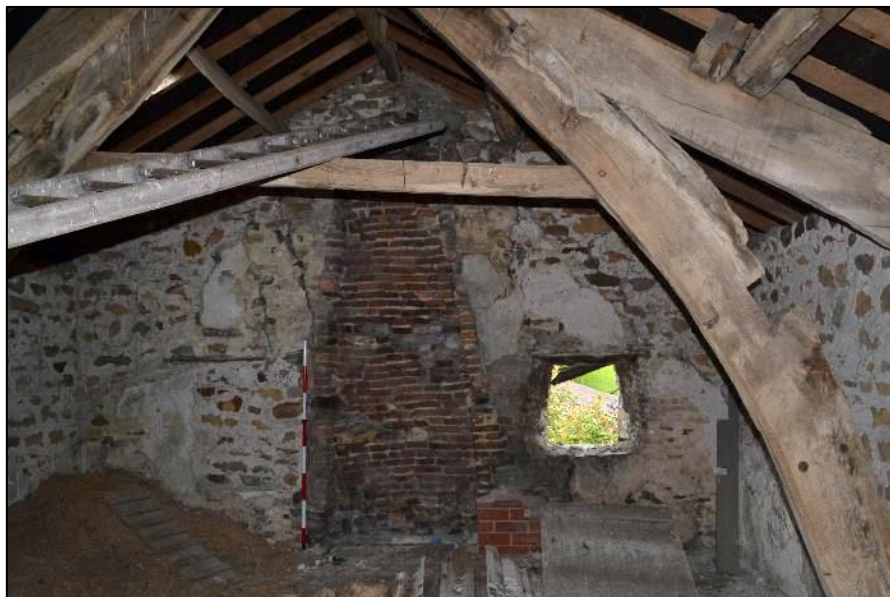
**Plate 19. General shot first floor. Looking west (scale 1.6m)**

- 4.2.30 There are only a few features to note on the first floor. The first is the brick chimney flue that has been constructed into the walls of the west elevation (Plates 12 & 19). The flue is handmade red bricks, and it appears conical in cross section which is how it survives. This feature is curious, and it certainly predates the raising of the roof as there is stone work above the bricks on Plate 19. It is possible that the chimney flue indicates a pre-industrial dairy function for the Barn, where small hearths were used in the creaming and sterilisation process. Alternatively, the flue may be the remains of a domestic smithing forge or even a small malting kiln. Whatever the true function, this feature appears suspiciously free of soot and scorching.

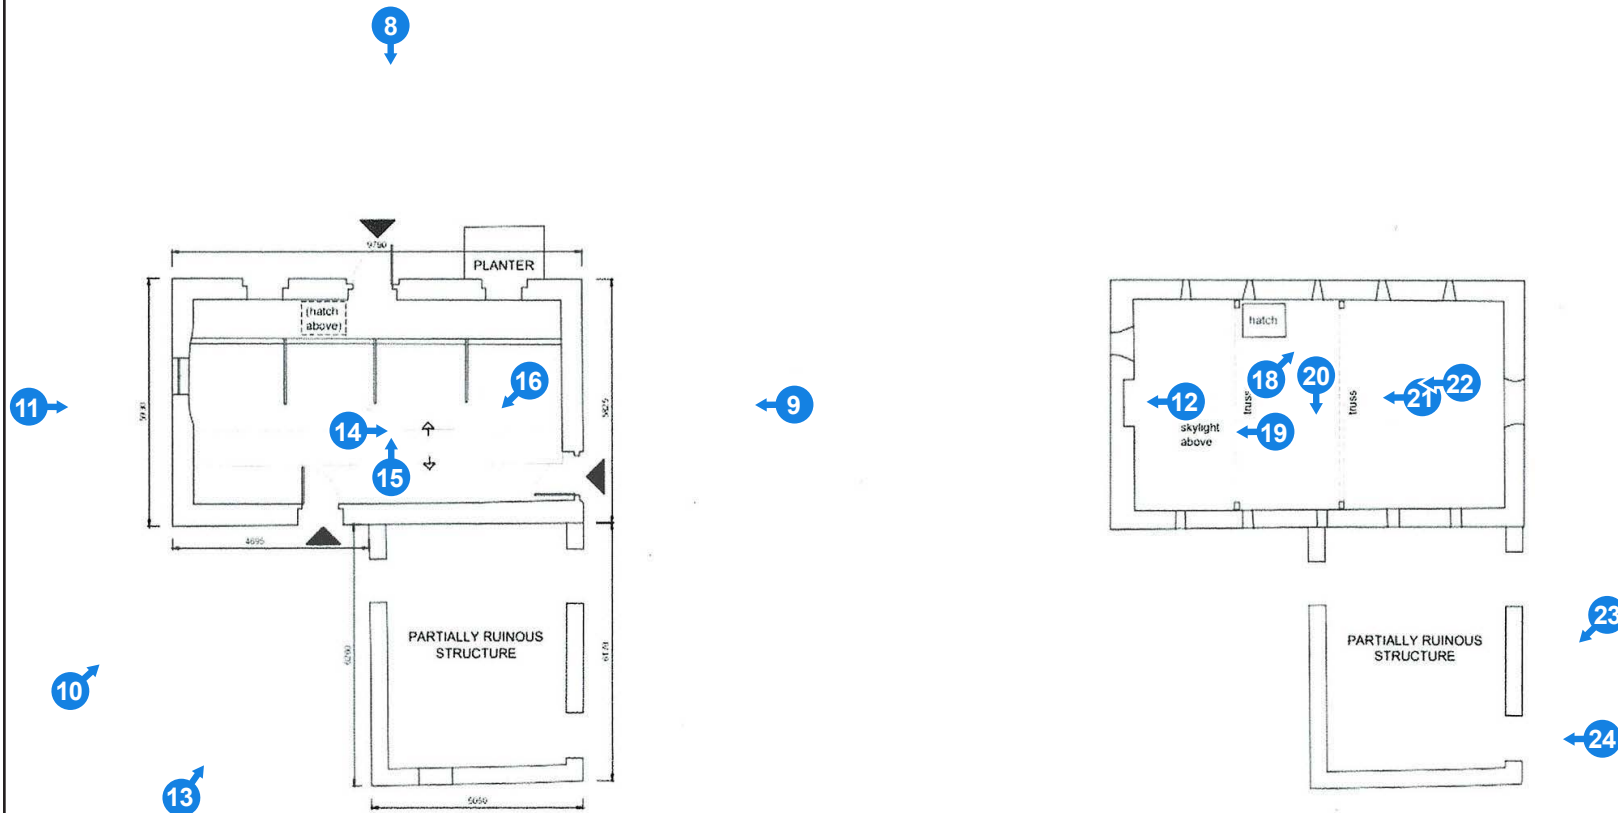
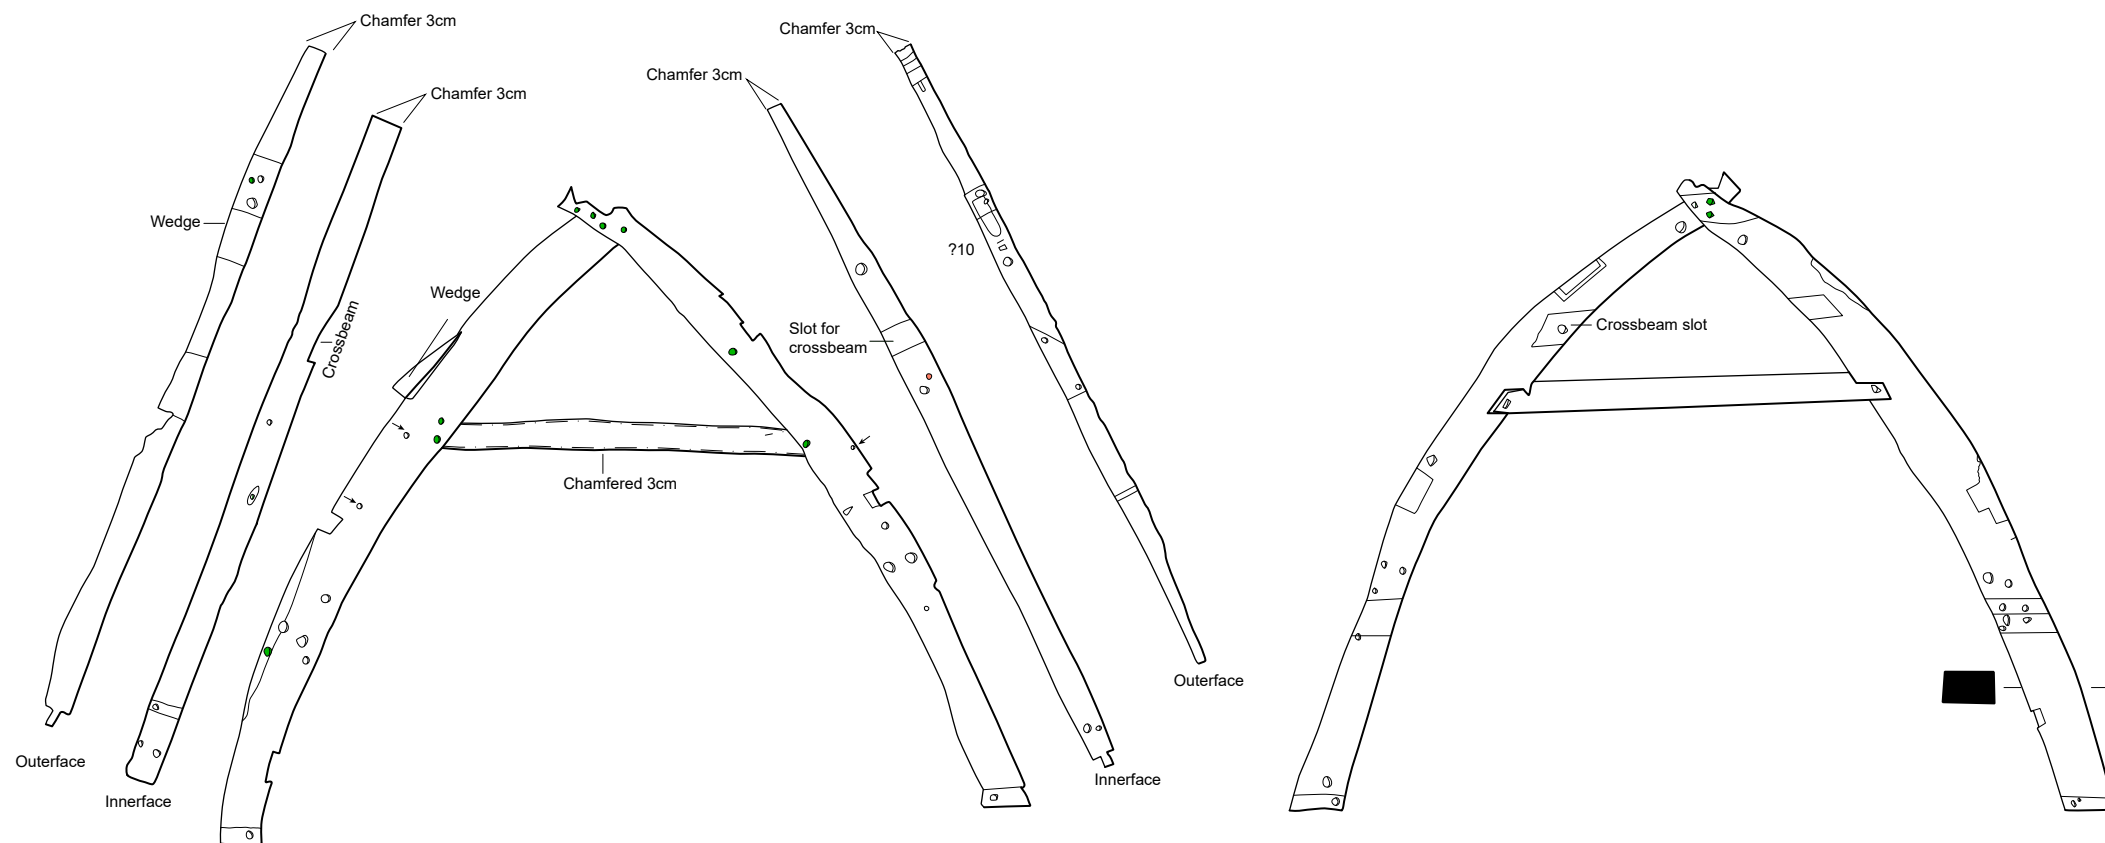
Figure 5: Cruck 1

Currently, the roof is a mostly modern superstructure, recently re-covered with slates (probably re-used). The existing original timbers, comprising two cross beams, and two pairs of roof crucks are in a very poor state of preservation, being badly affected by rot and woodworm infestation. They are likely not functional as weight bearing members, with modern timbers taking the weight of the roof. This report includes scale drawing of the crucks, made when the timbers were removed from the barn.

- 4.2.33 Plates 21 & 22 below show in some detail the original crucks, including how they are pegged at the apex and how the purlins run along the backs of the crucks. Scale drawings of the crucks are provided as Figures 5 & 6; the crucks were drawn in 2025, after they had been removed from the Barn. The crucks would each have originally included two stabilising collar beams, and each has a notch on the outer face that would have held a purlin.
