## **Barn at Cowley Brook Farm, Higher Road, Longridge, PR3 2YX**

### **Structural Condition Survey for Conversion to form Extension to Dwelling**

PSC-1073-CA

April 2026

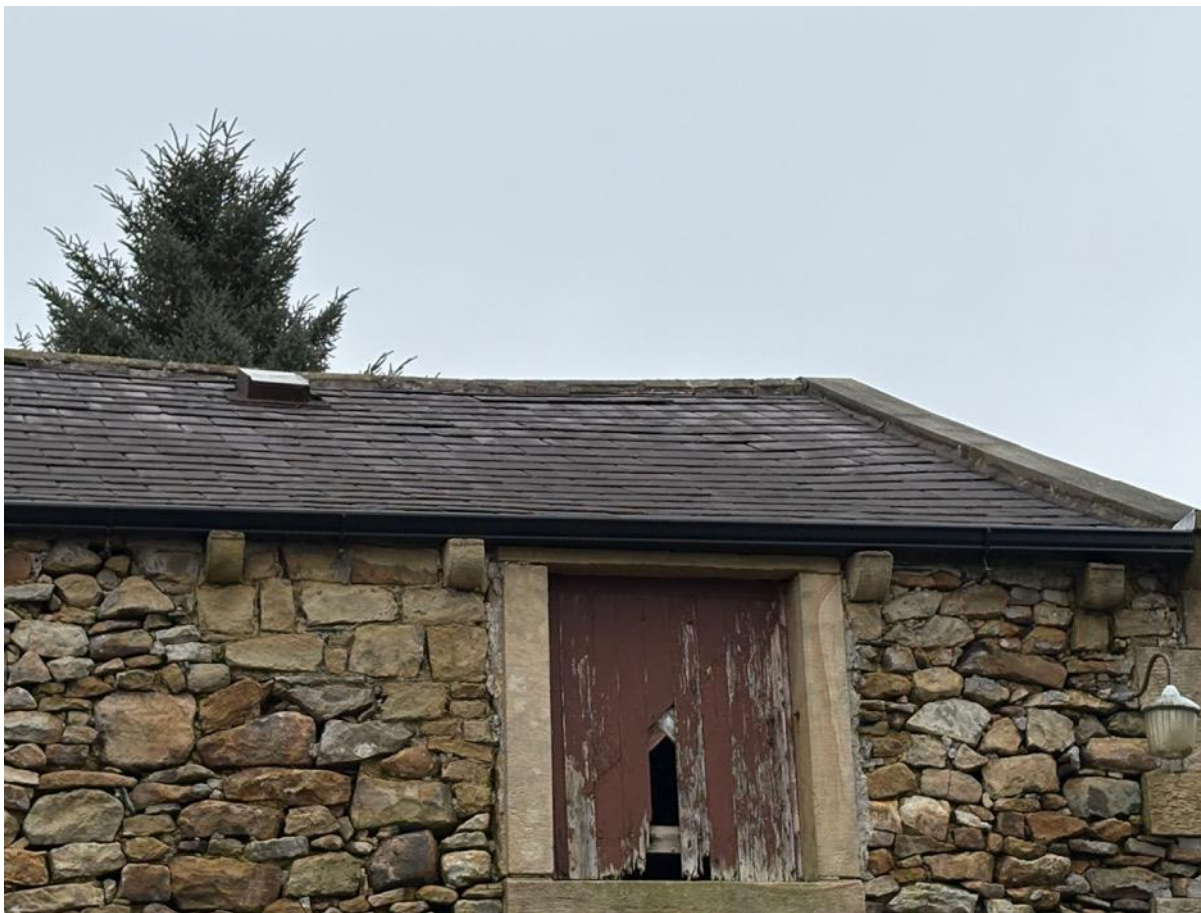
Photo 2 – South West Elevation and Roof

house. There are no signs of previous or ongoing movement but areas of the elevation are slightly out of plumb. The stone lintel over the main door is in good condition (photo 18). The main barn section has 3 window openings plus the main barn door and two further doorways (photo 1). The timber to the doorways is in a reasonable condition but the windows are in a poor condition. This section of the elevation has the benefit of guttering and downspouts which are in a reasonable condition.

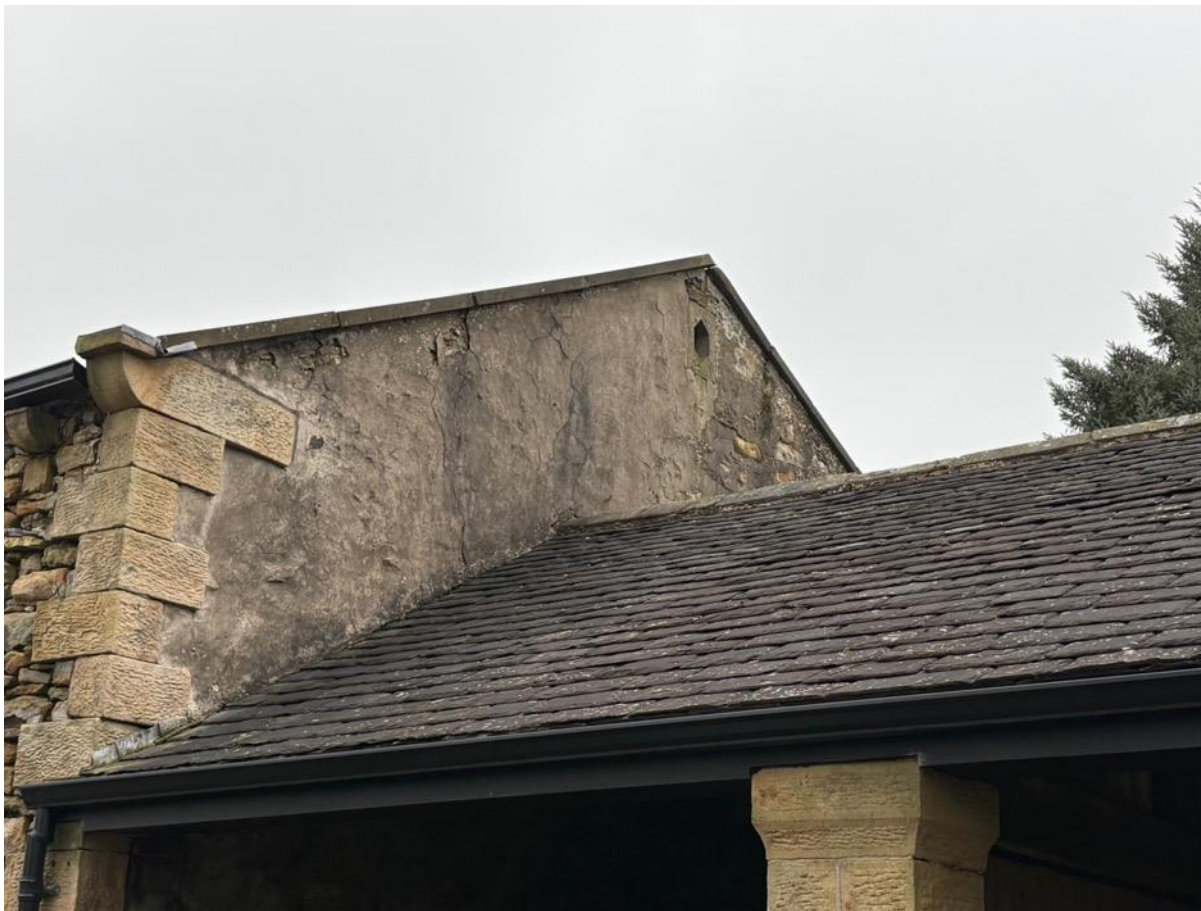
Photo 6 – South East Gable and Roof to Open Garage/Storage at South East End

The twin garage is adjacent to the south-east gable (photos 5 to 10) and is likely a later addition. The stonework to this building is in a good condition and the garages have the benefit of guttering and downspouts which are in a reasonable condition. Internal inspection shows a concrete floor with some cracking evident but no sign of major movement or failure. The roof is slate sitting on under boarding supported by timber rafters and purlins (photo 10). There are signs of water ingress but the timber appears to be free from major signs of rot or infestation. The roof slates and ridge tiles are all in place and in a reasonable condition. Photo 19 shows the rear north-east elevation to the garage area. This is built in random stone and acts as a retaining wall to the higher ground behind. The elevation is plumb, well pointed and has no sign of movement. There is a single opening at the centre. The roof slates are in a reasonable condition and the elevation has functioning gutters and downspouts.

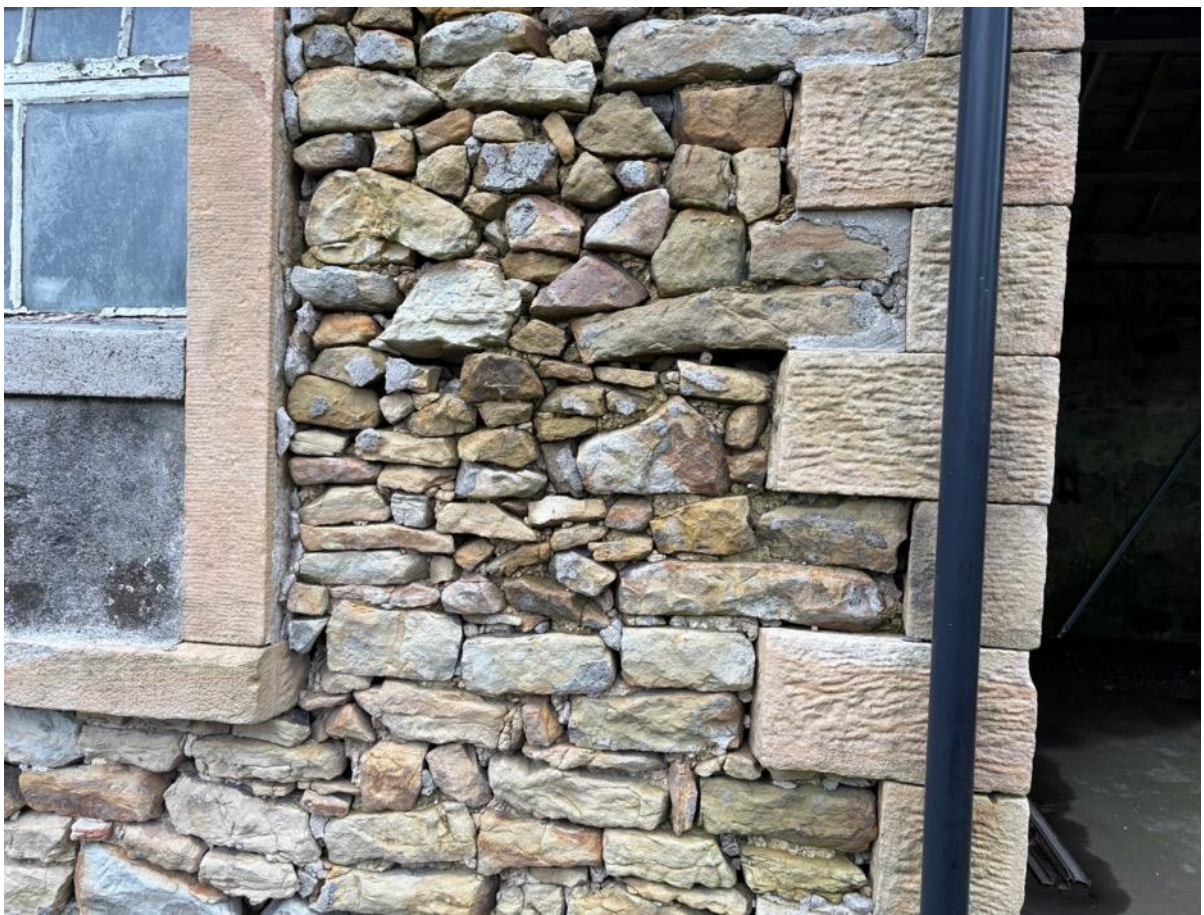
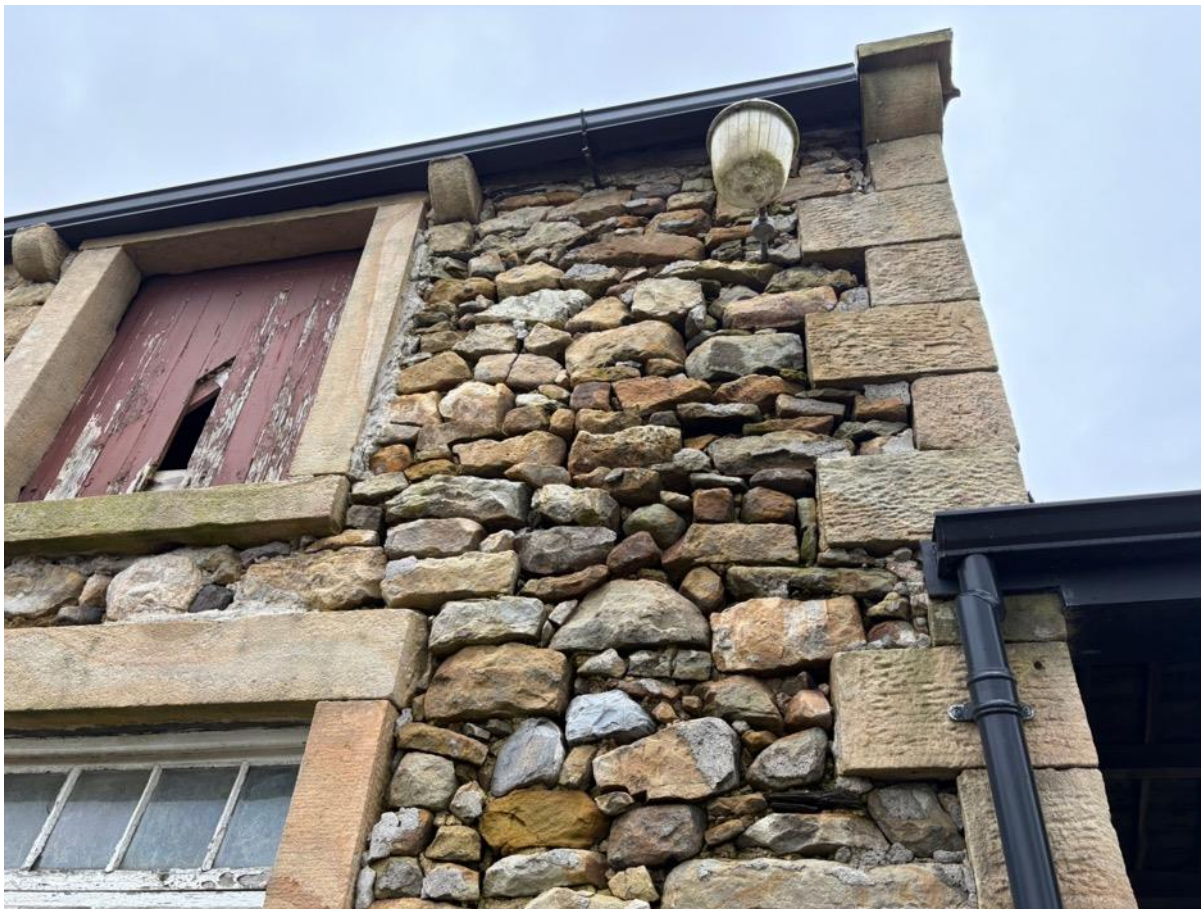
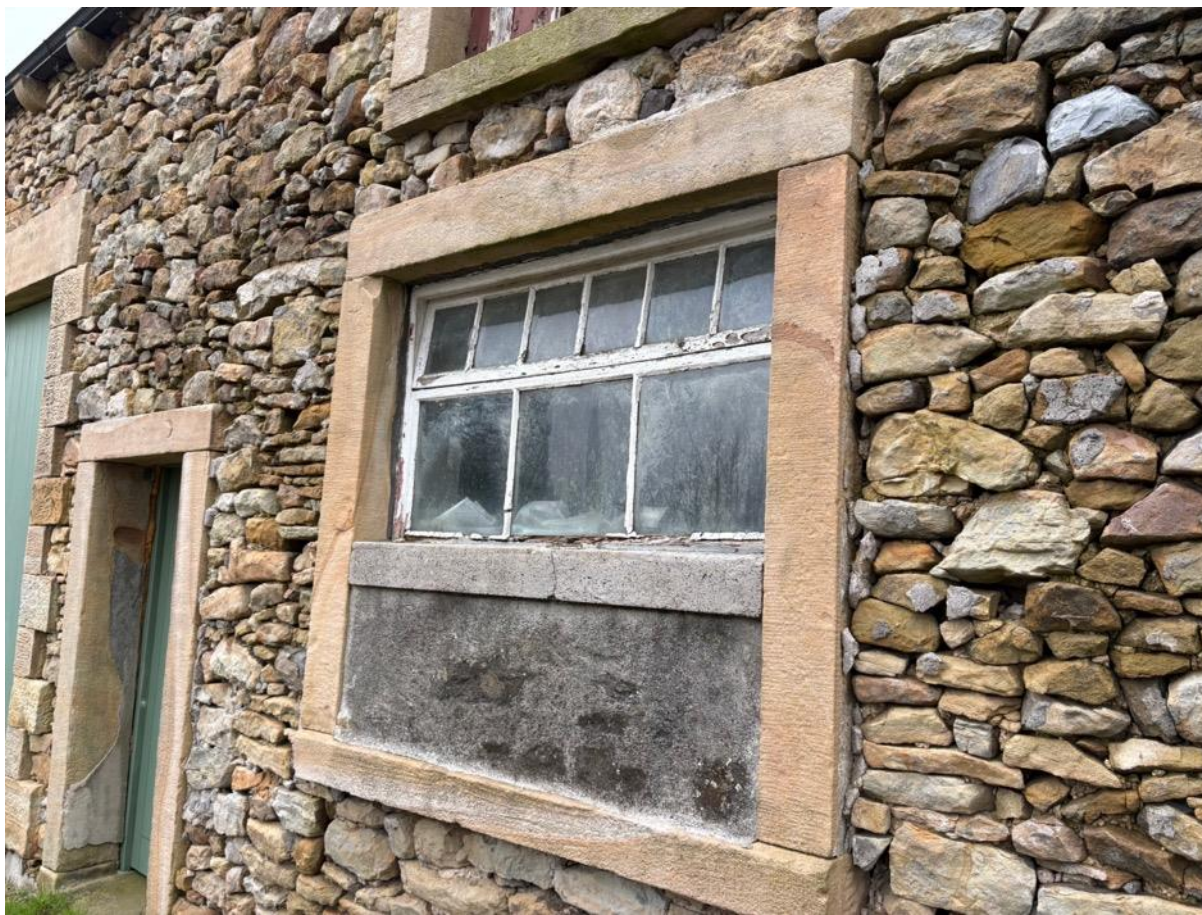
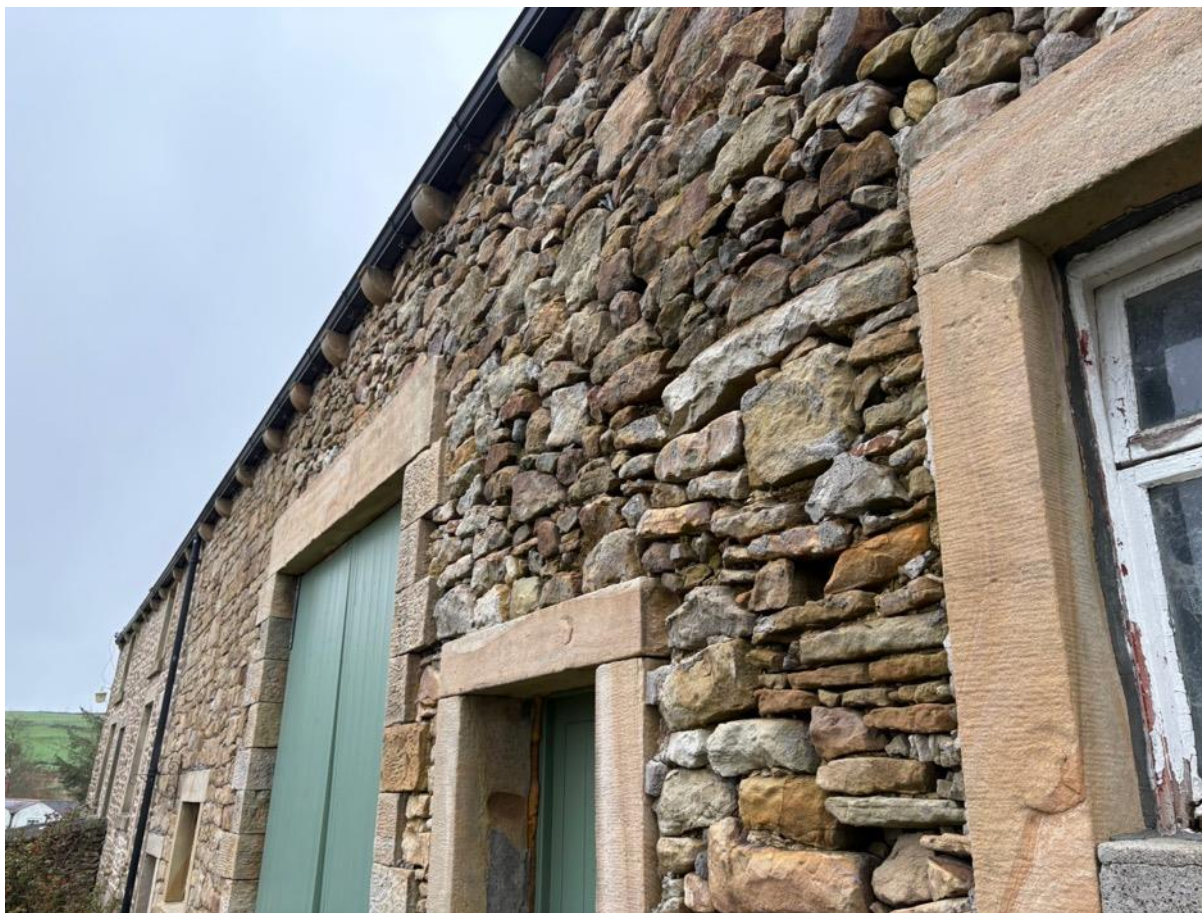
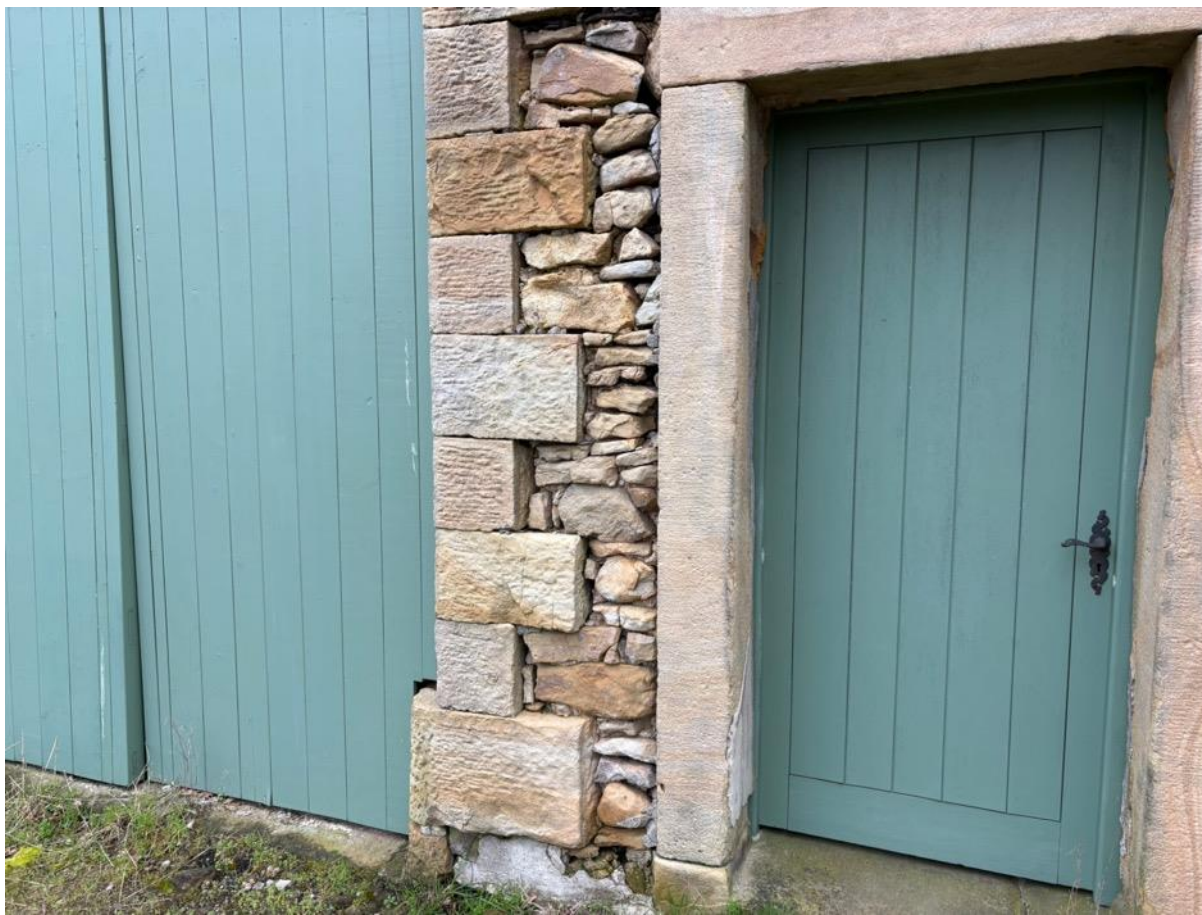
This elevation is in two sections covering the main barn and the twin garage on the gable. The walls are built in random sandstone and are 450mm thick. The walls appear to have been cleaned and had the pointing picked out. The section to the south-east above the main door and to the east of this appears to be of poorer quality stonework and the door jambs, sills and lintels sit proud of it (photos 11 to 16). This area may have been built later and possibly rendered. The stonework adjacent to the house is more regularly coursed and of much better quality (photos 16 and 17) and may have been built earlier as it sits at the same level as the

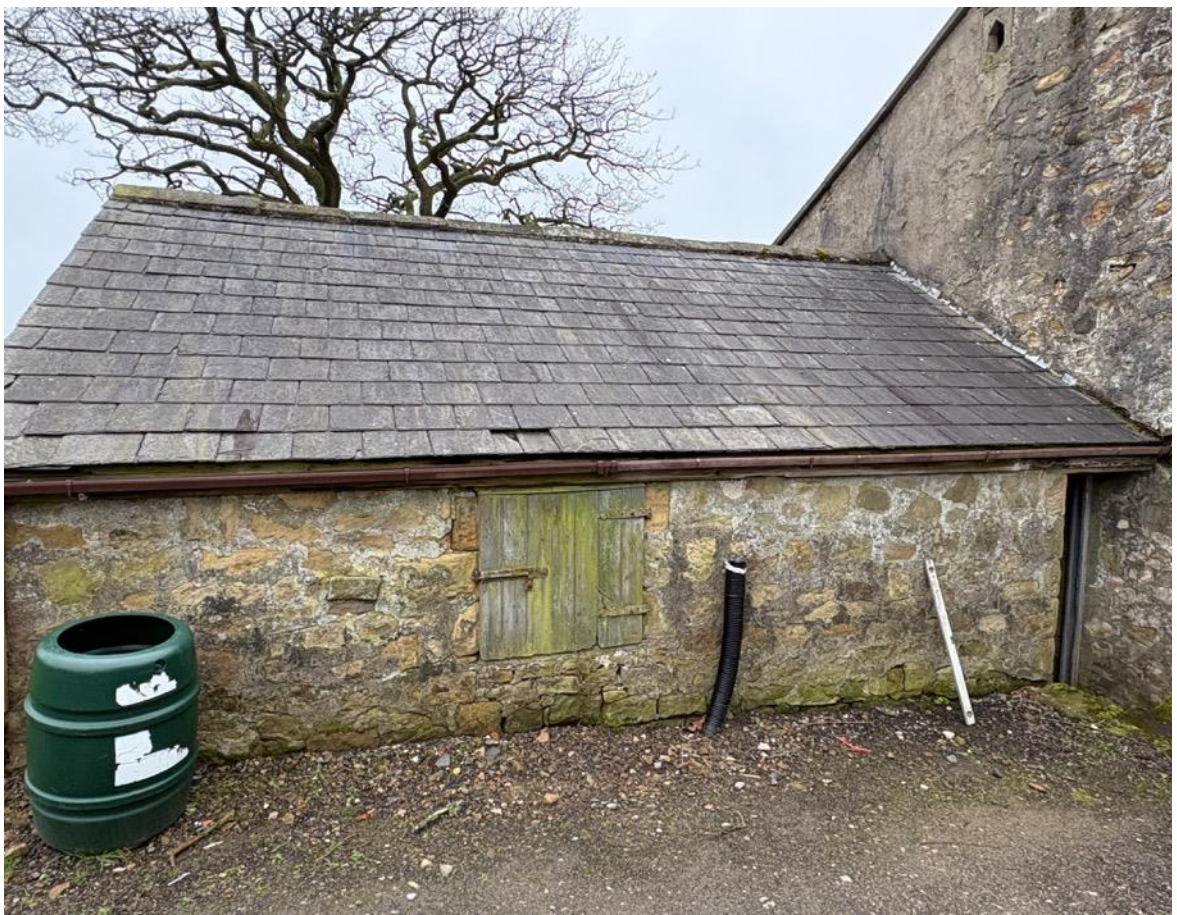
Photo 19 – North East Elevation to garage/storage

This elevation, 450mm thick, is plumb and free from any sign of movement. The wall is reasonably pointed with lime mortar and has not been picked out or cleaned as was the case to the front elevation. The gable extends to accommodate the rear lean-to section and there are two window openings, one to the loft of the main barn and one to the lean-to section (photo 21). The timber to these windows is in poor condition.

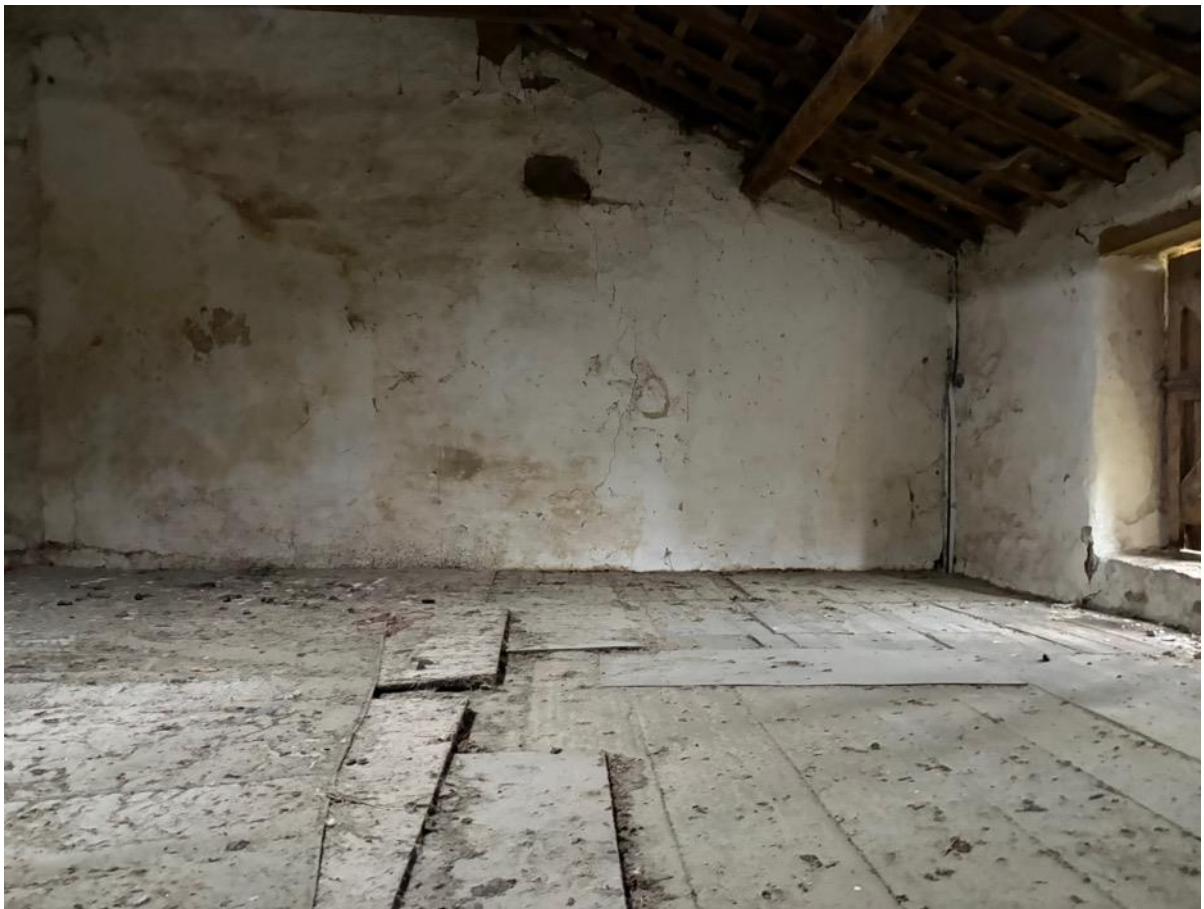
Photo 33 - Internal main barn loft

This larger area of the barn is full height in the central area at the main doors. To the north-west of this the ground floor is at a lower level and a mezzanine floor has been built on brick piers (photo 39). To the south-east of the main door there is full height masonry wall (photos 36 and 38) which is plumb and in reasonable condition with no sign of movement. The external walls are all reasonably plumb, well pointed and free from signs of movement. The rear wall where it retains higher ground is in good condition and there were no obvious signs of damp or water ingress. The main barn loft is south-east of the dividing wall (photos 32 to 35) and inspection of the walls at this higher level indicated they are in a reasonable condition.

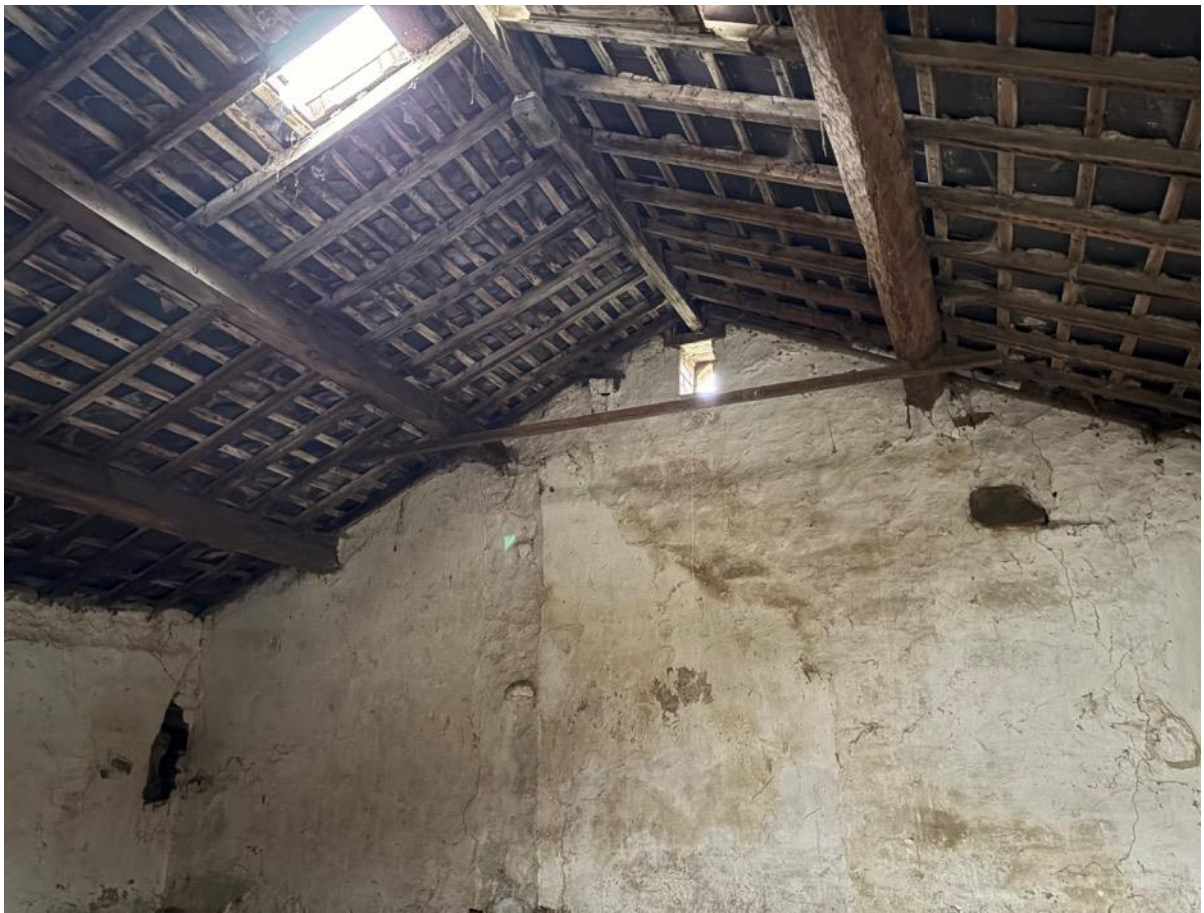
Photo 36 - Internal main barn – Dividing wall main barn

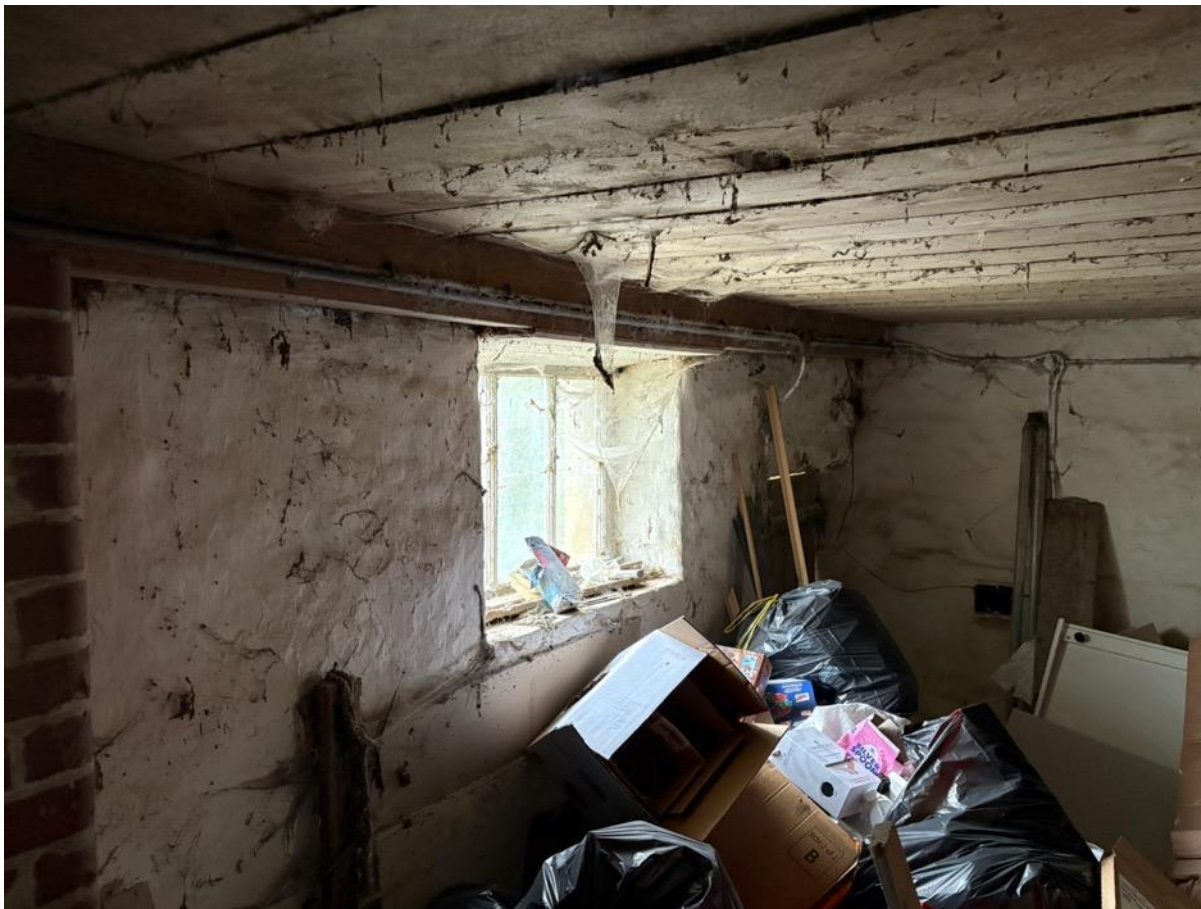
Photo 40 – Main barn internal

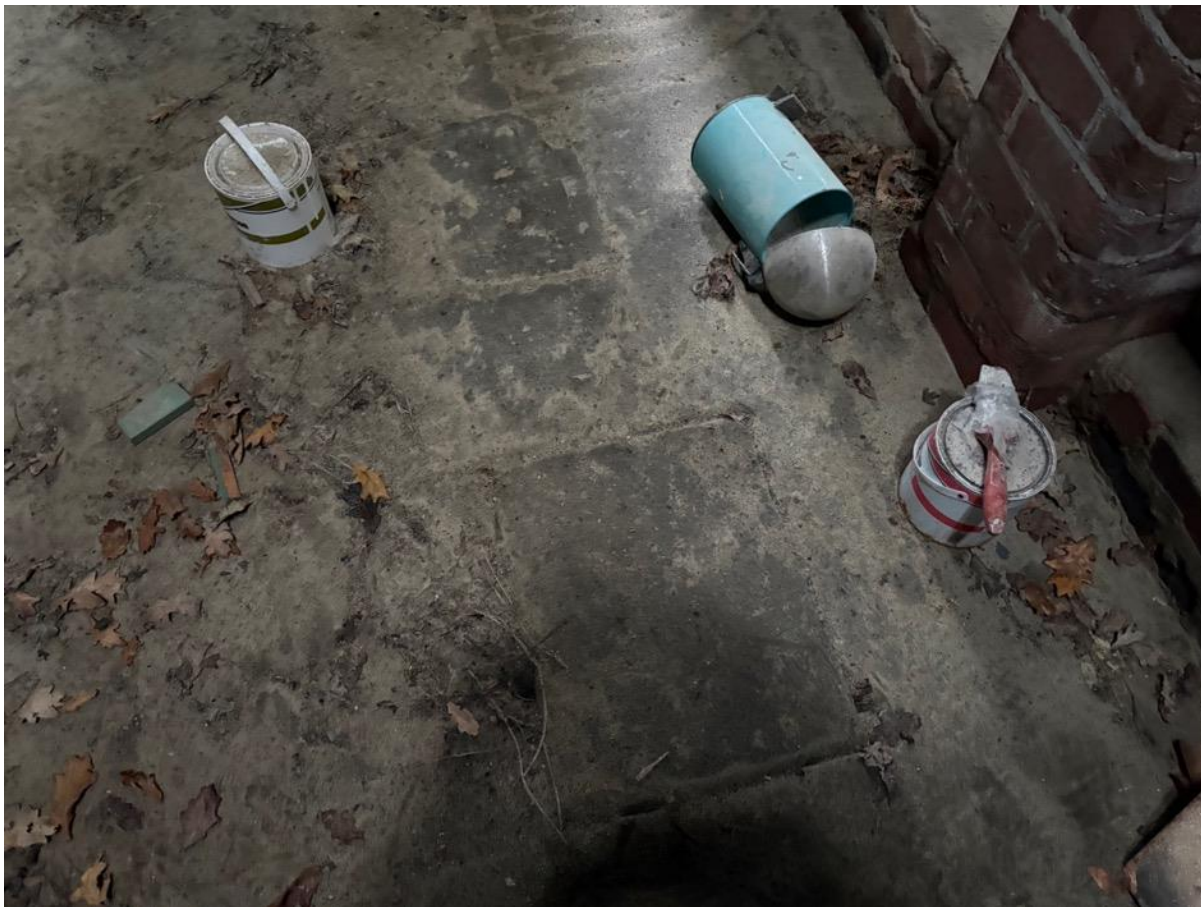
The timber to the roof truss, purlins and rafters all appeared in a reasonable condition with little or no sign of rot or infestation (photo 34). The solid flagged or paved floors, where visible appeared to be in a reasonable condition.

Photo 42 – Flagged Floor

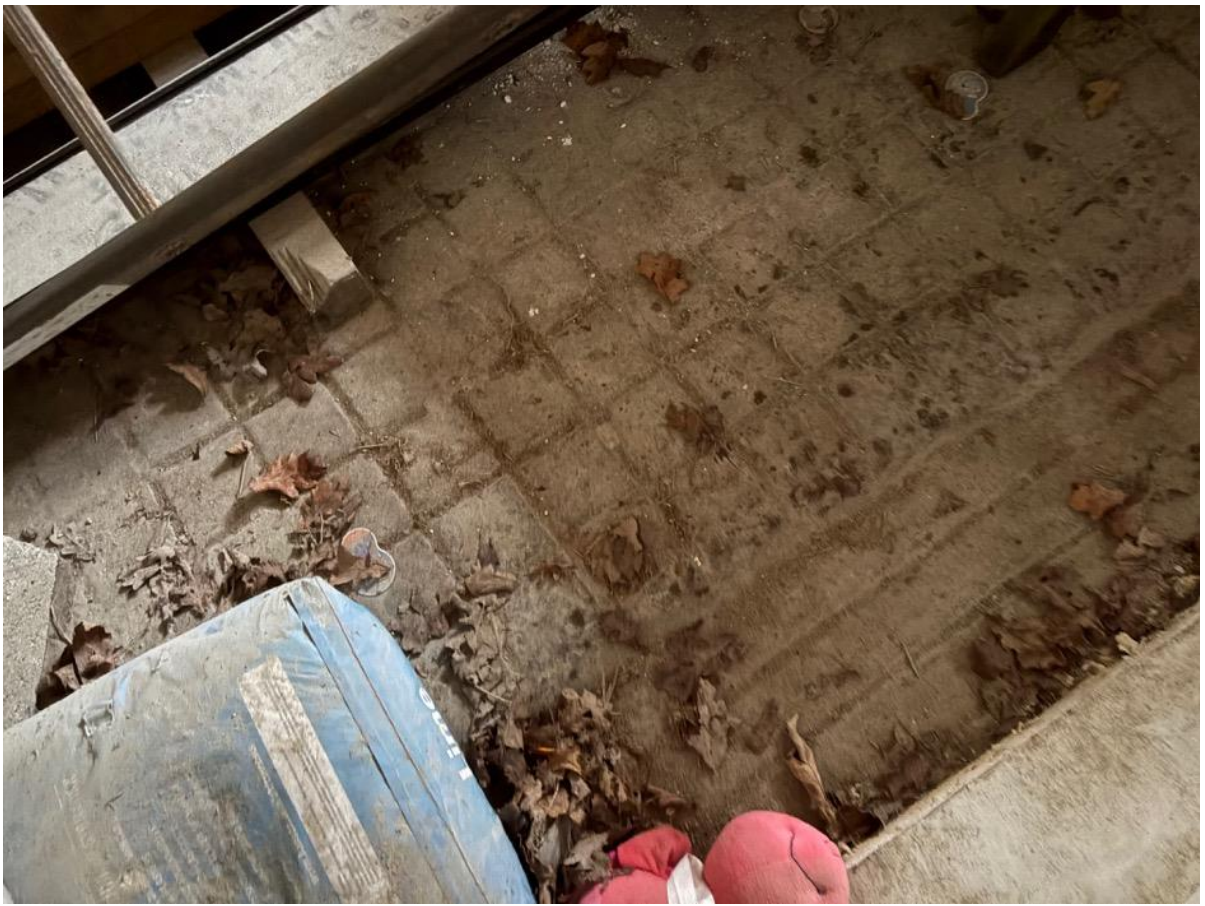
Photo 43 – Paved floor
