# **CONDITION ASSESSMENT OF BEECH TREE LOCATED AT REAR OF 1 ST DENYS CROFT, CLITHEROE. BB72BY**

**Client:** Mr and Mrs A Mckenzie 1 St Denys Croft, Clitheroe (The resident property owners)

**Date of Tree Inspection:** 31.7.26

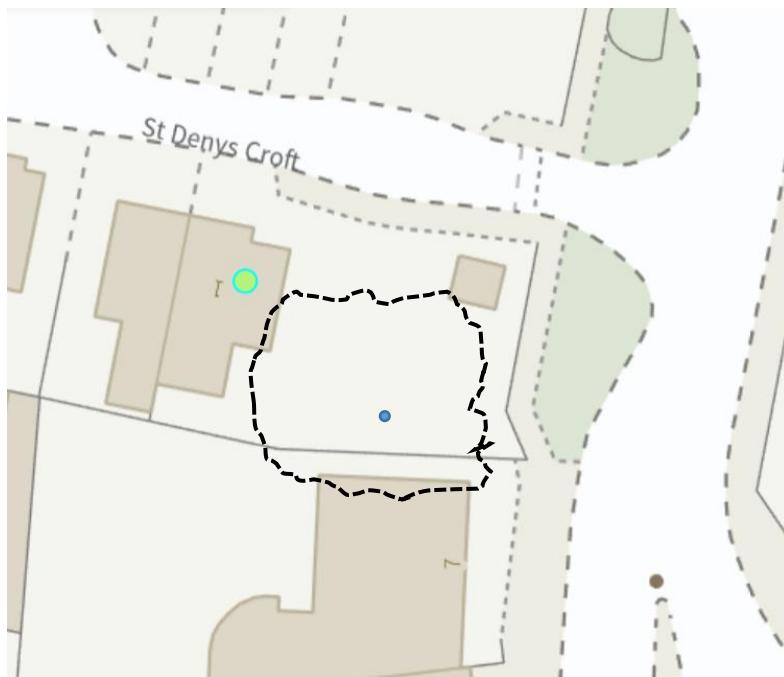
1. The mature Beech tree is located 300mm from the rear garden boundary wall and has a height of 20m and a girth Diameter at 1.5m of 1510mm. The tree is twin stemmed from 2m from ground level with a further rubbing semi-conjoinment at 7m from ground level. Ivy infestation is present up to 8m and this has inhibited visual inspection.

4. The canopy was in full growth at the time of the branch failure and the inspection and was **significantly different** to its condition when last inspected. There was an obvious lack of twig extension and a marked dieback shown by the canopy thinness as shown in the photo. The lower fork showed no signs of an included bark union but the ivy cover makes inspection obstructed as in the 2015 inspection.
