LIGHTWORKS  
STAINED GLASS

HORROCKSFORD OLD HALL FARM, CLITHEROE

HERITAGE LEADED LIGHT GLAZING: REPORT

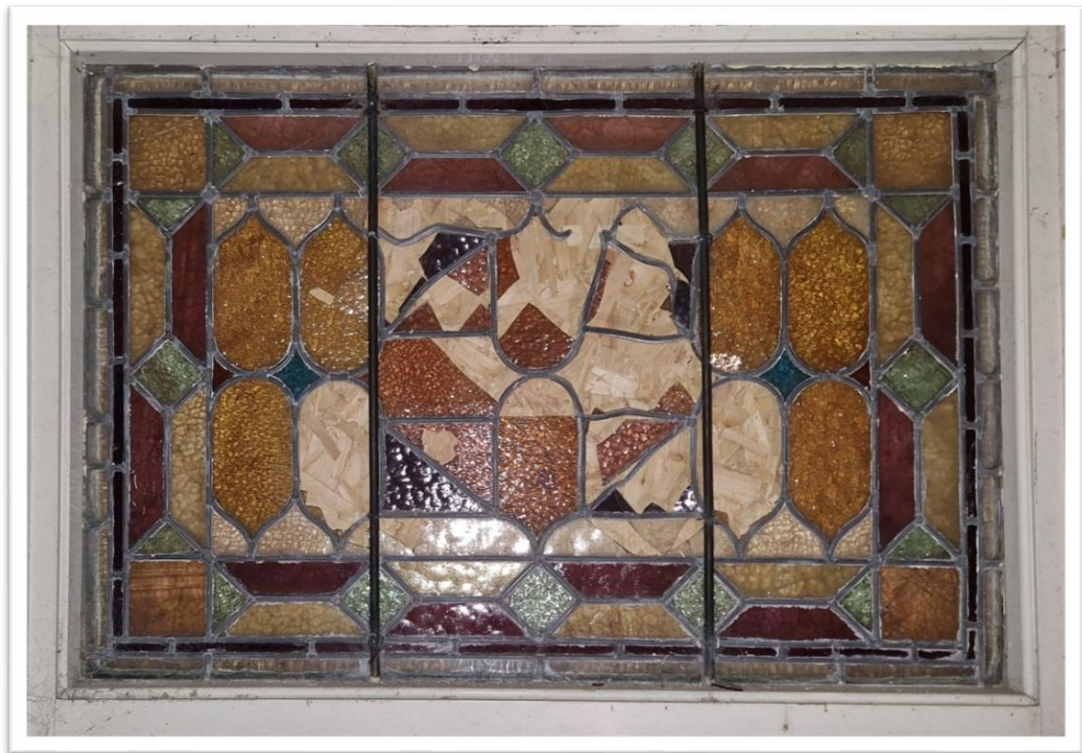
The glazing comprises a set of three panels of hand-crafted leaded glass: 2 x sidelights and 1 x transom panel (see fig.1).
