Kirk Mill, Chipping, Lancashire

Archaeological Building Investigation

Oxford Archaeology North

August 2013

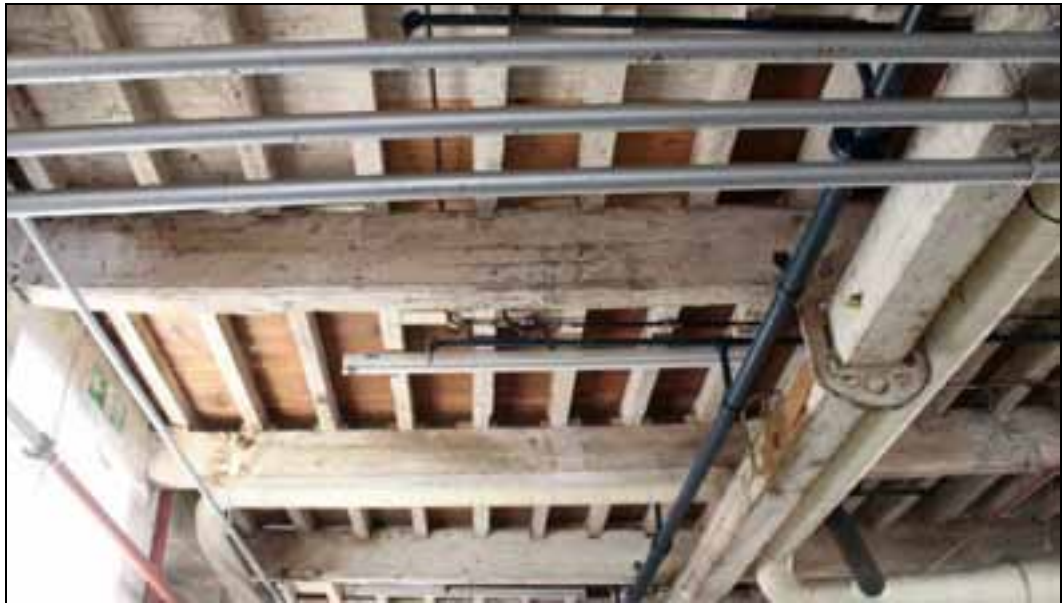
- 3.3.8 The ceiling of the extension comprises north/south-aligned 3 x 4½" (0.08 x 0.11m) joists carried on 6½ x 13" (0.16 x 0.33m) beams, the third from the southern end having Baltic timber marks at its western end. All beams, with the exception of the fourth beam from the southern end, which is a circular-sawn replacement, are stop-chamfered at either end, but not above a central north/south-aligned 8 x 10" beam with rolled-edged soffit (Plate 35). This suggests that this beam represents an insertion, originally being supported at either end by a 3½" diameter, cylindrical column with octagonal section foot. That at the southern end was removed subsequently, leaving only the scar of the column head (Plate 36). The beam was also strap-jointed to alternate beams with cast-iron brackets (Plate 35).

Plate 35: Additional longitudinal ceiling beam in west wing

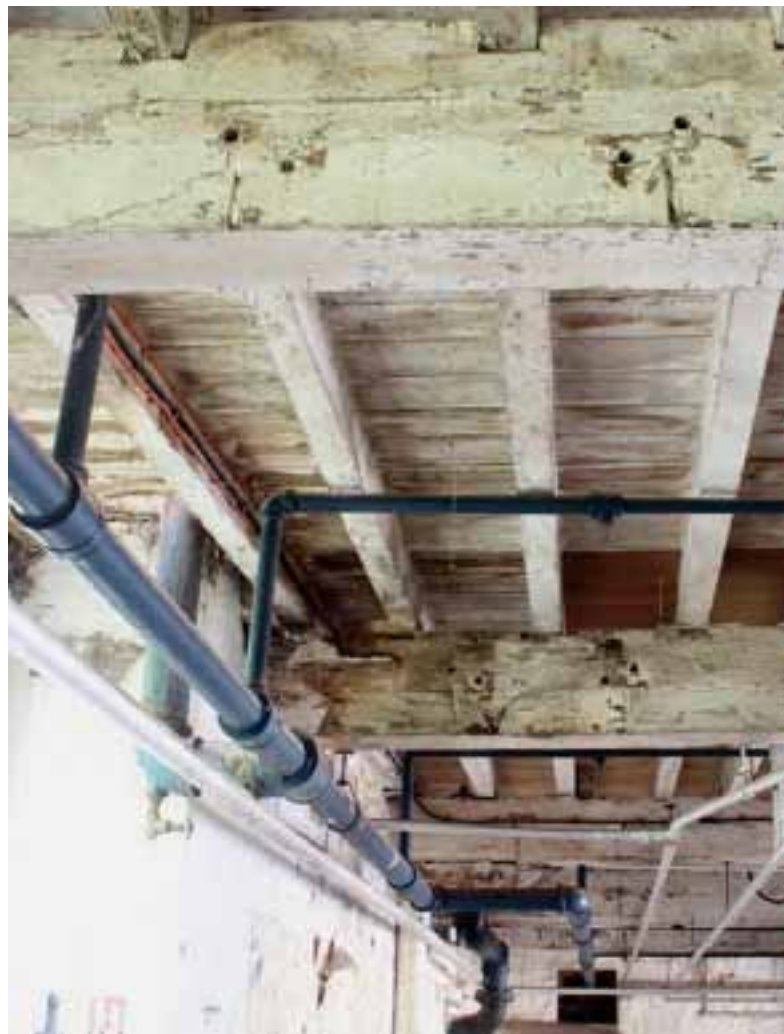
- 3.3.12 A further similar shaft was placed 40" from the north wall (Plate 40). Again the penultimate beam retained four round-headed bolts, with 4" vertical gouges on the western face, positioned 19" apart, presumably relating to drum scars. Similar scars were observed on the remaining beams (Plate 40). The bolt holes were not present in the two beams to the east of the late stairs to the first floor, but both of these comprise circular sawn replacements, the original beams to the east being 6 x 12" pit-sawn beams with narrow chamfers. The main body of the western original beam is flanked by timber $9\frac{1}{2}$ x 2" fitch plates for the majority of its original length, blocking the early cut-outs for shafting. This beam and the adjacent ones, also have a second semi-circular cut-out.

Plate 40: Bolt holes and scars for northern line shaft, with end bearing in background

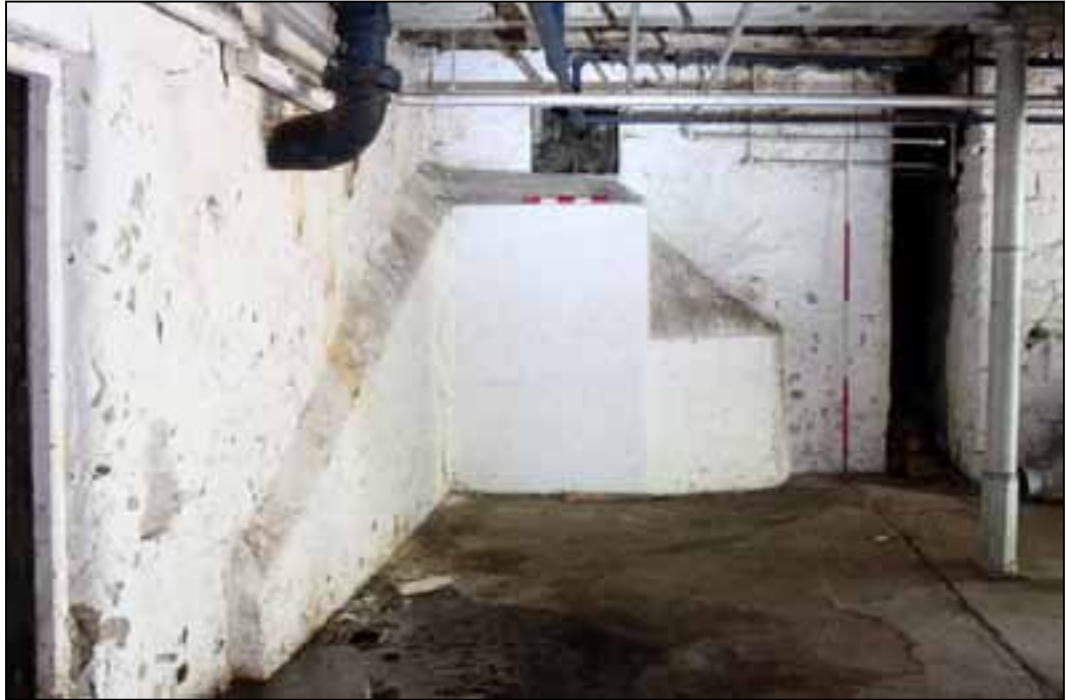
- 3.3.13 Additional timbers were placed between the eastern beams at their northern ends. One of these has bolts projecting from the soffit, 2' apart, relating to the northern line shaft, and aligns with a 2' wide end bearing box in the east wall (Plates 40 and 41) above a significant stone base supporting the gearing for the waterwheel above (Plates 41 and 42).

Plate 41: Substantial stone base for gearing footstep with line shaft end bearing box

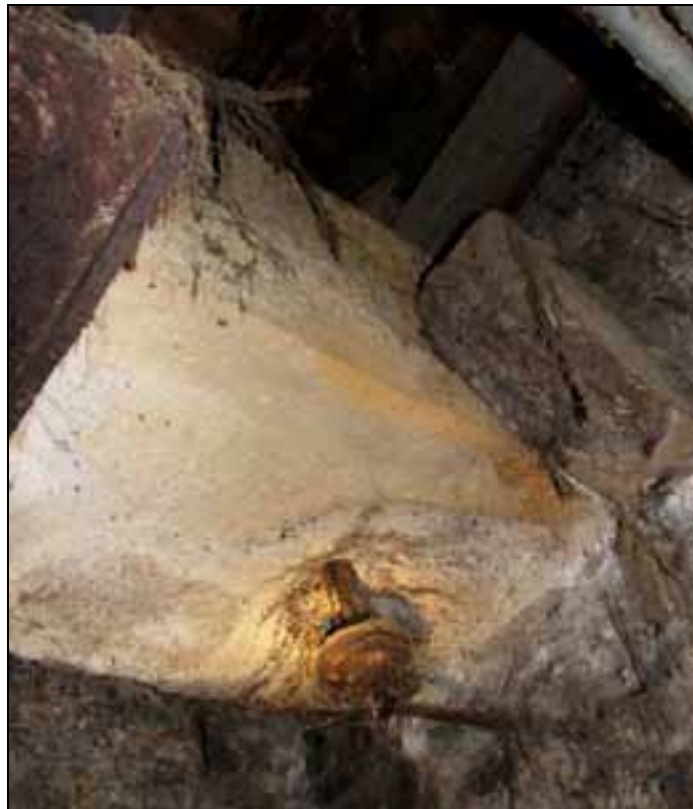
Plate 42: Large sandstone footstep for waterwheel gearing

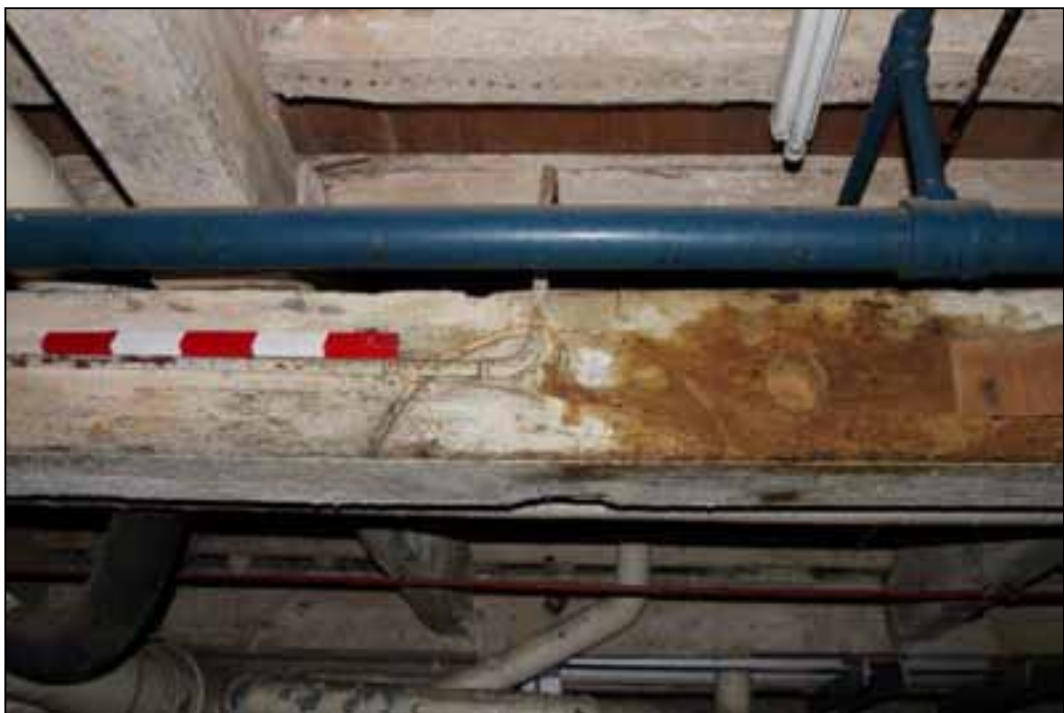
3.3.14 Within the western extension, the longitudinal beam clasped to the ceiling beam (Plate 35) had several cut-outs in its western face for line shafting, the southern example having an accompanying 18" (0.46m) diameter drum roller scar (Plate 43). However, none of these aligned with other line shafting, which ran perpendicular to this beam, strongly suggesting that it was reused in its present position. At their eastern end, the ceiling beams of the extension are lap-jointed into a 5½ x 12" transverse beam with a very slender chamfer. This has a gouged 6 x 4" semi circular shafting rebate towards its northern end, overlain by a later 3½ x 10" timber fitch plate on its eastern side, demonstrating the disuse of the line shaft at this time. The beam also bears the compression scar for a column head plate in a similar position to extant columns further to the east within the original part of the mill.

Plate 43: Scar of line shaft drum on face of beam

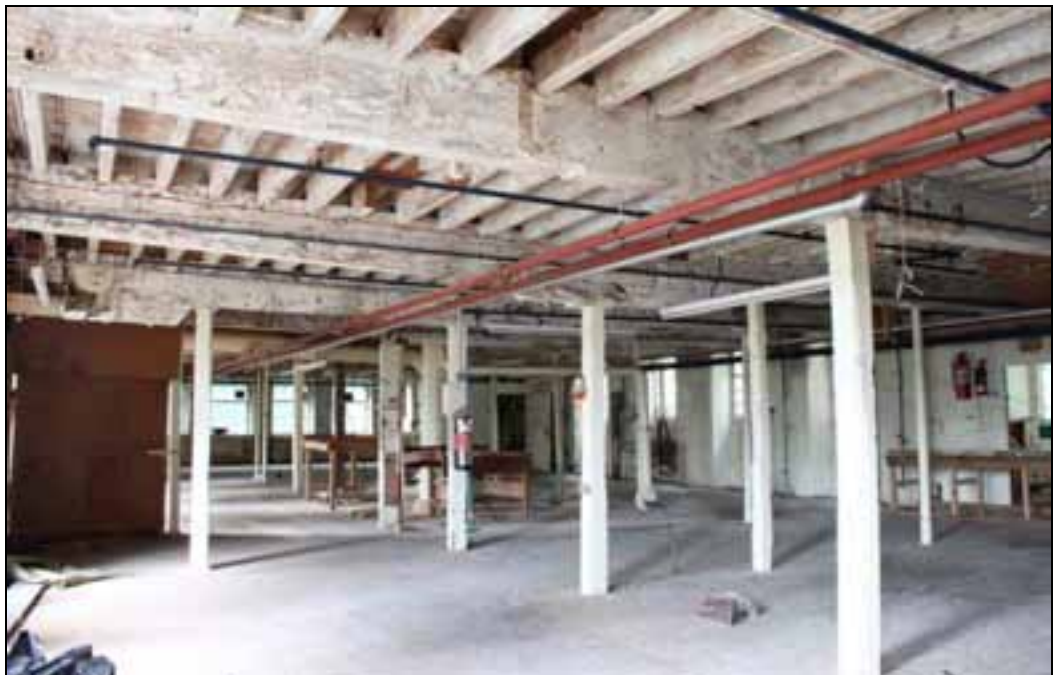
Plate 47: General view across the first floor, looking north-west

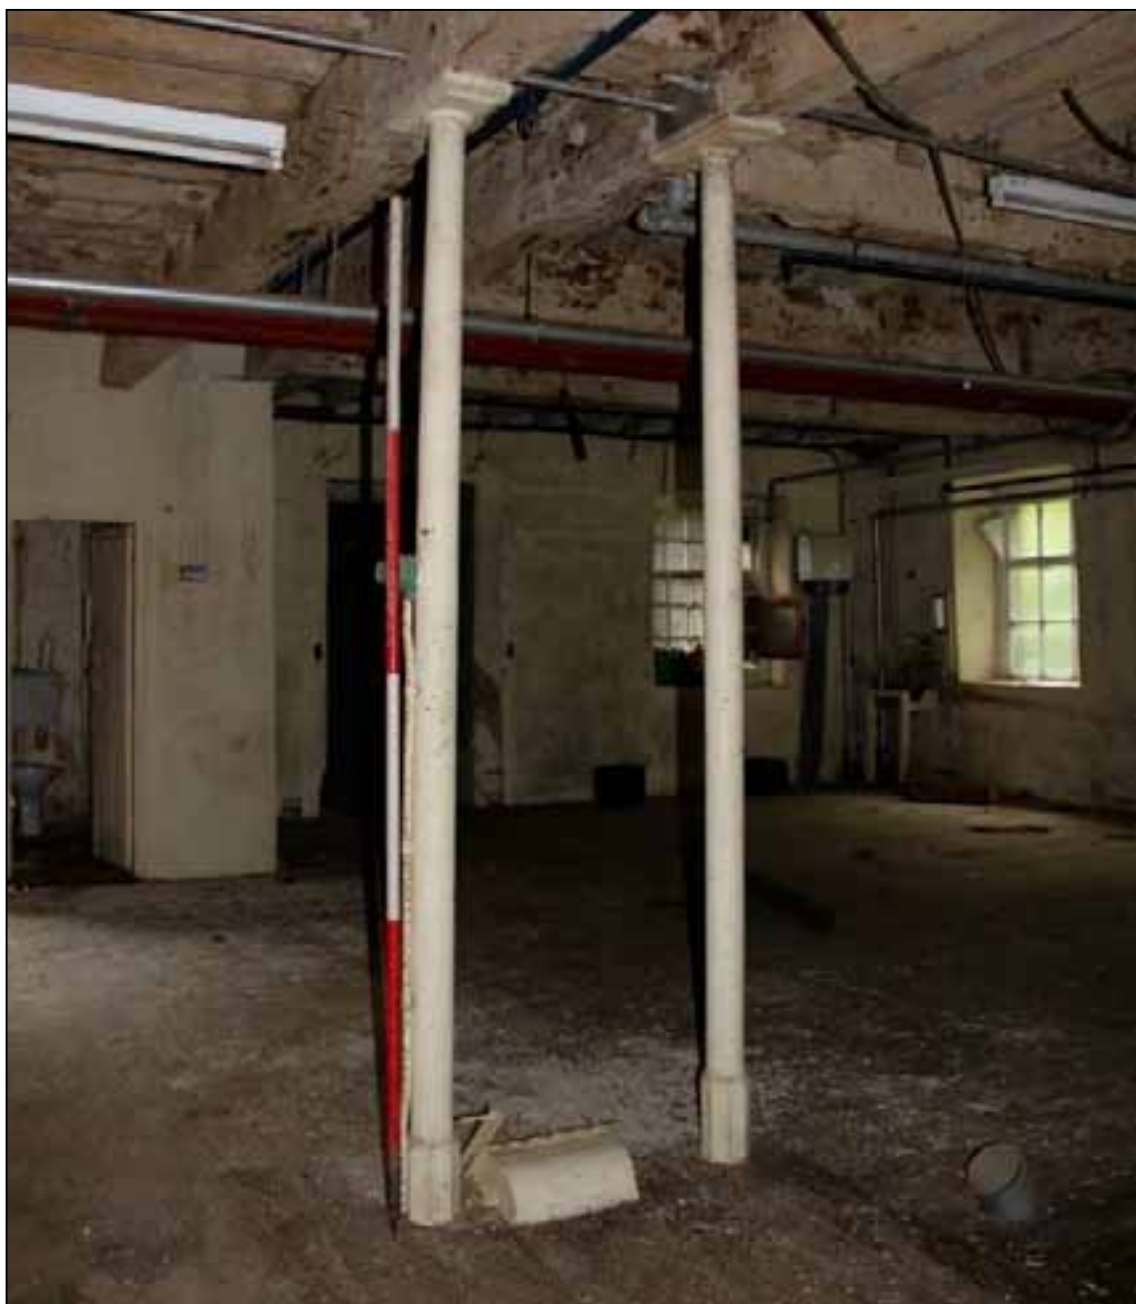
Plate 49: First-floor columns with octagonal-section feet

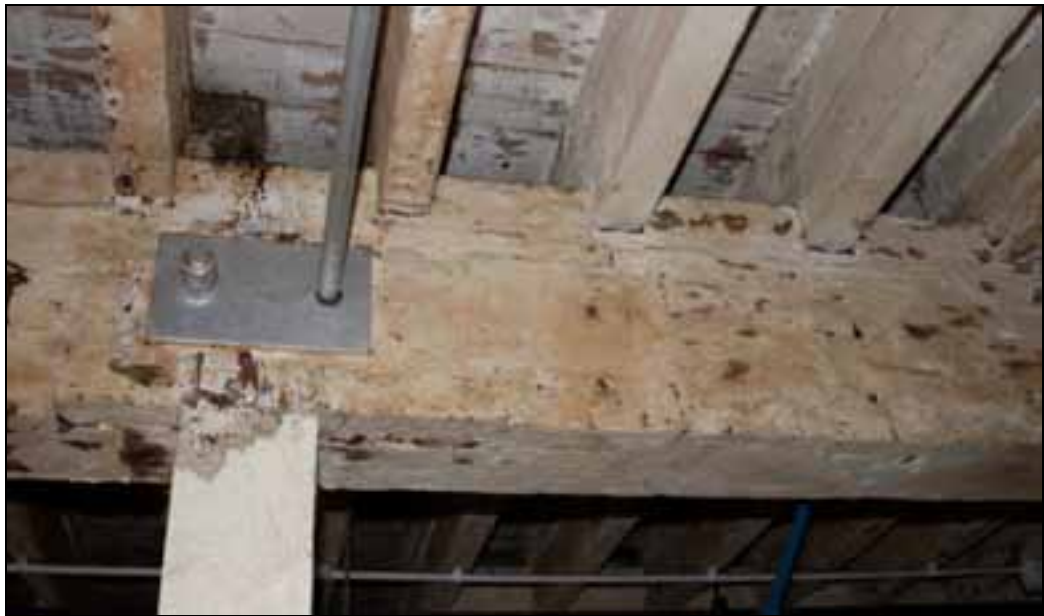
3.3.21 The western beam has a replaced section on its eastern face, which possibly relates to the end of the original line shaft. The infilling timber has bolt holes relating to later hangers (Plate 51), observed on each beam to the east, the last of which has an apparently associated scar for a very large wheel or drum (possibly 6' diameter), the joists above all being replaced (Plate 48). This drive aligns with a large blocked bearing box in the east wall (Plate 48), associated with the extant gearing for the present waterwheel. Circular cut-outs in the eastern three beams relate to an earlier line shaft, placed almost immediately to the south, whilst the adjacent beam has a repaired soffit, presumably infilling the earlier cut-out. The third beam has a 2' wide 1" deep scar for a drum on its western face, and a large strengthening timber bolted below (Plate 52). The beam to the west has a similar strengthening member projecting from the south wall.

Plate 51: Timber fillet in beam face and later line shaft hanger bolt holes

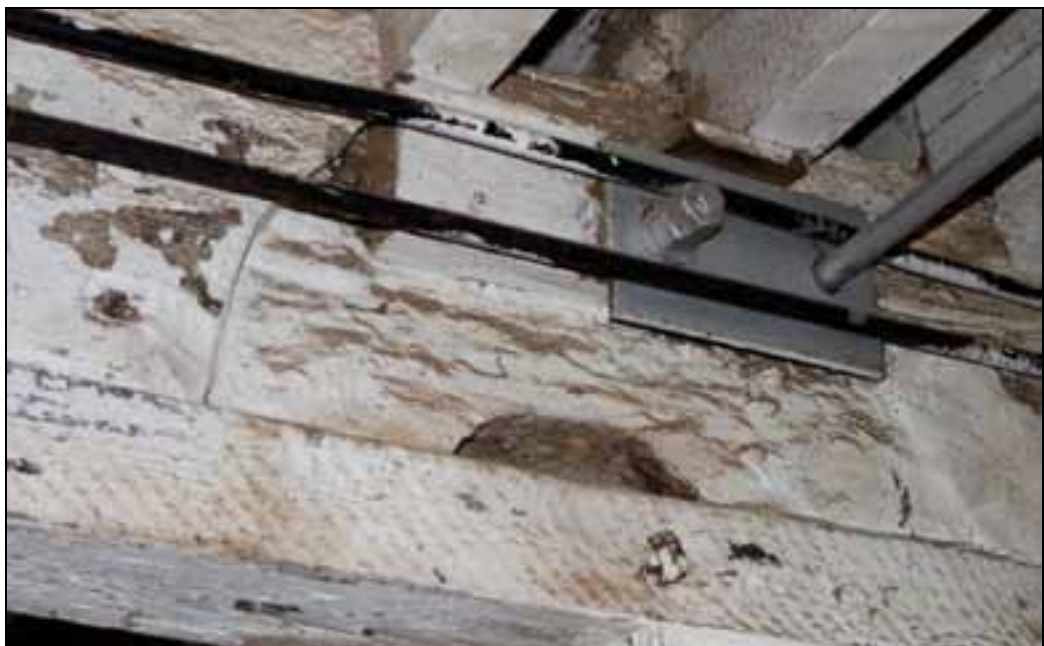
Plate 52: Rebate for drum on original line shaft, with cut-out in soffit for shaft

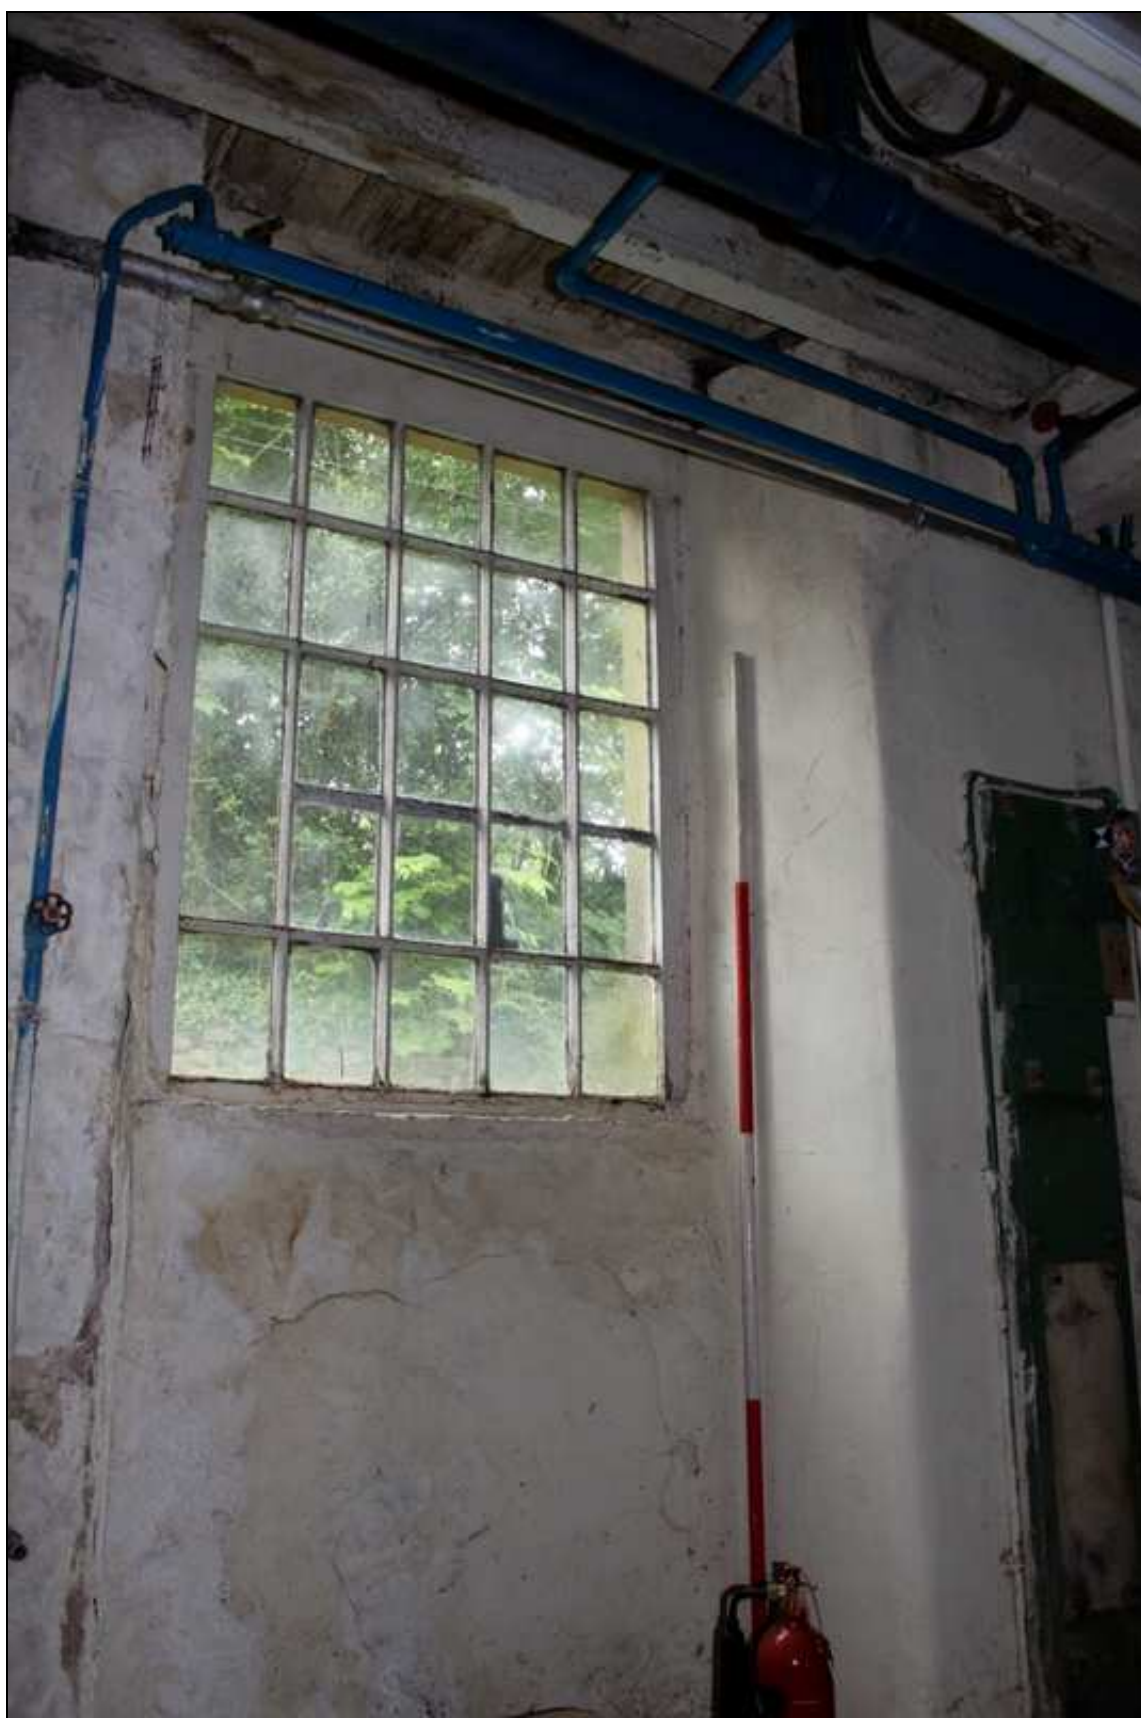
Plate 55: 25-light window in north wall, first floor

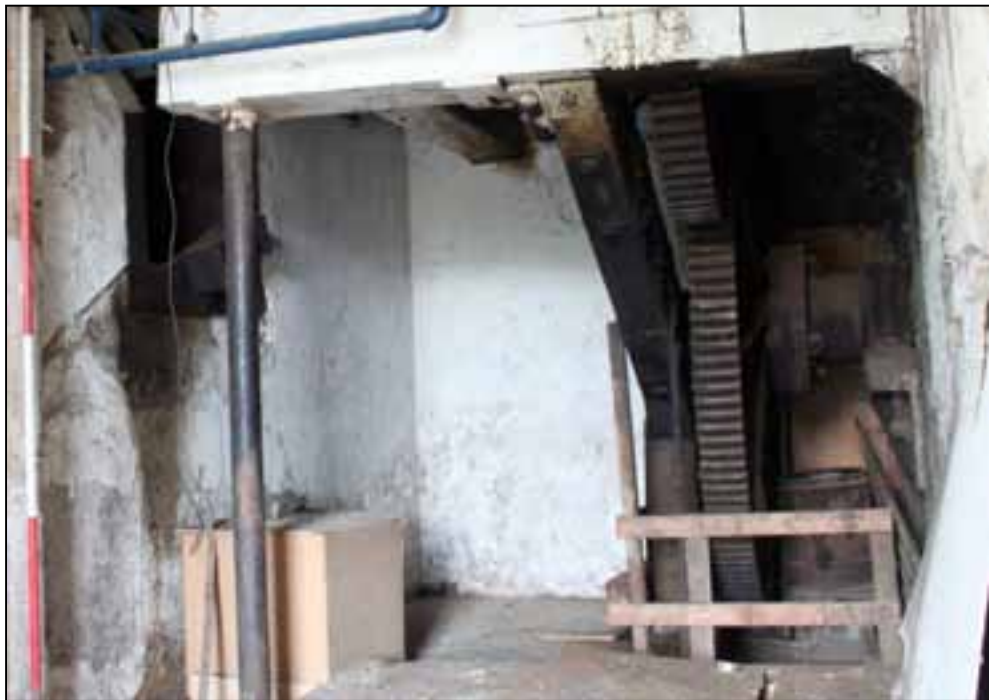
Plate 57: Extant waterwheel gearing

- 3.3.31 The primary motion shaft, beyond the clutch plate has been removed, but it originally passed through a bearing box in the west wall of the bay (Plate 57). This had an additional offset angled casting in its face (Plate 57), presumably associated with the linkage of the shaft from the engine. Bolt holes, two bolts, and compression scars in the soffit of the transverse beam within this bay (Plate 68), relate to a mounting for a hanger, possibly carrying a bevel gear, translating a vertical drive from the engine below towards the wall-box to the west.

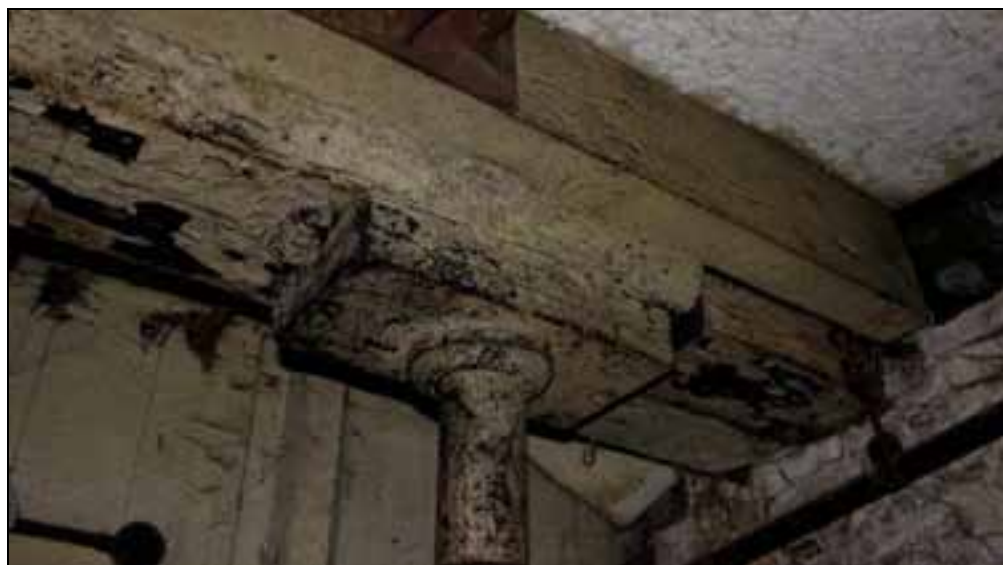
Plate 58: Column carrying scarf-jointed of extended ceiling beam

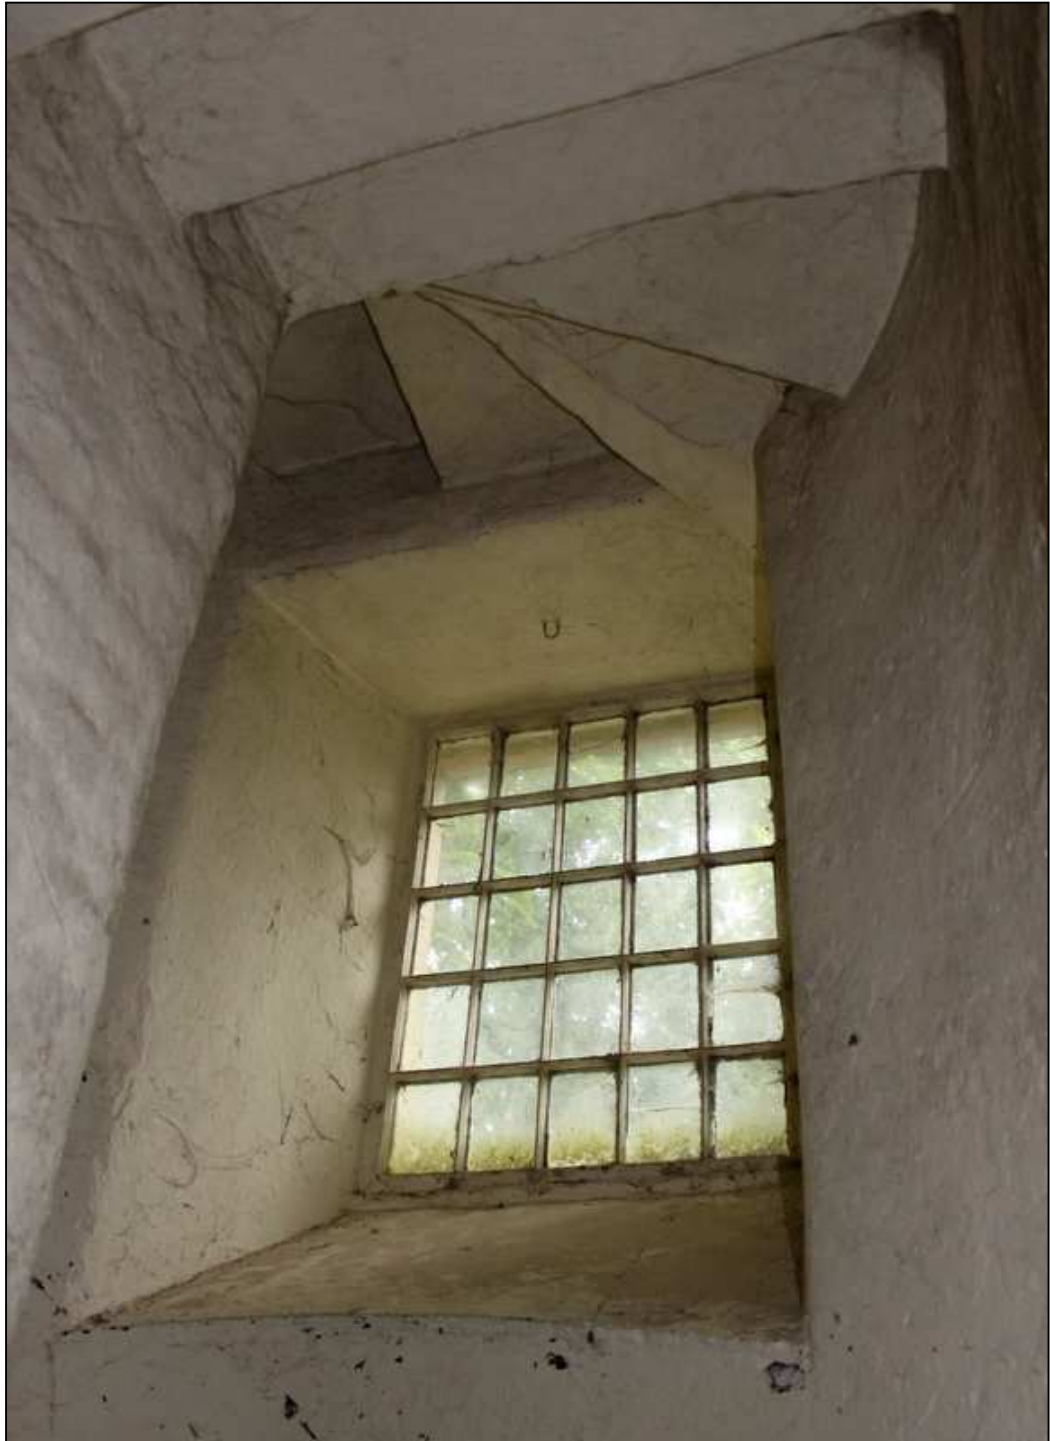
- 3.3.26 The stair tower was of fireproof construction at first- and second-floor level, and is divided by a stone partition into two chambers. External access into the stair tower was afforded in its east face, at first-floor level, which is the external ground-floor level at the rear of the mill. It comprised a narrow double-door with 10-light timber skylight above (Plate 14), leading to the half-landing at first-floor level. The north wall of the stair tower had windows into the stairwell, with a blocked 16-light window on the spiral between the first and ground floors, and an extant 25-light fixed window between the first and second floors (Plate 59).

Plate 59: Stair-light window with fireproof spiral stair above

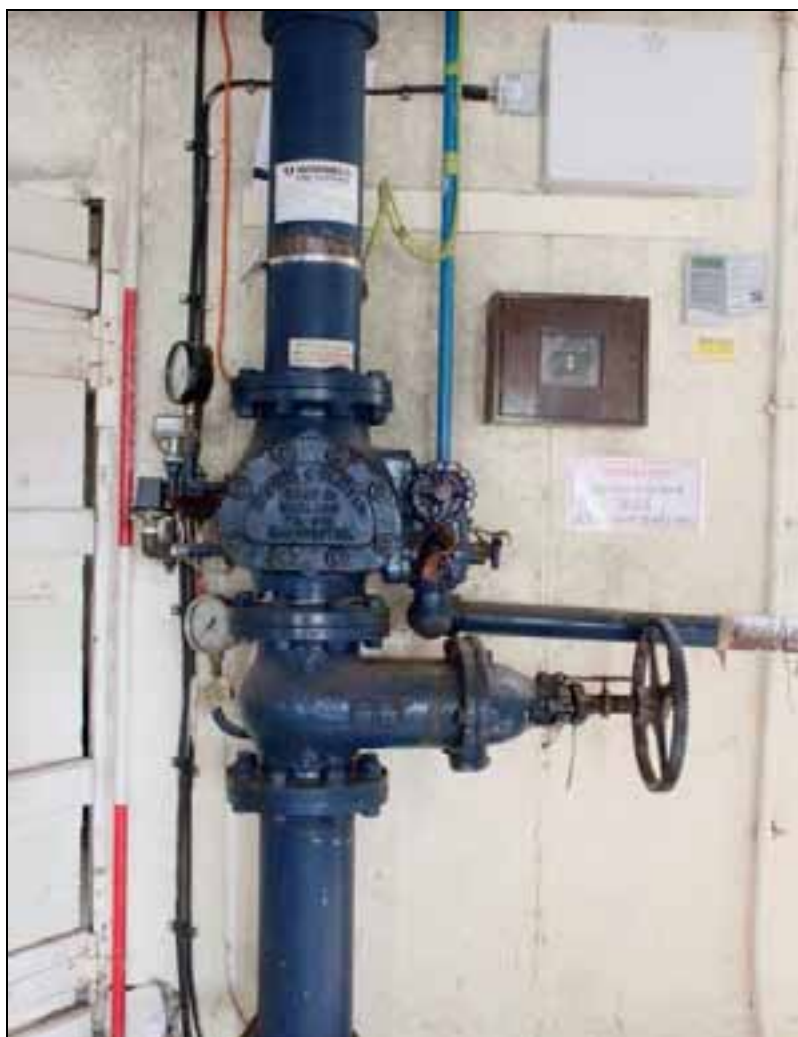
Plate 62: 'Christmas tree' control valve of sprinkler system

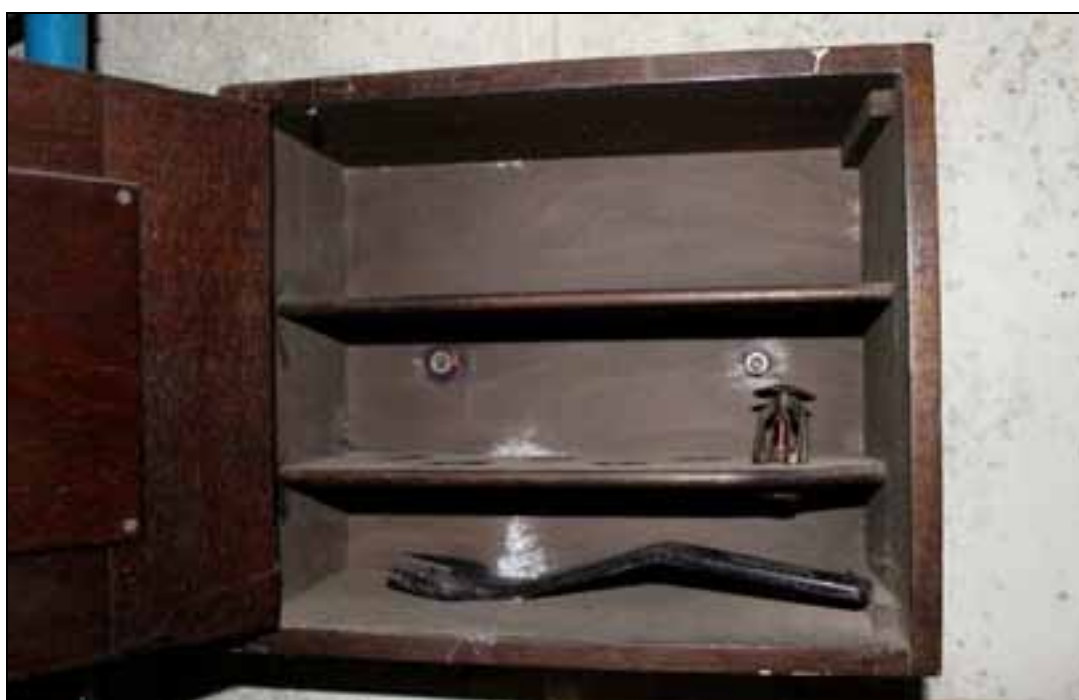
Plate 63: Cabinet housing spare parts for sprinkler system

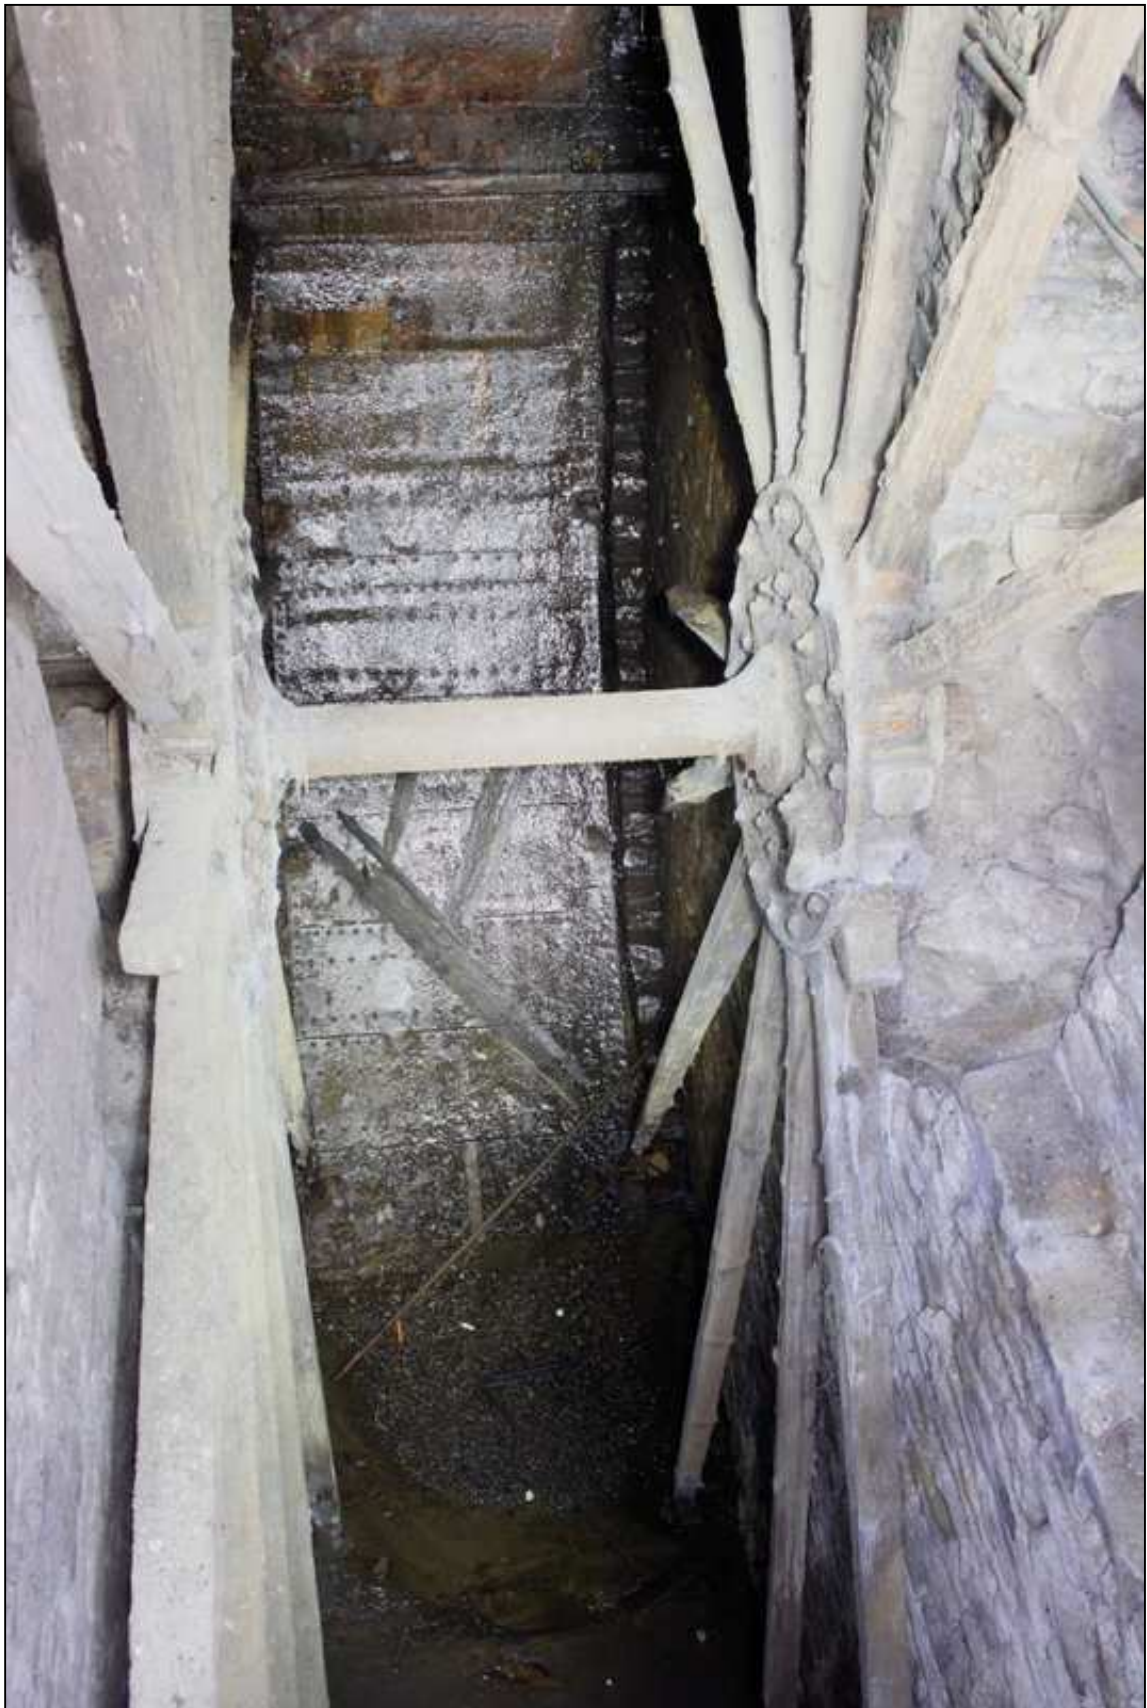
- 3.3.32 The current waterwheel is the full height of the ground and first floors, and almost the full 7' width of the bay in which it is housed (Plates 69 and 70). This represents an extension to the original mill, with this waterwheel probably being erected whilst an original waterwheel continued to function in the adjacent bay to the west. The high breast-shot wheel has cast-iron rims housing metal sheet elbow-buckets (Plate 71), supported by slender timber spokes socketed into a small diameter cast-iron hub (Plates 69 and 70).

Plate 70: Axle and eastern bearing of waterwheel

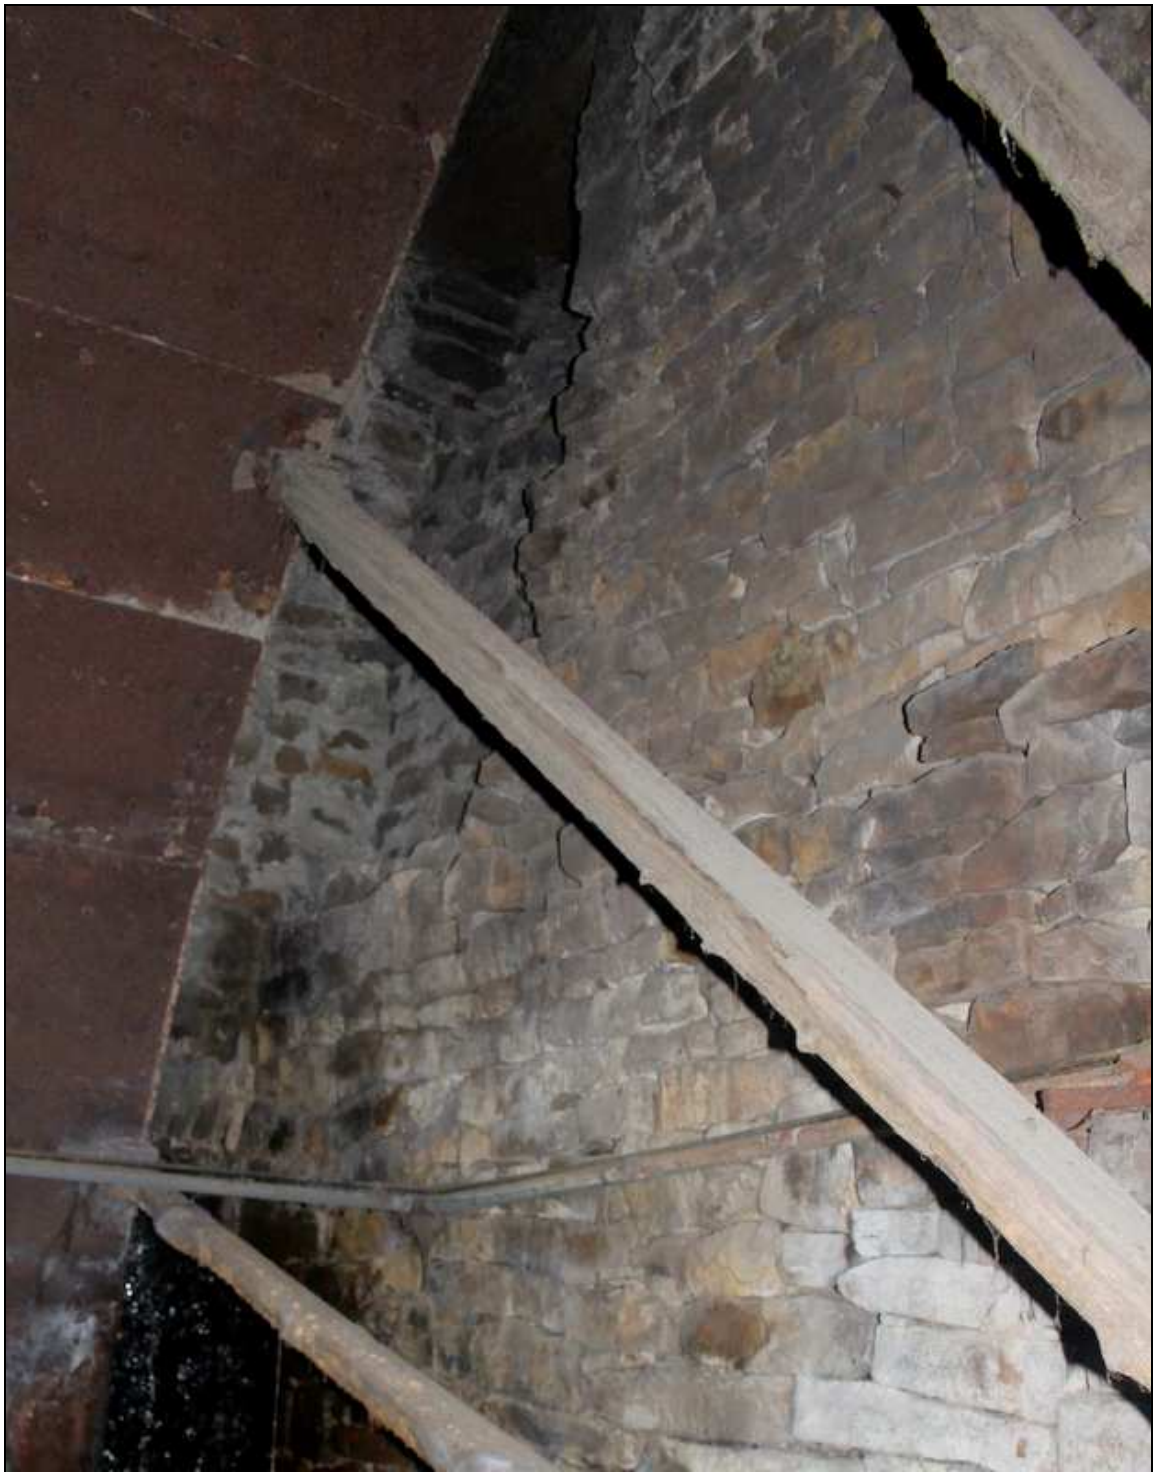
- 3.3.33 The east wall of the wheel pit diminishes in thickness to each floor level, consistent with that of an external wall (Plate 69). Quoin stones on the edge of an infilled aperture at the north end of the east wall, just below ceiling level (Plate 72), appear to represent the southern jamb of a doorway affording access to the waterwheel, prior to the construction of an extension on its eastern side. A concrete bridge with doorways either end, inserted across the southern side of waterwheel bay, cuts the waterwheel, rendering it unusable, but provided access between the original mill, and a later extension to the east of the waterwheel, and was inserted after 1933, when the waterwheel became redundant.

Plate 72: East wall of wheel house with quoin return of probable doorway at to

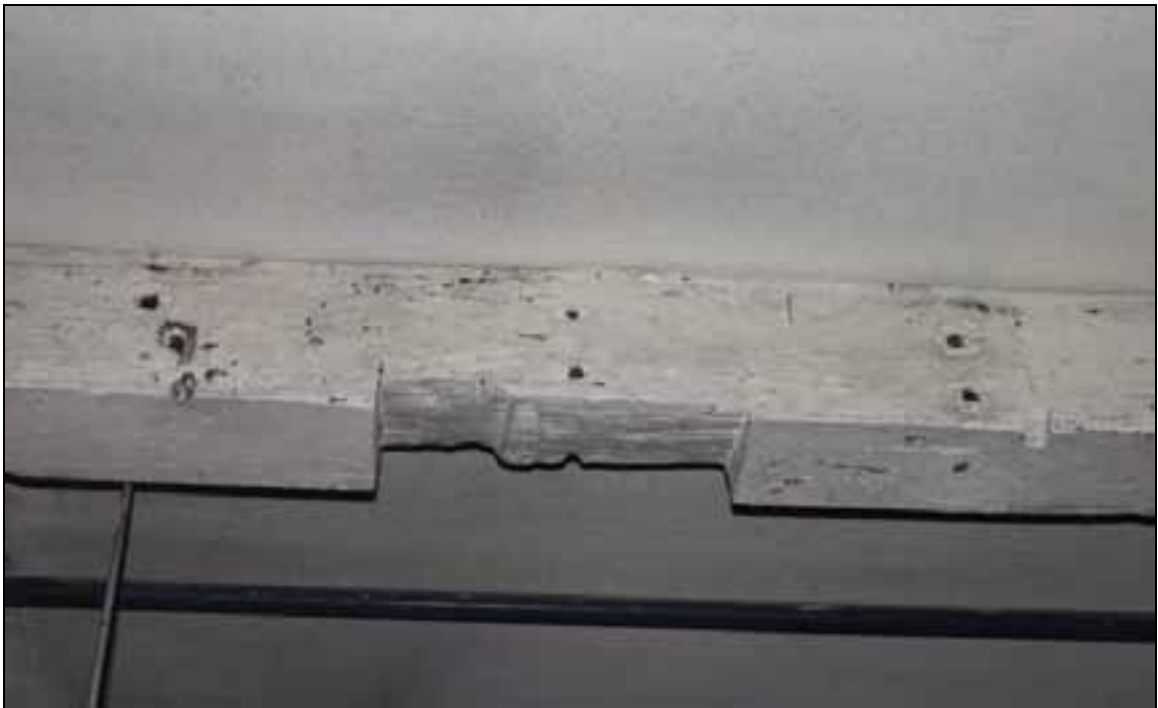
Plate 73: Evidence for original line shafting in east extension

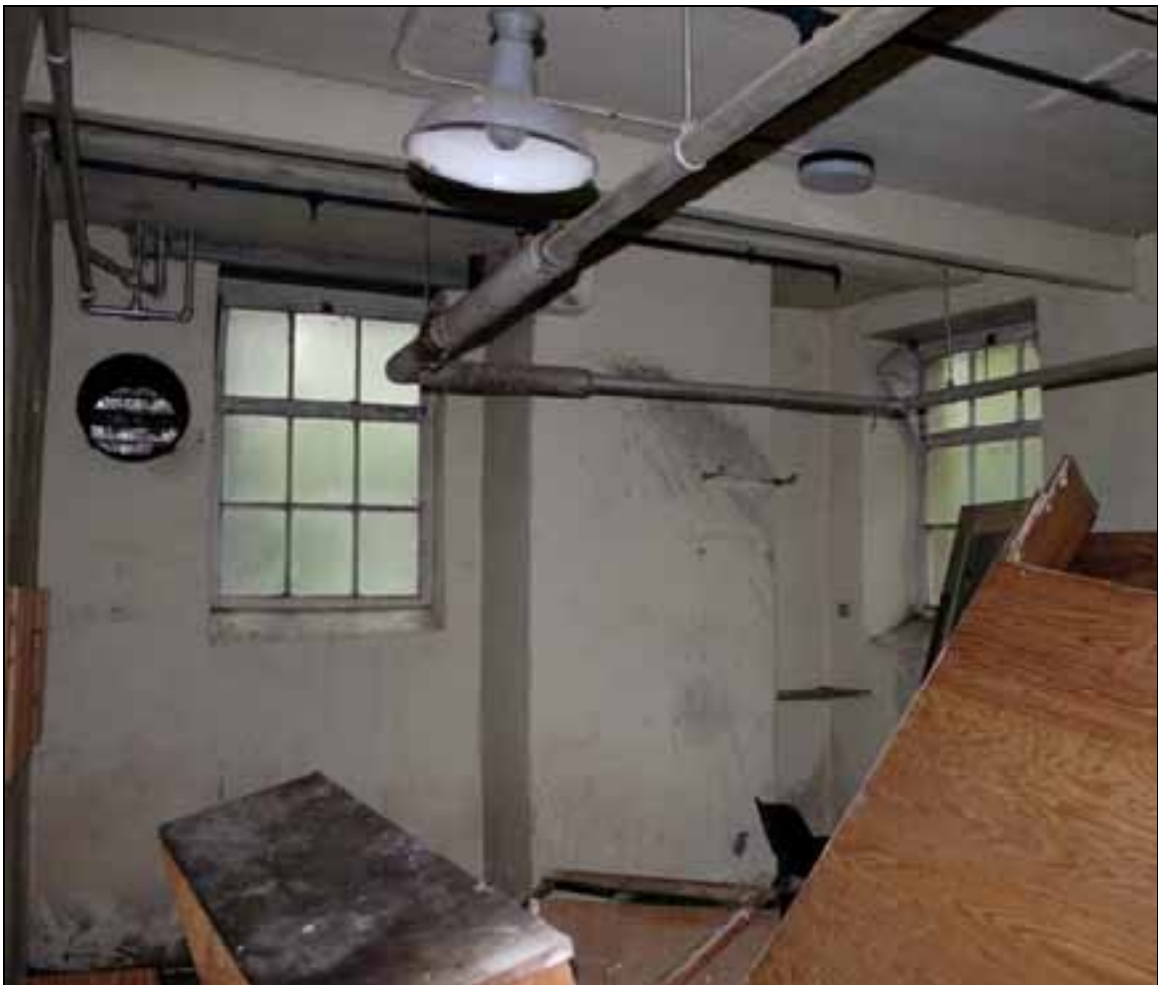
Plate 74: Chimney breast in repositioned north wall of east extension

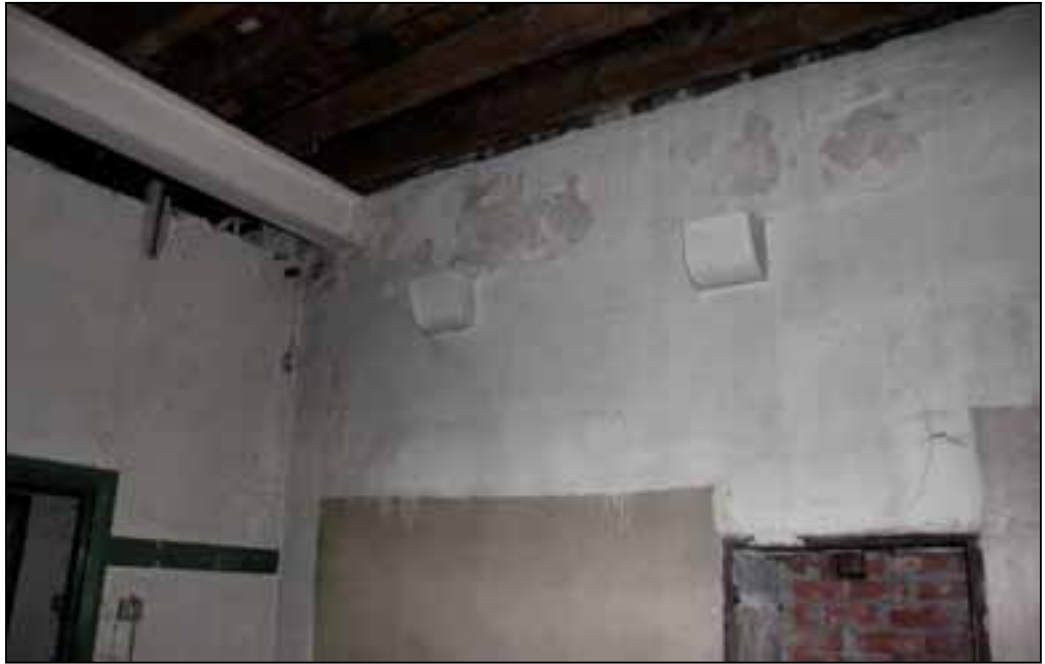
Plate 76: Sandstone corbels in south external wall of original eastern extension

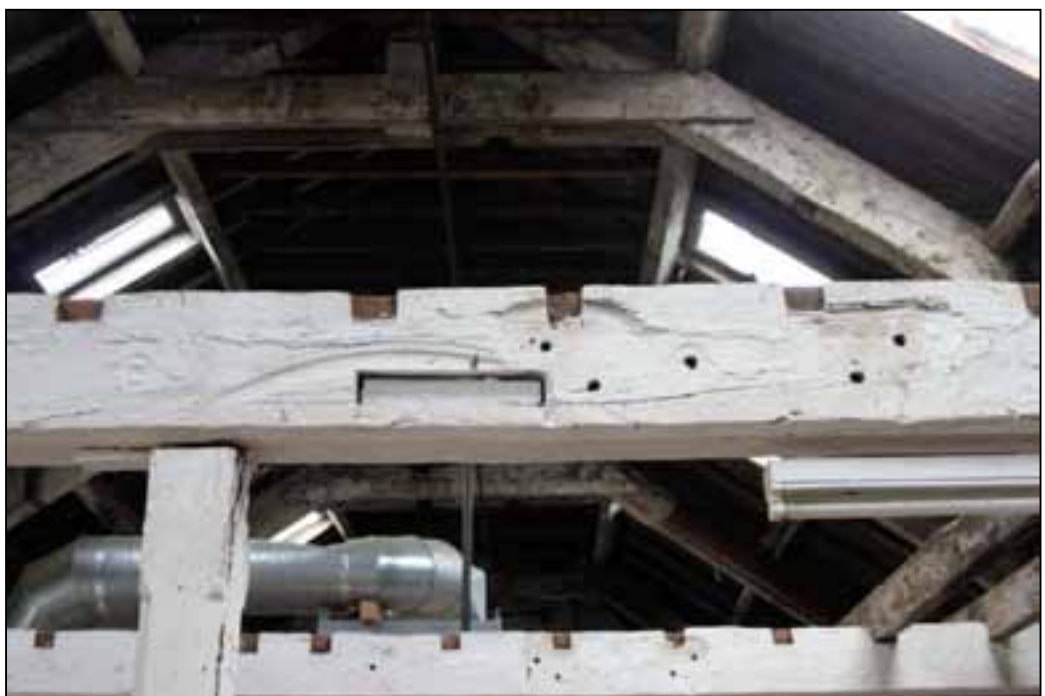
3.3.37 **Second floor:** the second floor of the spinning block was similar to that below, with timber props supporting the original beams at their midpoint. Whilst most were plain, that in the eastern bay of the original spinning block was lamb's tongue-chamfered (Plate 77). The original beams were, however, not scarf-jointed into timber beams extending to the wall of the northern extension of the original mill, as on the floors below, but instead remained short of the repositioned wall (Plate 78), their exposed ends being supported on hollow cylindrical, cast-iron columns of varying type, having either a flat or a ribbed head plate (Plates 78 and 79), and a plain, or octagonal-section foot (Plate 78).

Plate 77: Drum scar and line shaft bolt holes, second floor
