Kirk Mill, Chipping, Lancashire

Archaeological Building Investigation

Oxford Archaeology North

August 2013

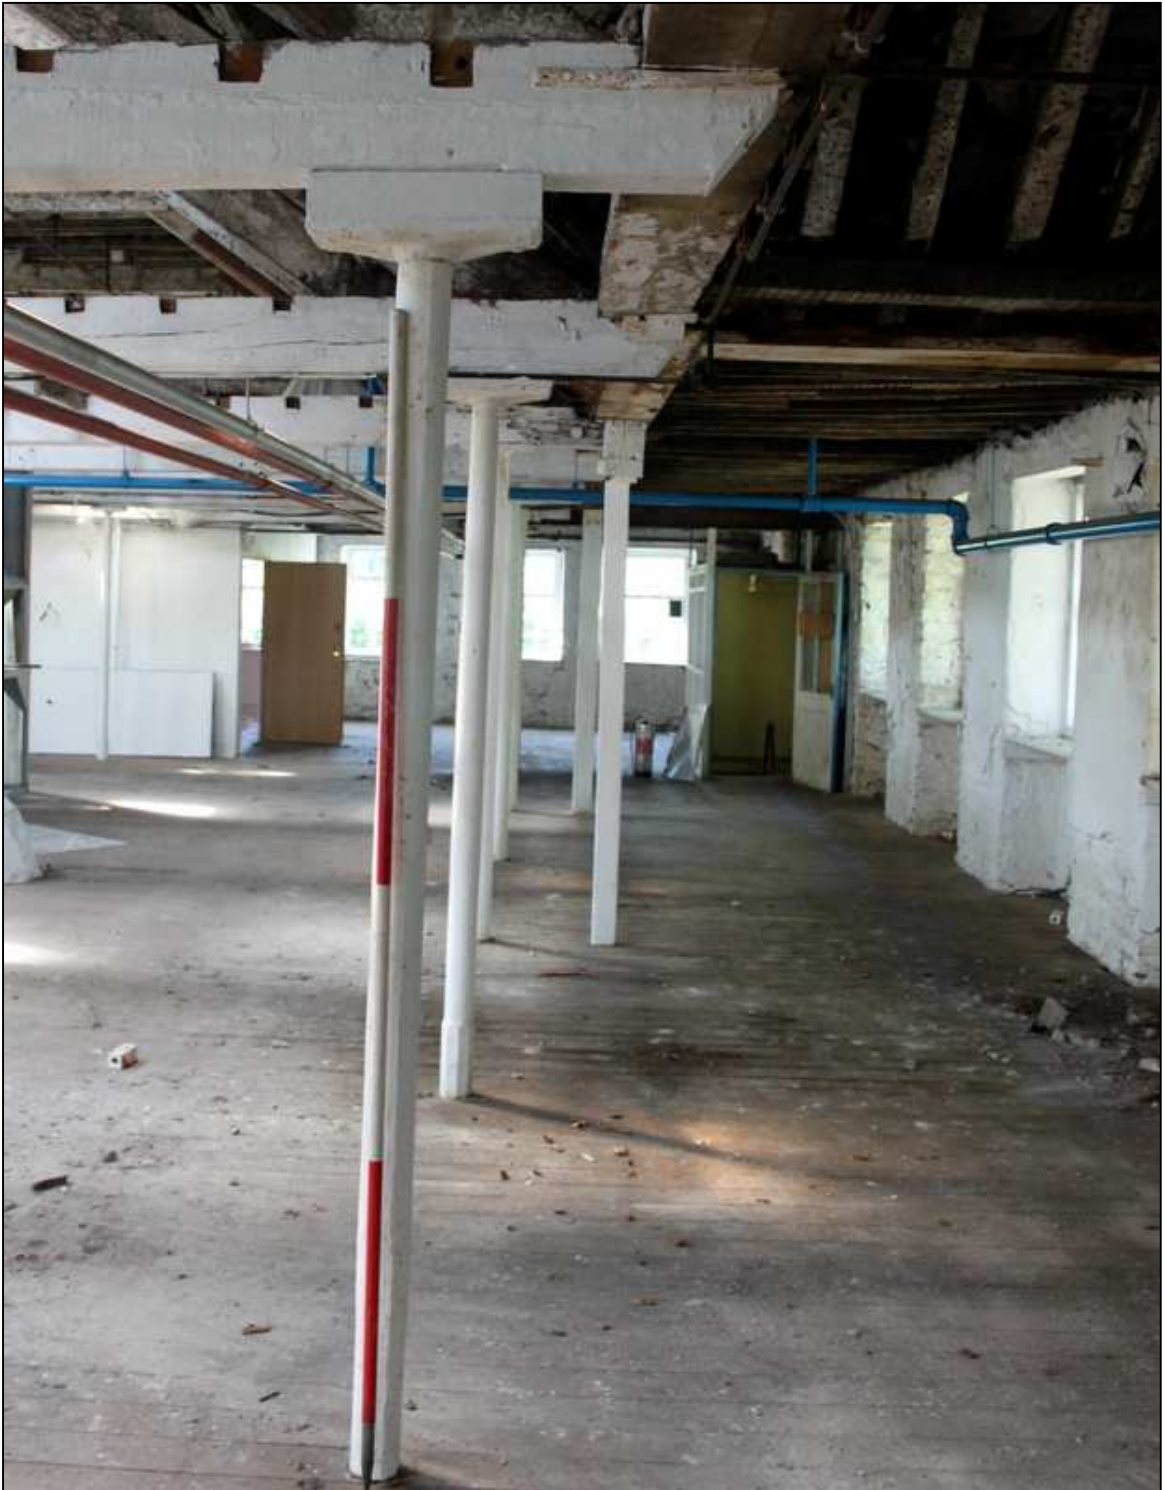
Plate 78: Second-floor columns supporting exposed beam ends

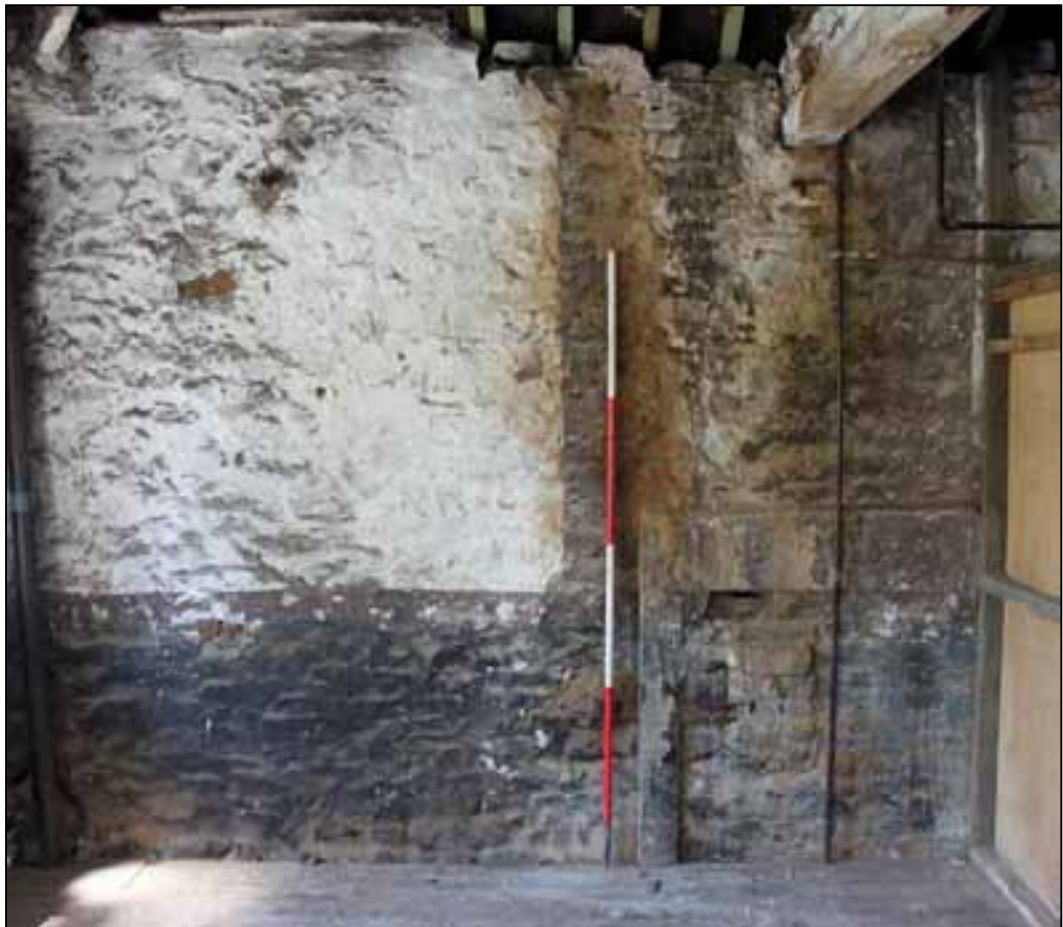
- 3.3.41 Within the western extension of the mill, a blocked aperture in the north wall had dressed stone jambs and lintel, and appeared to have formed a fireplace (Plate 82). This may have formed a small office in the original construction of the west wing, where it extended beyond the main mill at that time. It was presumably blocked when the earlier structure was extended, with the whole of the western extension forming part of the enlarged spinning floor.

Plate 82: Jamb and lintel of fireplace in north wall of west wing

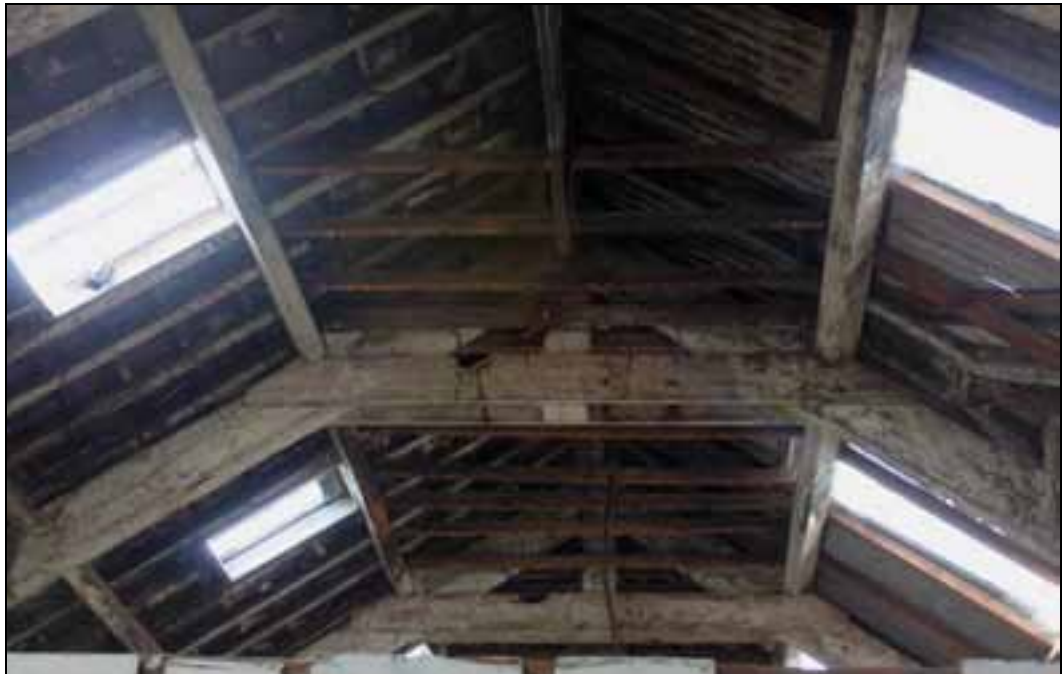
3.3.42 The earliest extant element of the roof comprised king post trusses, with clasped ridge purlin and sandstone roof tiles, carried on three purlins to each pitch (Fig 4; Plate 83). The purlins were butt-ended above the trusses which have chiselled roman numeral assembly marks on their eastern faces (Plate 84), and originally had angled braces from the angled king post foot to immediately below the central purlin of each pitch, as demonstrated by blocked or redundant sockets in this position on each principal rafter (Plate 77). The king posts of each truss were cut subsequently, and the angled braces removed, with collar planks placed across each truss, at the height of the upper purlins (Plates 77 and 83). This created an open loft, and dovetail housed sockets in the tie beams (Plate 77), demonstrating that the loft formed was floored at this time. The new collars also have semi-circular cut-outs in their upper faces (Plate 83), almost certainly to carry a pipe for the sprinkler system, rather than a timber line shaft, which would have generated too much friction and heat in a weight-bearing timber housing.

Plate 83: Remodelled king post trusses

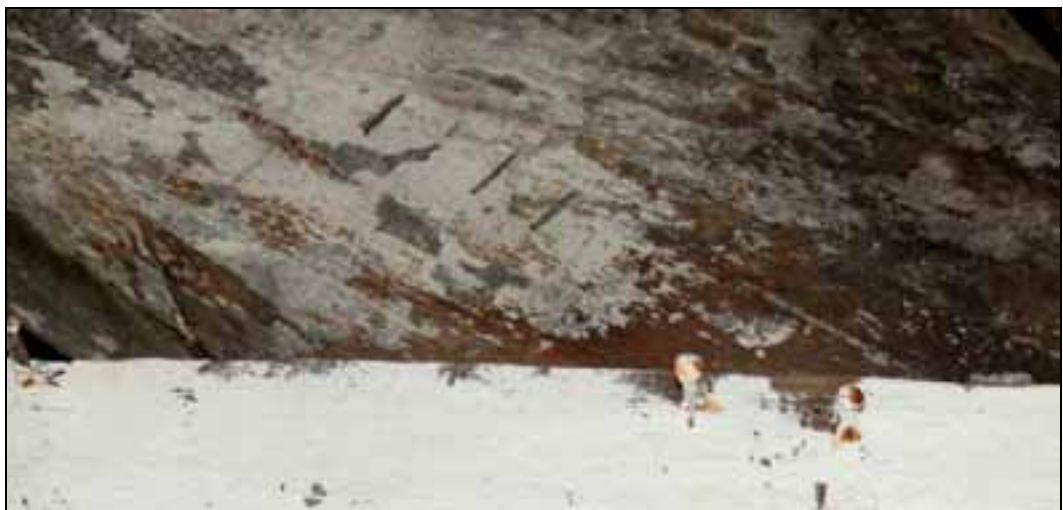
Plate 84: Chiselled carpenter's assembly marks

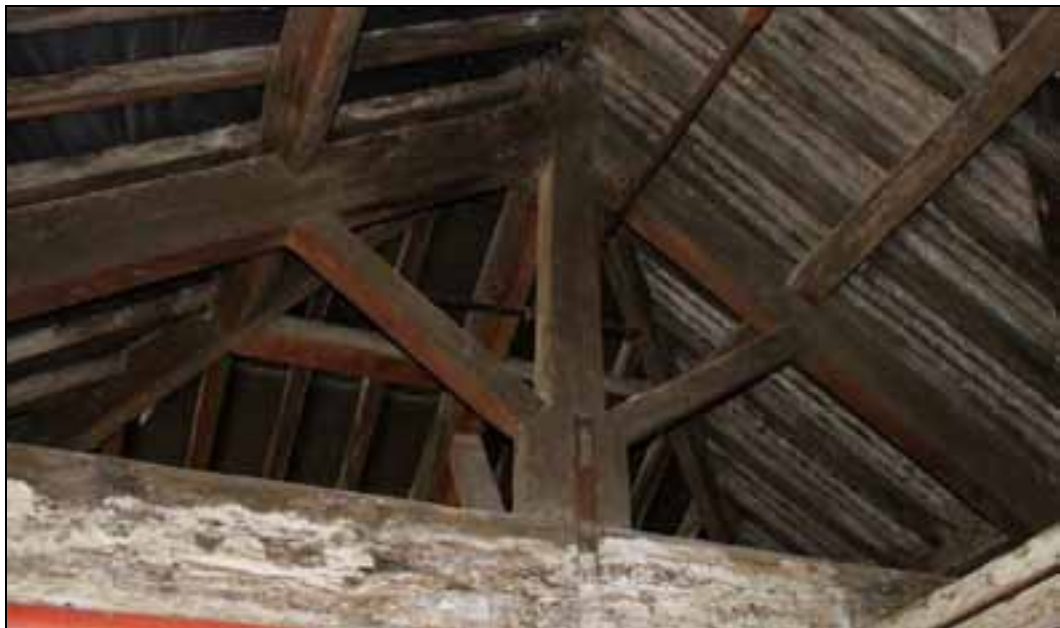
- 3.3.43 The western extension of the mill has a perpendicular roof formed of braced king post trusses, with the king post stirruped to the tie beam with an iron strap (Plate 85). Despite the obstruction caused by the king posts, longitudinal trimmers between the tie beams have double-tenon mortices in their faces for floor joists (Plate 86), indicating that the roof space was utilised.

Plate 85: King post truss above west wing

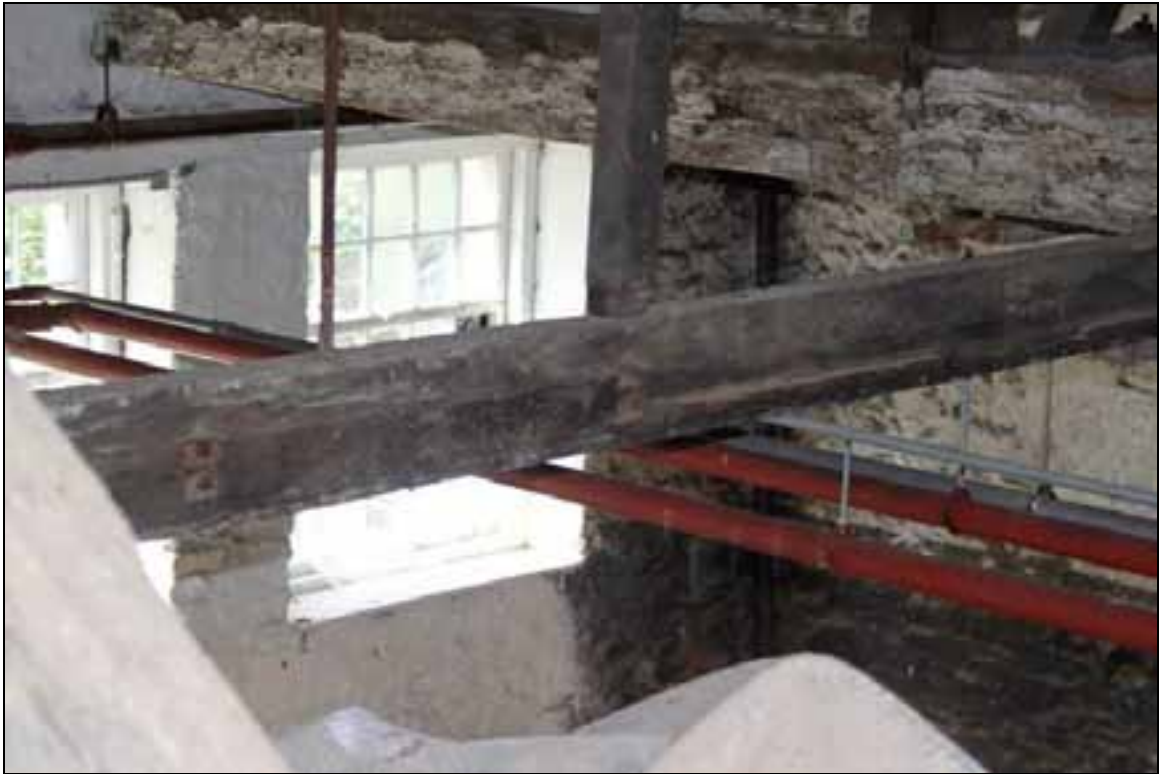
Plate 86: Mortices for ceiling joists above west wing

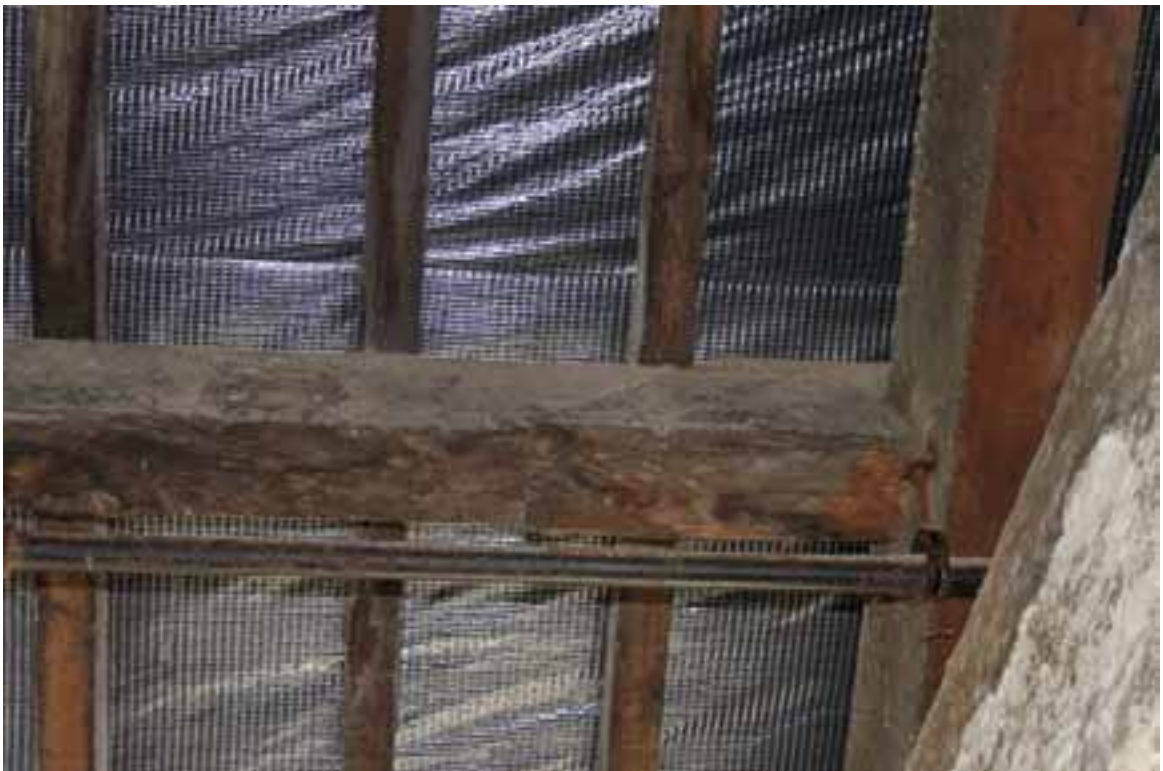
- 3.3.45 A lath and plaster wall was also inserted into the roof space between the two roofs (Plate 87). The purlins of the new west roof were trenched, through purlins, rather than being butt-ended, as in the earlier roof, and were longitudinally jointed with simple splayed scarf joints (Plate 89).

Plate 89: Scarf joint in purlin of west wing

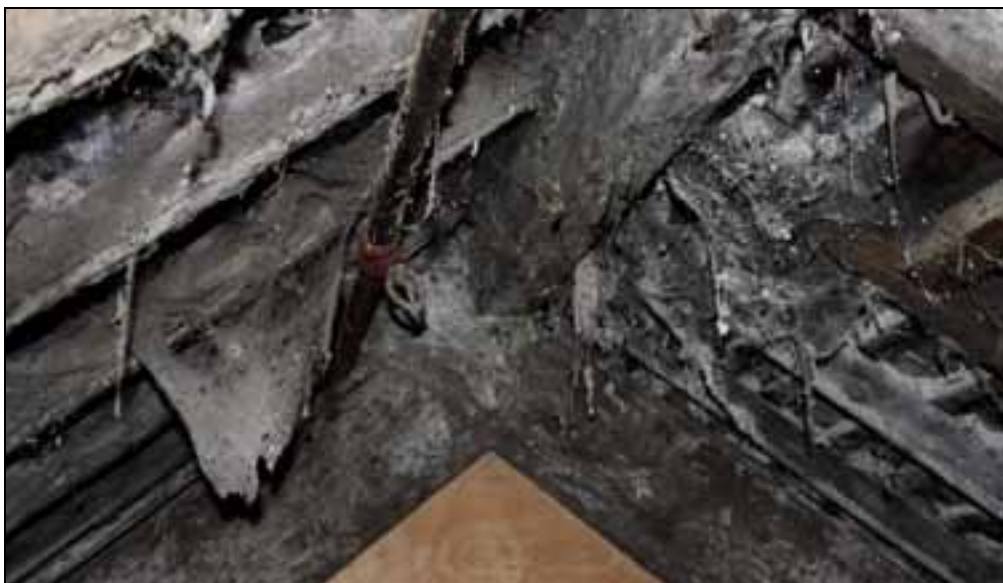
Plate 91: Apex of stair tower roof

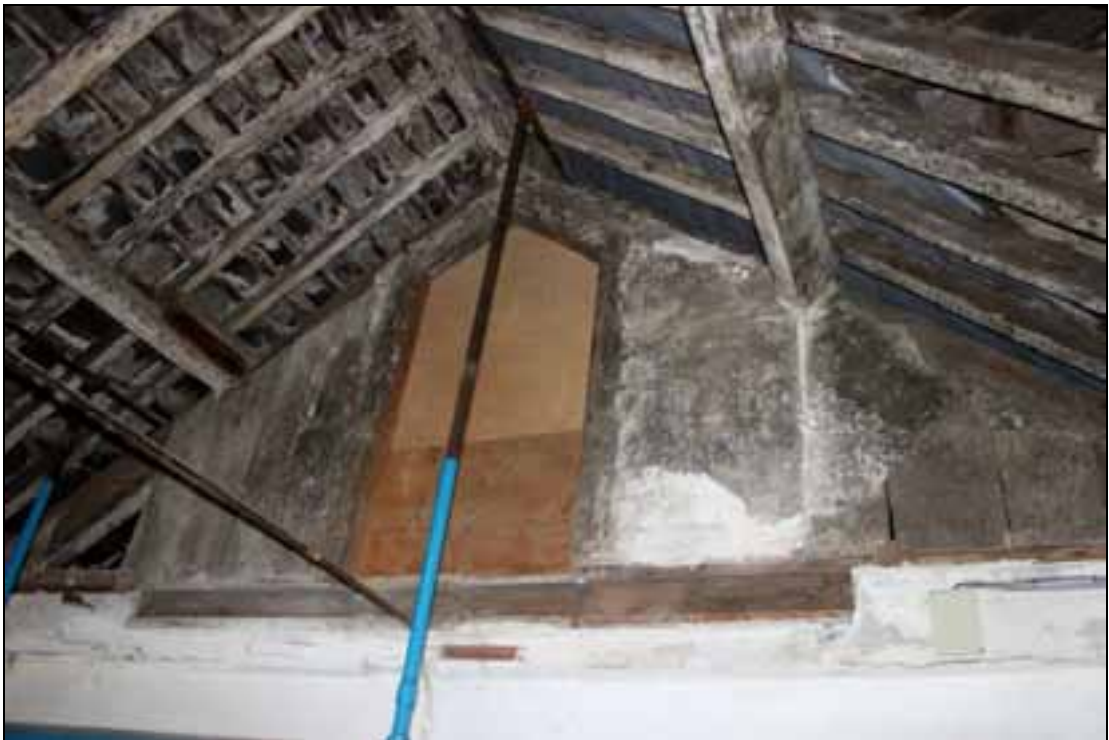
Plate 92: Doorway in attic above stair tower, with associated lath and plaster partitions

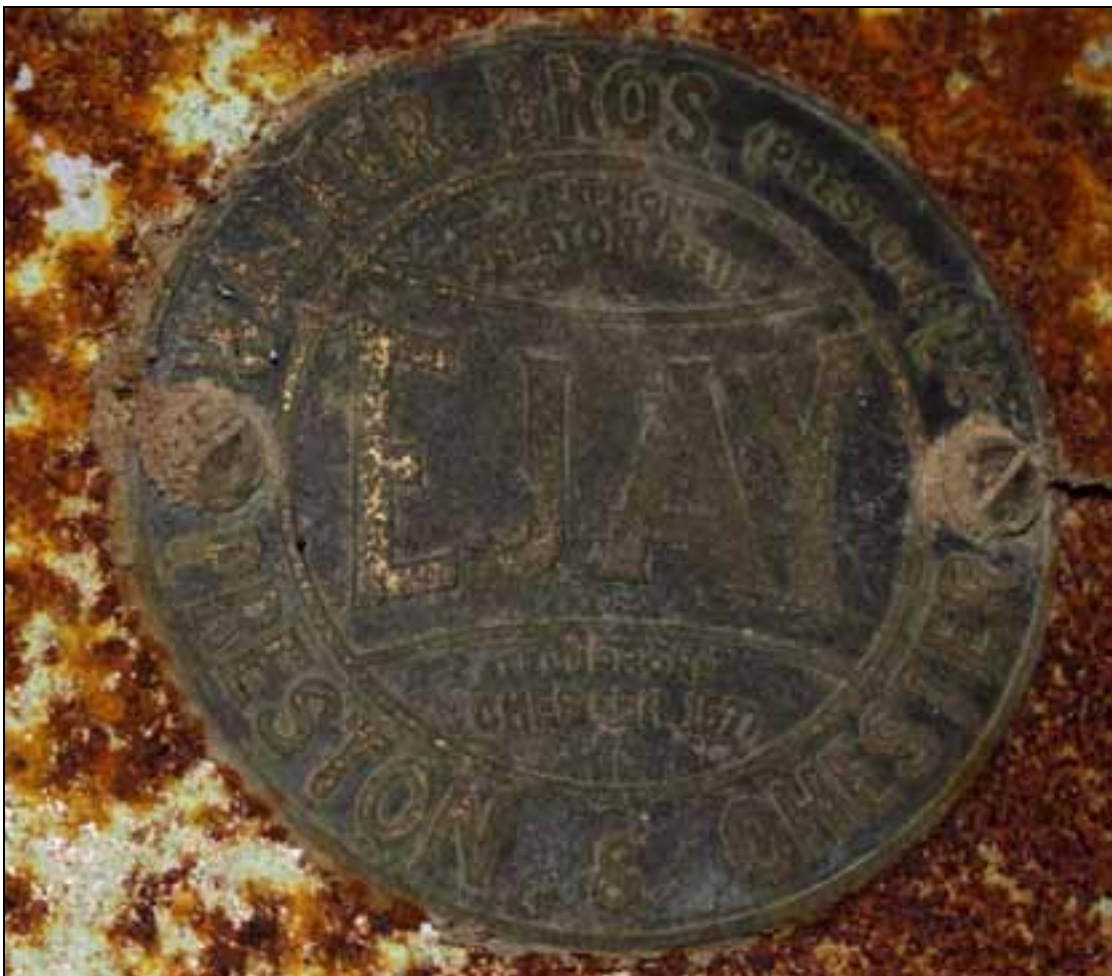
Plate 93: Maker's plate on fire-fighting hose reel

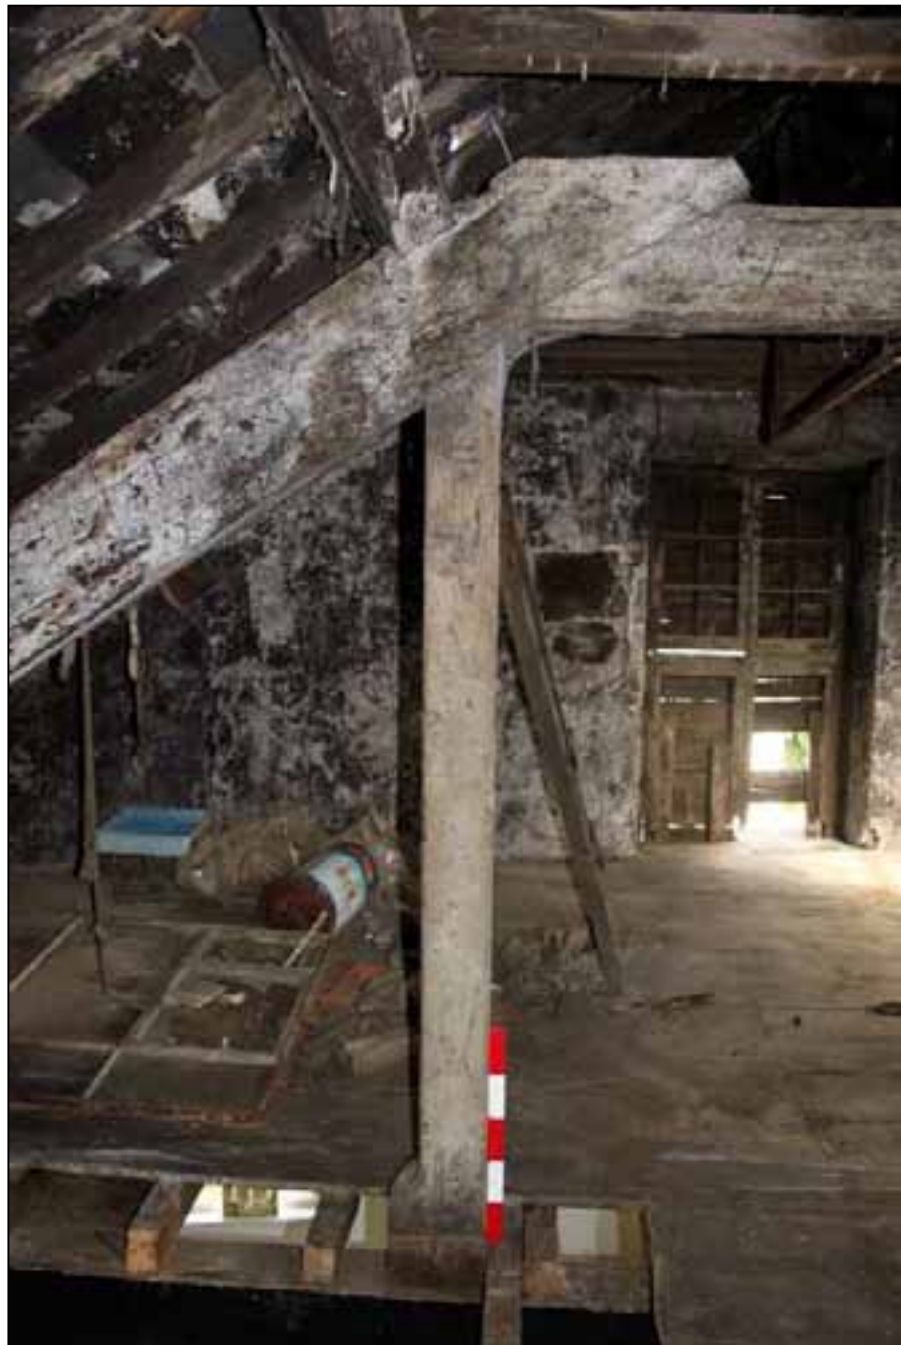
3.3.48 The roof of the eastern extension appears similar to that above the engine and wheel houses, having open bays within the attic. However, the trusses comprise queen struts, rather than queen posts, with the vertical members supporting the principal rafters of the truss (Plate 96), which extend only as far as the collar (kerb principals). The struts have similar jowled feet to the earlier examples to the west (Plate 96), suggesting that angle braces to the lower purlin may have been utilised in the original construction of both phases of the roof. The collars of each truss, and the straining beams of the earlier trusses to the west have semi-circular cut-outs, similar to those of the king post trusses to the west, and almost certainly relate to a pipe for the sprinkler system, rather than for a line shaft (Plate 94).

Plate 96: Queen strut truss above east extension
