Kirk Mill, Chipping, Lancashire

Archaeological Building Investigation

Oxford Archaeology North

August 2013

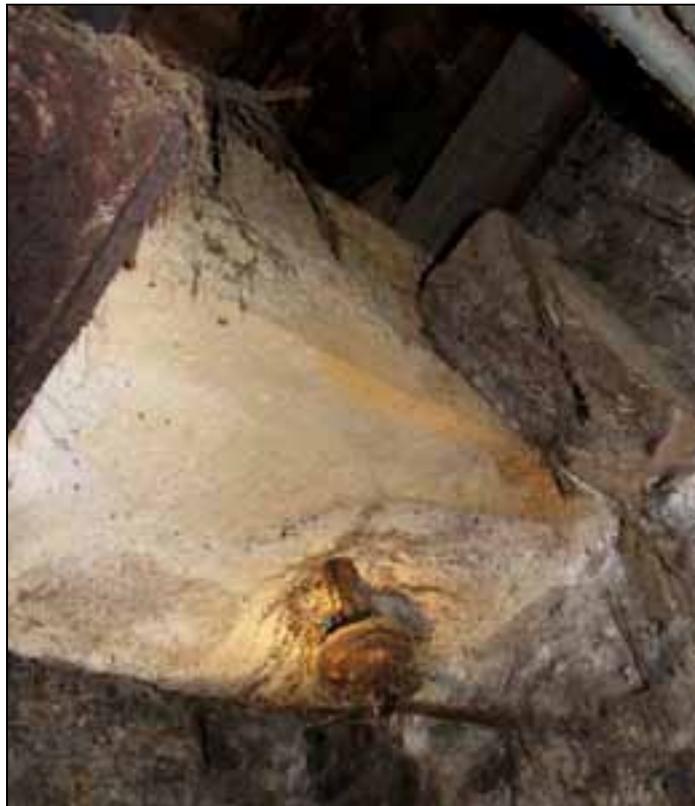
- 3.3.13 Additional timbers were placed between the eastern beams at their northern ends. One of these has bolts projecting from the soffit, 2' apart, relating to the northern line shaft, and aligns with a 2' wide end bearing box in the east wall (Plates 40 and 41) above a significant stone base supporting the gearing for the waterwheel above (Plates 41 and 42).

Plate 42: Large sandstone footstep for waterwheel gearing

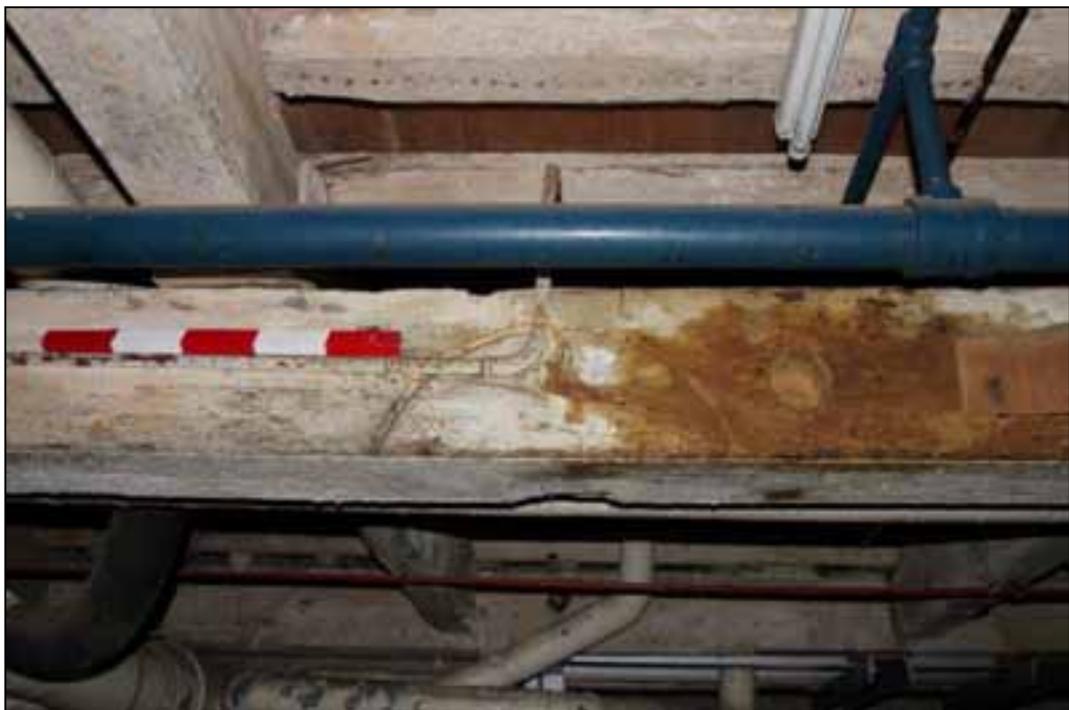
3.3.14 Within the western extension, the longitudinal beam clasped to the ceiling beam (Plate 35) had several cut-outs in its western face for line shafting, the southern example having an accompanying 18" (0.46m) diameter drum roller scar (Plate 43). However, none of these aligned with other line shafting, which ran perpendicular to this beam, strongly suggesting that it was reused in its present position. At their eastern end, the ceiling beams of the extension are lap-jointed into a 5½ x 12" transverse beam with a very slender chamfer. This has a gouged 6 x 4" semi circular shafting rebate towards its northern end, overlain by a later 3½ x 10" timber fitch plate on its eastern side, demonstrating the disuse of the line shaft at this time. The beam also bears the compression scar for a column head plate in a similar position to extant columns further to the east within the original part of the mill.

Plate 43: Scar of line shaft drum on face of beam

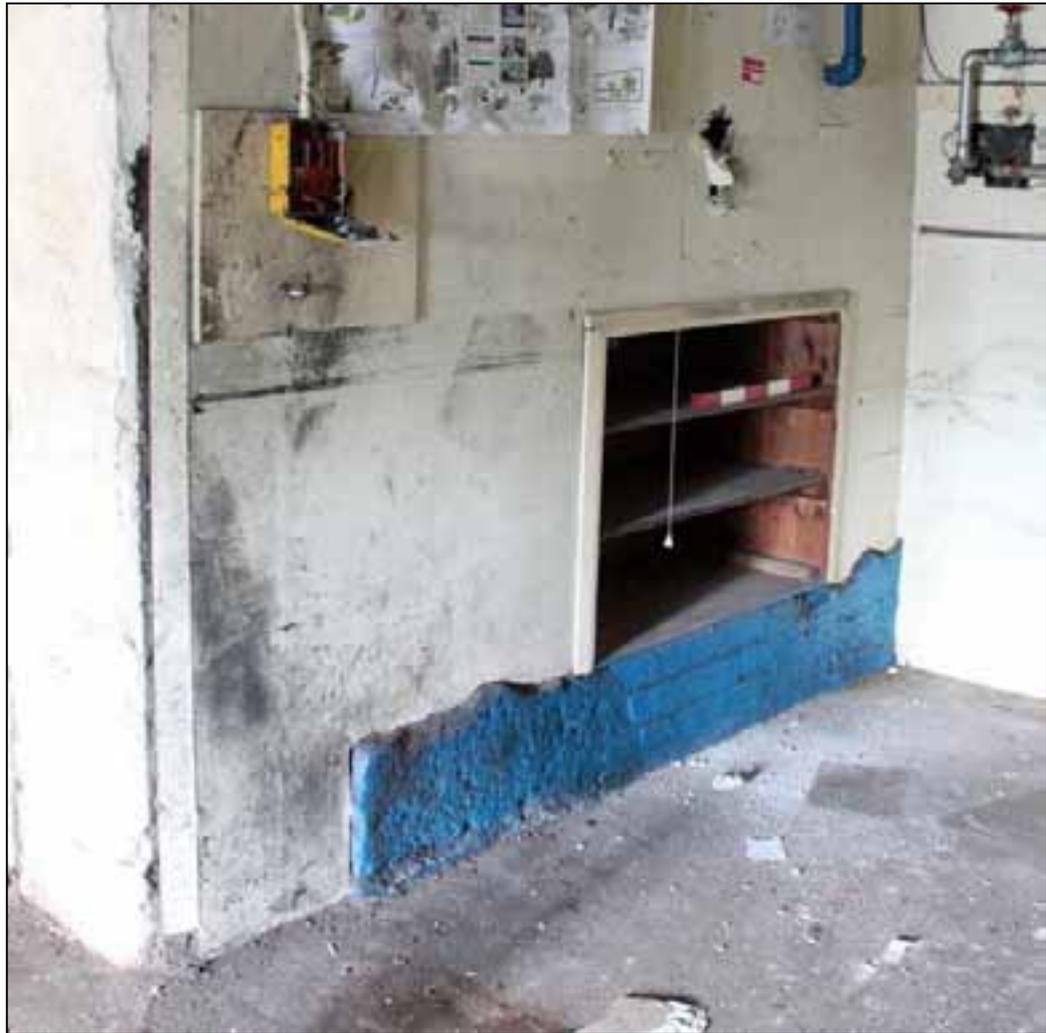
3.3.17 The floor of the adjacent 8' 4" wide bay is 2' higher. This bay has a transverse stone wall, placed on the probable alignment of the original north wall, and which has an 8' southerly return on its western side (Fig 2). At its base, the return has a 7' sandstone block with a central 30" wide rebate, infilled with brick (Plate 45). A cupboard above infills an original aperture through the wall, blocked by a board on the western face. This relates to an axle and drive shaft, but it remains unclear whether this was associated with an earlier waterwheel than that present in the bay to the east, or a later engine, which was almost certainly placed in this bay.

Plate 45: Pad for axle mounting, with curved rebate infilled with brick

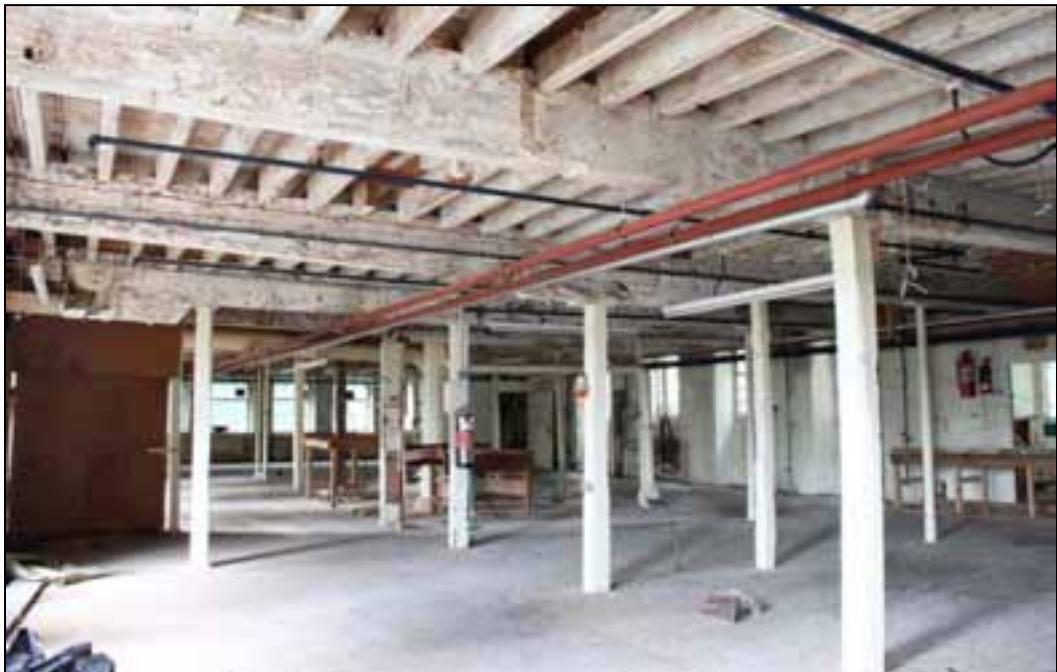
3.3.20 **First floor:** the first floor is of similar construction to the floor below, with scarfed beam extensions to the extant north wall (Plate 47). All of the original beams are supported by timber props at their approximate mid point, several of which retain bark, although that in the eastern bay is lamb's-tongue chamfered to each face (Plate 48). Several beams have further timber props to the north or south, whilst the two inserted beams at the junction with the western extension have a slender cast-iron column, with slight entarsis, and an octagonal foot at their mid-point (Plate 48) with timber props below a pad spanning both beams at the north end. These augmented or replaced cast-iron columns, similar to those at the mid-point, the western of which survives beneath the scarf joint within the western ceiling beam (Plate 50).

Plate 47: General view across the first floor, looking north-west

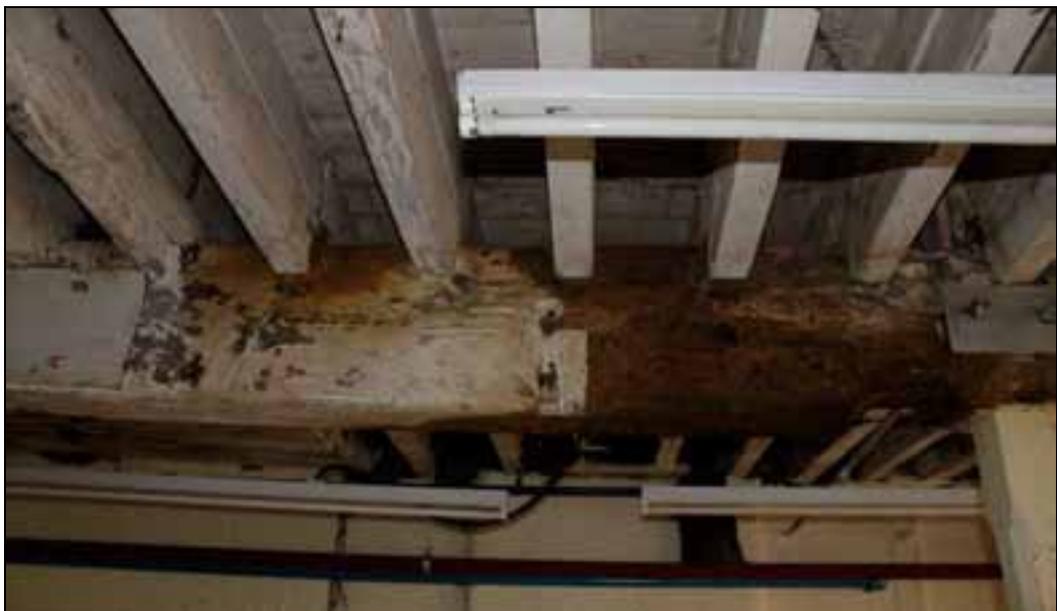
Plate 48: Scar of large drum and chamfered prop

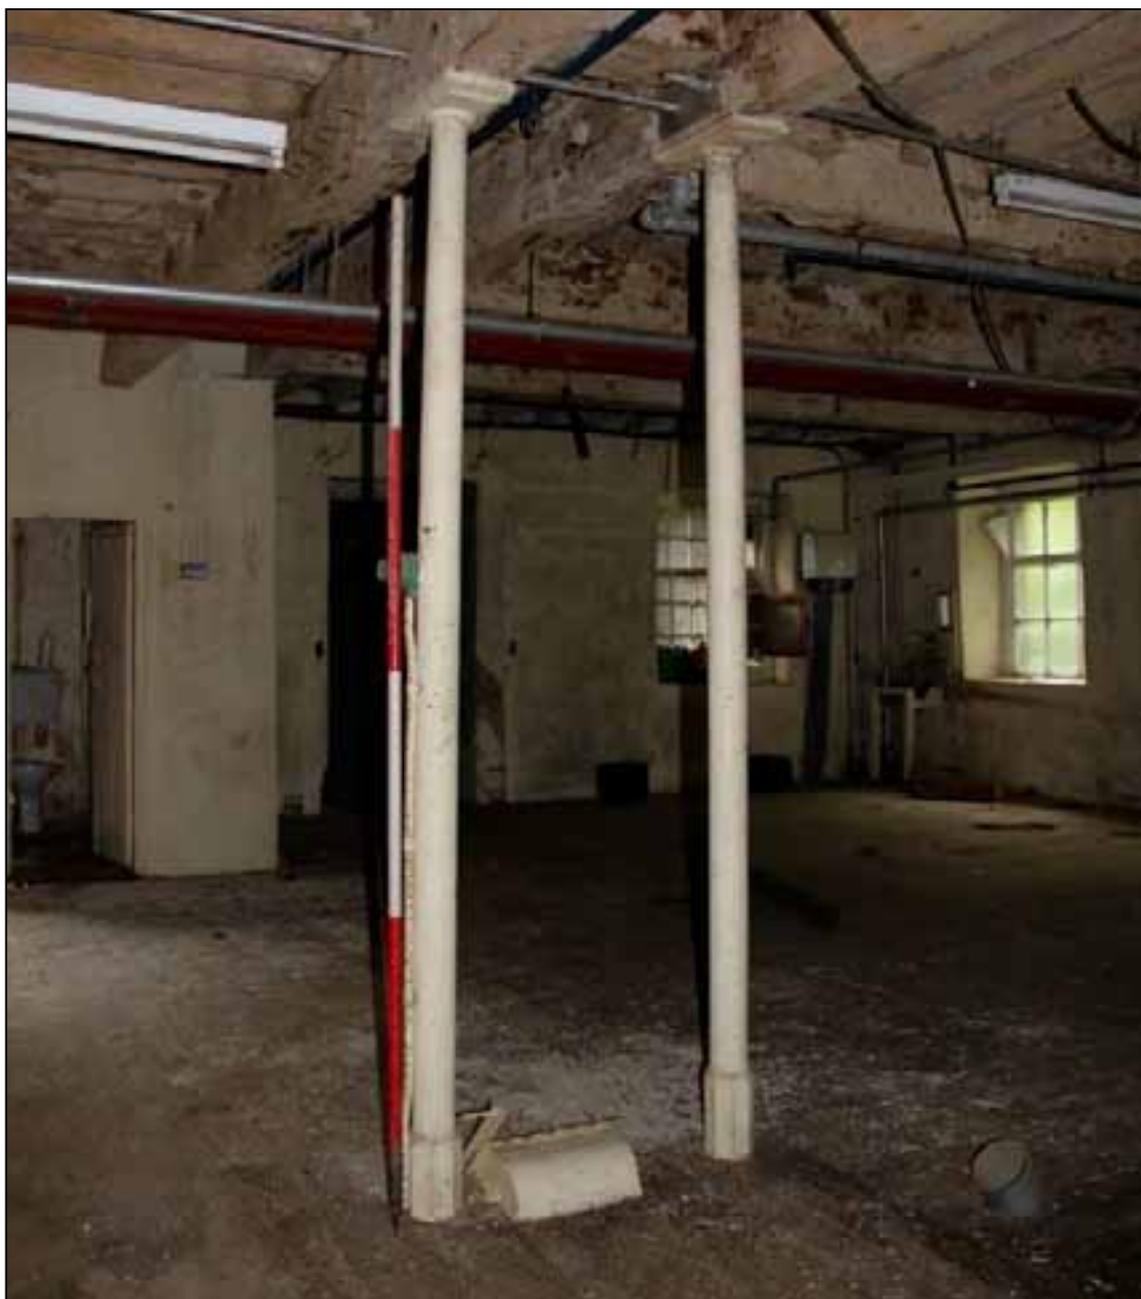
Plate 49: First-floor columns with octagonal-section feet

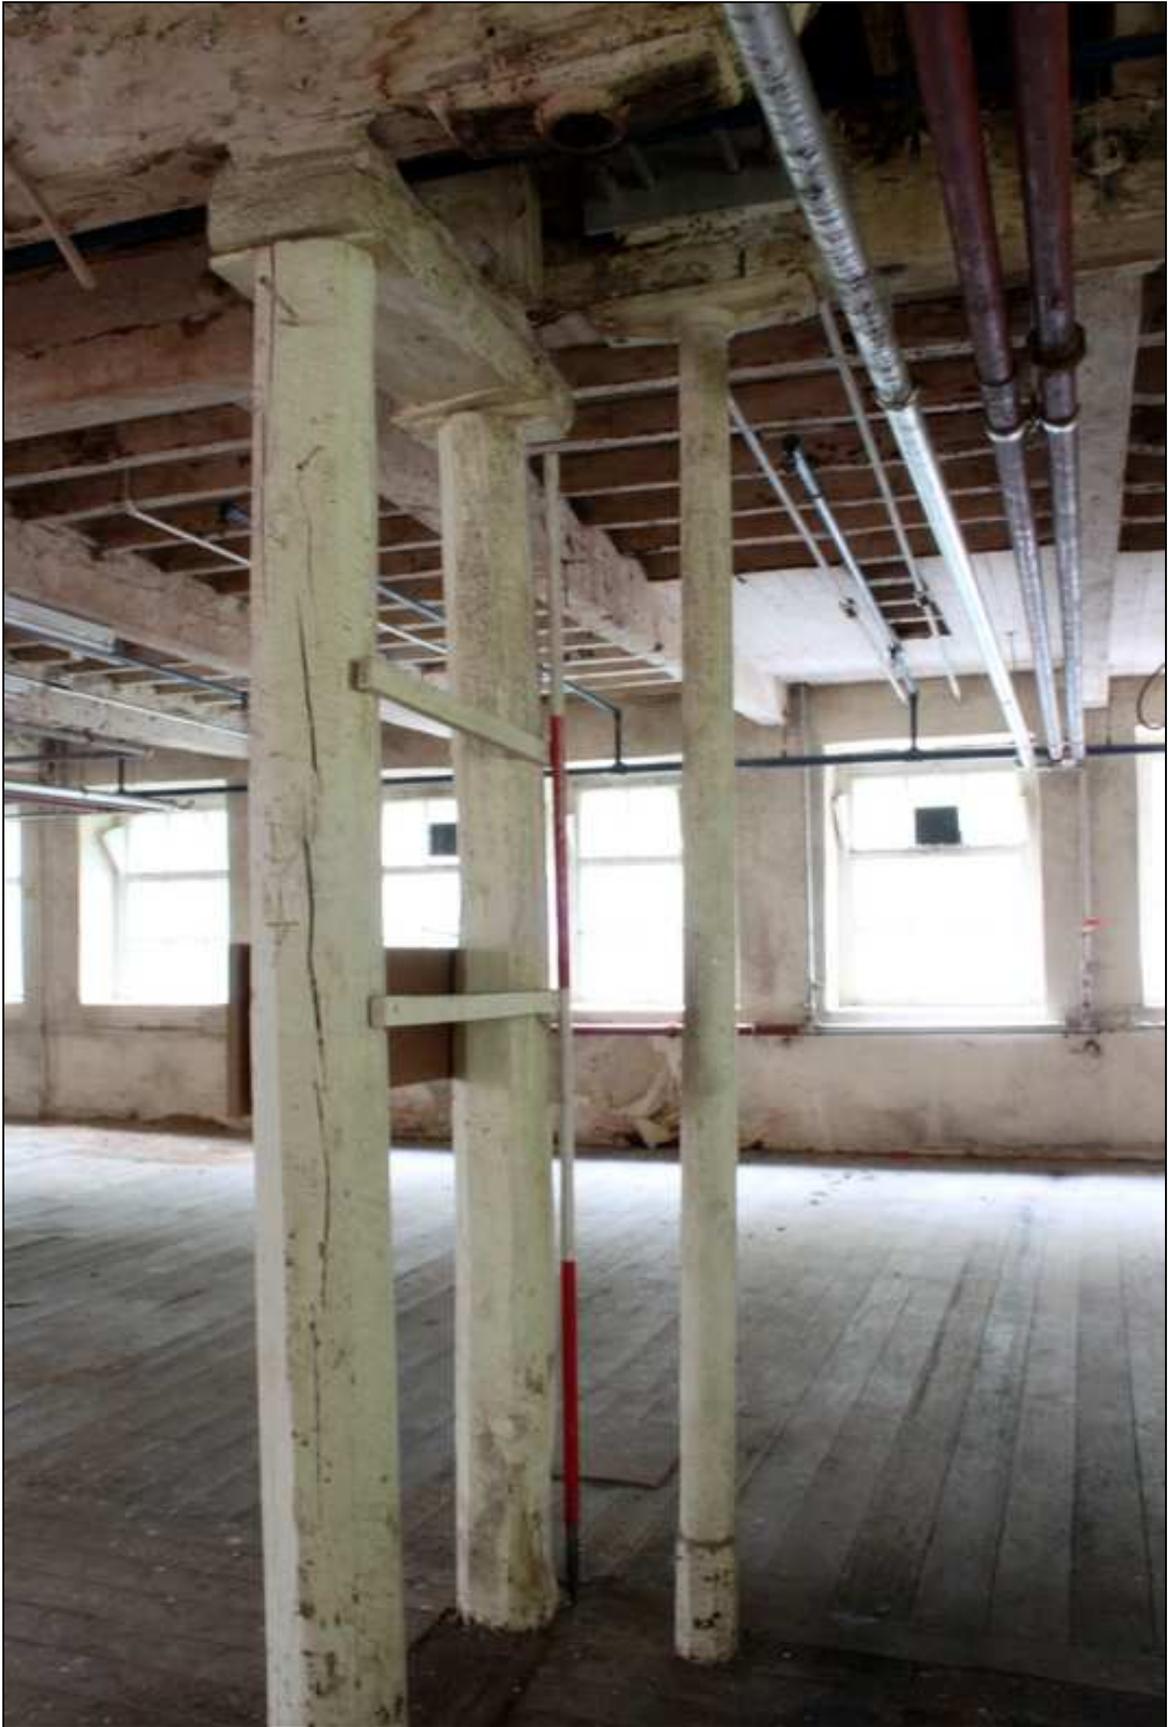
Plate 50: Timber props to ceiling beams adjacent to cast-iron column to scarf joint

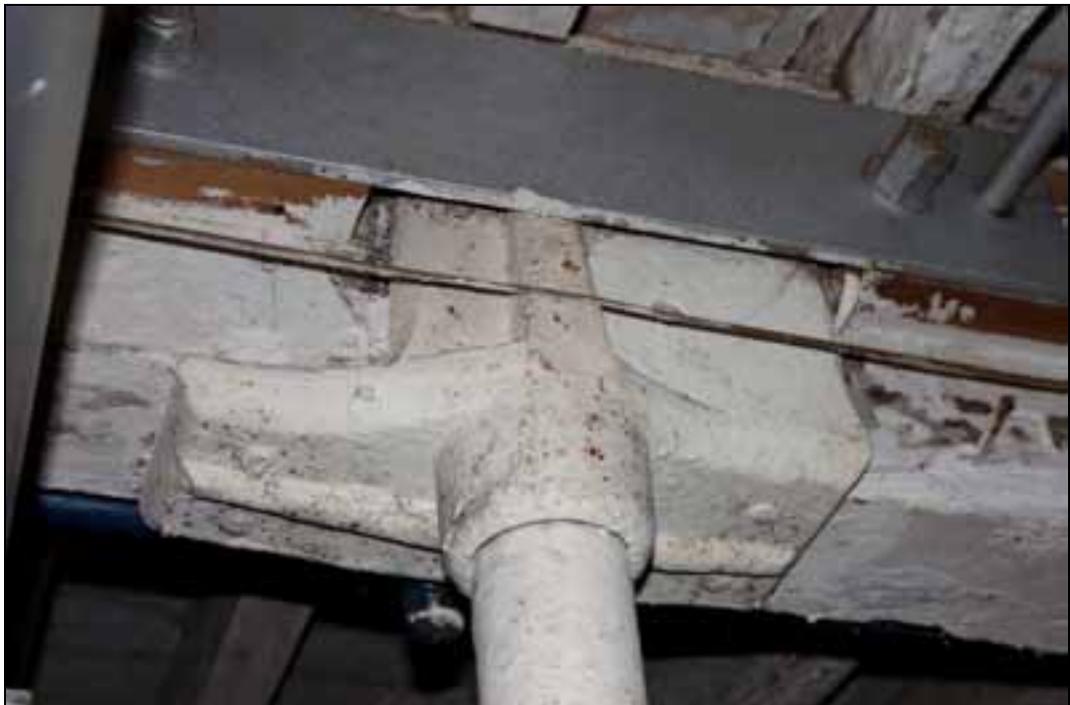
- 3.3.23 All beams have narrow cast-iron columns placed below the scarf joint, with that below the fifth beam having an L-section head plate, offsetting the column to the western side of the beam (Plate 53). Many of the other columns have significant lean, particularly the eastern three bays (Plate 54). The flooring of the main mill at first-floor level comprises 5½" and 4½" north/south-aligned boards.

Plate 53: L-section column head plate

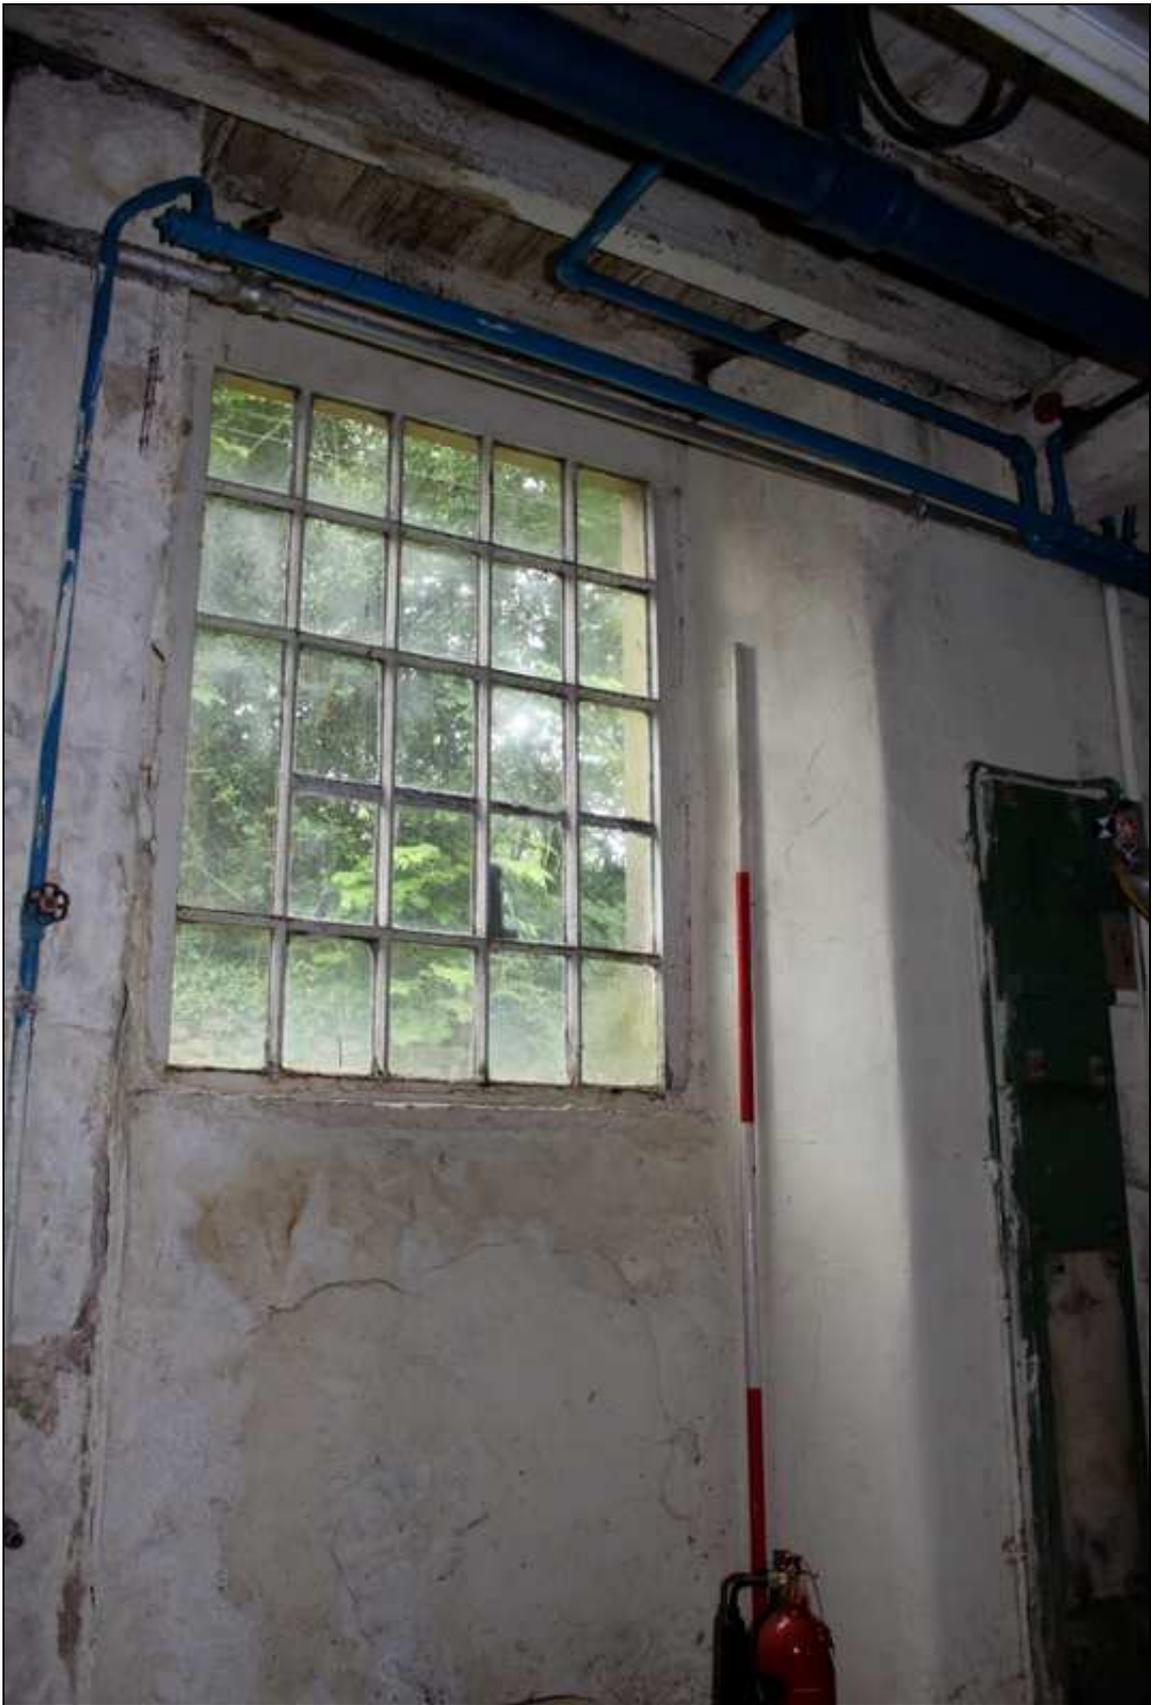
Plate 55: 25-light window in north wall, first floor

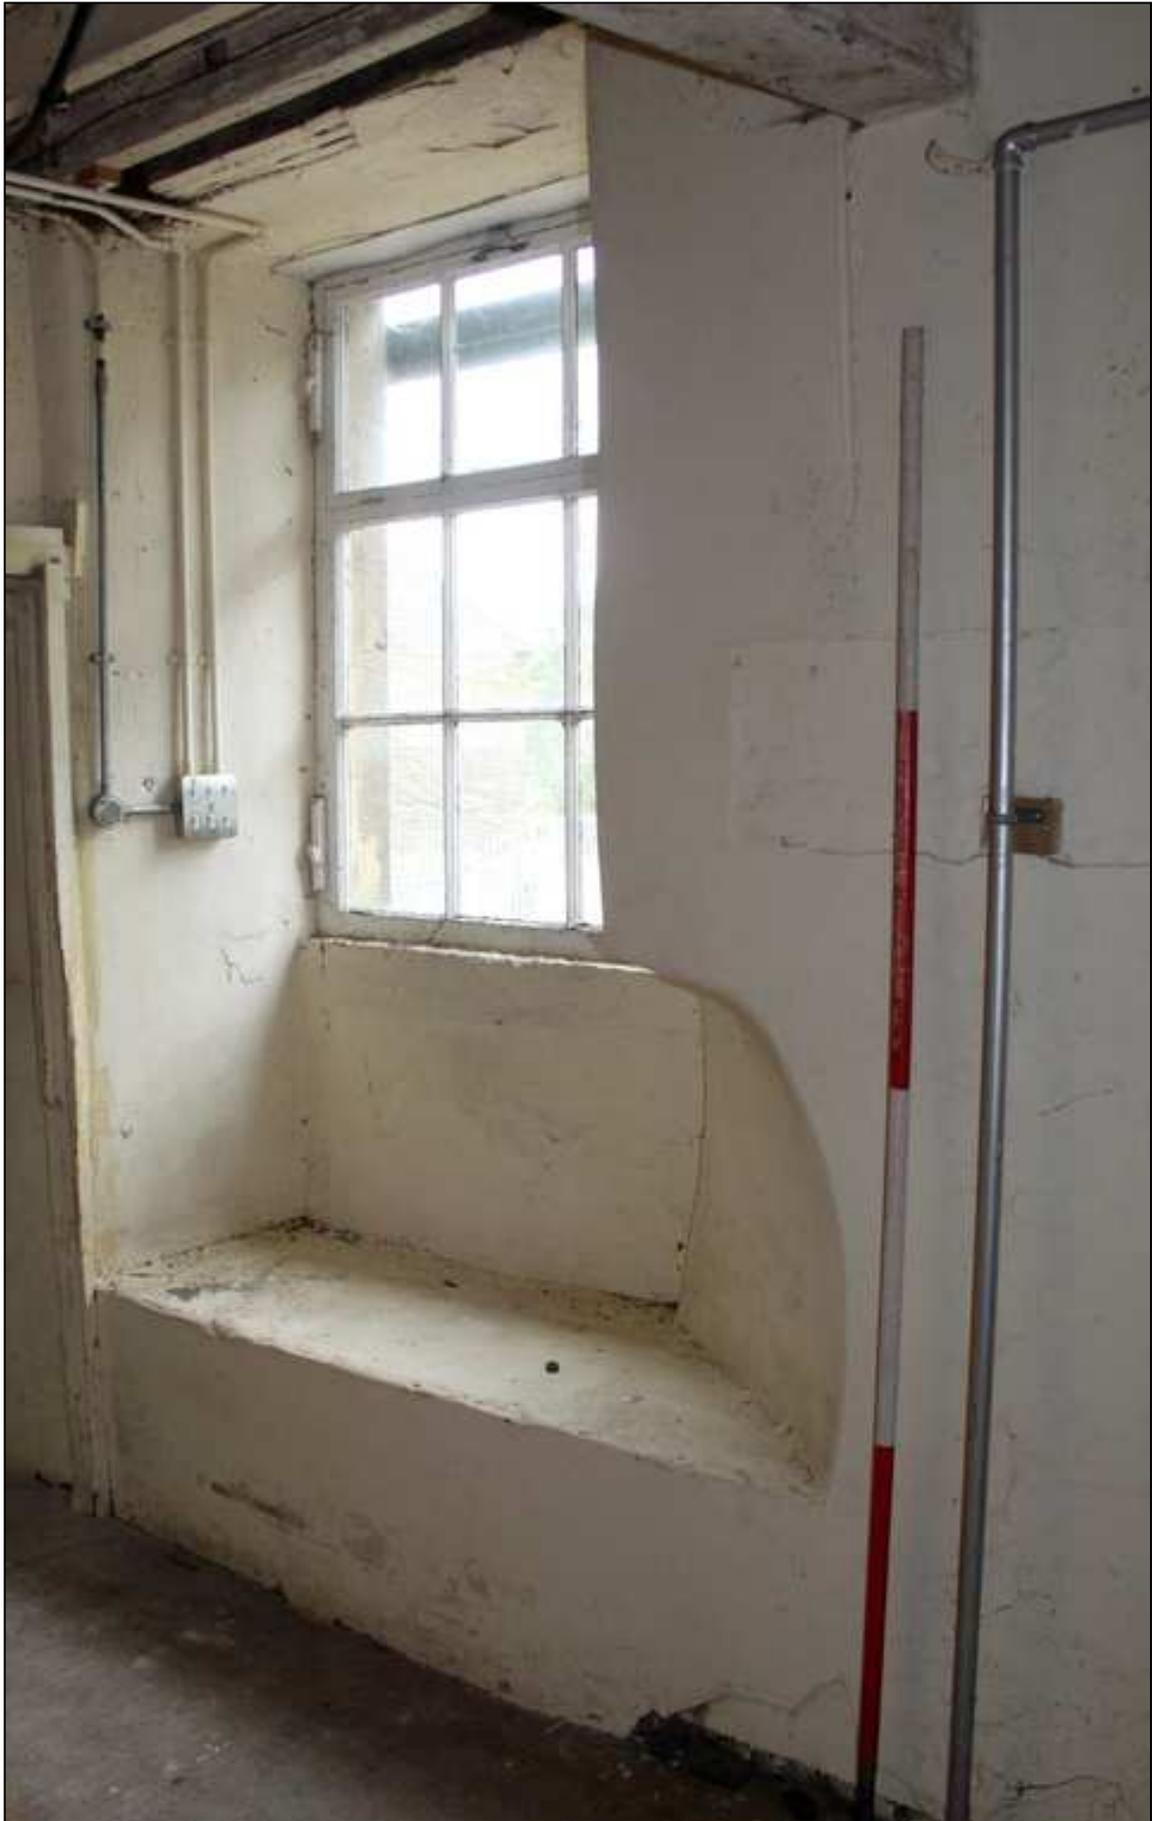
- 3.3.24 The extension to the western end of the mill has a door in the eastern bay of the south wall, with a dressed surround, and apparently representing an original loading door from the yard. All windows throughout the floor in all but the west wall, and the east bay of the south wall are recessed to floor level, with those in the north wall again being offset to a higher level (Plate 55), as at ground floor level. Several retain 25-light small-paned timber windows. The window aperture of the east bay of the south wall has a 20" high sill and a curved 30" high rebate in its western jamb (Plate 56), possibly cut away to allow for the headstock of a wider mule.

Plate 56: Rebate in south wall, possibly for mule headstock

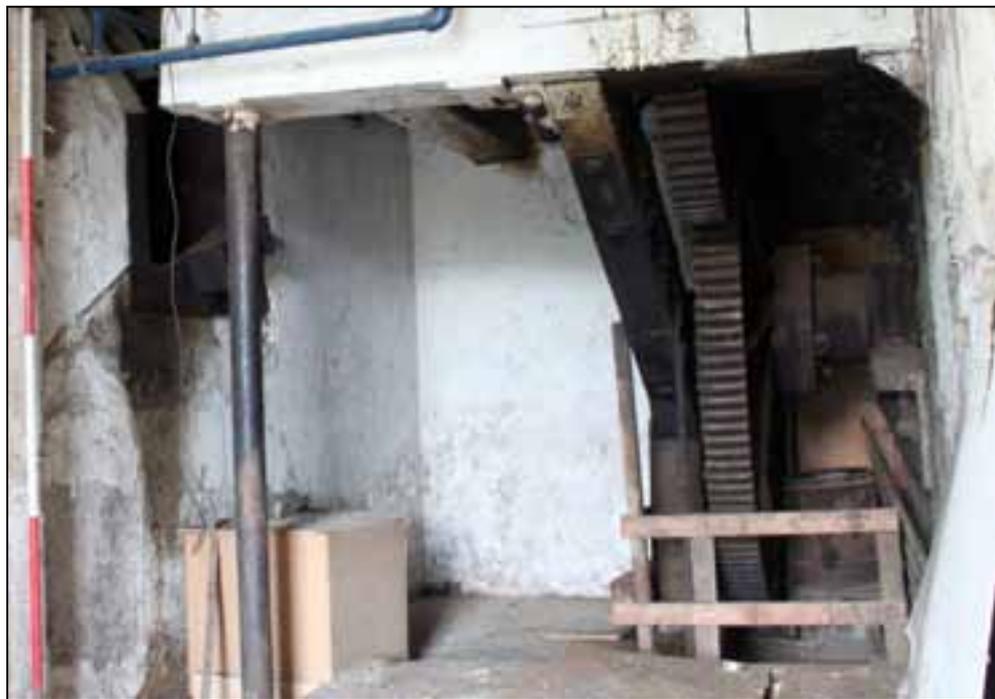
Plate 57: Extant waterwheel gearing

- 3.3.31 The primary motion shaft, beyond the clutch plate has been removed, but it originally passed through a bearing box in the west wall of the bay (Plate 57). This had an additional offset angled casting in its face (Plate 57), presumably associated with the linkage of the shaft from the engine. Bolt holes, two bolts, and compression scars in the soffit of the transverse beam within this bay (Plate 68), relate to a mounting for a hanger, possibly carrying a bevel gear, translating a vertical drive from the engine below towards the wall-box to the west.

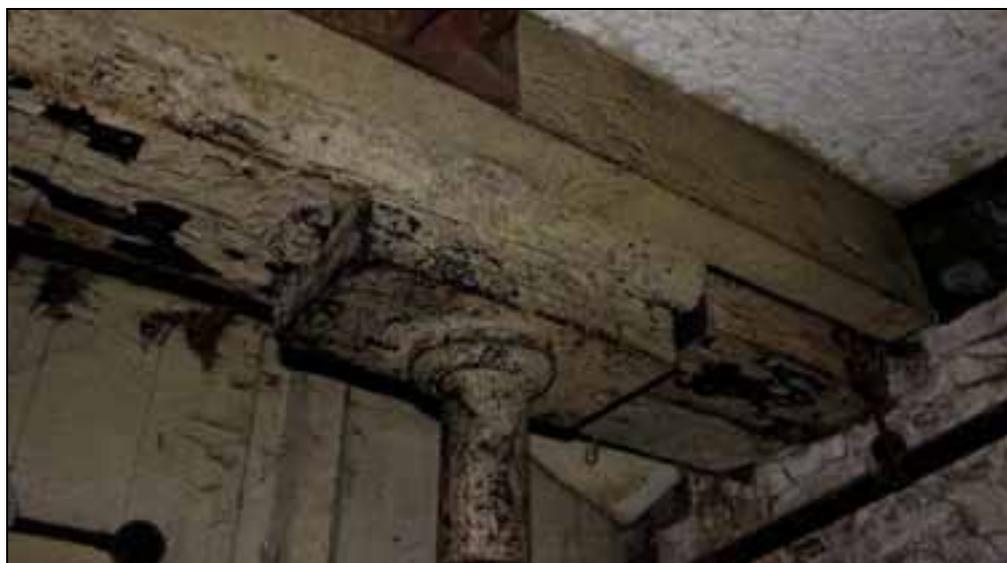
Plate 58: Column carrying scarf-jointed of extended ceiling beam

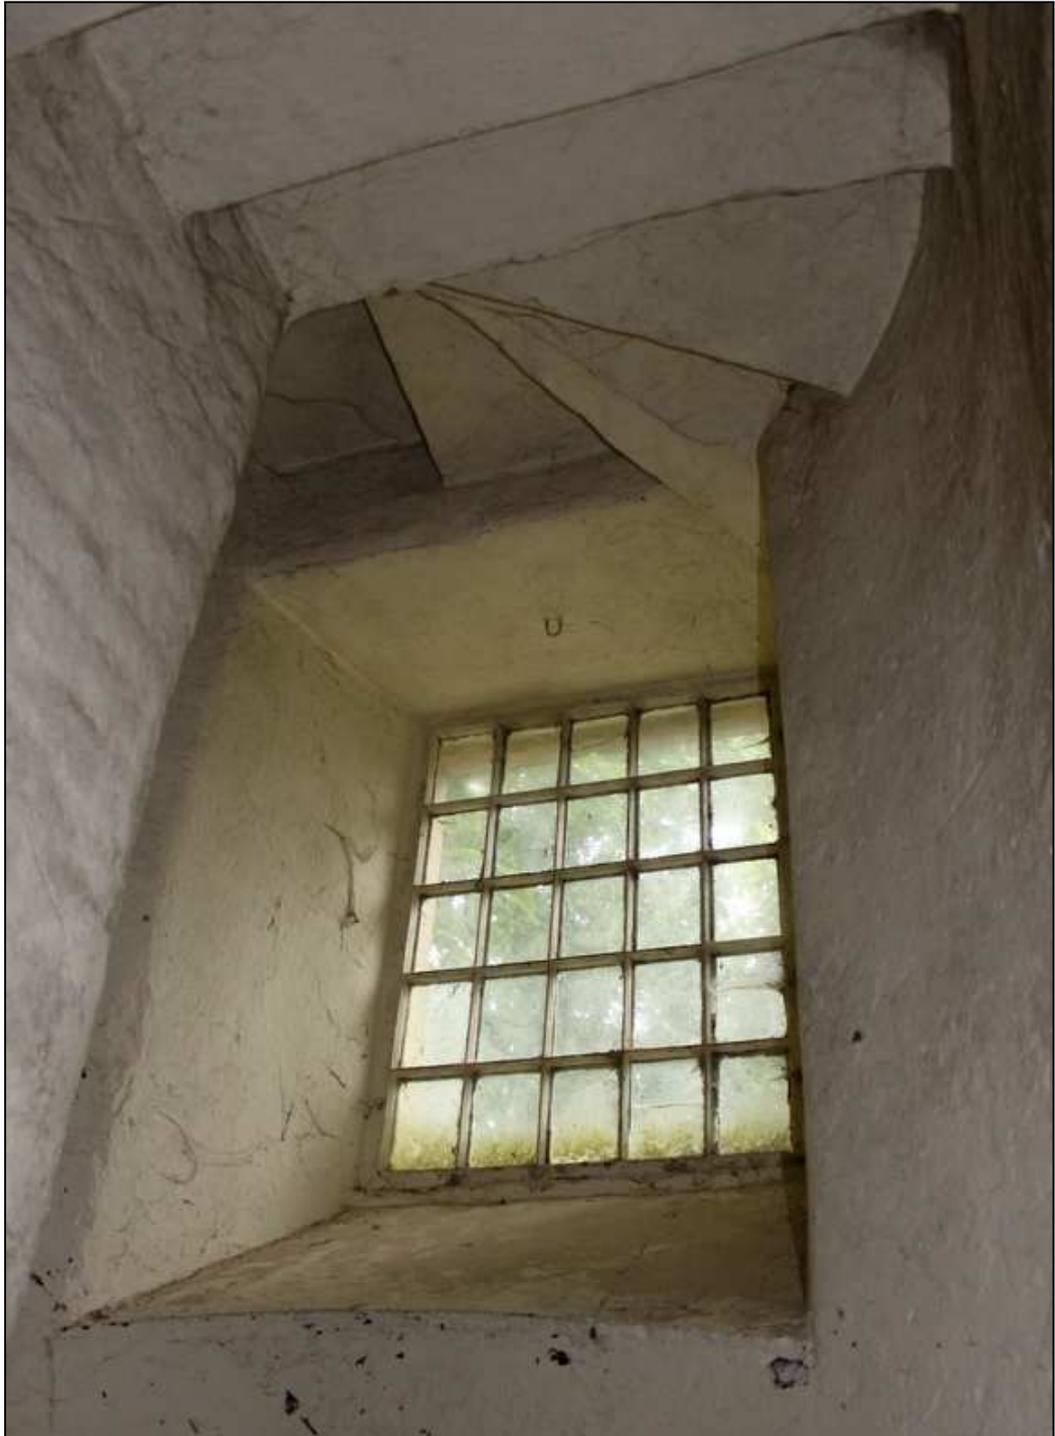
- 3.3.26 The stair tower was of fireproof construction at first- and second-floor level, and is divided by a stone partition into two chambers. External access into the stair tower was afforded in its east face, at first-floor level, which is the external ground-floor level at the rear of the mill. It comprised a narrow double-door with 10-light timber skylight above (Plate 14), leading to the half-landing at first-floor level. The north wall of the stair tower had windows into the stairwell, with a blocked 16-light window on the spiral between the first and ground floors, and an extant 25-light fixed window between the first and second floors (Plate 59).

Plate 59: Stair-light window with fireproof spiral stair above

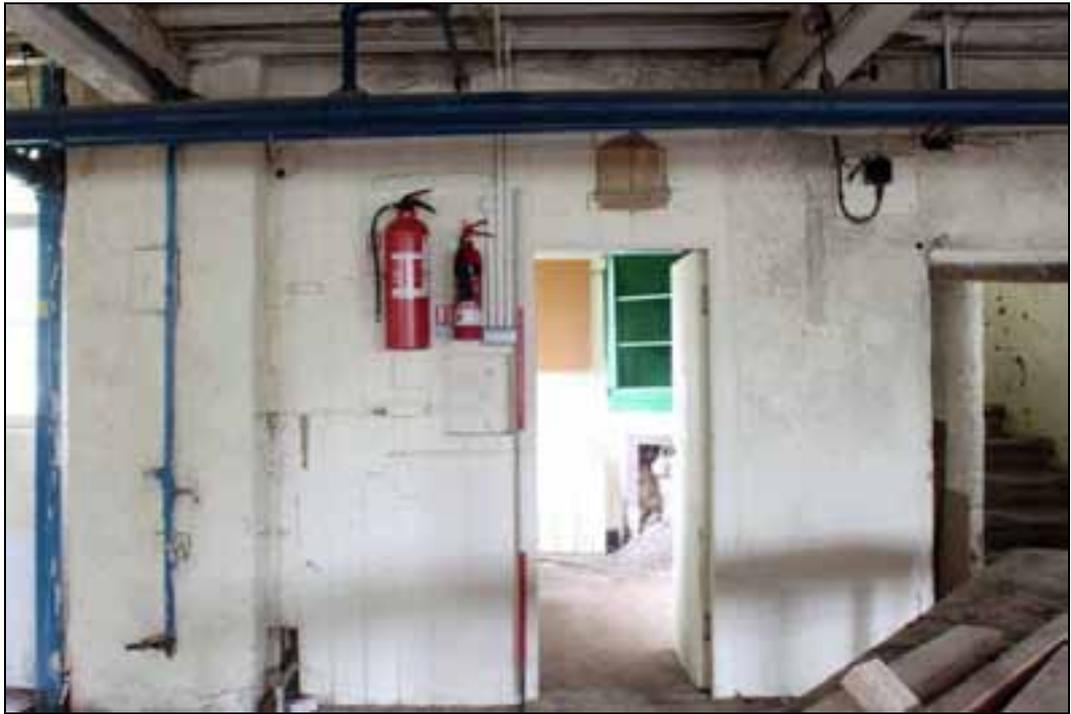
3.3.27 At first-floor level, a full width, full-height stone-arched aperture (Plate 60) afforded access into the west bay of the stair tower, which had a brick fireplace in its north-east angle (Plate 60). This formed part of an office which had a timber panel partition to the main structure (Plate 60), with the second floor landing being carried on a T-section fish-bellied beam (Plate 61). Within the main body of the mill, the main control valve, or 'Christmas tree' for the Mather and Platt sprinkler system was placed adjacent to stair tower (Plate 62), with a rare survival of an associated replacement sprinkler-head cabinet, mounted on the wall nearby (Plates 62 and 63).

Plate 60: Wide arched opening into office within western side of stair tower

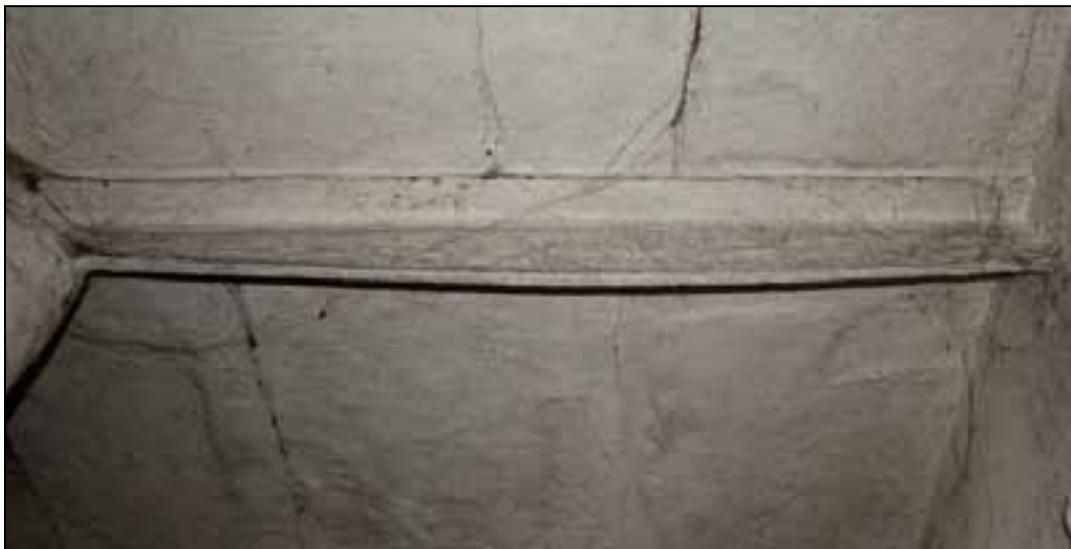
Plate 61: Fish-bellied T-section beam carrying stair tower landing

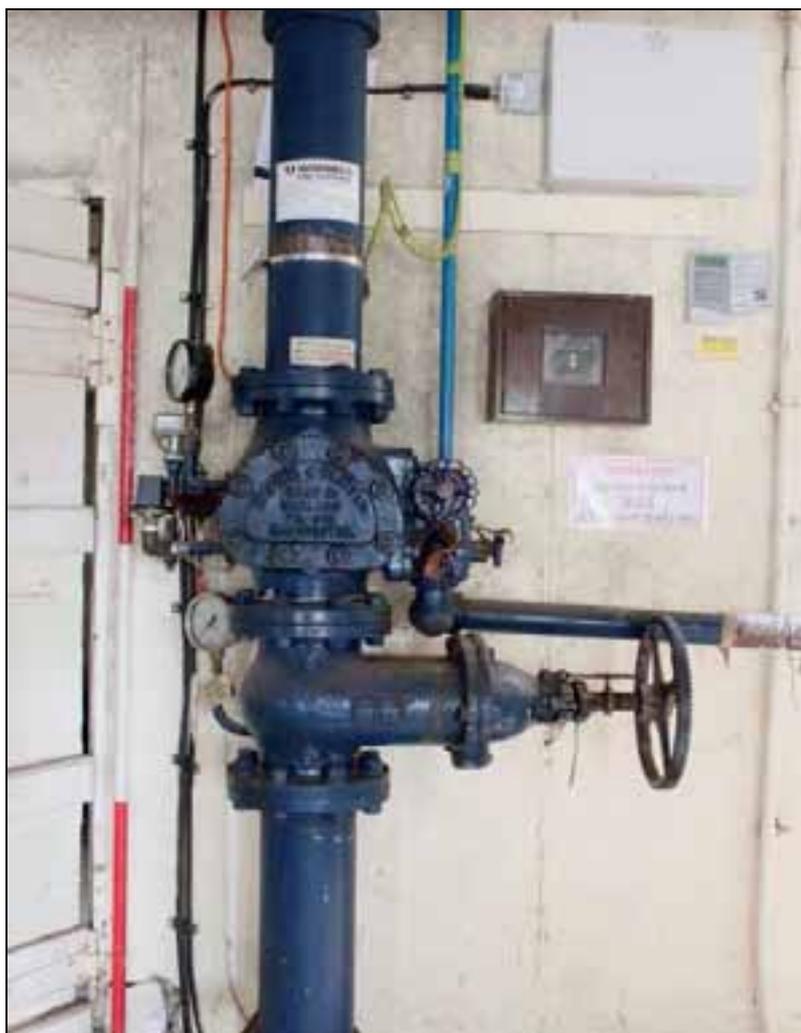
Plate 62: 'Christmas tree' control valve of sprinkler system

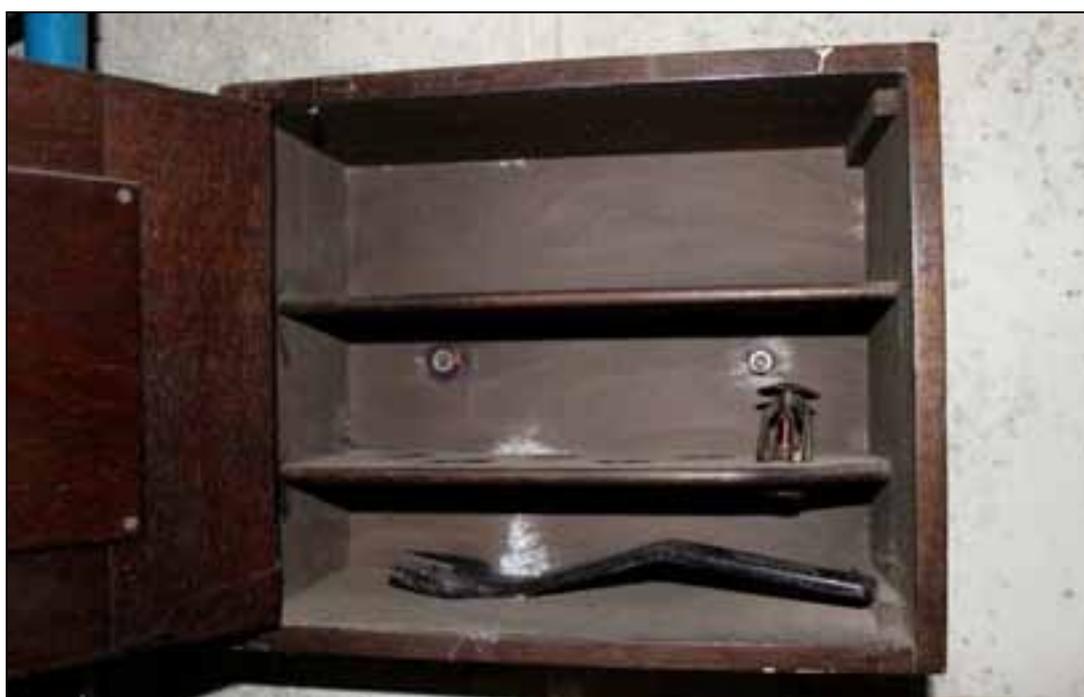
Plate 63: Cabinet housing spare parts for sprinkler system

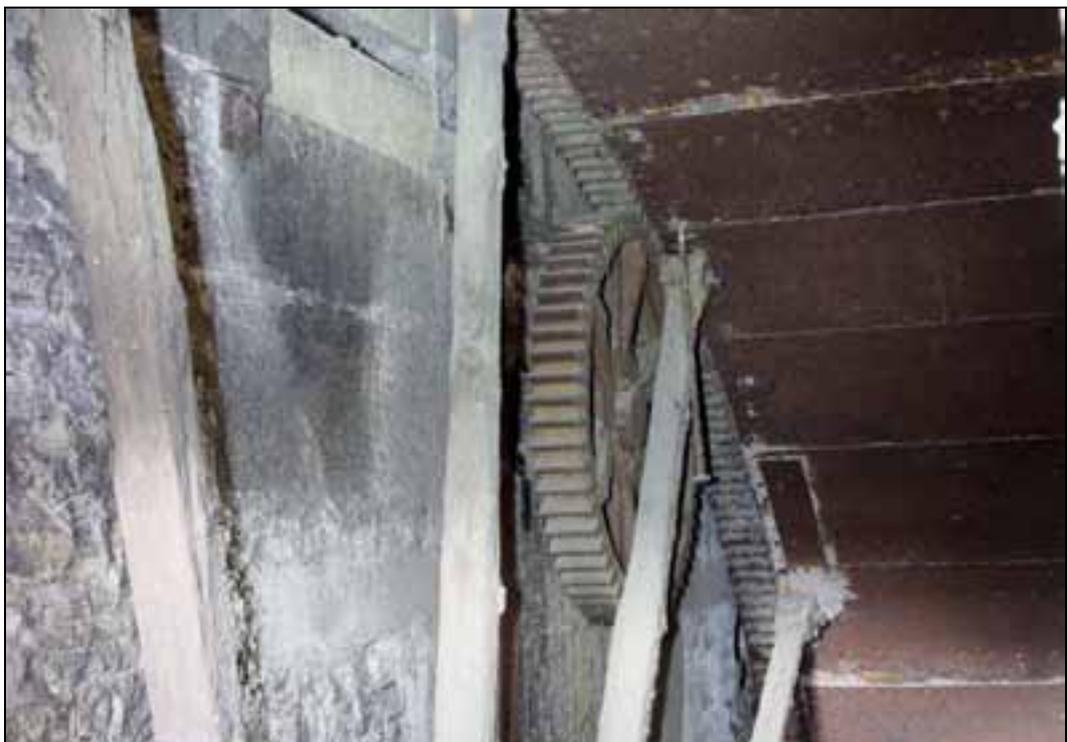
Plate 64: Pinion wheel on rim gear of waterwheel

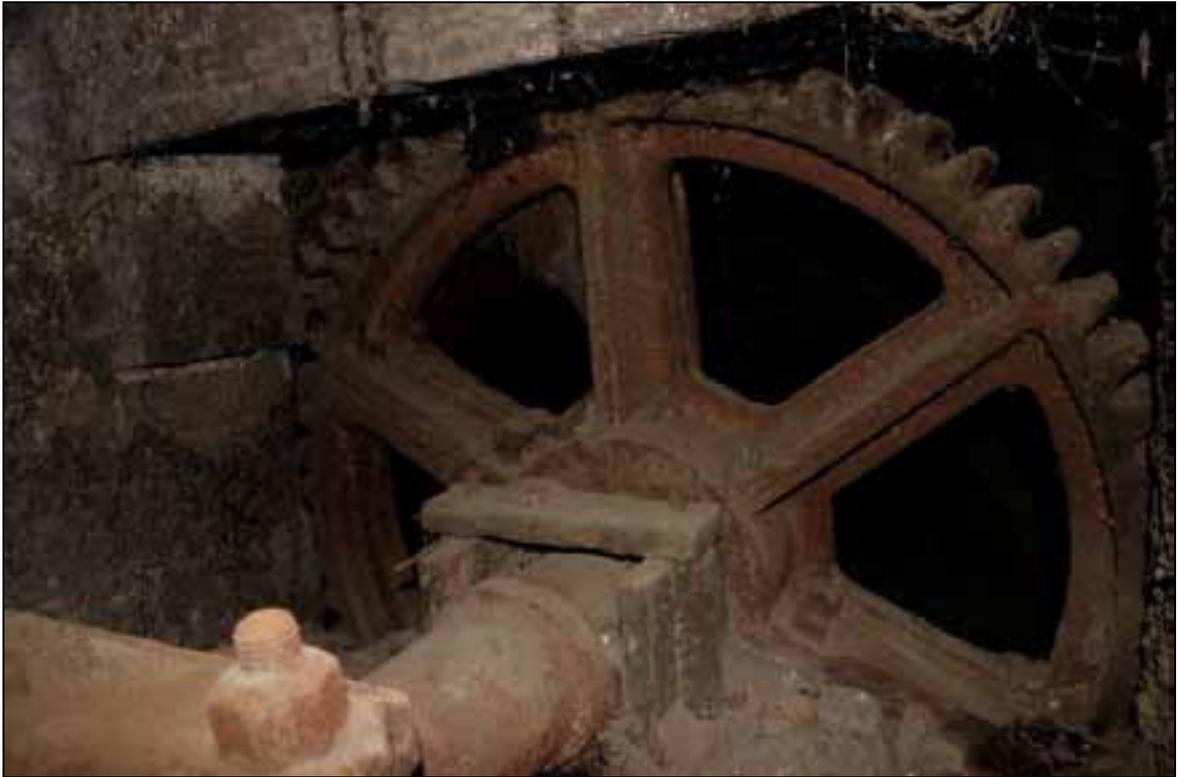
Plate 65: Axle and bearing of pinion wheel

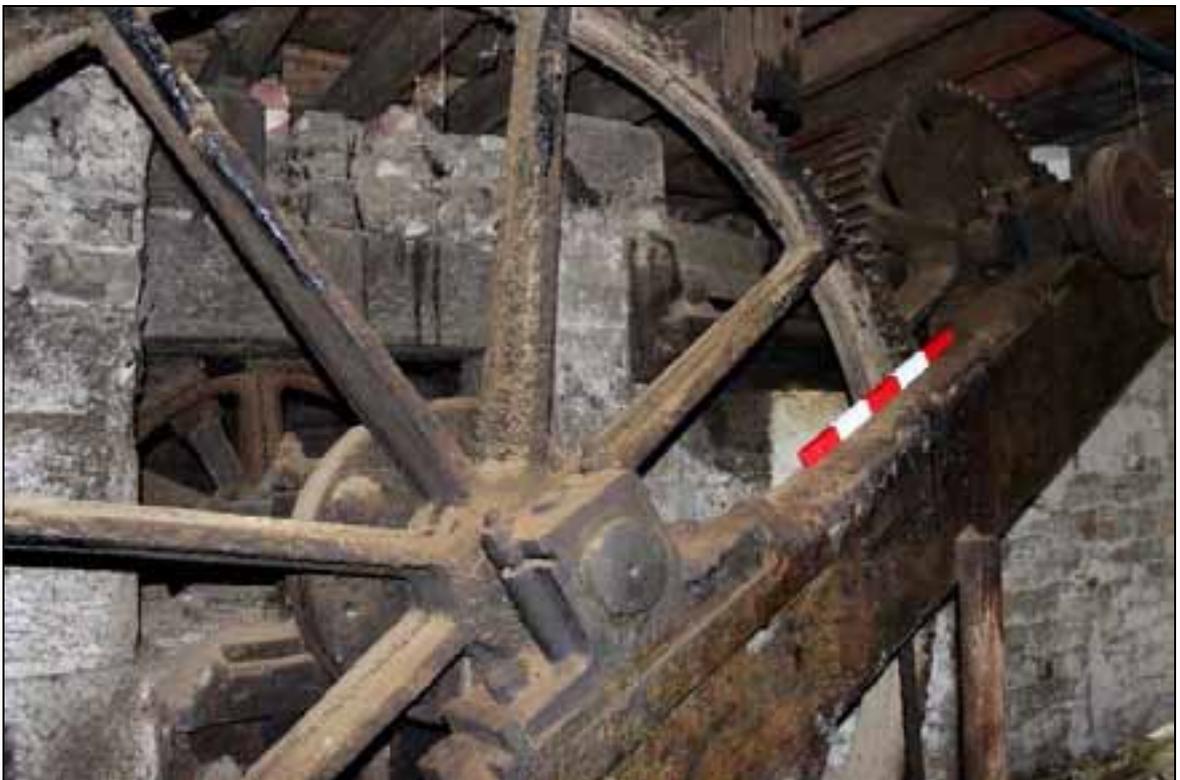
Plate 66: 8' gearing wheel on pinion wheel axle

- 3.3.29 A shaft driven by the 2' wheel extended immediately below the ceiling beam towards the spinning room to the west, and terminated in what appears to have been a clutch plate, almost adjacent to the gear wheel (Plates 66 and 67). The great difference in size between the two wheels would have given a massive increase in the rotational speed of the line shaft, in comparison with that of the primary motion shaft, which again rotated at a much greater speed than the waterwheel itself. The clutch afforded the ability to disconnect the waterwheel gearing from the primary motion shaft, allowing it to be powered by the supplementary steam engine.
