Kirk Mill, Chipping, Lancashire

Archaeological Building Investigation

Oxford Archaeology North

August 2013

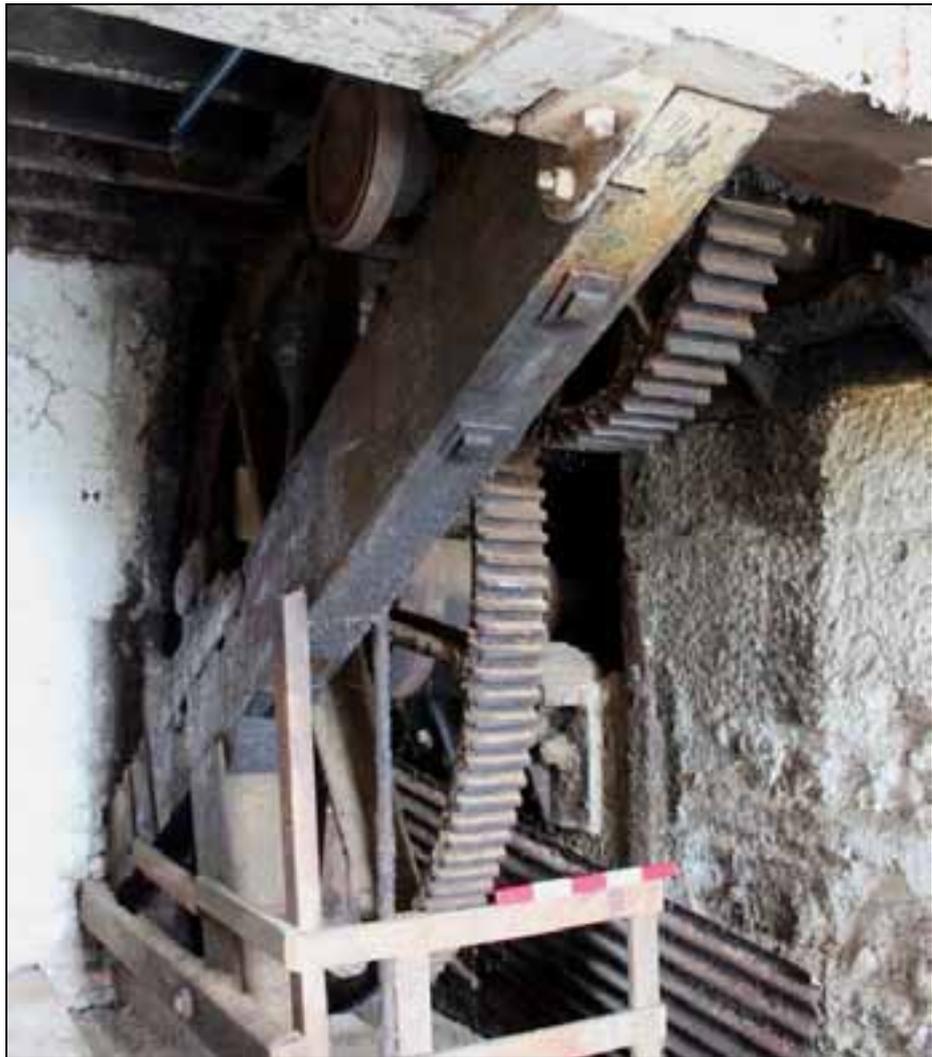
Plate 67: Gearing driven by pinion wheel, with clutch-plate on drive shaft

- 3.3.29 A shaft driven by the 2' wheel extended immediately below the ceiling beam towards the spinning room to the west, and terminated in what appears to have been a clutch plate, almost adjacent to the gear wheel (Plates 66 and 67). The great difference in size between the two wheels would have given a massive increase in the rotational speed of the line shaft, in comparison with that of the primary motion shaft, which again rotated at a much greater speed than the waterwheel itself. The clutch afforded the ability to disconnect the waterwheel gearing from the primary motion shaft, allowing it to be powered by the supplementary steam engine.

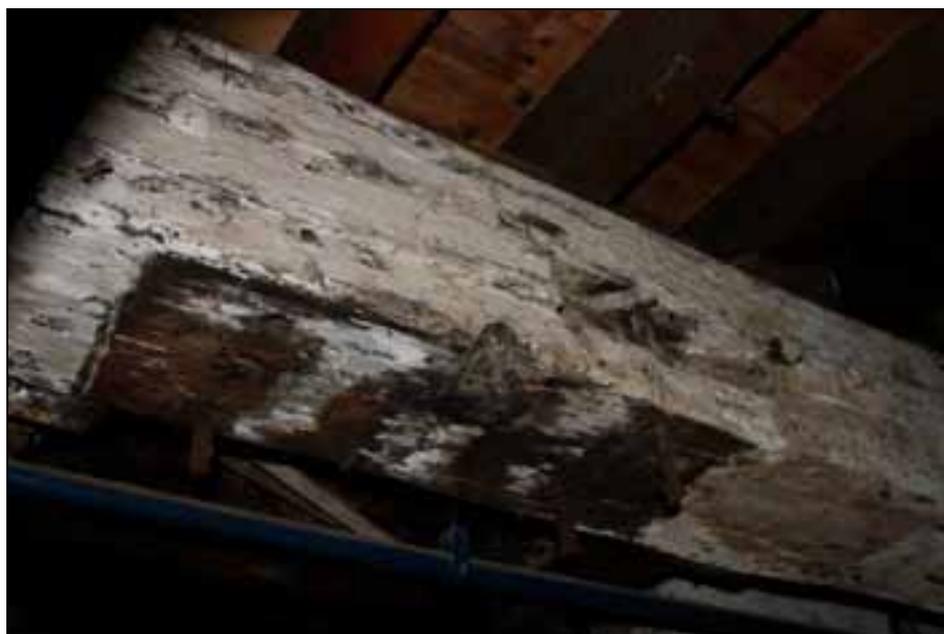
Plate 68: Compression scar and bolts associated with vertical shaft from steam engine

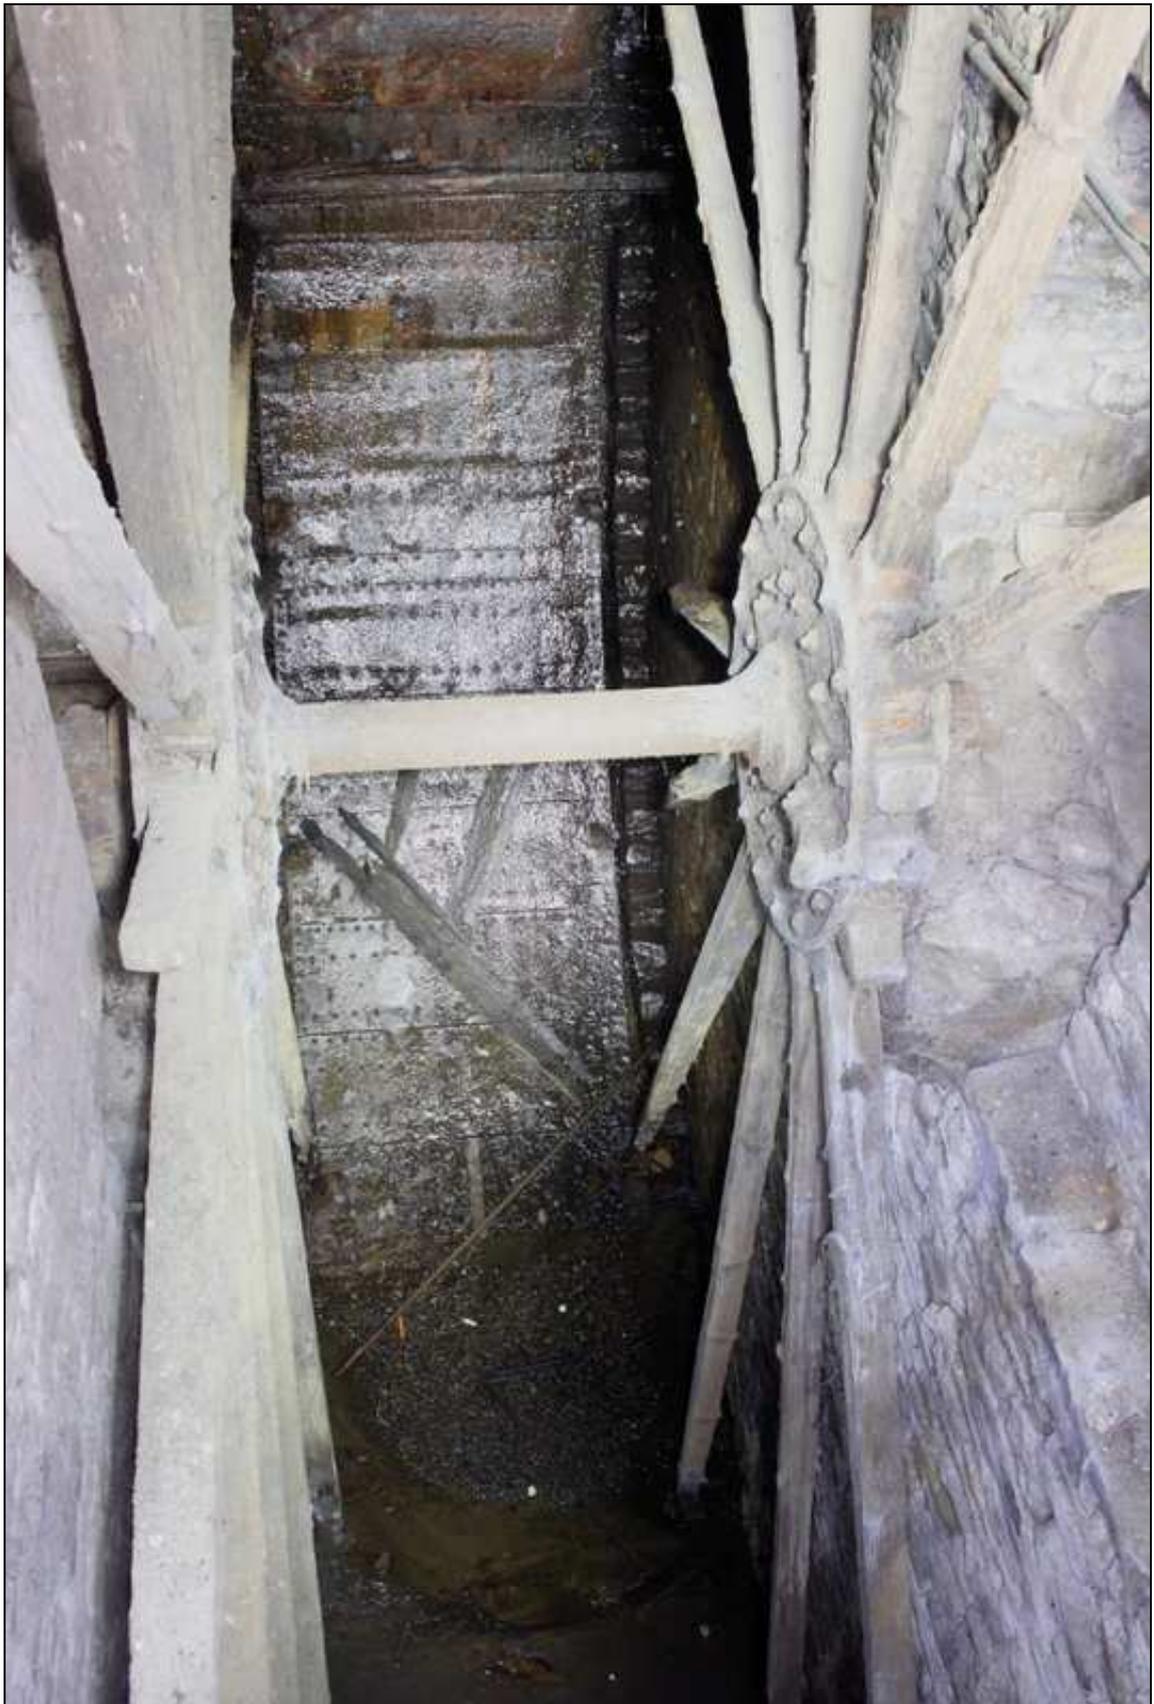
- 3.3.32 The current waterwheel is the full height of the ground and first floors, and almost the full 7' width of the bay in which it is housed (Plates 69 and 70). This represents an extension to the original mill, with this waterwheel probably being erected whilst an original waterwheel continued to function in the adjacent bay to the west. The high breast-shot wheel has cast-iron rims housing metal sheet elbow-buckets (Plate 71), supported by slender timber spokes socketed into a small diameter cast-iron hub (Plates 69 and 70).

Plate 70: Axle and eastern bearing of waterwheel

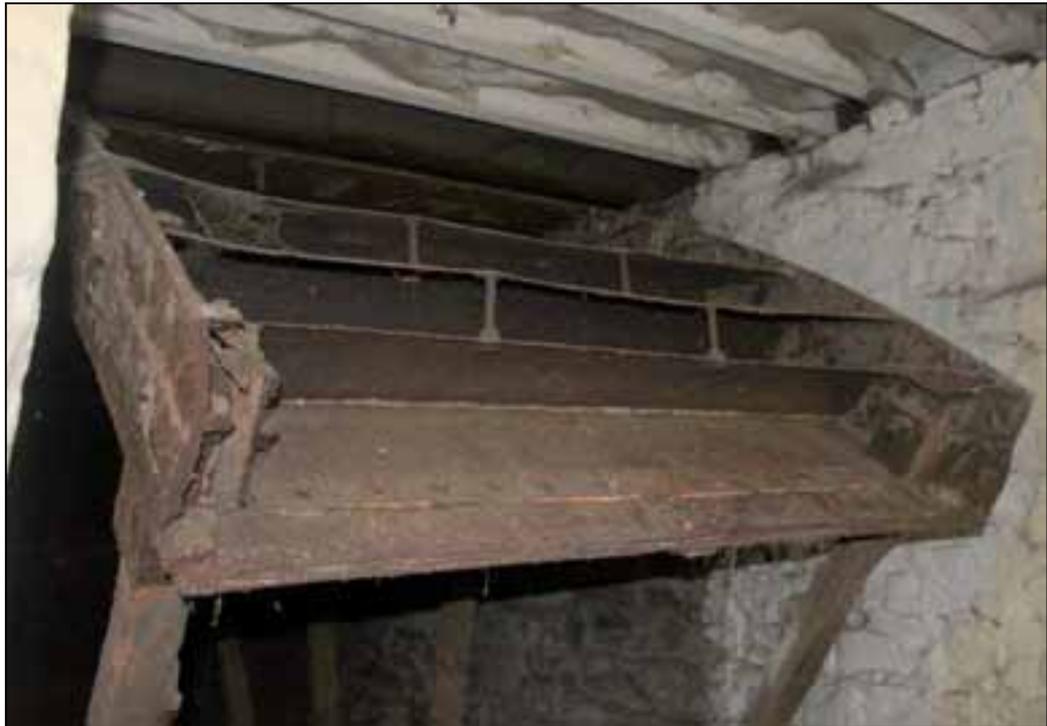
Plate 71: Detail of buckets and spoke sockets

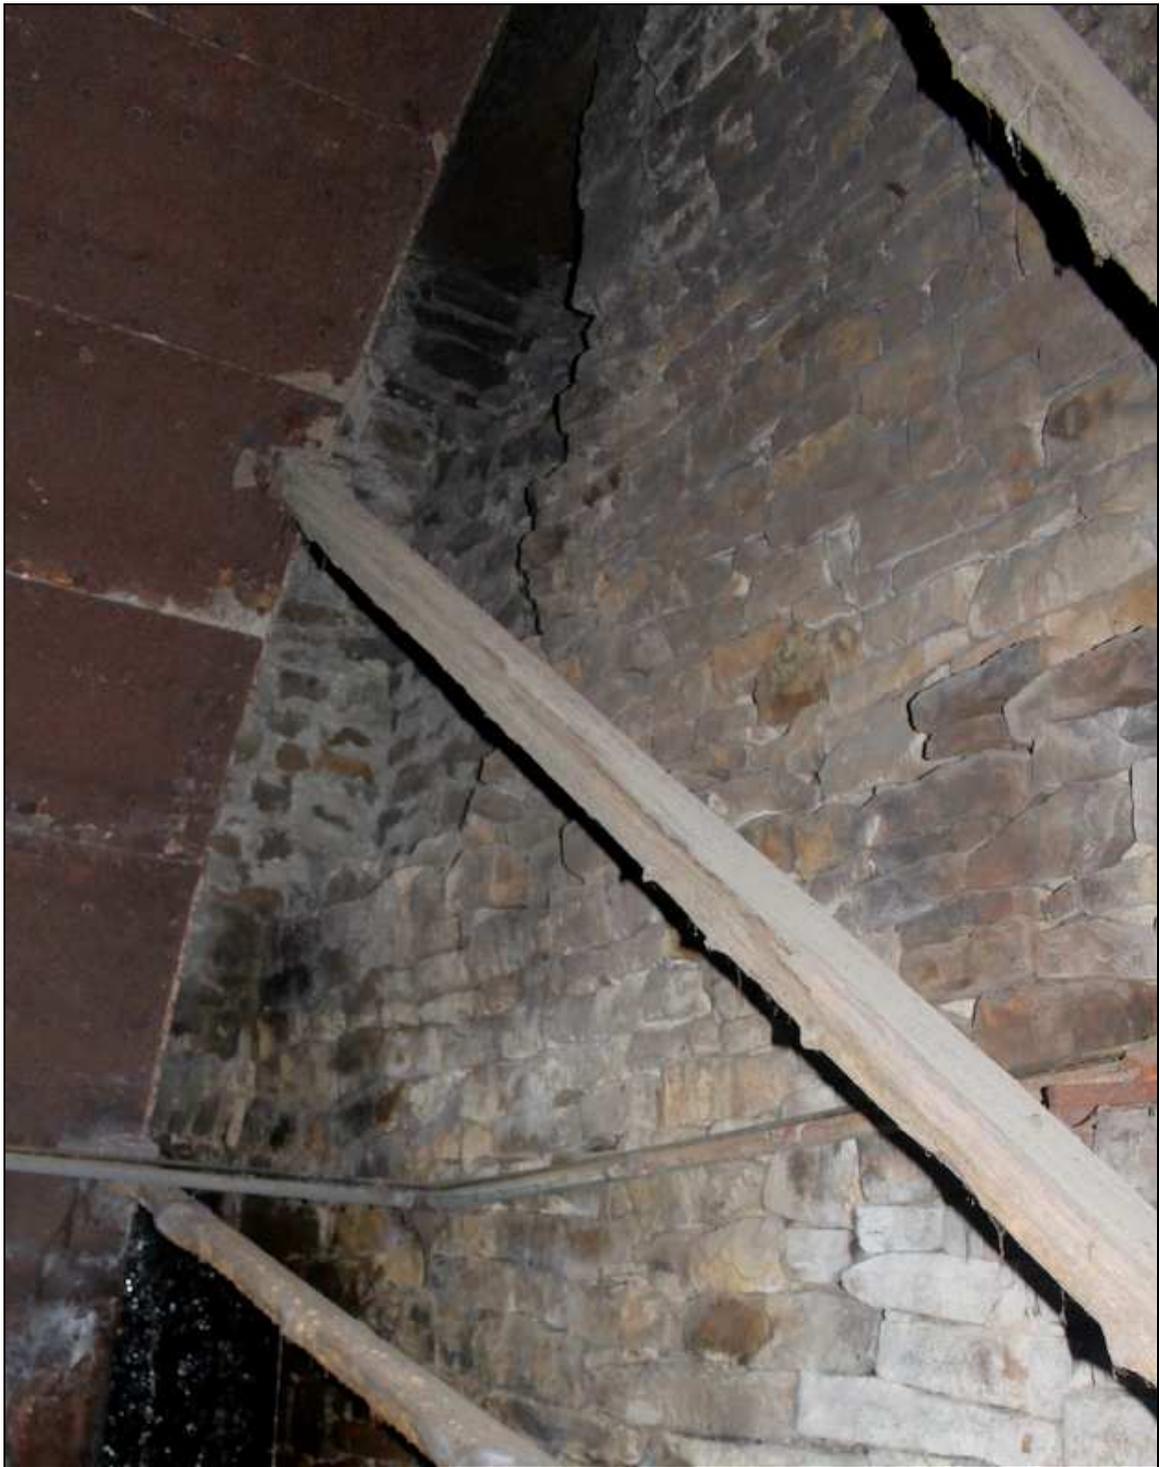
- 3.3.33 The east wall of the wheel pit diminishes in thickness to each floor level, consistent with that of an external wall (Plate 69). Quoin stones on the edge of an infilled aperture at the north end of the east wall, just below ceiling level (Plate 72), appear to represent the southern jamb of a doorway affording access to the waterwheel, prior to the construction of an extension on its eastern side. A concrete bridge with doorways either end, inserted across the southern side of waterwheel bay, cuts the waterwheel, rendering it unusable, but provided access between the original mill, and a later extension to the east of the waterwheel, and was inserted after 1933, when the waterwheel became redundant.

Plate 72: East wall of wheel house with quoin return of probable doorway at to

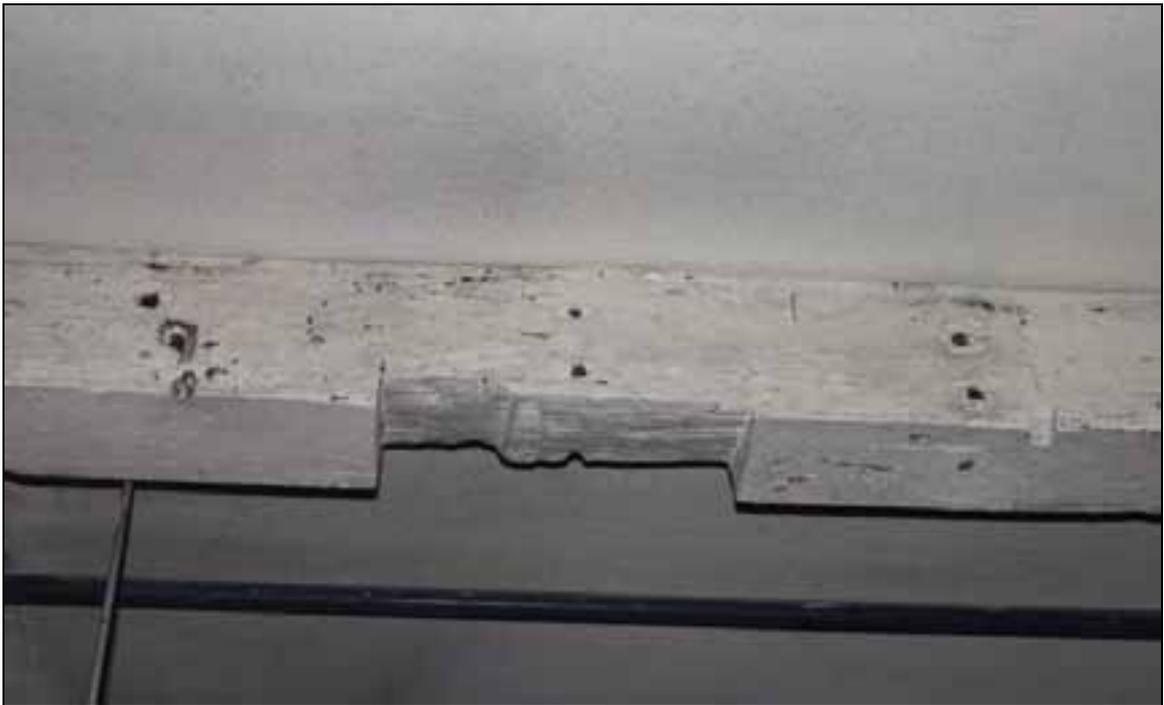
Plate 73: Evidence for original line shafting in east extension

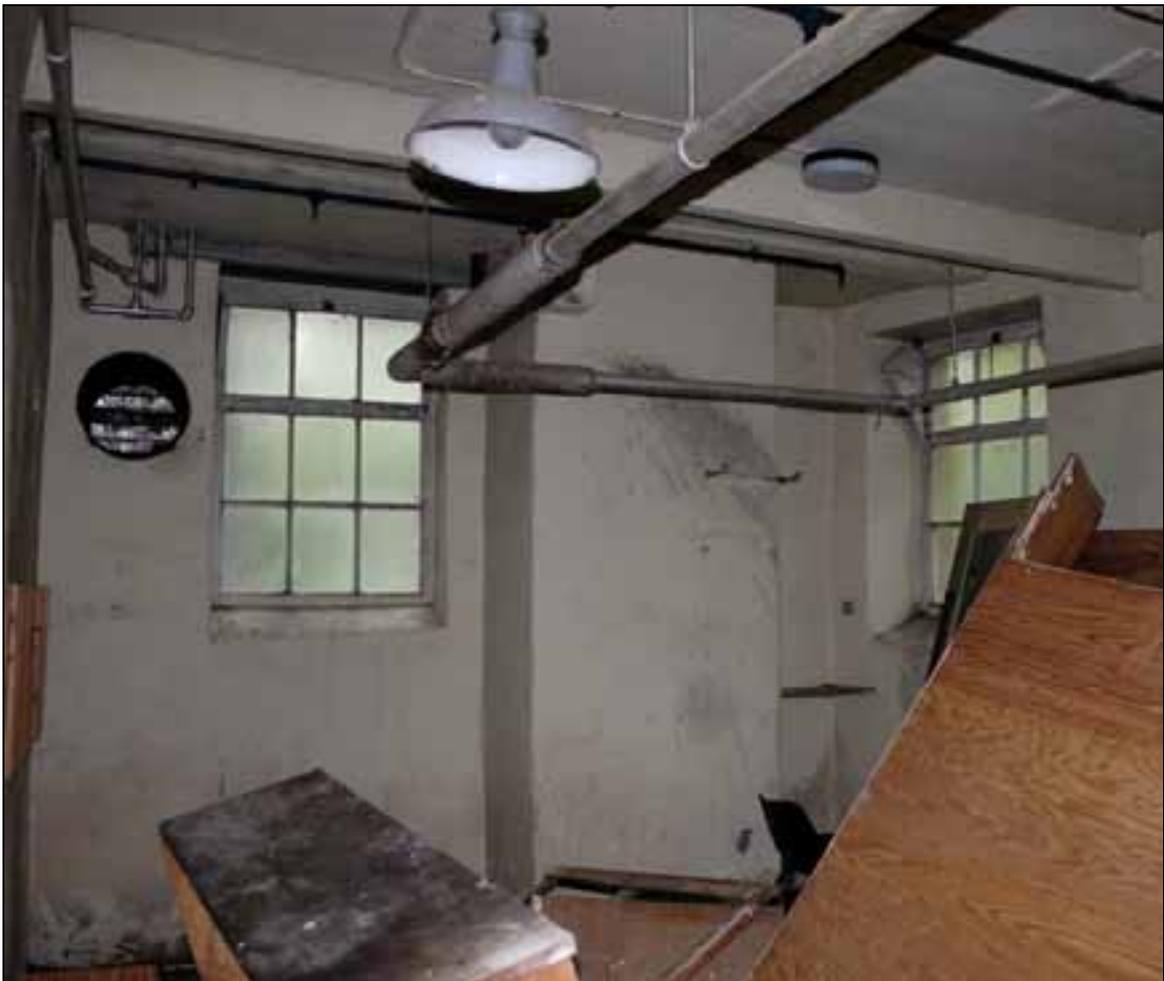
Plate 74: Chimney breast in repositioned north wall of east extension

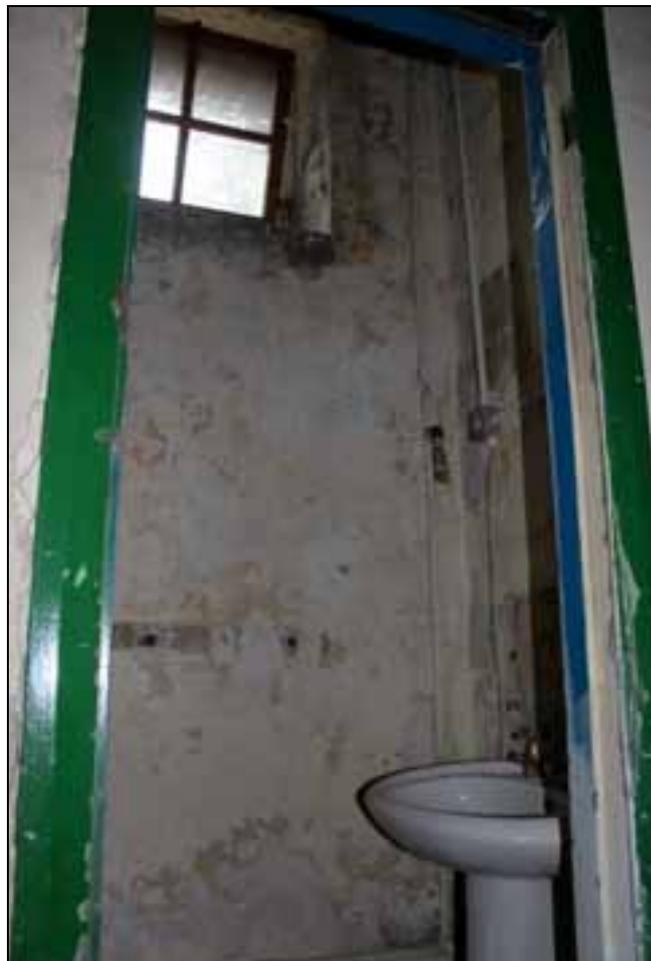
- 3.3.36 At first-floor level the extension comprised a lobby, adjacent to the earlier extension, with three doors to a privy and two further offices (Fig 3). The privy had a small four-light tilt window at the top of the west wall (Plate 75), and a modern toilet suite, whilst the floor in the western of the two larger rooms was raised by 2'6" (0.75m) in the southern part of the room, above the open-fronted bay below. The larger eastern room had two nine-light top-vented timber windows in the eastern wall, both probably original to the construction of the extension. The north wall had a fireplace cut into the 2' (0.61m) thick wall of the earlier extension (Plate 76), possibly placed in a window aperture of the earlier structure. Two convex sandstone corbels below the ceiling almost certainly carried a wall plate associated with the roof of the extension, prior to a brick-built second floor being added, at which point, the ceiling height also appears to have been increased to its present level.

Plate 75: Privy in southern extension of east wing

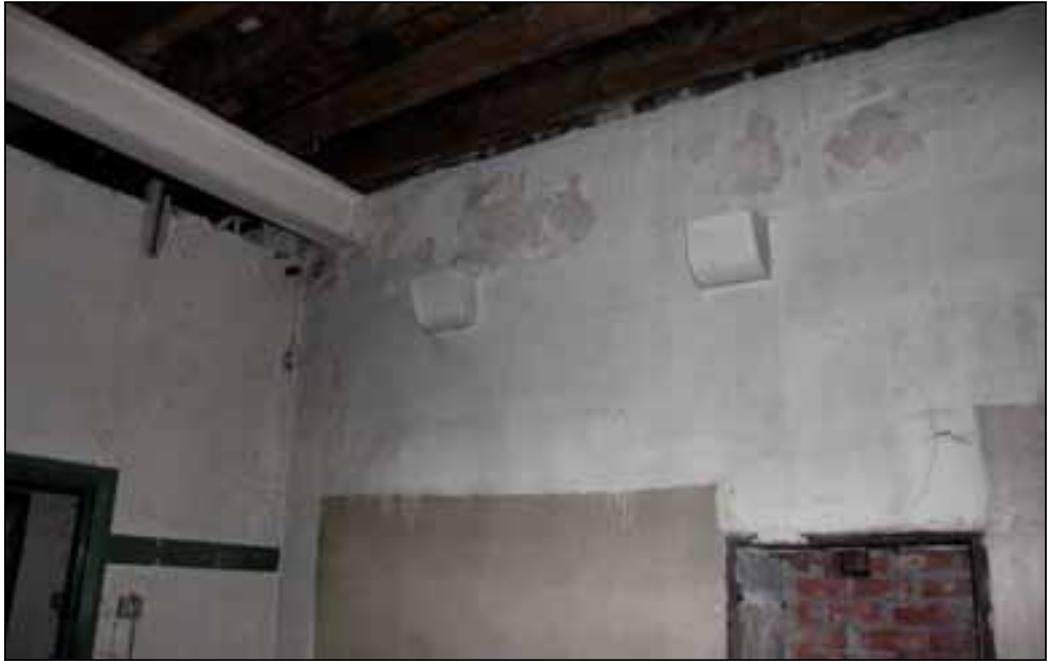
Plate 76: Sandstone corbels in south external wall of original eastern extension

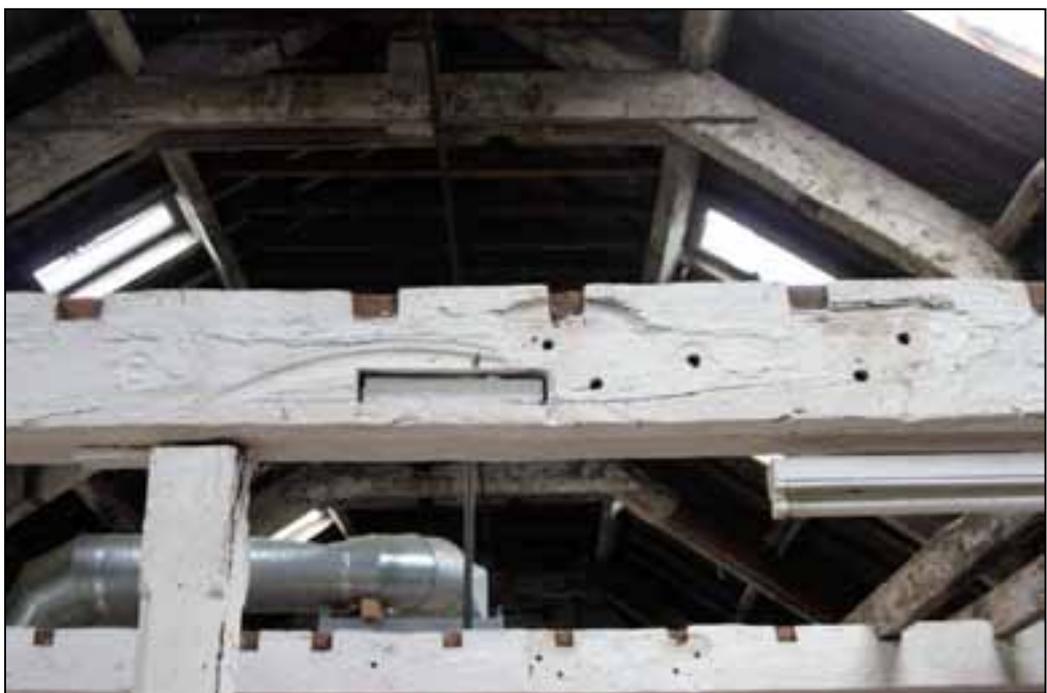
3.3.37 **Second floor:** the second floor of the spinning block was similar to that below, with timber props supporting the original beams at their midpoint. Whilst most were plain, that in the eastern bay of the original spinning block was lamb's tongue-chamfered (Plate 77). The original beams were, however, not scarf-jointed into timber beams extending to the wall of the northern extension of the original mill, as on the floors below, but instead remained short of the repositioned wall (Plate 78), their exposed ends being supported on hollow cylindrical, cast-iron columns of varying type, having either a flat or a ribbed head plate (Plates 78 and 79), and a plain, or octagonal-section foot (Plate 78).

Plate 77: Drum scar and line shaft bolt holes, second floor

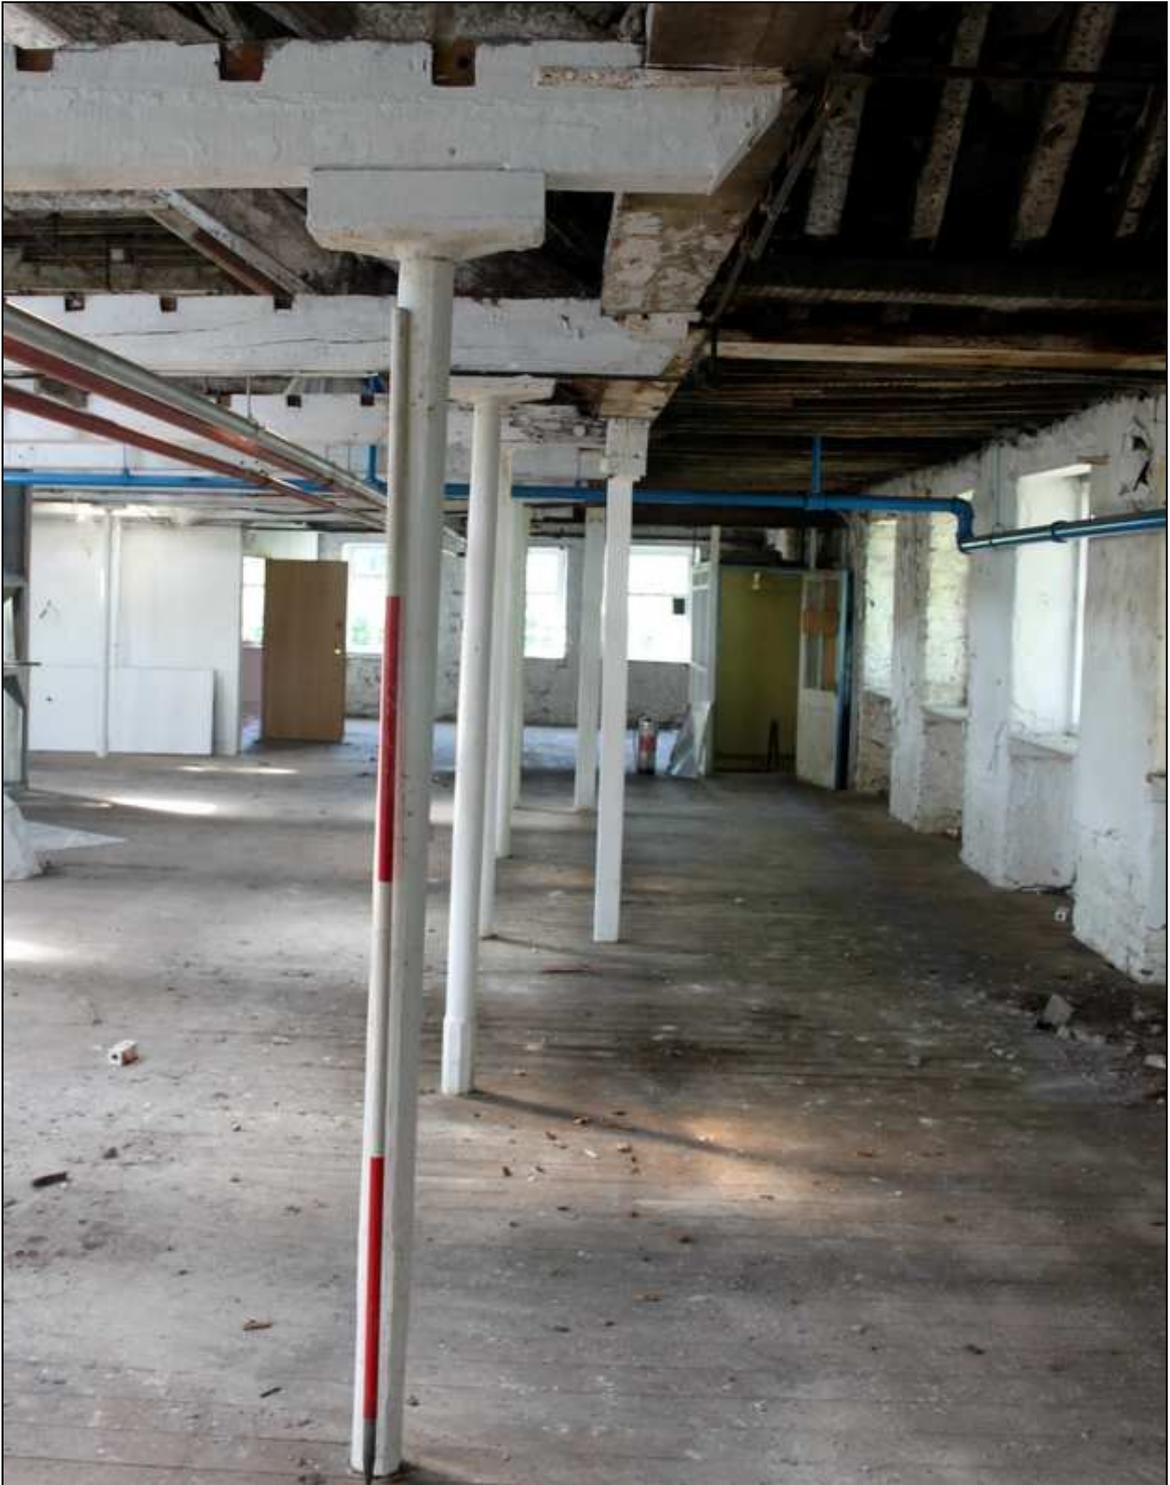
Plate 78: Second-floor columns supporting exposed beam ends

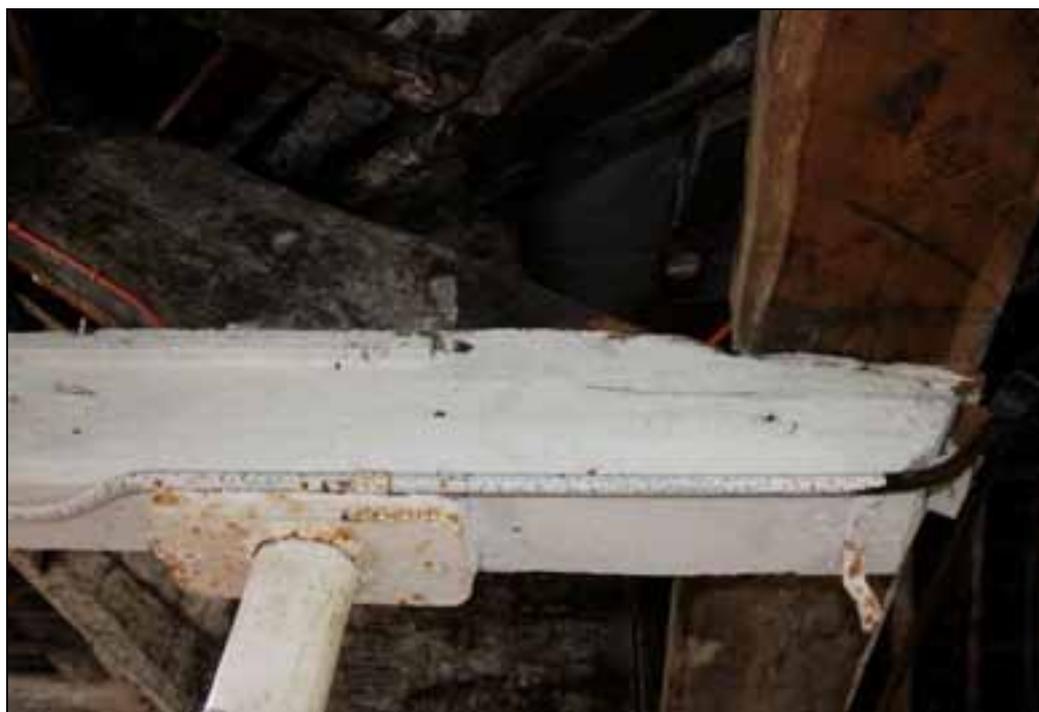
Plate 79: Plain column capital, second floor

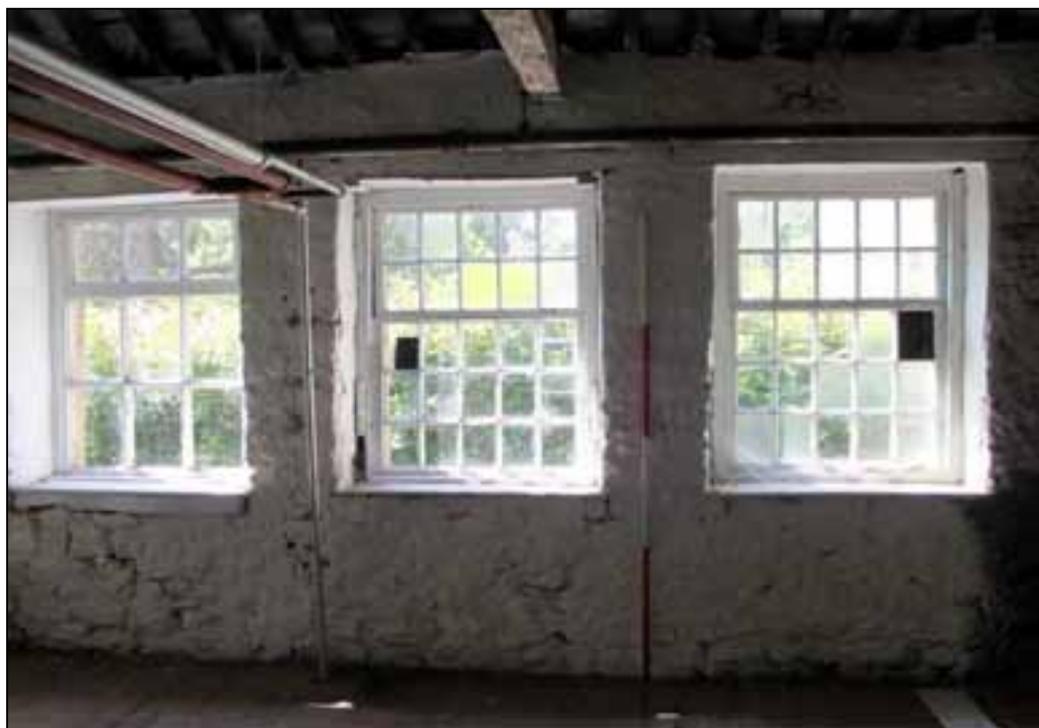
3.3.38 Windows were similar to those on the floors below, with the exception of those in the north wall, which matched those elsewhere, rather than extending to wall-head height (Plate 78). Many housed nine-light, top-vent windows, although some timber 25-light vertical sash windows also survived (Plate 80).

Plate 80: Second-floor windows

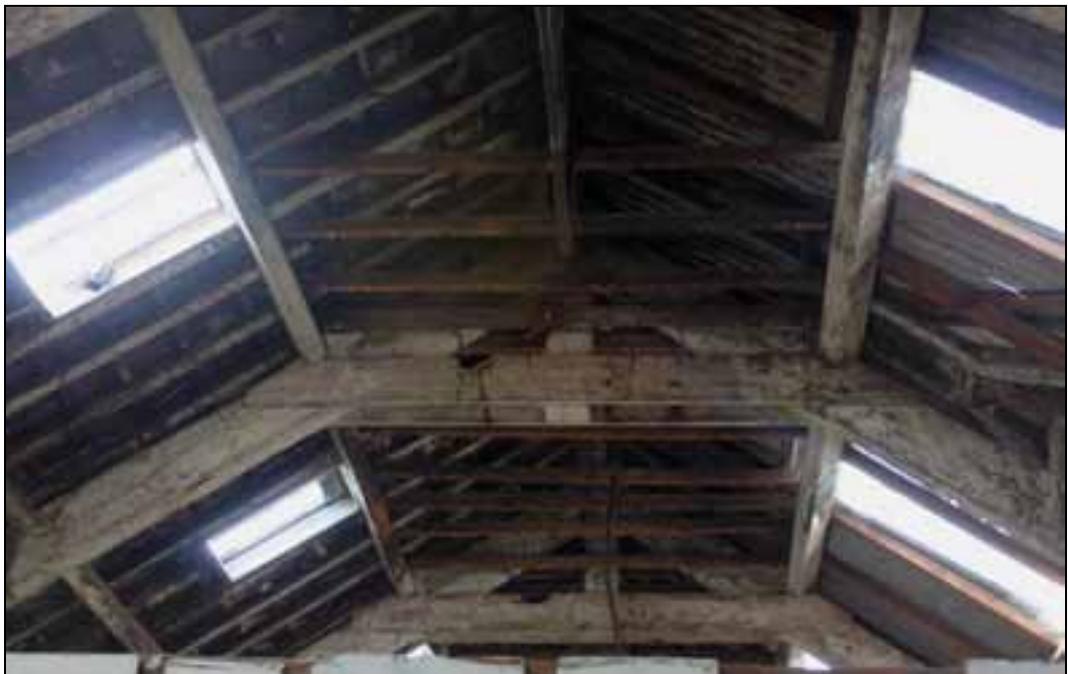
3.3.42 The earliest extant element of the roof comprised king post trusses, with clasped ridge purlin and sandstone roof tiles, carried on three purlins to each pitch (Fig 4; Plate 83). The purlins were butt-ended above the trusses which have chiselled roman numeral assembly marks on their eastern faces (Plate 84), and originally had angled braces from the angled king post foot to immediately below the central purlin of each pitch, as demonstrated by blocked or redundant sockets in this position on each principal rafter (Plate 77). The king posts of each truss were cut subsequently, and the angled braces removed, with collar planks placed across each truss, at the height of the upper purlins (Plates 77 and 83). This created an open loft, and dovetail housed sockets in the tie beams (Plate 77), demonstrating that the loft formed was floored at this time. The new collars also have semi-circular cut-outs in their upper faces (Plate 83), almost certainly to carry a pipe for the sprinkler system, rather than a timber line shaft, which would have generated too much friction and heat in a weight-bearing timber housing.

Plate 83: Remodelled king post trusses

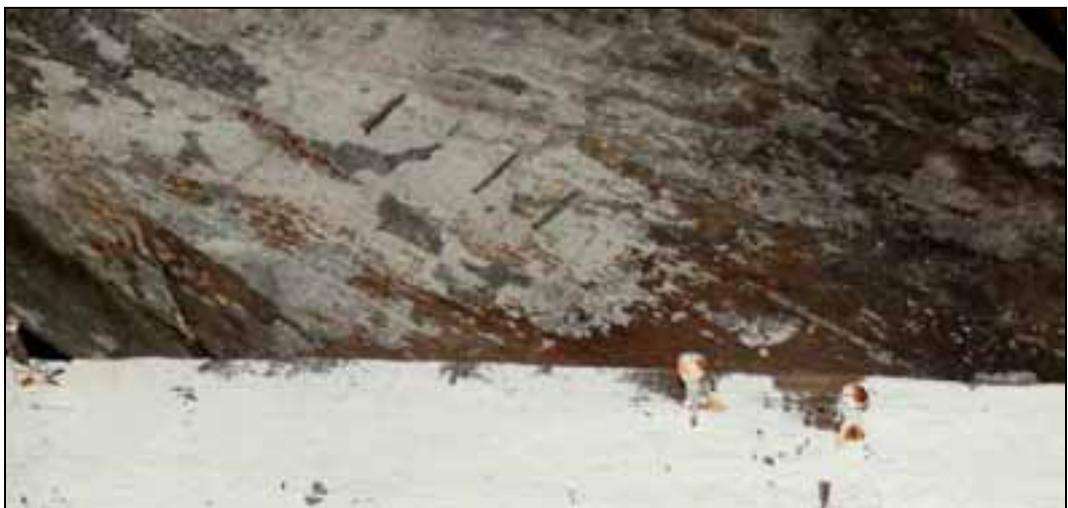
Plate 84: Chiselled carpenter's assembly marks

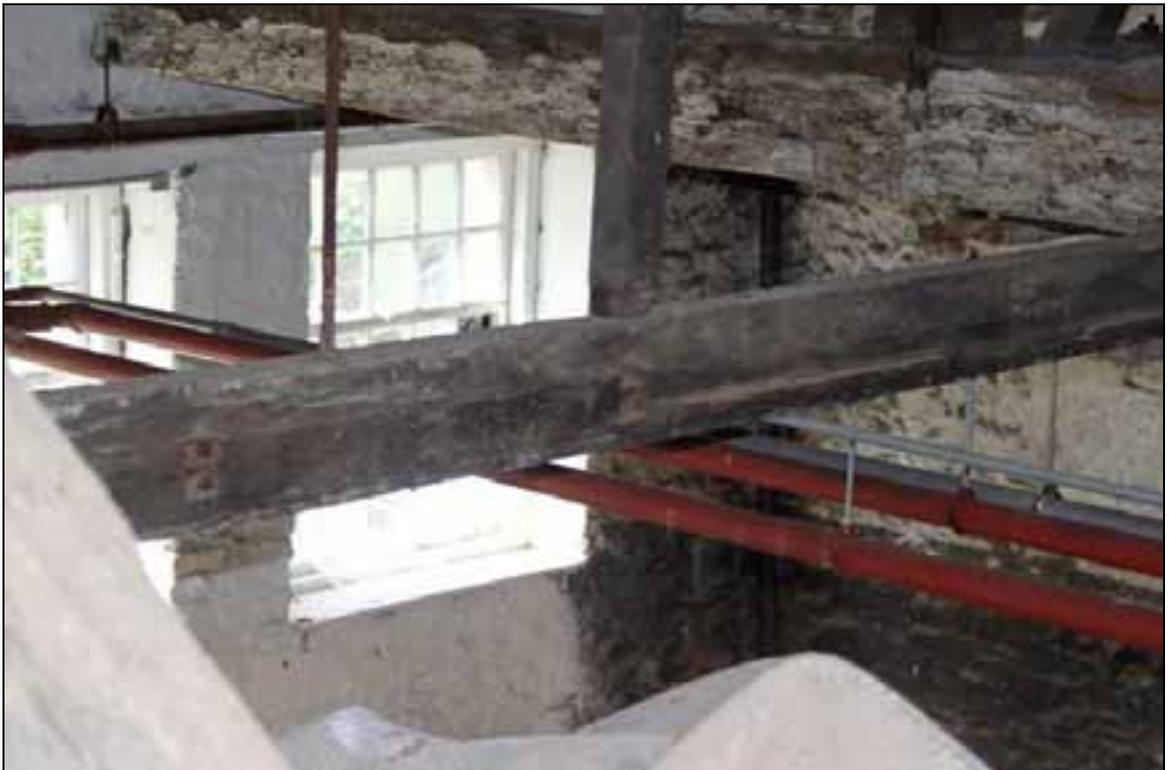
- 3.3.43 The western extension of the mill has a perpendicular roof formed of braced king post trusses, with the king post stirruped to the tie beam with an iron strap (Plate 85). Despite the obstruction caused by the king posts, longitudinal trimmers between the tie beams have double-tenon mortices in their faces for floor joists (Plate 86), indicating that the roof space was utilised.

Plate 86: Mortices for ceiling joists above west wing

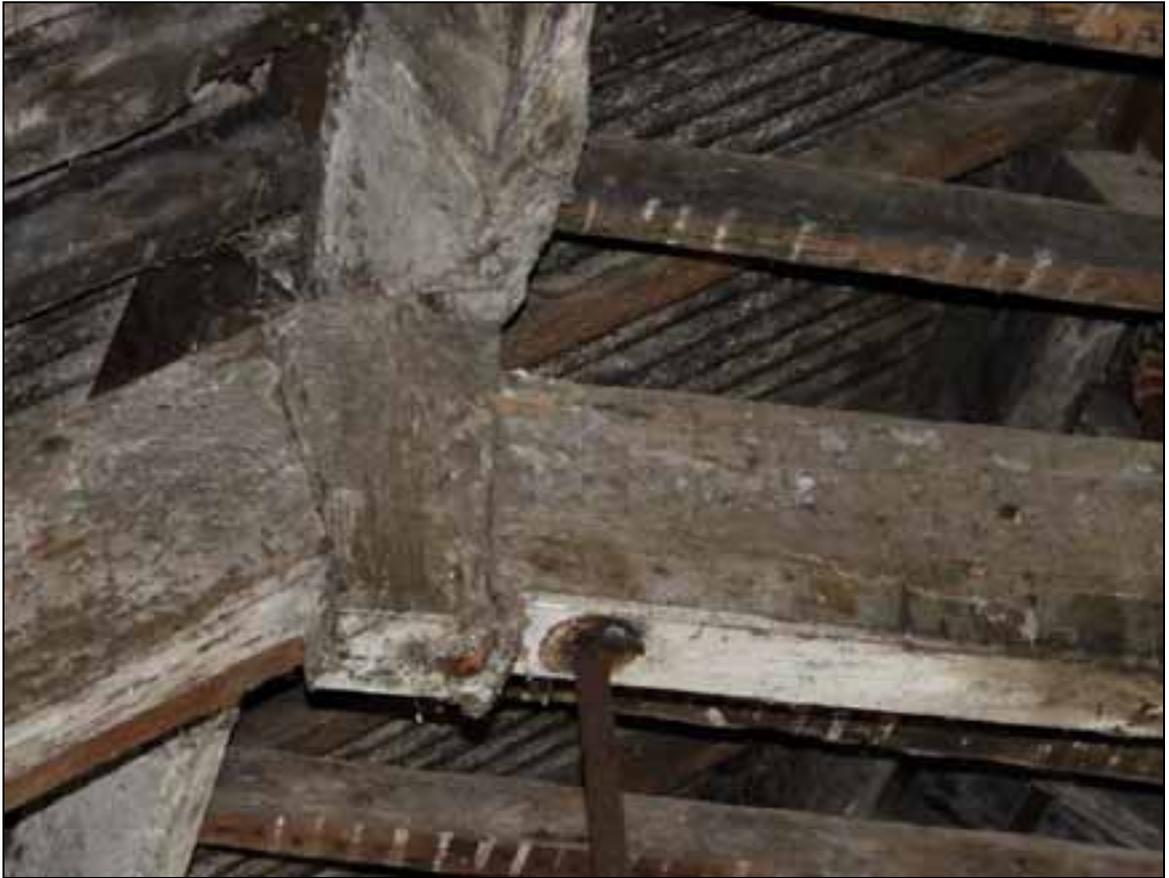
- 3.3.44 The western end of the roof was presumably originally hipped, and thus a new truss needed to be installed to carry the ridge from the original roof to that of the perpendicular extension, in order to avoid a valley between the two roofs. The truss installed was of queen post type, with two vertical members having a jowled head (Plate 87), carrying the shorter principal rafters, a straining beam placed between the two posts, and the weight of the upper purlin, which was housed in a notch within the head (Plate 88). These queen posts were also cut subsequently, and replaced with a pair of iron rods, placed immediately on their inside (Plate 87).

Plate 88: Jowled head of queen post, carrying side purlin, with adjacent replacement rod

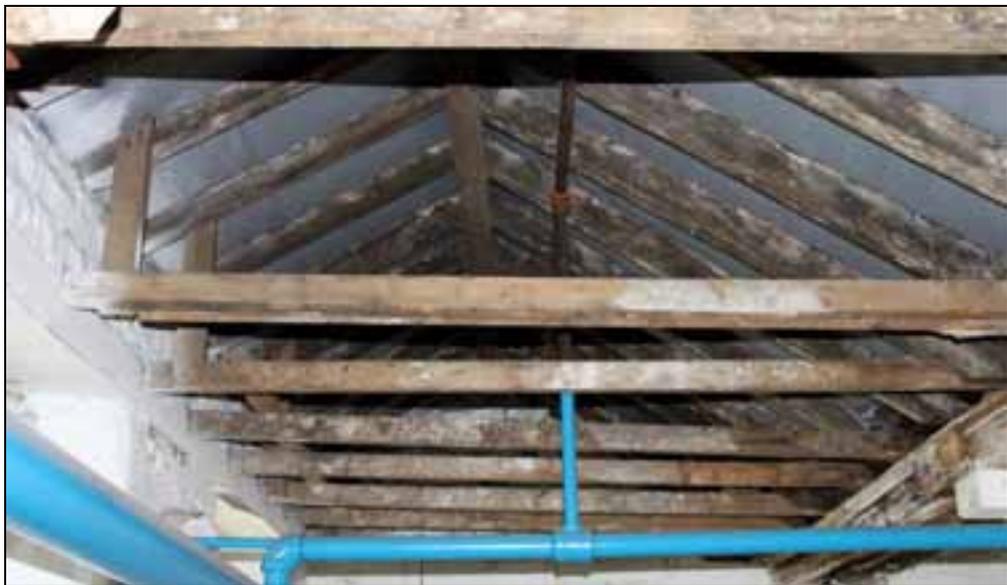
3.3.46 The extended north bay of the original mill had a separate low pitched roof of common rafters over a square-section ridge purlin (Plate 90). The valley between the two roofs was carried on the northern ends of the original tie beams, and presumably drained through the external wall at the eastern end. The stair tower had a perpendicular pitched roof comprising simple coupled trusses, with the southern principal rafter oversailing that of the north pitch, and having the ridge purlin trenched into its apex (Plate 91). A single purling to each pitch was also trenched into the trusses (Plate 92). The joint between the stair tower roof and had an end wall panel of lath and plaster (Plate 92), creating a separate room above the stair tower. This had a doorway in its southern face, into the loft (Plate 92), with an apparent original corridor above the roof of the north bay to a second, now removed, doorway into the main loft. The stair tower also retained fire hoses in the roof space, and at second floor landing level, manufactured by EJAY Walker brothers of Preston and Chester (Plate 93).

Plate 90: Common rafter roof of extended northern bay of main mill

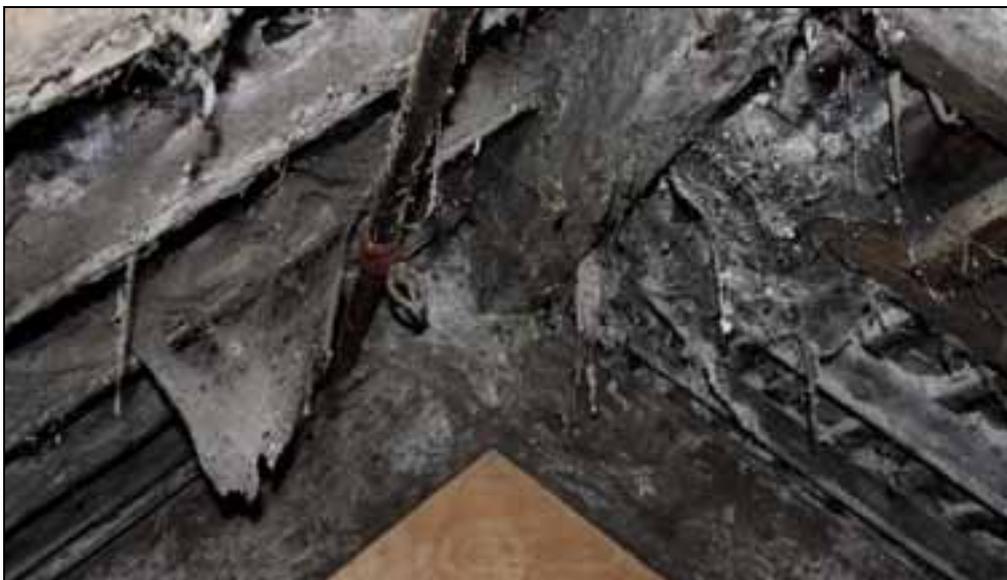
Plate 91: Apex of stair tower roof

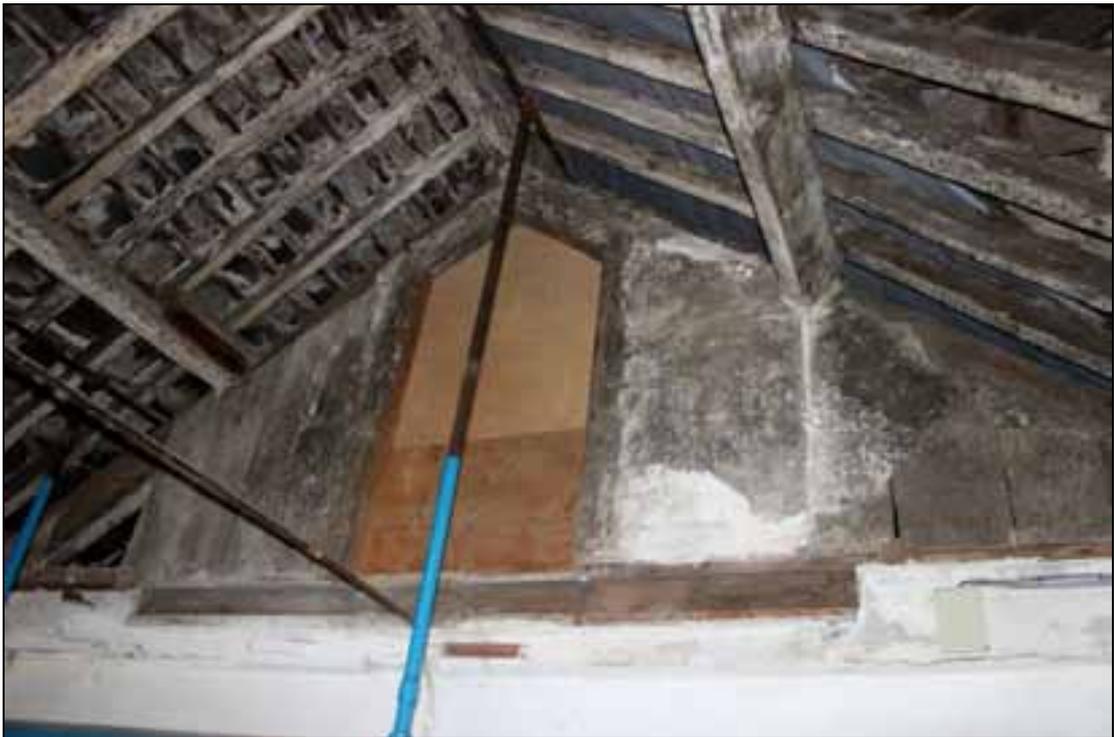
Plate 92: Doorway in attic above stair tower, with associated lath and plaster partitions

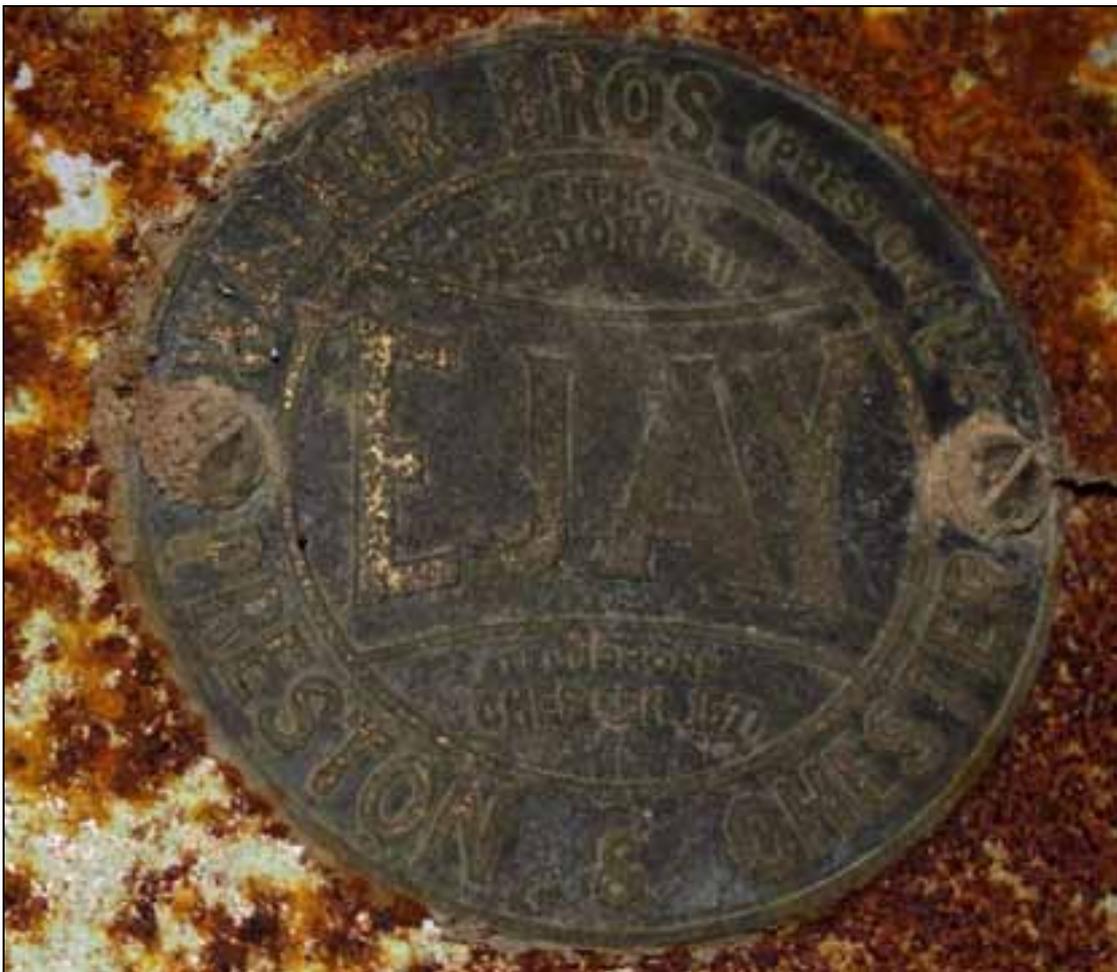
Plate 93: Maker's plate on fire-fighting hose reel

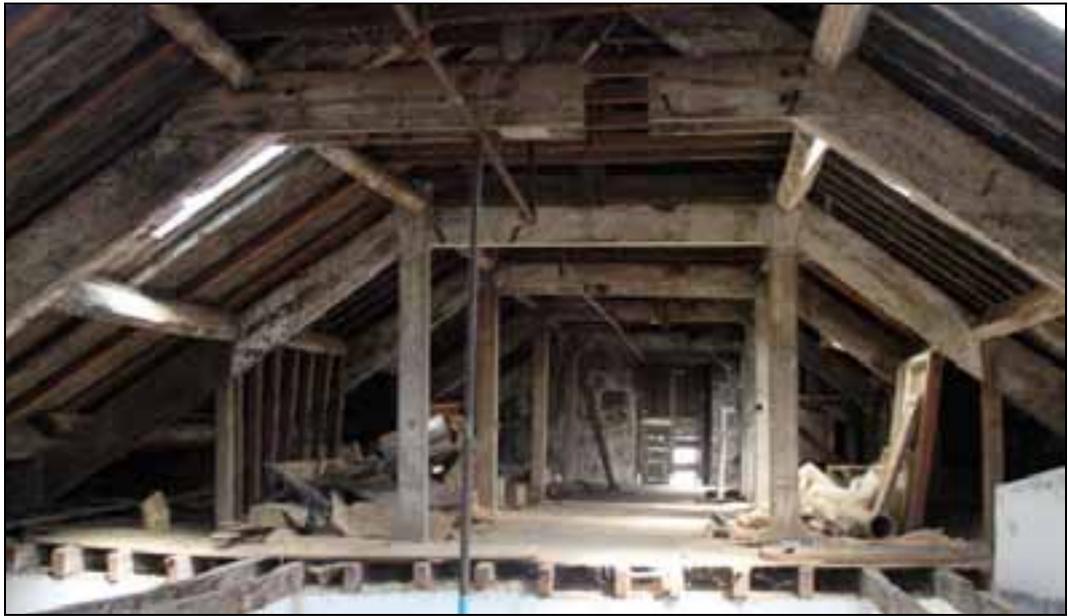
3.3.47 The roof structure above the engine and wheel houses differed from the main roof, comprising two queen post trusses (Plate 94), with jowled feet (Plate 95) and each post carrying the upper of two rectangular-section purlins to each pitch. Posts below the lower purlin do not form part of the truss, but instead form studs for a former partition to the eaves (Plate 94), which appears to have been a relatively recent addition, and certainly post-dates the extension of the mill to the east, as it is also present within this part of the roof.

Plate 94: Queen post trusses above engine and wheel houses
