Kirk Mill, Chipping, Lancashire

Archaeological Building Investigation

Oxford Archaeology North

August 2013

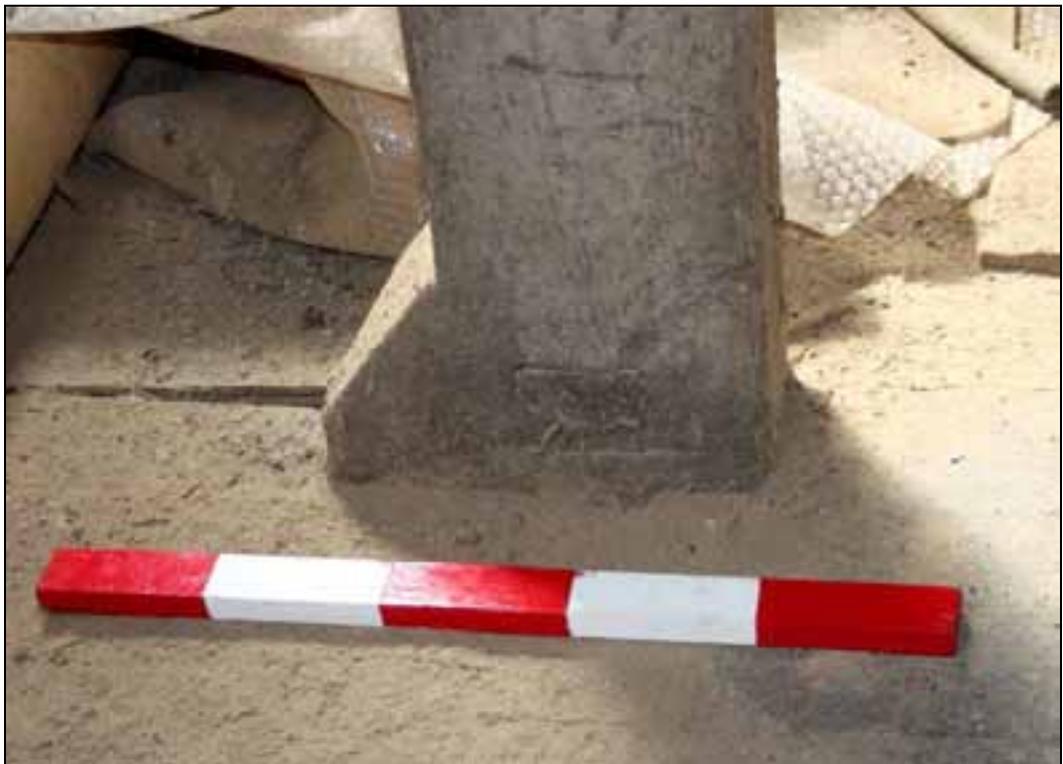
Plate 95: Jowled foot of queen post

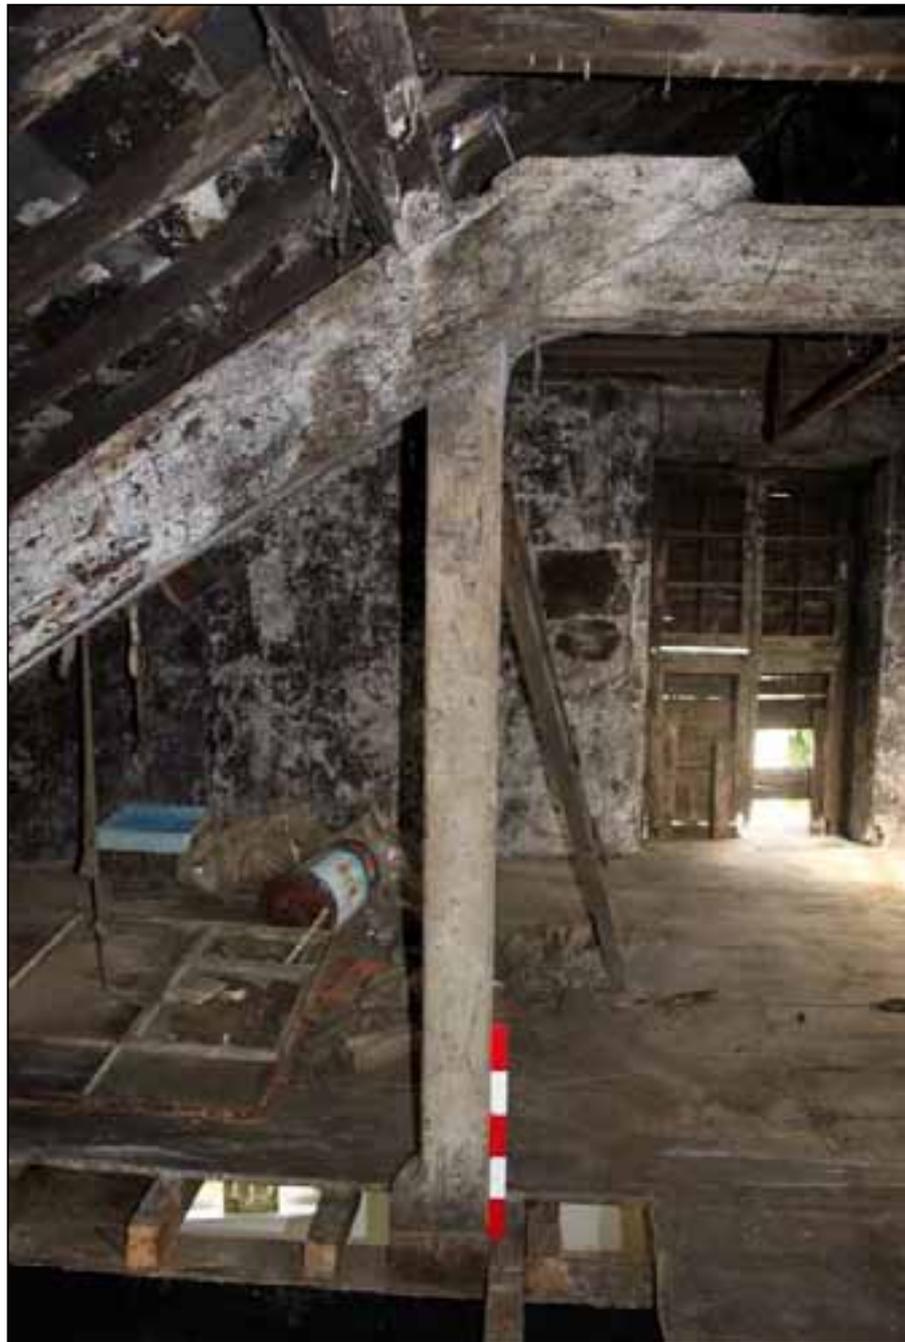
3.3.48 The roof of the eastern extension appears similar to that above the engine and wheel houses, having open bays within the attic. However, the trusses comprise queen struts, rather than queen posts, with the vertical members supporting the principal rafters of the truss (Plate 96), which extend only as far as the collar (kerb principals). The struts have similar jowled feet to the earlier examples to the west (Plate 96), suggesting that angle braces to the lower purlin may have been utilised in the original construction of both phases of the roof. The collars of each truss, and the straining beams of the earlier trusses to the west have semi-circular cut-outs, similar to those of the king post trusses to the west, and almost certainly relate to a pipe for the sprinkler system, rather than for a line shaft (Plate 94).

Plate 96: Queen strut truss above east extension

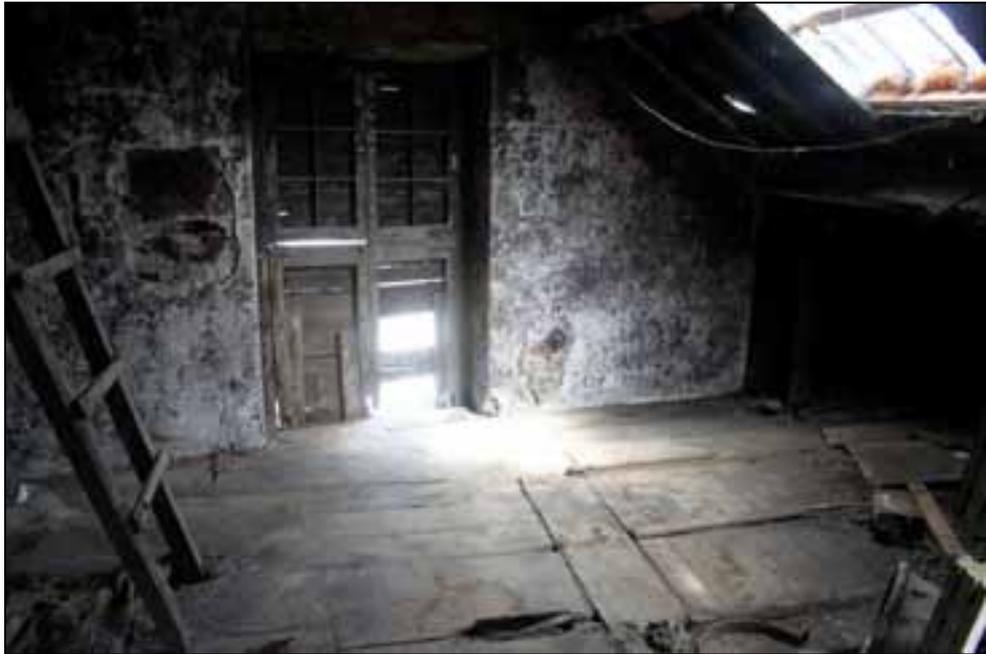
- 3.3.49 The eastern gable of the extension has a double door, forming the upper floor of a loading loophole (Plates 94 and 96), with direct access to the road (Plate 19). It retains no evidence for a hoist, but has an associated trapdoor in the planked timber floor (Plates 94 and 97).

Plate 97: Loading door and associated trapdoor above east extension

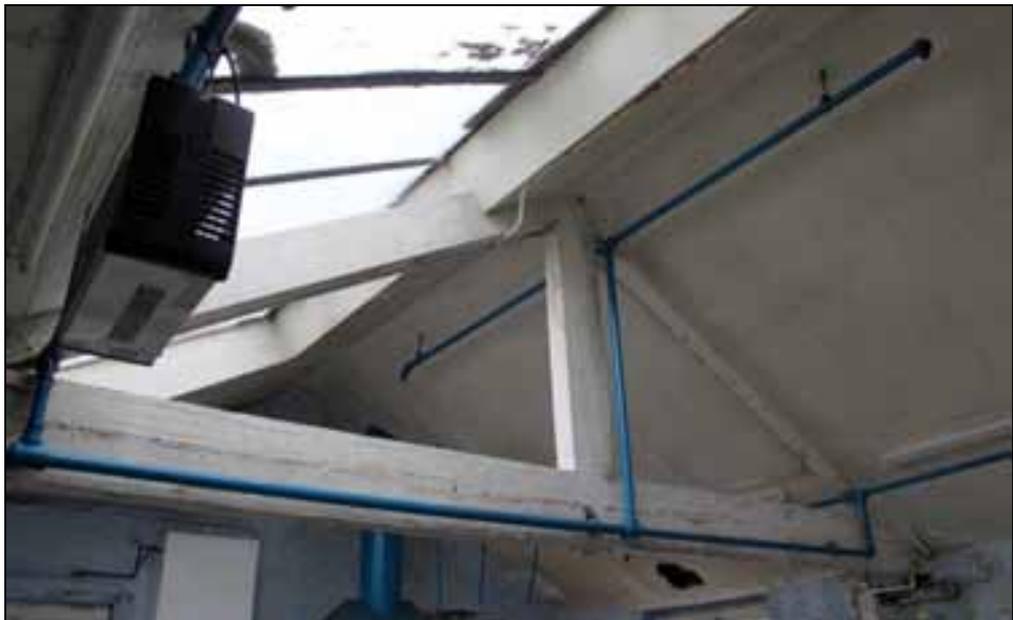
- 3.3.50 The brick extension to the south of the eastern extension of the mill has a separate pitched roof. This is carried on a solitary king post truss with a skylight band on the north pitch (Plate 98). Smaller, timber-framed skylights to both pitches of the earlier roofs (Plates 83 and 97) probably also represent insertions. The southern extension also has a corbel projecting from the chimney stack in its north-east corner, which possibly carried an external gutter on the earlier extension.

Plate 98: King post truss and glazing band above raised south extension

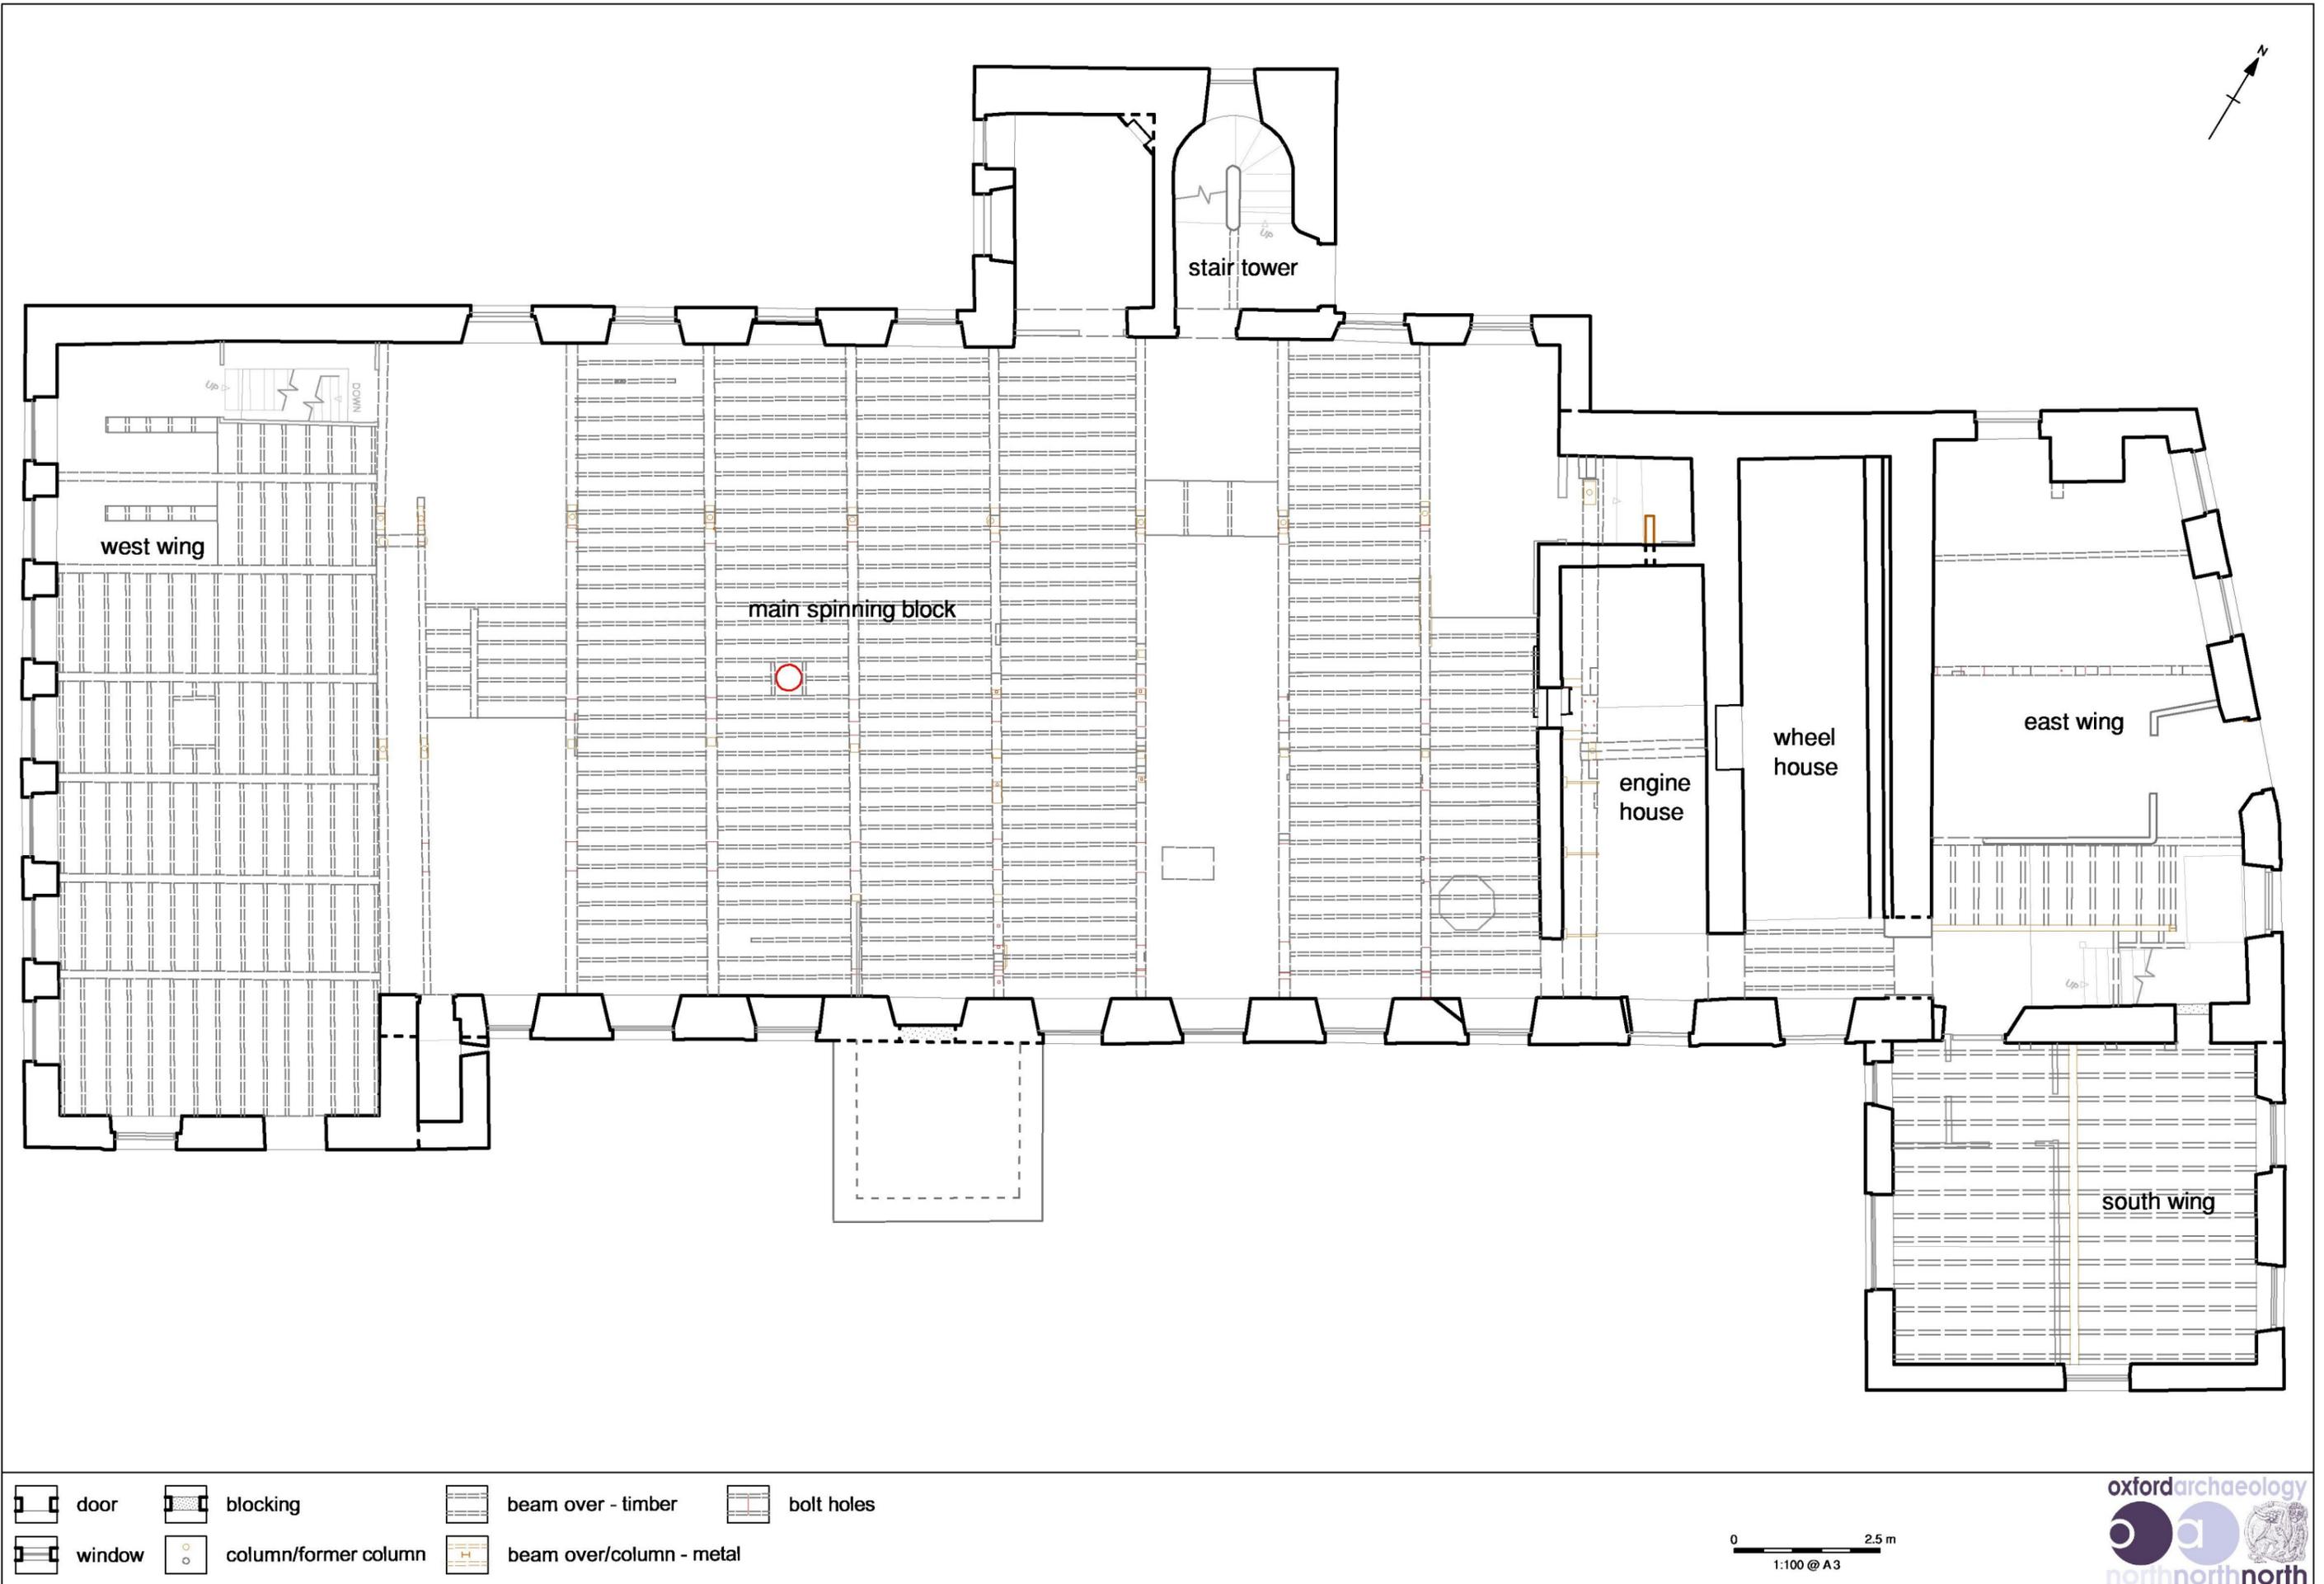
Figure 3: First-floor plan

3.3.25 The east wall of the spinning block does not continue to the repositioned north wall, instead having an eastward return 7' from the extant north wall (Fig 3). This is of coursed-rubble construction on its northern face, and probably represented the face of an engine house, partitioned within the enlarged mill. It was punctured by a ceiling-level beam (Plate 57), which appears to have been used to extend the original mill into the position of the external waterwheel, once the new waterwheel had been installed within the enlarged structure. This is supported by a column below a butt-joint at its north end (Plate 58), similar to the beams in the main spinning block, and demonstrating that it predated the repositioning of the north wall. This area was timber panelled latterly to create a store. A vertical aperture in the east end of its south wall presumably carried a shaft or belt from the adjacent gearing associated with the waterwheel.

- 3.3.34 A stone-built extension to the east of the wheel chamber had only a low narrow passage, affording access to the waterwheel axle bearing at ground-floor level, where it was terraced into the hill slope. At first-floor level, the extension was erected to the same width as the earlier waterwheel chamber, and infilled the space to the edge of the lane to the east. It appears to have originally comprised a single large room, with windows in each of its three external elevations, and probably represented a preparation room or warehouse, with cut-outs in the soffit of the timber ceiling beams suggesting it had two line shaft positions (Plate 73). The north wall was repositioned subsequently to the level of the expanded waterwheel house, apparently coinciding with its conversion to an office. A chimney breast was included in the repositioned wall, with a projecting corbel carrying a ceiling beam inserted in the position of the original wall (Plate 74). A stud partition wall was almost certainly contemporary, and separated the probable office from the southern part of the floor, with an entrance lobby to the original double doorway in the eastern wall (Fig 3). This had a small-paned 16-light timber skylight above, similar in style to a 25-light sash window to the south (Plate 19), which was internally partially overlain by an inserted half-turn staircase, placed in the south-east corner of the extension (Fig 3).

- 3.3.36 At first-floor level the extension comprised a lobby, adjacent to the earlier extension, with three doors to a privy and two further offices (Fig 3). The privy had a small four-light tilt window at the top of the west wall (Plate 75), and a modern toilet suite, whilst the floor in the western of the two larger rooms was raised by 2'6" (0.75m) in the southern part of the room, above the open-fronted bay below. The larger eastern room had two nine-light top-vented timber windows in the eastern wall, both probably original to the construction of the extension. The north wall had a fireplace cut into the 2' (0.61m) thick wall of the earlier extension (Plate 76), possibly placed in a window aperture of the earlier structure. Two convex sandstone corbels below the ceiling almost certainly carried a wall plate associated with the roof of the extension, prior to a brick-built second floor being added, at which point, the ceiling height also appears to have been increased to its present level.

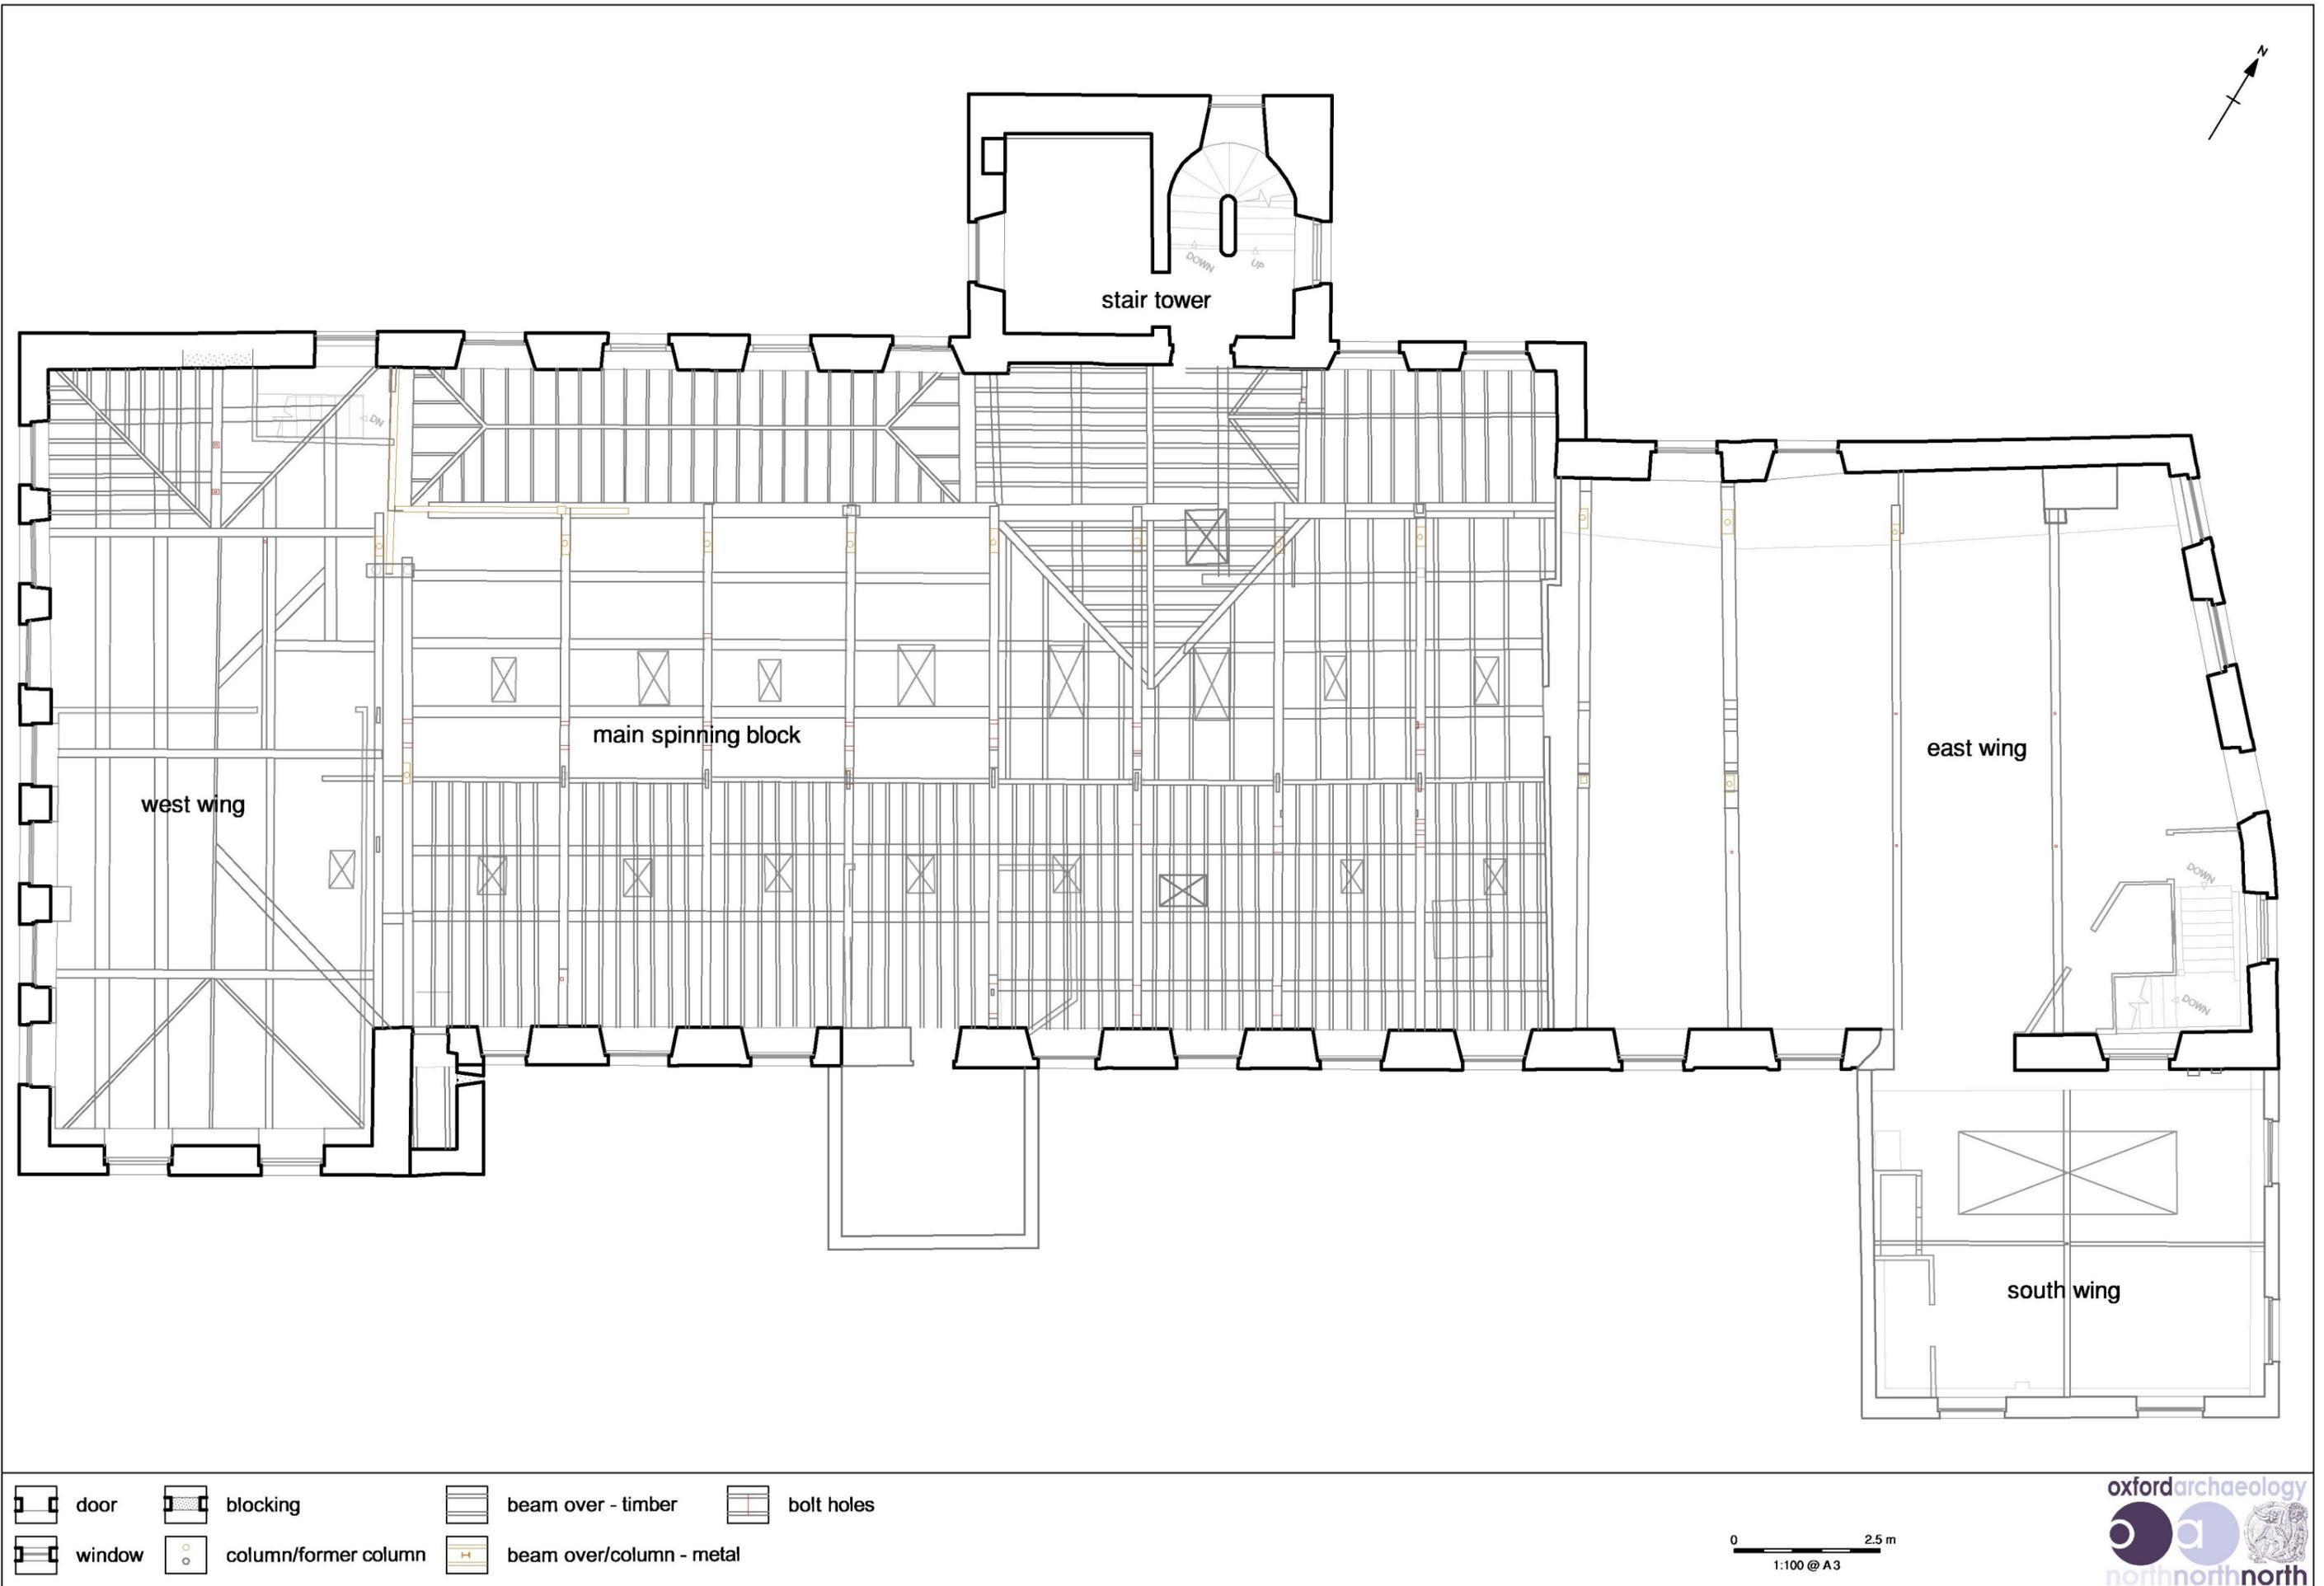
Figure 4: Second-floor plan

- 3.3.40 A timber stud partition extended to the south of the original eastern stone wall return, across the full width of the building (Fig 4). Although this followed the alignment of the partition between mill and waterwheel house on the floors below, it is probable that the area above the engine house at second-floor level was open-plan following the expansion of the mill, with the construction of an internal waterwheel house. Evidence within the roof space (*Section 3.3.31, below*), and the full height of the wheel house wall to the north (Plate 81), show that the appended wheel house was of similar height to the mill, and thus had a floor above the waterwheel, effectively making it an internal wheel, rather than being a lower, wider structure adjoining the outer face of the mill. The floors of the bay adjacent to the new waterwheel also appear to have been incorporated into the main spinning block at all floor levels.

3.3.42 The earliest extant element of the roof comprised king post trusses, with clasped ridge purlin and sandstone roof tiles, carried on three purlins to each pitch (Fig 4; Plate 83). The purlins were butt-ended above the trusses which have chiselled roman numeral assembly marks on their eastern faces (Plate 84), and originally had angled braces from the angled king post foot to immediately below the central purlin of each pitch, as demonstrated by blocked or redundant sockets in this position on each principal rafter (Plate 77). The king posts of each truss were cut subsequently, and the angled braces removed, with collar planks placed across each truss, at the height of the upper purlins (Plates 77 and 83). This created an open loft, and dovetail housed sockets in the tie beams (Plate 77), demonstrating that the loft formed was floored at this time. The new collars also have semi-circular cut-outs in their upper faces (Plate 83), almost certainly to carry a pipe for the sprinkler system, rather than a timber line shaft, which would have generated too much friction and heat in a weight-bearing timber housing.
