# **Ancillary Barn Conversion at Hougher Hall Farm, Old Clitheroe Road, Ribchester. PR3 2YU**

## **Structural Appraisal Report**

S1440 rev0

May 2011

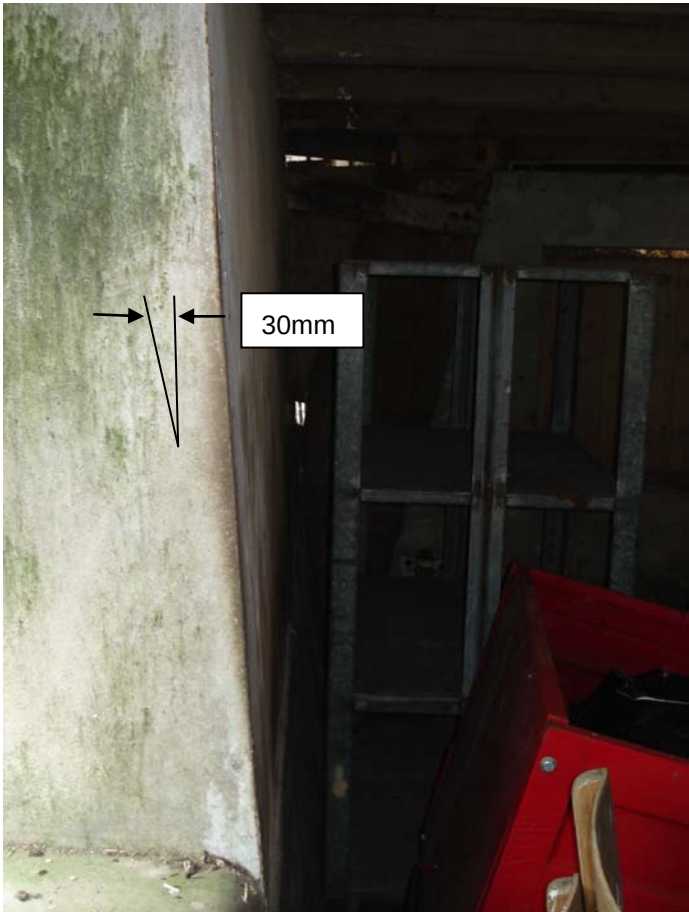
*Agricultural Barn Stalls;* Within the Main Barn structure, 'stalls' have been created within and area adjacent to the south facing gable elevation (Plate 15), partitioned from the barn area by means of a single storey height, load bearing masonry partition. Additionally, a more formative timber first floor provides a 'storage platform', supported by intermediate timber beams spanning from gable to partition. All internal wall elevations hold a rendered façade. The internal aspect of the front elevation is vertically plumb, whereas the gable and rear elevations over a 1.0m length offer vertical misalignment of 10 and 30mm respectively (Plate 16). First floor 86x78 joists @ 450mm centres span from front to rear, supported intermediately by two number 230x100 timber beams spanning the width of the stall area. Visual evidence of wood boring insect infestation of the floor beam members is apparent; however excessive deflection/overstress of the structural members is not noted. The ground floor is of solid ground bearing concrete construction, visibly sloping from partition to gable elevations, however not offering any evidence of historic or recent movement.

Plate 15 – ‘Stalls’ within Main Barn structure

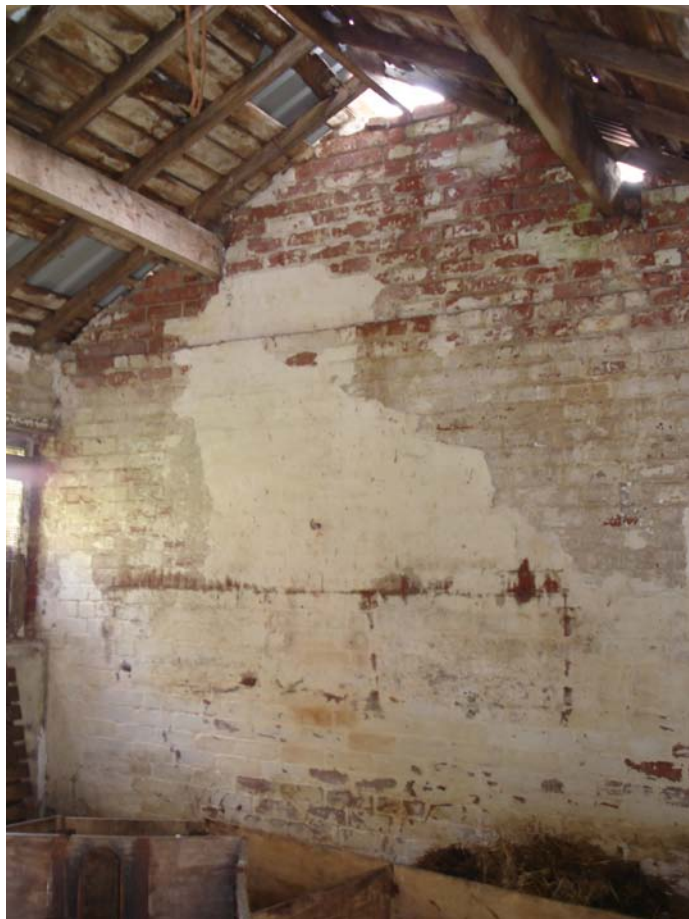
Plate 26 – Store 2/3 internal partition butt joint with rear elevation

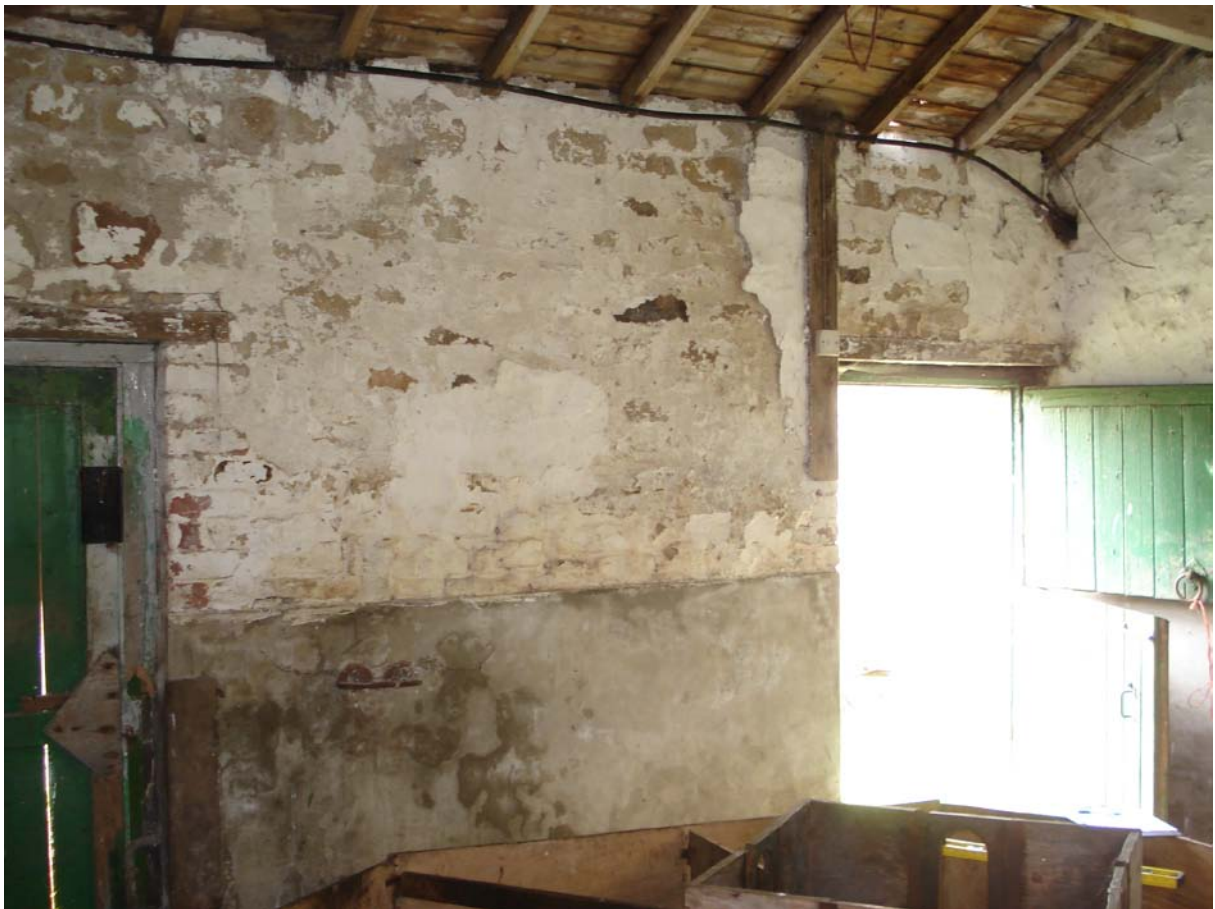
Plate 27 – Store 3 internal brickwork partition to Store 4

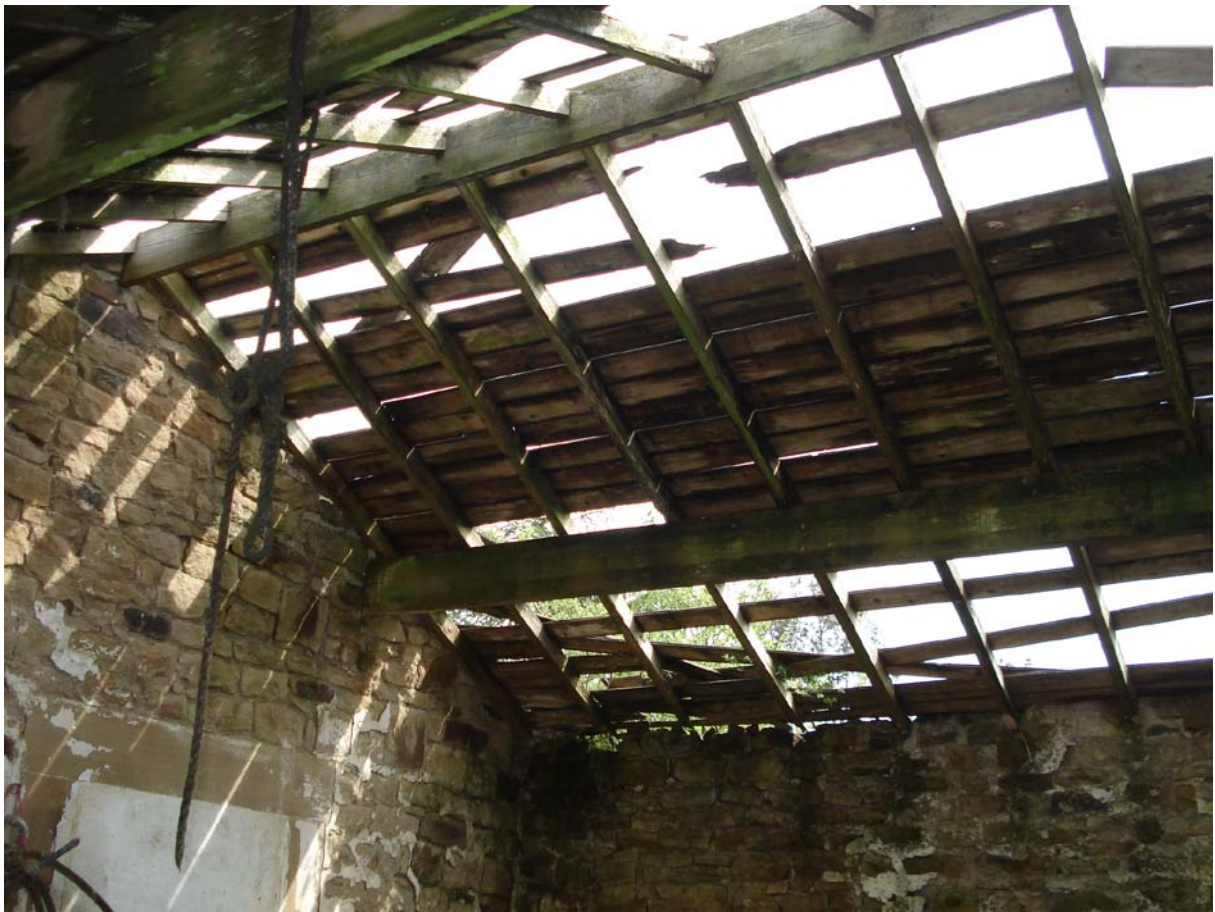
Plate 32 – Store 5

*Stores (West);* The western 'Store' area comprises of two individual stores separated by means of a load bearing masonry partition. This report will detail the individual store areas identified in a north to south direction when viewed from the central courtyard area (reference Plate 09). Store 5 (Plate 32) is also in a severely dilapidated condition. Obviously exposed to historic weathering, timber boarding is missing, exposing rafter and purlin members to moisture, rot and wood boring insect penetration (Plate 33). With no front elevation, presumably to accommodate the movement of agricultural plant, the internal wall elevation exhibit obvious signs of mortar weathering (Plate 34). The ground floor slopes from rear to front, of solid concrete ground bearing construction.
