**APPRAISAL**

**BARNS REF: B7**

**ELMRIDGE FARM**  
**Chipping**

**W/12/550**

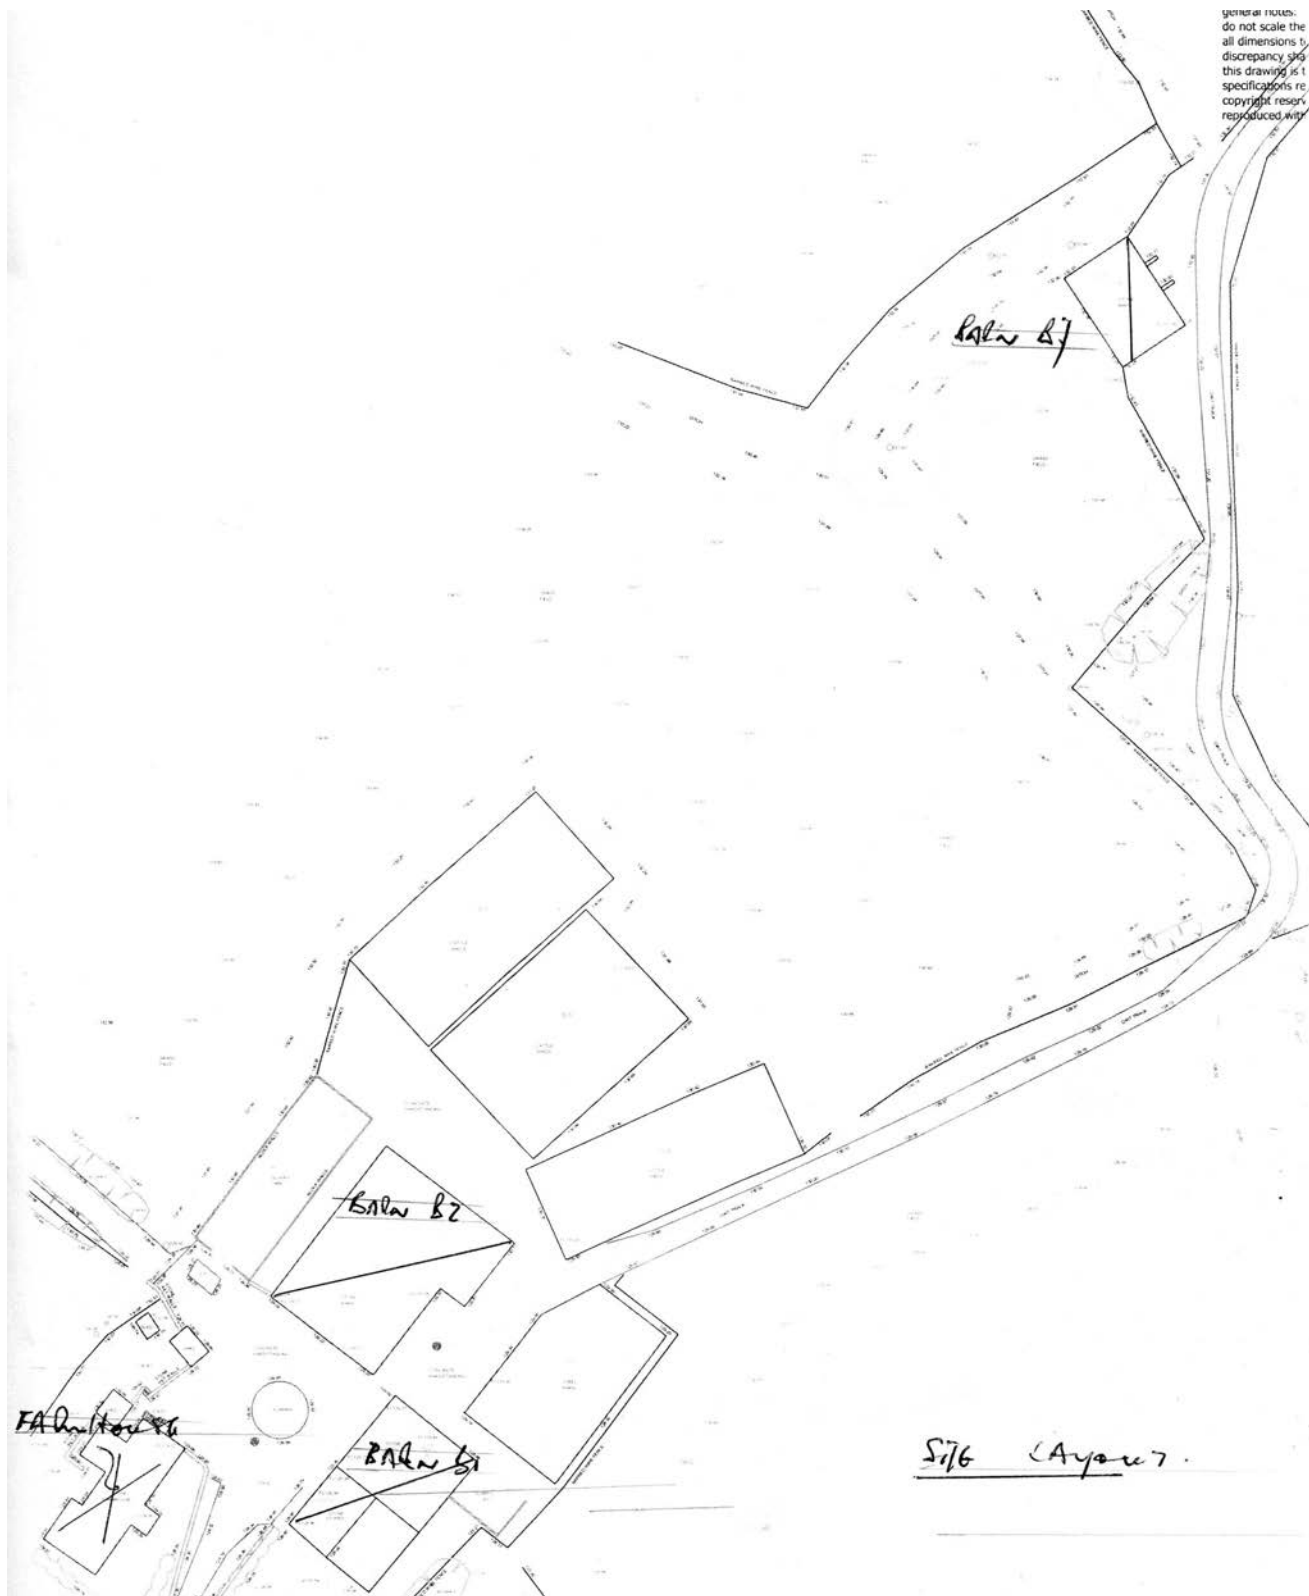
Barn B-7

Access was restricted in this area.  
The walls were checked at ground floor level.  
The front wall leans out at 20 in 1000; elsewhere the walls accessible are virtually plumb.  
The rear wall displays a noticeable bulge at high level.  
There is a near vertical crack on the right hand wall near to the front.

Access was restricted in this area.  
There is a crack on the front wall immediately adjacent to the left hand side.

- 4.07 There is noticeable bulging on the rear wall internally at high level.
- 4.08 We recommend this area is taken down and rebuilt.
- 4.09 There is cracking to the front wall immediately adjacent to the left hand wall.

- 4.10 We recommend this area of wall is taken down and rebuilt ensuring an adequate bond with the adjacent walls.
- 4.11 We have no information with regard to the proposed conversion or works associated.
