Design and Access Statement

29 Church Street, Ribchester:

External works, car parking and garage proposals including the proposed demolition of existing outbuildings.

IWA Architects

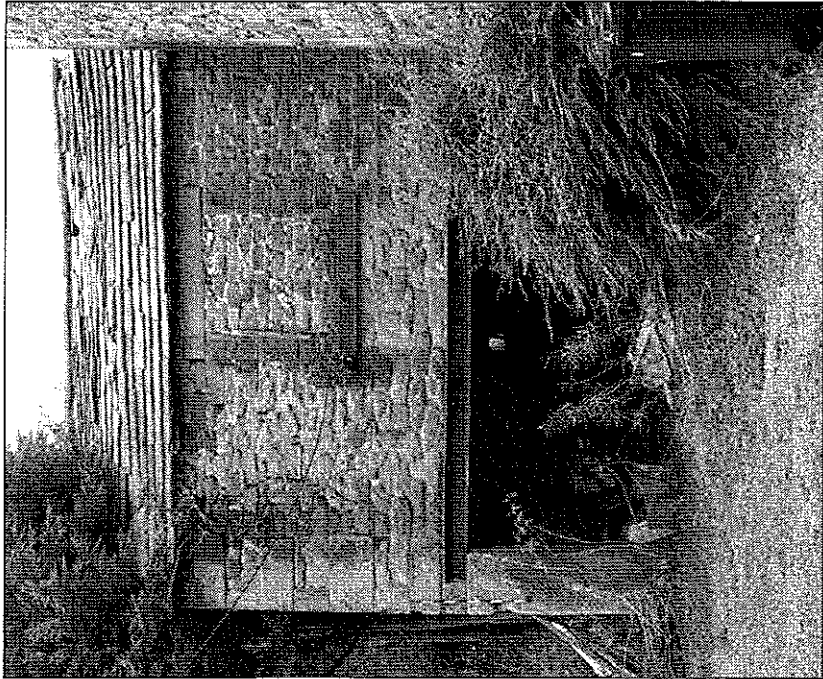
Photo 1: North-east elevation

- 5.1 The outbuilding is of two storeys, and is built from sandstone rubble with punch-dressed quoins and stone slate roof, materials typical for the district and period. The stonework is slightly better to the north-east front, but this side has had a large doorway inserted beneath a steel lintel, do doubt to enable its use as a garage, in the mid 20th century (photos 1 & 2). All that remains to indicate an earlier arrangement is the jamb of a doorway (with marked diagonal tooling) at the left-hand end of this elevation, but there is also a blocked window or forking hole to the first floor. An unblocked, two-part forking hole survives in the south-east gable (hidden by the conifers), which was probably put in when the earlier opening was blocked. The only openings in the south-west side are one or two breathers, and the cement line of an adjoining lean-to roof is visible here (which fits with the map evidence for there having been a building there, well into the 20th century). It is interesting to note that the boundary wall running to the south-west contains a date-stone of 1834 (carrying the initials J W – presumably those of John Waterworth), but its almost random inclusion suggests that the wall may have been rebuilt. However, as no quoins are visible in the south-west face of the building where the wall adjoins, it does imply that the wall pre-dates the outbuilding.

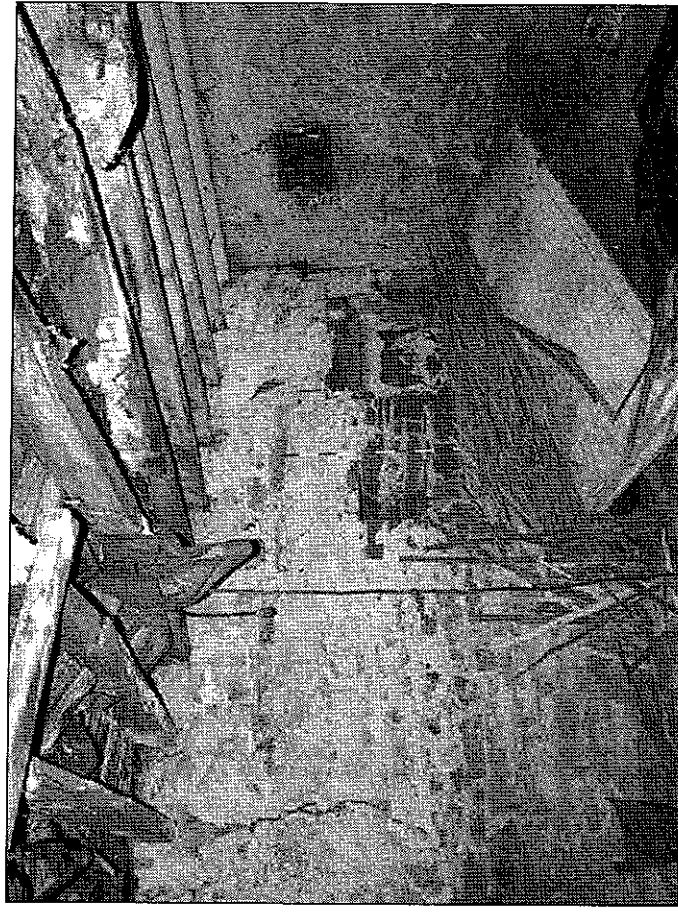
Photo 6: Interior, from the north

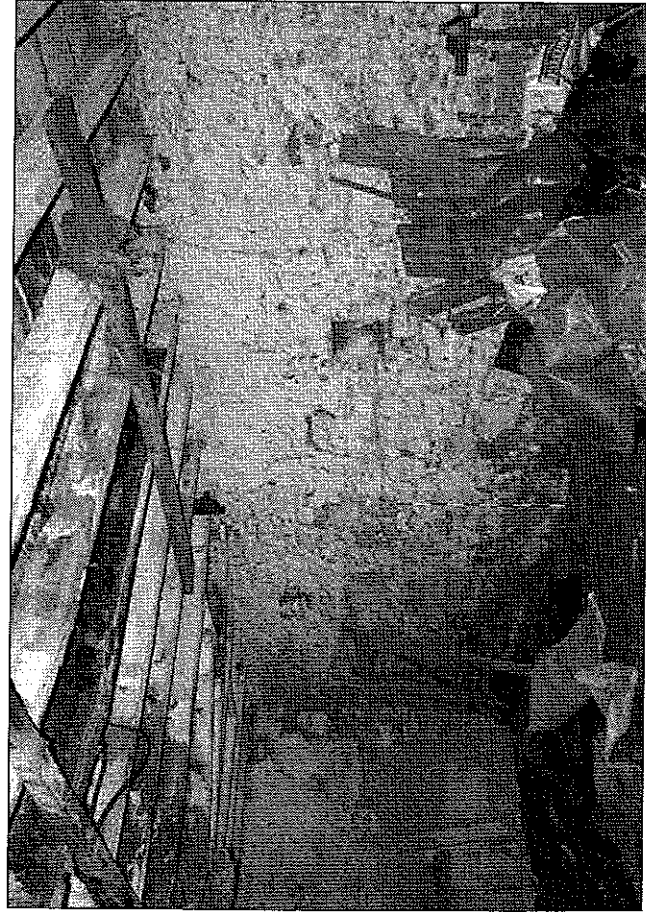
Photo 5: Interior, from the east
