## **HERITAGE STATEMENT**

**IN SUPPORT OF A PLANNING APPLICATION AND A  
LISTED BUILDING CONSENT APPLICATION TO  
CHANGE THE USE OF A BARN TO A CAFÉ AND  
VISITOR CENTRE CENTRE.**

**STEPHEN PARK, DALE HEAD, SLAIDBURN, BB7 4TS**

**Janet Dixon Town Planners Ltd.  
10A Whalley Road  
Clitheroe  
Lancashire  
BB7 1AW**

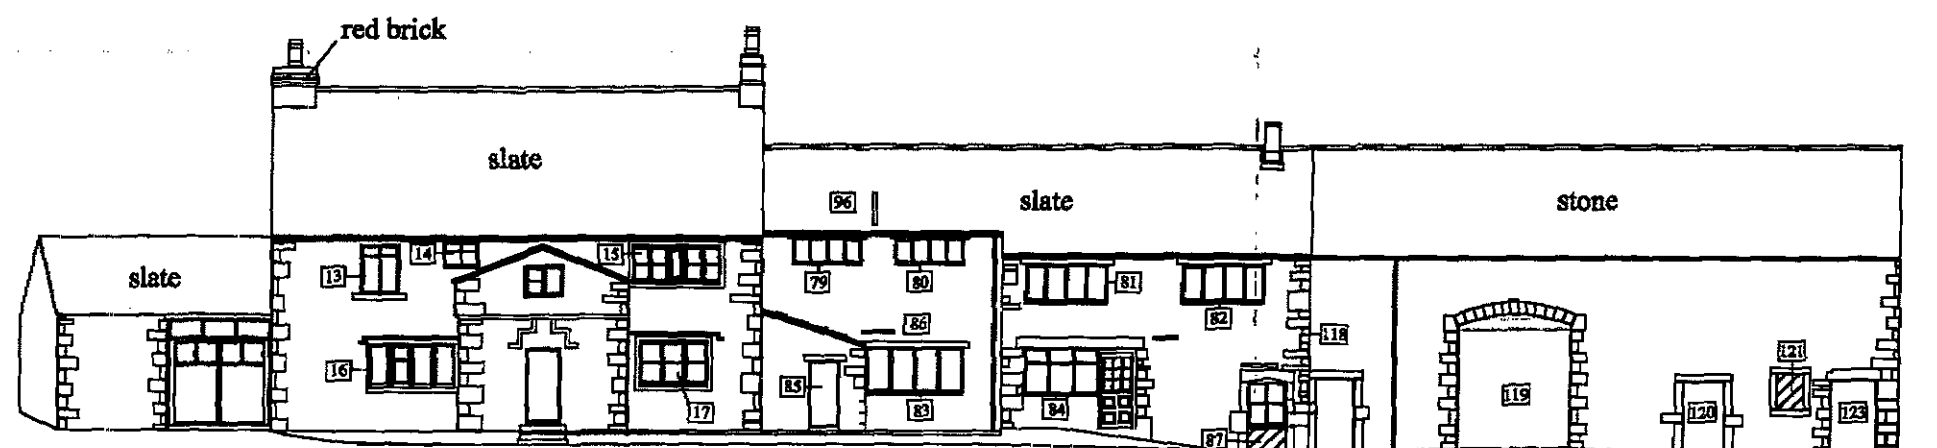
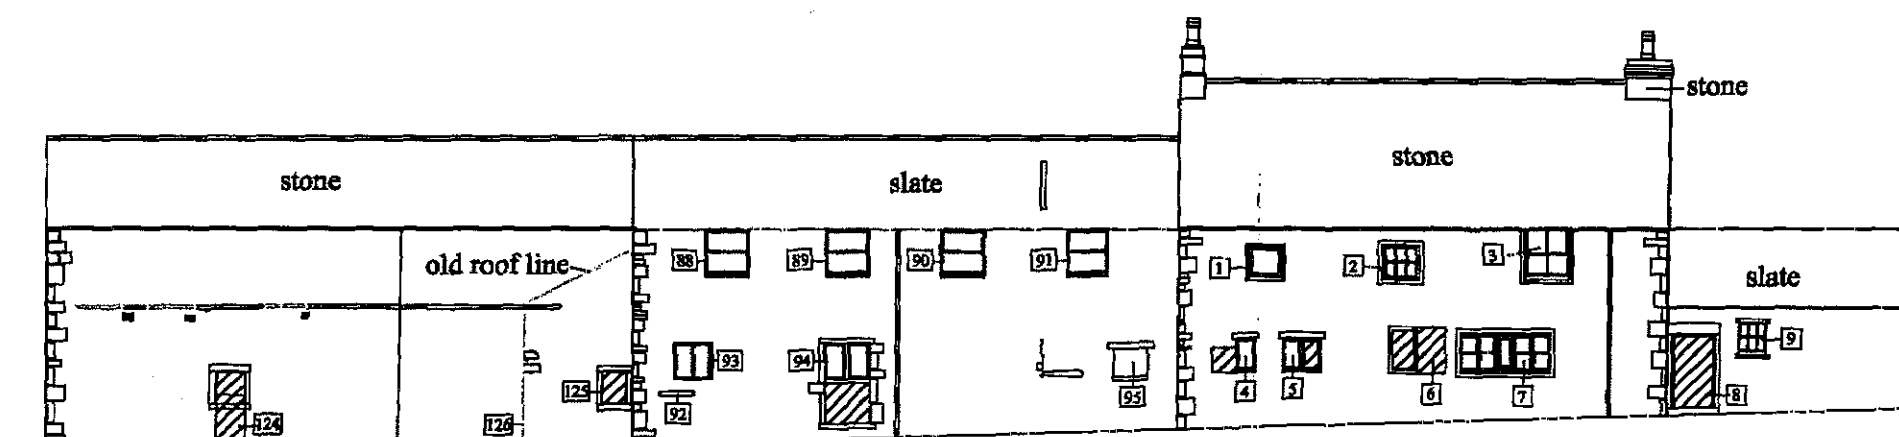
Figure 2: Farmhouse showing norththwest and southeast elevations

Southeast Elevation

Northwest Elevation

- 2.1.3 The porch (Fig. 2, Plate 1) has been built of evenly coursed sandstone with millstone grit quoin stones. The external stone work has been heavily pointed to the extent that it is almost rendered. The roof is of slate with sandstone ridge pieces; it is pitched and orientated at right angles to the south-east elevation. The first floor is marked on two sides by a stone step or jetty with a mullion window to the gable. There are two ground floor windows [21 & 28]. The main porch doorway [25] is very elaborate with quoin stones with moulded edges, leading to a horizontal zigzag effect in bold relief along the lintel. Above this relief work is a date stone with the initials: I.H.A. 1700. The initials are believed to refer to Heber of Marton (Dixon & Järvinen 1989, 70). Situated above the lintel and datestone, is a stepped hood-moulding. The porch doorway is currently painted and would have originally been unpainted (Mitchell 1992, 41). There is a plinth around the porch but compared to the house plinth it is narrower and lower.

- 2.1.6 The rear elevation of the house, (Fig. 2) consists of seven windows [1-7] three to the first floor and four to the ground floor. Two of the first floor windows appear to be in an original state with the exception of the central mullion from each window having been removed. Window [3] has been enlarged both vertically and horizontally with all but one of the moulded casing stones being relocated. The ground floor window [4] is currently used as a ventilator and is quite narrow with rudimentary sill and lintel, and appears to be a much later insertion. Window [5] is similar to [1 & 2] but with the central mullion retained. A much taller mullion window with external moulding [6] is centrally placed in the lower ground floor elevation. The increase of height to this window would seem to denote its use as a staircase window. The kitchen window [7] is also an original feature with four mullions remaining *insitu*. The rear door [8] is more problematic in interpretation. It appears to be contemporary with the original front door judging by the elaborate circular design. However, it has been incorporated into a much later extension. After close inspection it was thought that the quoined doorway was removed from its original south-west facing position when the 'oasthouse', an outshot to the west of the house was added. This work was well executed with the sandstone courses continue from the house into the extension.

- 2.2.5 The front of the barn (Fig. 2) features two original doorways at either end [62 & 65]. These are characterised by large quoin stones and lintels. Door [62] has been blocked with sandstone, possibly dating to the insertion of doors [57 & 58] and the modification of the layout of the south-east end of the barn into a twin aisled shippam. To the center of the elevation is a large wagon door [64]; the door itself is no longer present and a modern window occupies the original opening. The lintel to the doorway is of two-piece sandstone construction with associated quoining down the northern side; the southern side is incorporated into the extended step to the southeastern half of the barn. Internally the doorway was supported by a single arched timber, which has been strengthened through the addition of a straight re-used timber lintel. A boarded up window [63] displays an elaborate stone moulded window surround, which has been re-used to form a small rectangular window to the barn's ground floor. There are numerous ventilation holes [66] through out this elevation, which are again above the first floor level. A number of these are blocked.

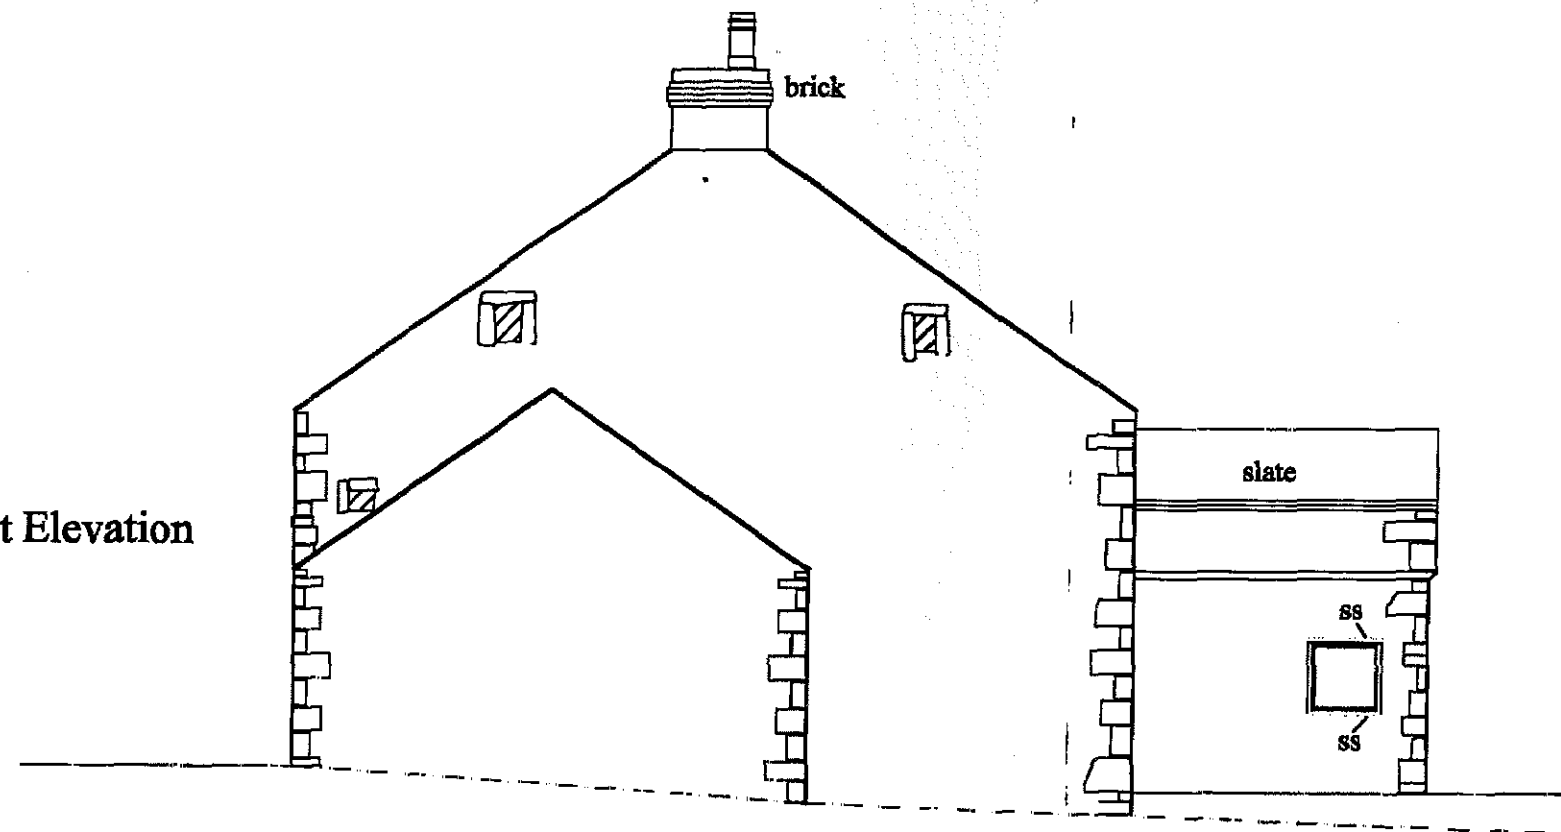
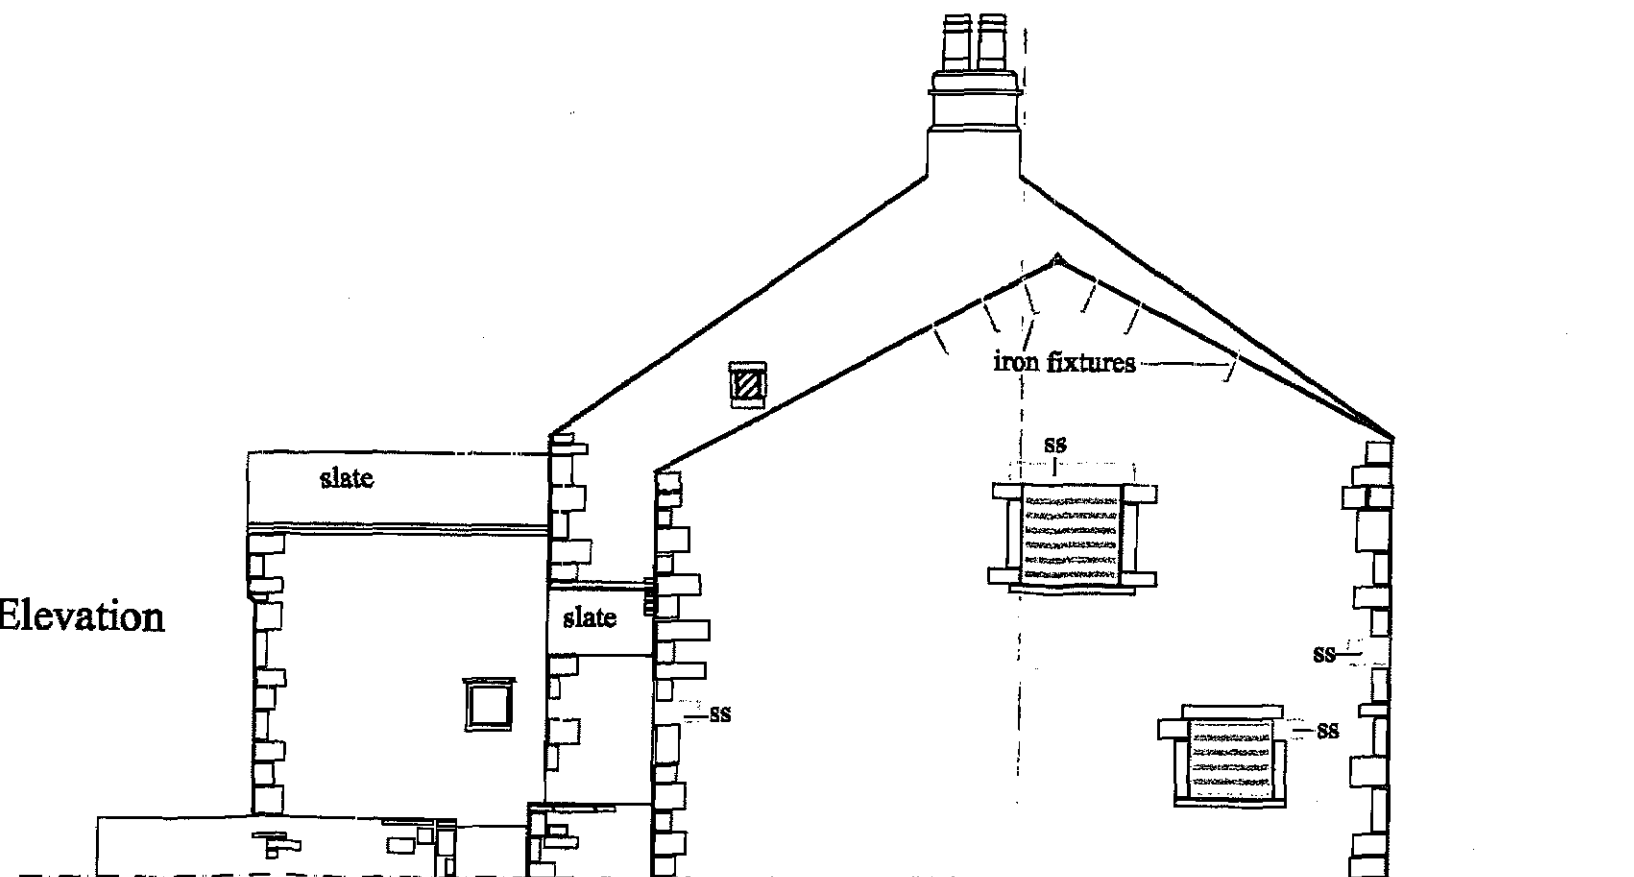
Figure 3: Farmhouse showing southwest and northeast elevations

Southwest Elevation

Northeast Elevation

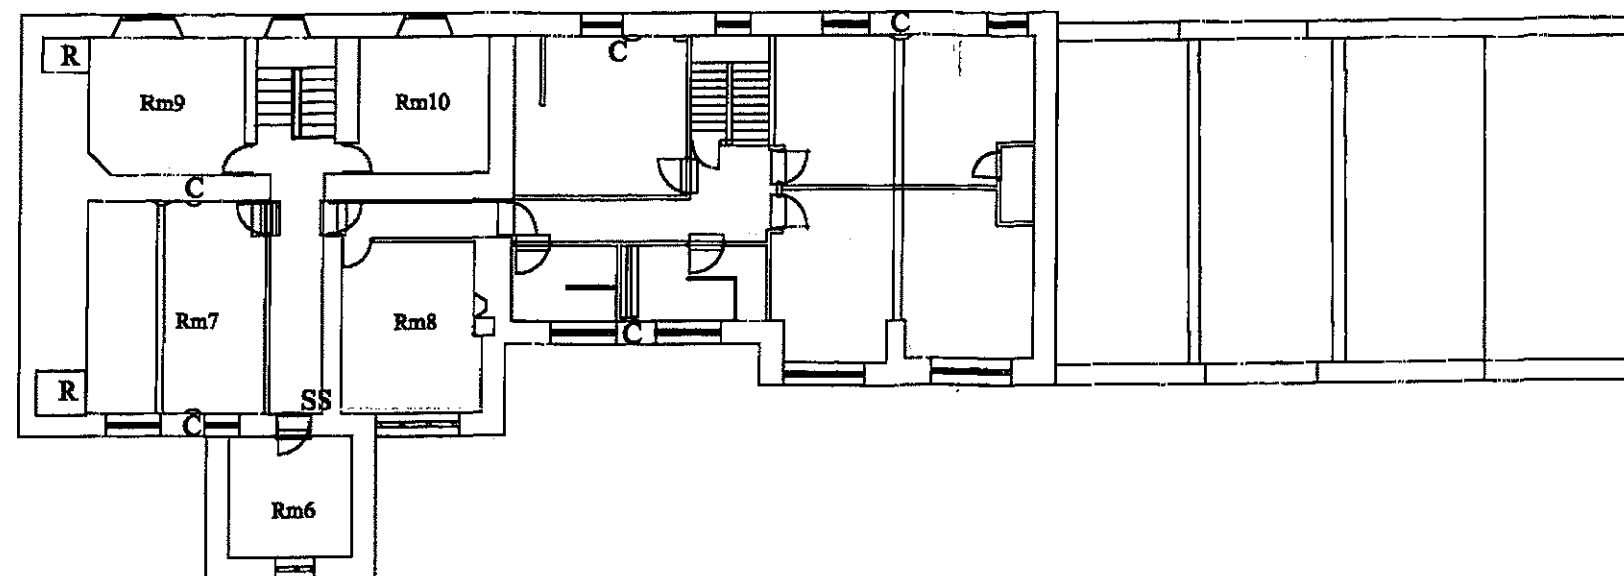
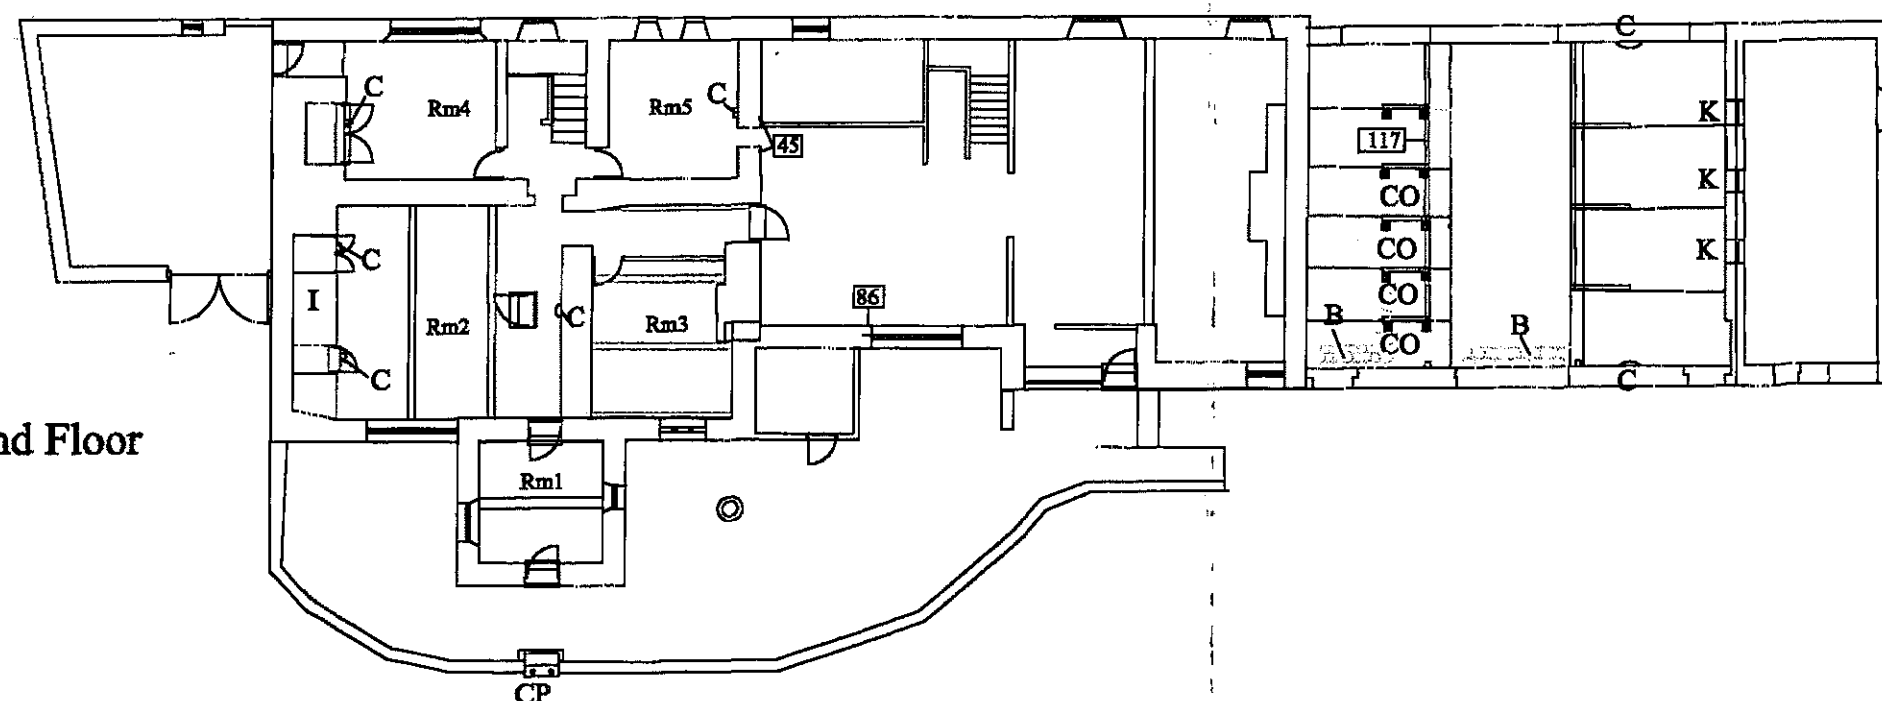
Figure 4: Ground and First Floor Plans of the Farmhouse Range

First Floor

Ground Floor

- 2.1.10 Internally the house (Fig. 4) was originally divided into eight rooms; four to the ground floor, and four first floor bedrooms with the possibility of further rooms within the attic space. The hall (Rm. 2) and parlour (Rm. 3) were to the front of the building with the kitchen (Rm. 4) and service room (Rm. 5) to the rear separated by a staircase to the first floor. This simple plan has not altered

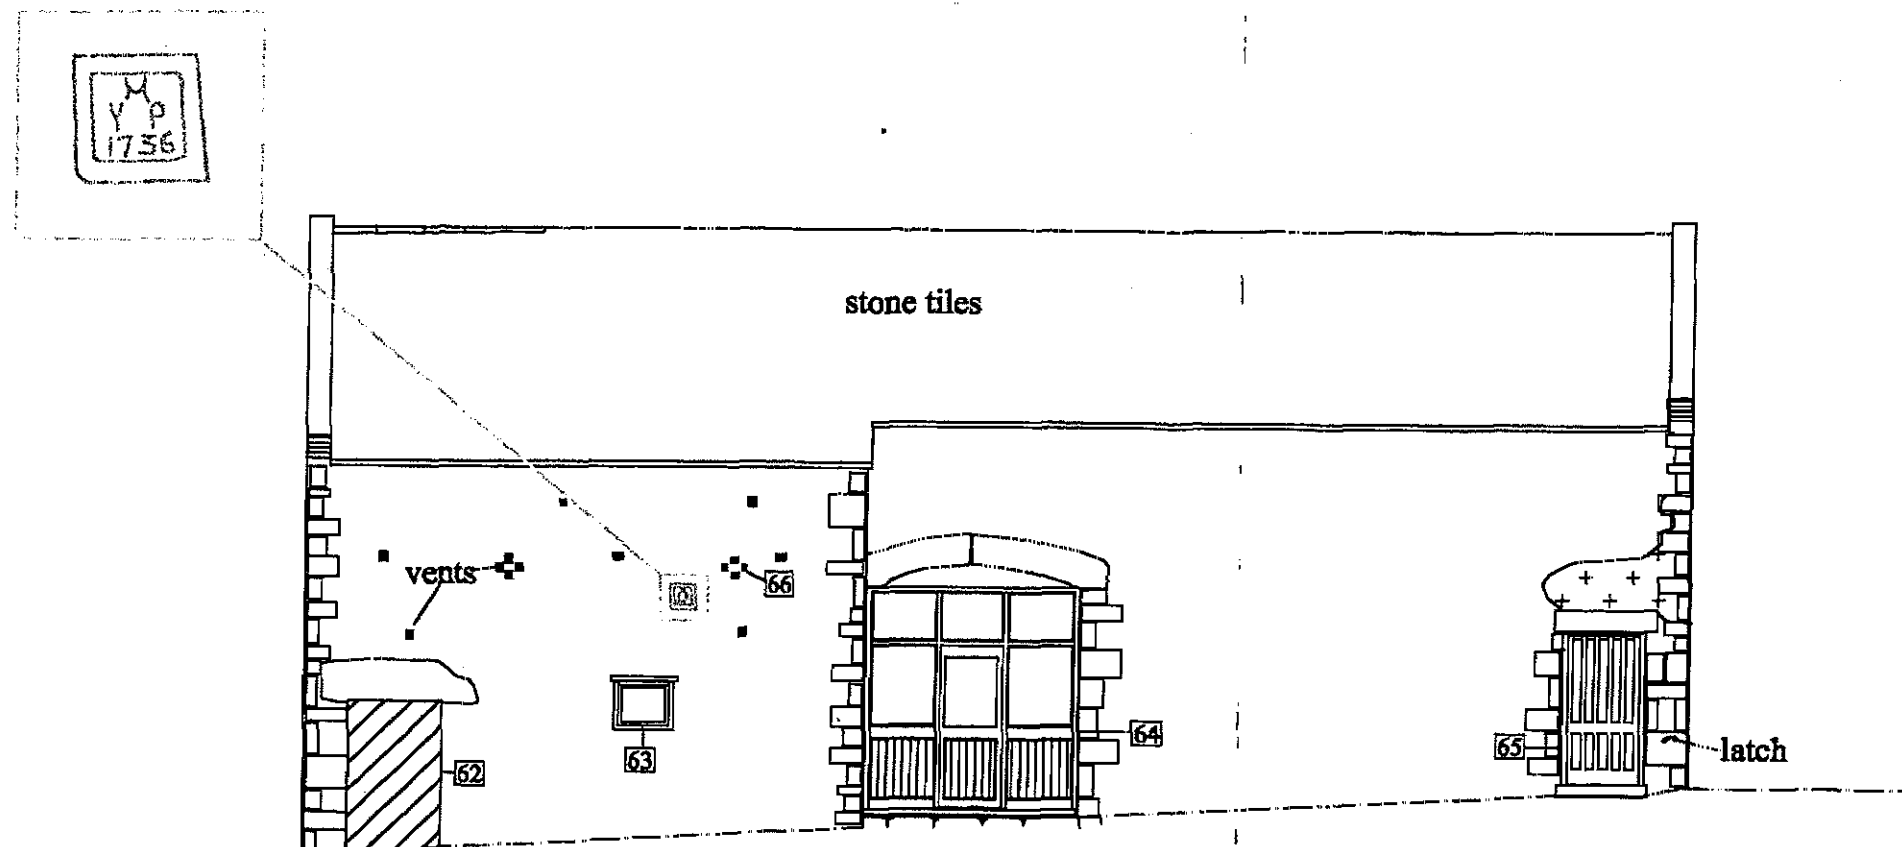
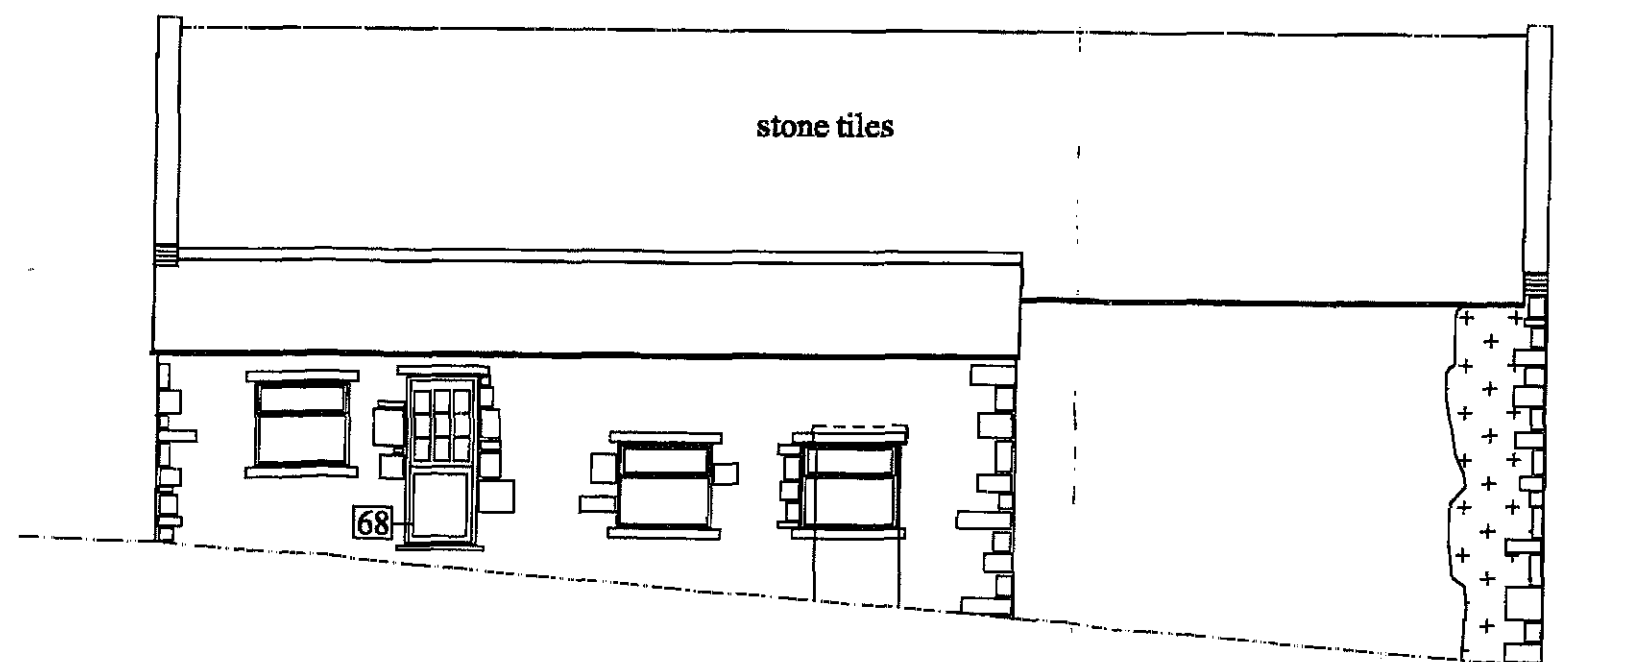
Figure 5: Old Barn showing northeast and southwest elevations

Northeast Elevation

Southwest Elevation

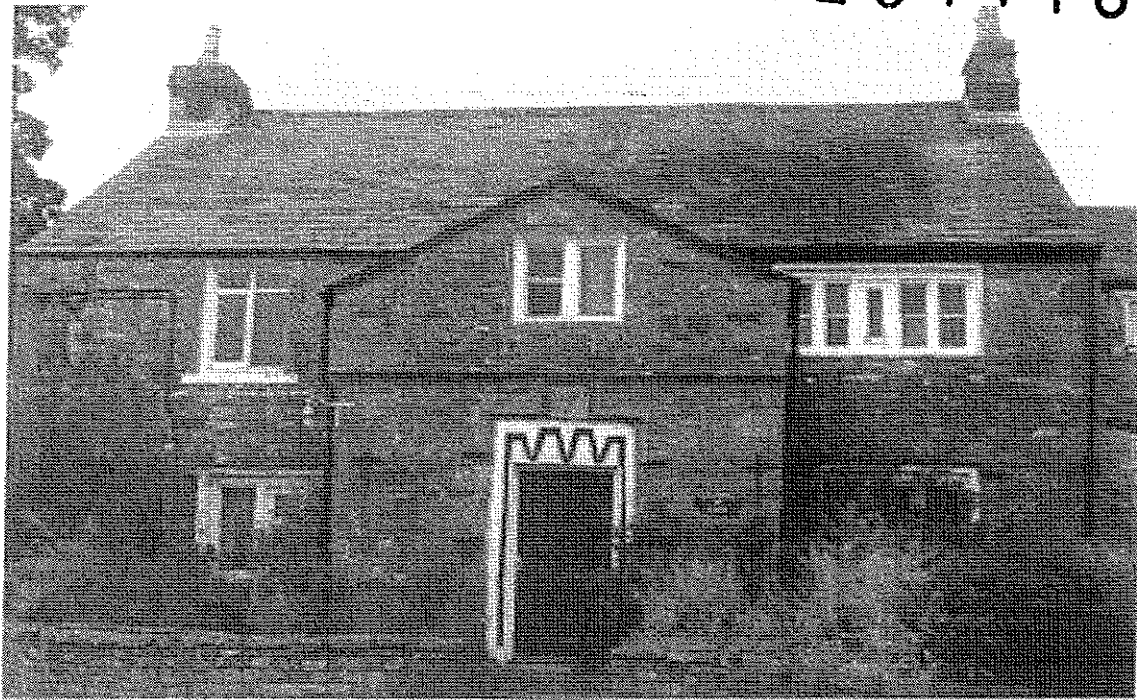
Plate 1

Stephen Park Farm House

Looking north-west

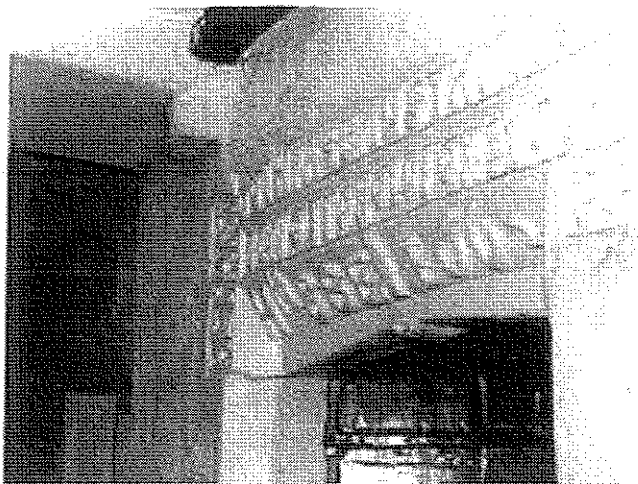
Plate 2 Ornate doorway into the Parlour (Rm 3)  
Looking north

- 2.1.13 The entrance to the parlour is marked by a quoined doorway [34] with broad chamfers and an elaborate lintel and would have originally been accessed directly from the hall. What appear to be the original hinges and latch-plate are located on the inside rebate. The lintel is inscribed in bold in relief: HE THAT DOTH PASE MUST HONEST BE NOT TO BOLD FORE YOU SEE. H<sup>m</sup>BSE. 1662 (Plate 2). The initials refer to the Molyneux family, inheritors of the Hellifield estate (Dixon & Dixon 1992, 122). It has been proposed that this motto was associated with the paying of Tithes by tenant farmers (Mr P. Tilbury pers. comm.). The pine plank and batten door (Plate 3) into the parlour features a pair of round ended strap hinges and a wooden lock encasement. There are two similar doors: a wider example into the service area (Rm. 5), and one to the first floor, which appear to be consistent with an early, possibly original date. The parlour again features two exposed bridging beams [35], and secondary beams [37] both stop chamfered. The secondary beams are, as with the hall supported by plain rounded corbels [38]. The joists have been under drawn with plaster. All that remains of the fireplace is a blocked chimneybreast over which, has been built a modern stone fire with seating ledge. Above the modern fireplace is another corbel larger than the beam support examples which supports the chimney breast present in the bedroom above (Rm. 8). The parlour has been divided by a modern stud wall, which creates a corridor to Barn 1 from the main house, this has necessitated an additional doorway into the parlour.

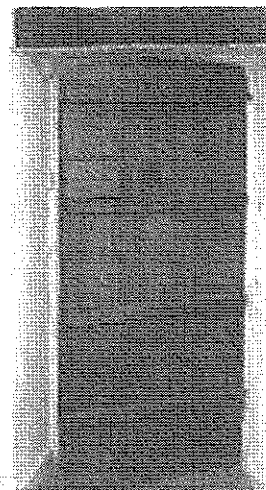
Plate 3 Inside of the  
parlour door

The inscription reads: HE THAT DOETH AS HE MUST NOT BE NOT TO HOLD FORT YOU SEE IT INE 1662

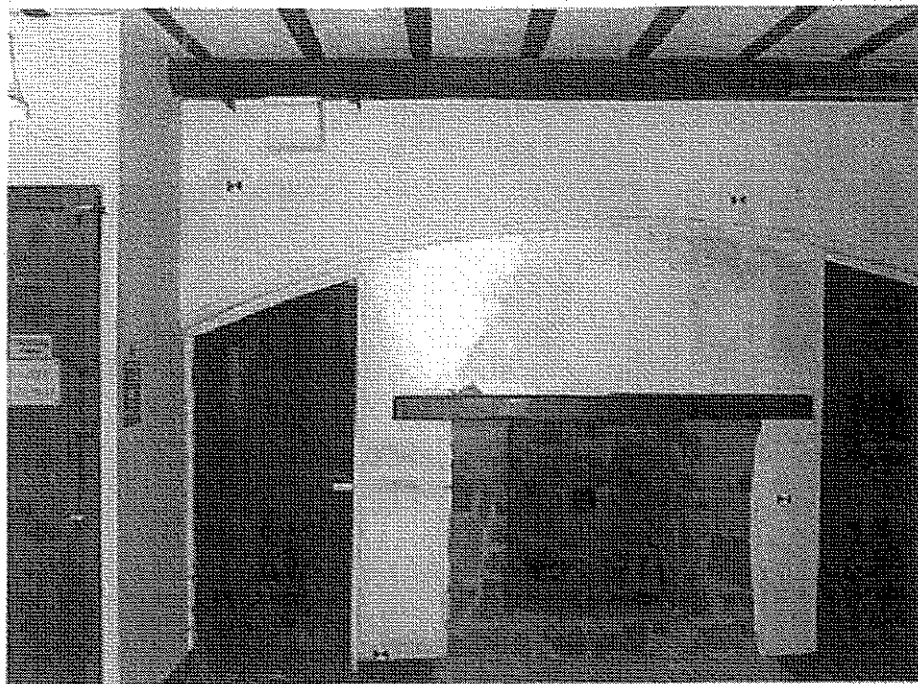
Plate 4 Blocked Inglenook Fireplace with corbelled beams Looking south-west

- 2.1.11 The hall was the largest ground floor room, entry into which was directly from the outside prior to the construction of the porch (dated 1700). The large arched fireplace [33] was originally an inglenook. The recess and hearth are filled with cupboards and a relatively recent fireplace with associated chimneybreast (Plate 4). Originally the inglenook would have been open with a dog-grate at the centre and large stone chimney hood. To the base of one of the inglenook cupboards is a small area of stone paving clearly underlying the present floor level.

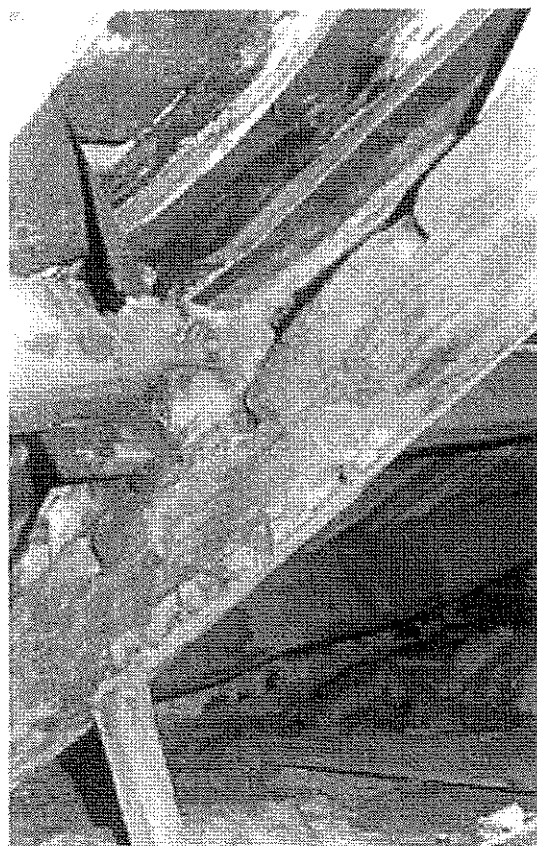
Plate 5 The farmhouse roof with braced principal rafter Looking south-west

2.1.25 Access into the attic space allowed an inspection of the roof. The roof comprises four sets of purlins and a ridge purlin supported by two trusses [51 & 52]. Truss [51] consists of a central post, the king post, which rises from the tie beam to support the ridge purlin. The principal rafters of the truss are braced to the king post about a third of the way up. There are additional braces between the principal rafter and the tie beam. All joints to the king post truss are mortised and tenon, peg holes cross through the joints but no pegs remain insitu. The purlins are rebated into the principal rafters. Truss [52] is a half truss with the wall between the hall and the parlour extending into the roof. The half truss consists of a reused beam for the principal rafter (Plate 4) with tenons to the upper surface. Reuse of timbers is also reflected in truss [51] and the purlins, which display a sequence of peg holes possibly from partition walling. Also visible in the attic were two bridging beams orientated south-east to north-east spanning Room 7. These bridging beams each feature two sets of mortice holes set into the upper timbers, there are no joists remaining insitu, but this arrangement does appear to indicate attic accommodation. The attic room would have been illuminated by up to four small quoined windows [11,12,18 & 19]. Two walls in the attic above room 9 had been rendered and lime washed but the altered ceiling has removed evidence of a floor.

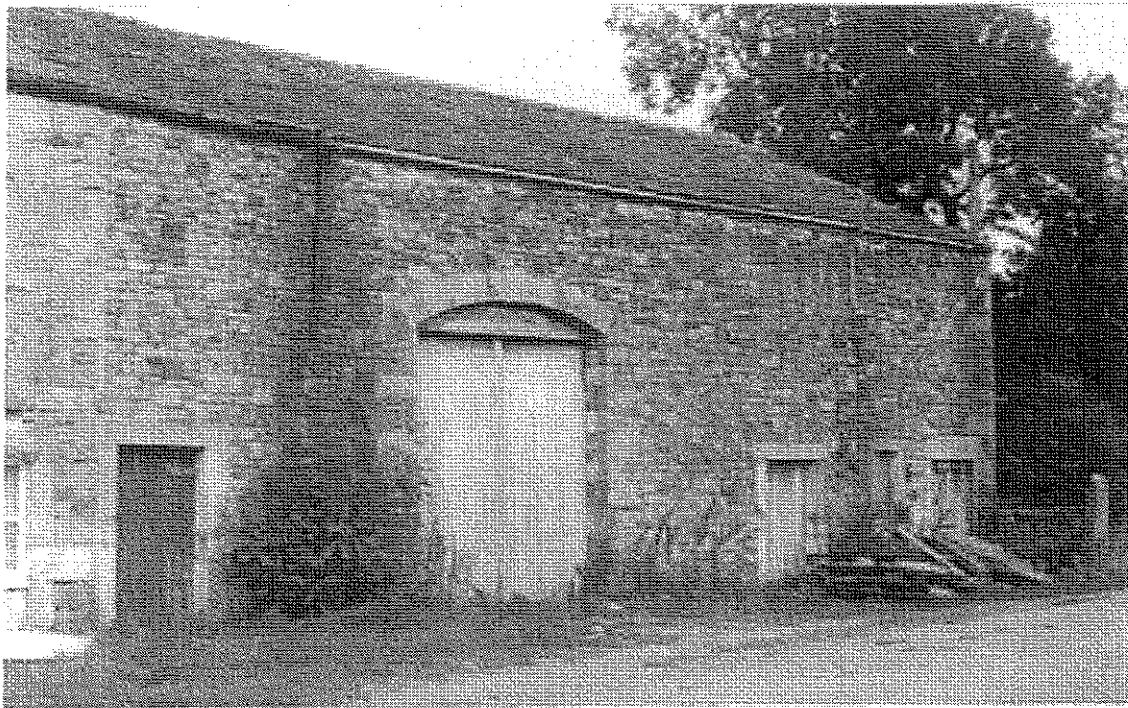
Plate 6 Front elevation of Barn 2

Looking north-east

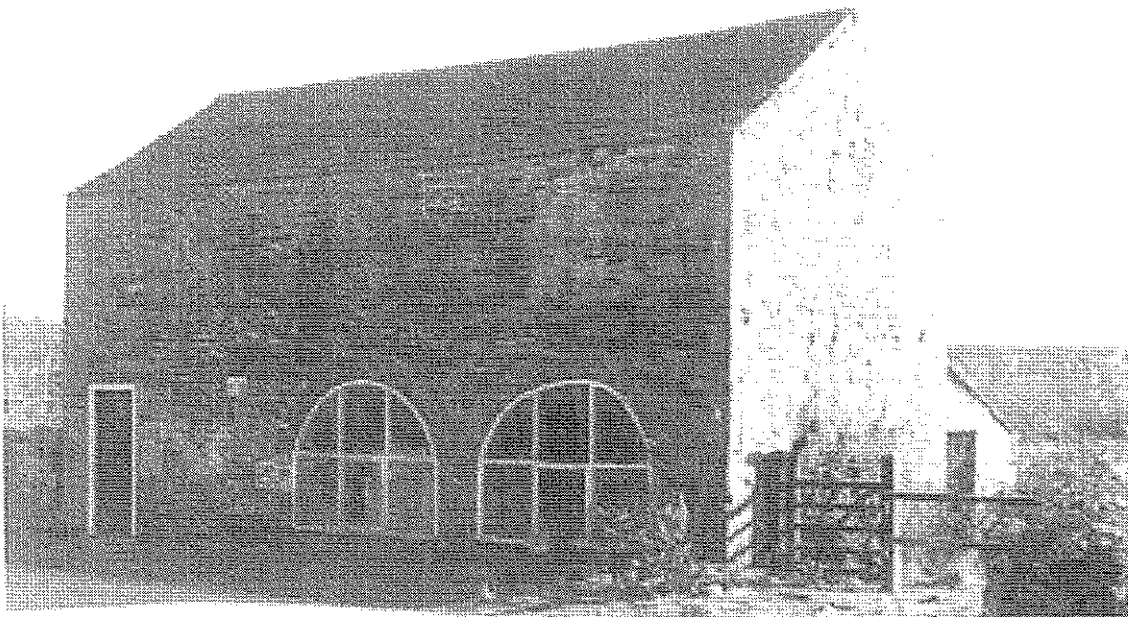
Plate 7 Front elevation of the Carshed

Looking south-east

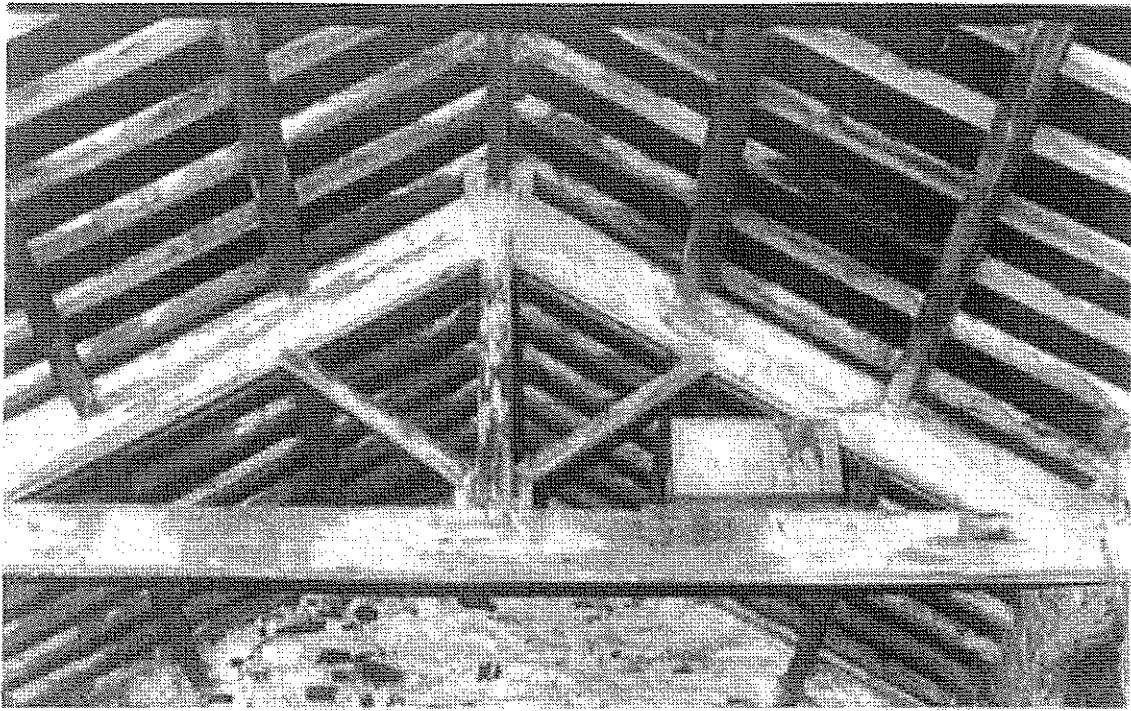
Plate 8 The Cartshed king post roof truss

Looking west

- 2.5.6 Although recently renovated the interior of the cart-shed remains relatively unchanged. All internal features have been extensively white washed. The roof is of kingpost construction with two trusses [112-3] (Plate 8), forming three bays. The trusses consist of machine cut timbers forming broad tie-beams and principal rafters. The king post supports two sets of trenced purlins and a ridge purlin. To the base of the king post is a pair of struts supporting the principal rafters. There were no bolts present in the trusses, which would tend

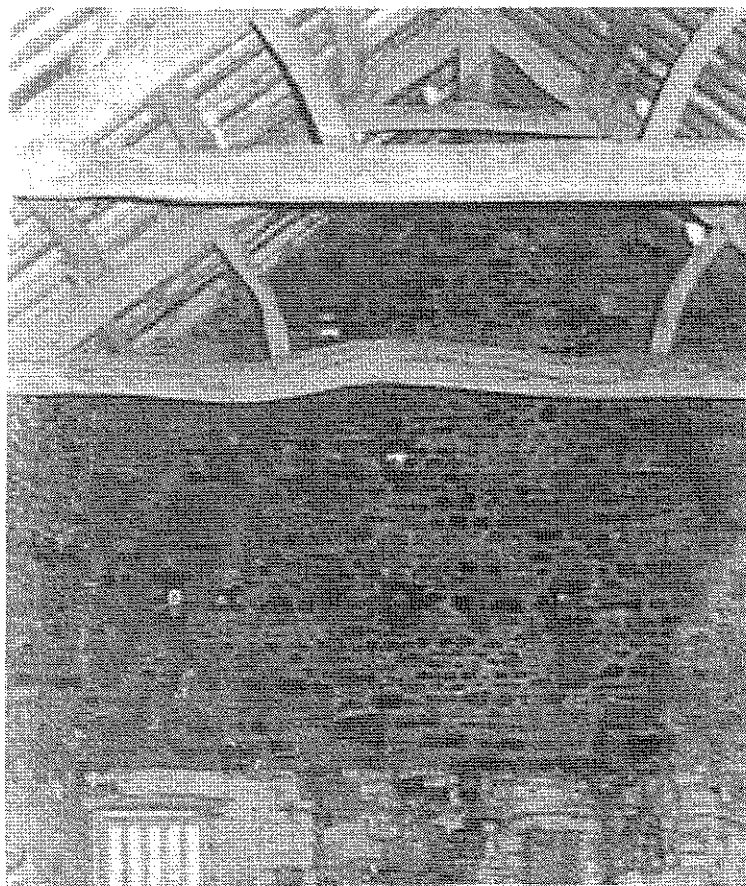
Plate 9 The southern roof trusses of the Old Barn

Looking south

2.2.2 The roof is supported by the two gable walls and an arrangement of four trusses. Three of the trusses are original the fourth is of machine cut timbers, as are the majority of rafters throughout the barn. These would appear to represent a major episode of restoration. The three original trusses are constructed of oak and rest on corbels to the supporting walls. Truss [53], is a collar beam and king post truss (Plate 9) as opposed to [54 & 55] which are queen post trusses with a king block supporting the ridge. The difference in the trusses appears to reflect the greater span of truss [53] (Dixon & Dixon 1992, 123). The purlins appear to be original and consist of half split trunks; they overlap the principal rafters and are probably trenched into them. An additional buttress has been built to support truss [53] towards the southwestern corner.

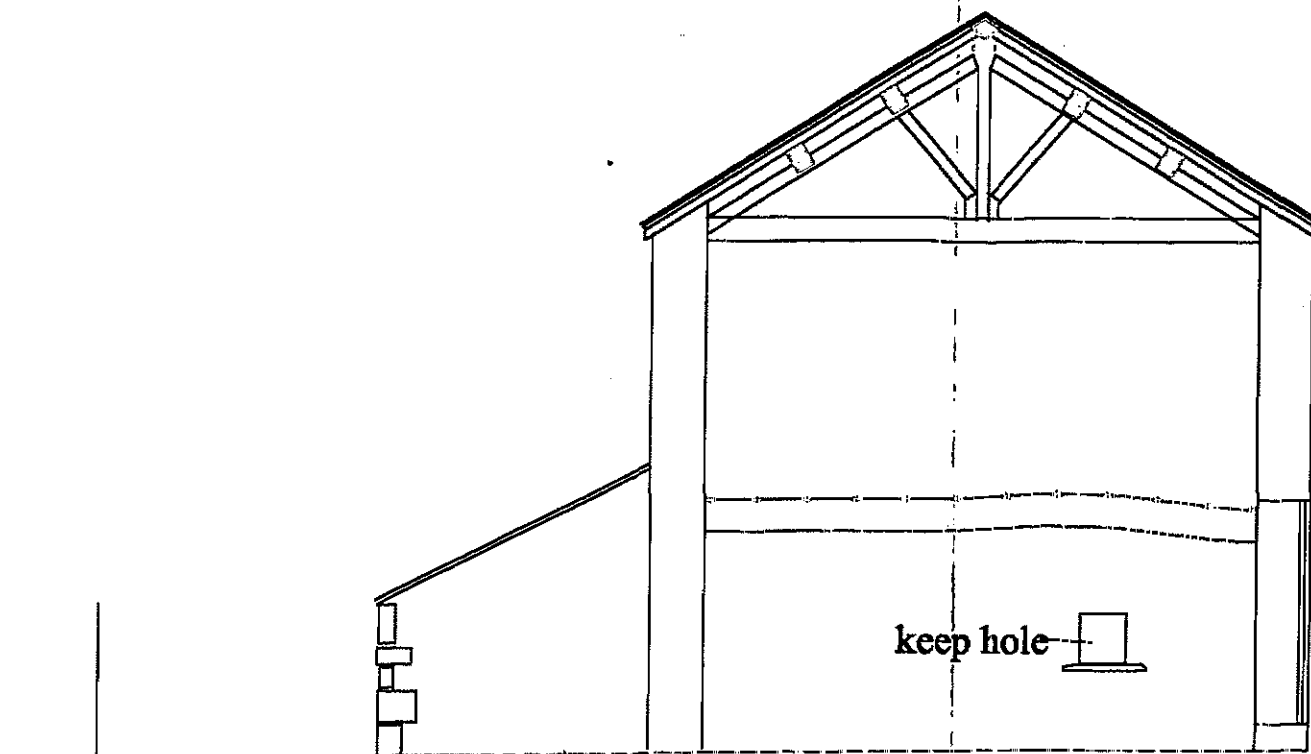
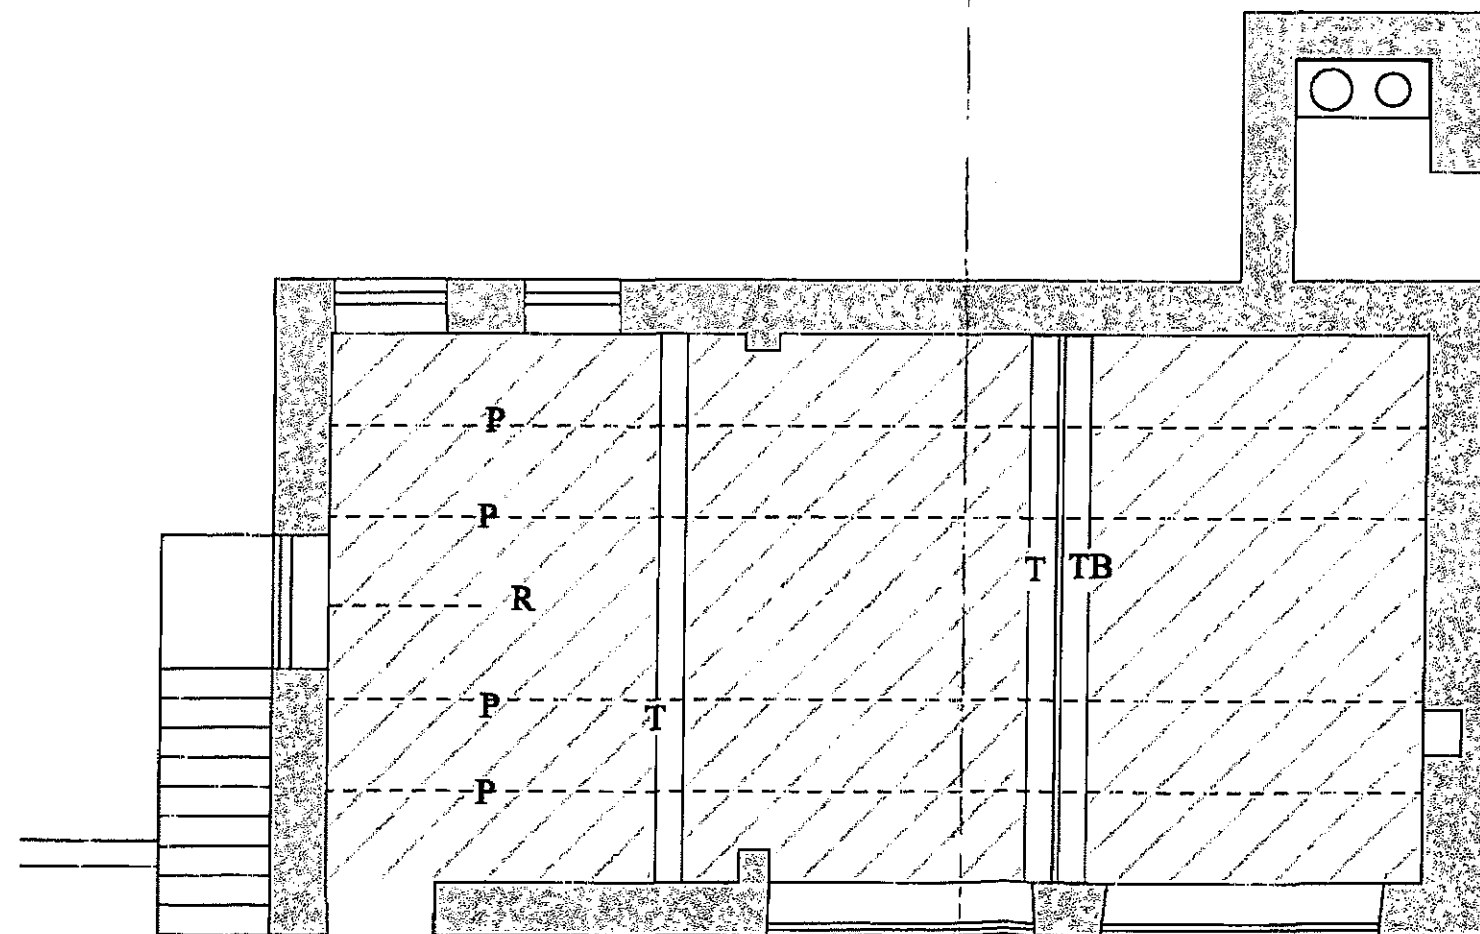
Figure 10: Cross section and ground floor plan of cartshed

Cross Section

Ground Plan

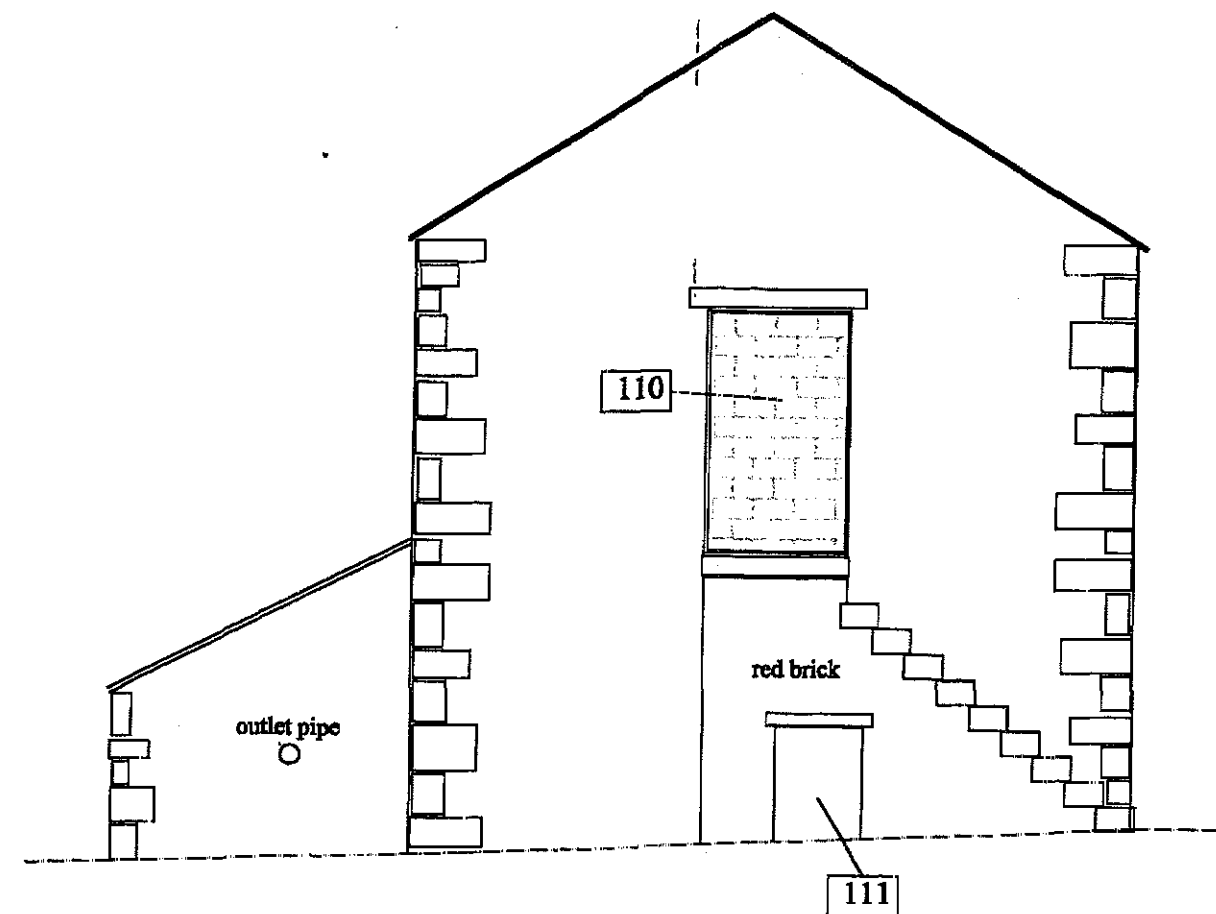
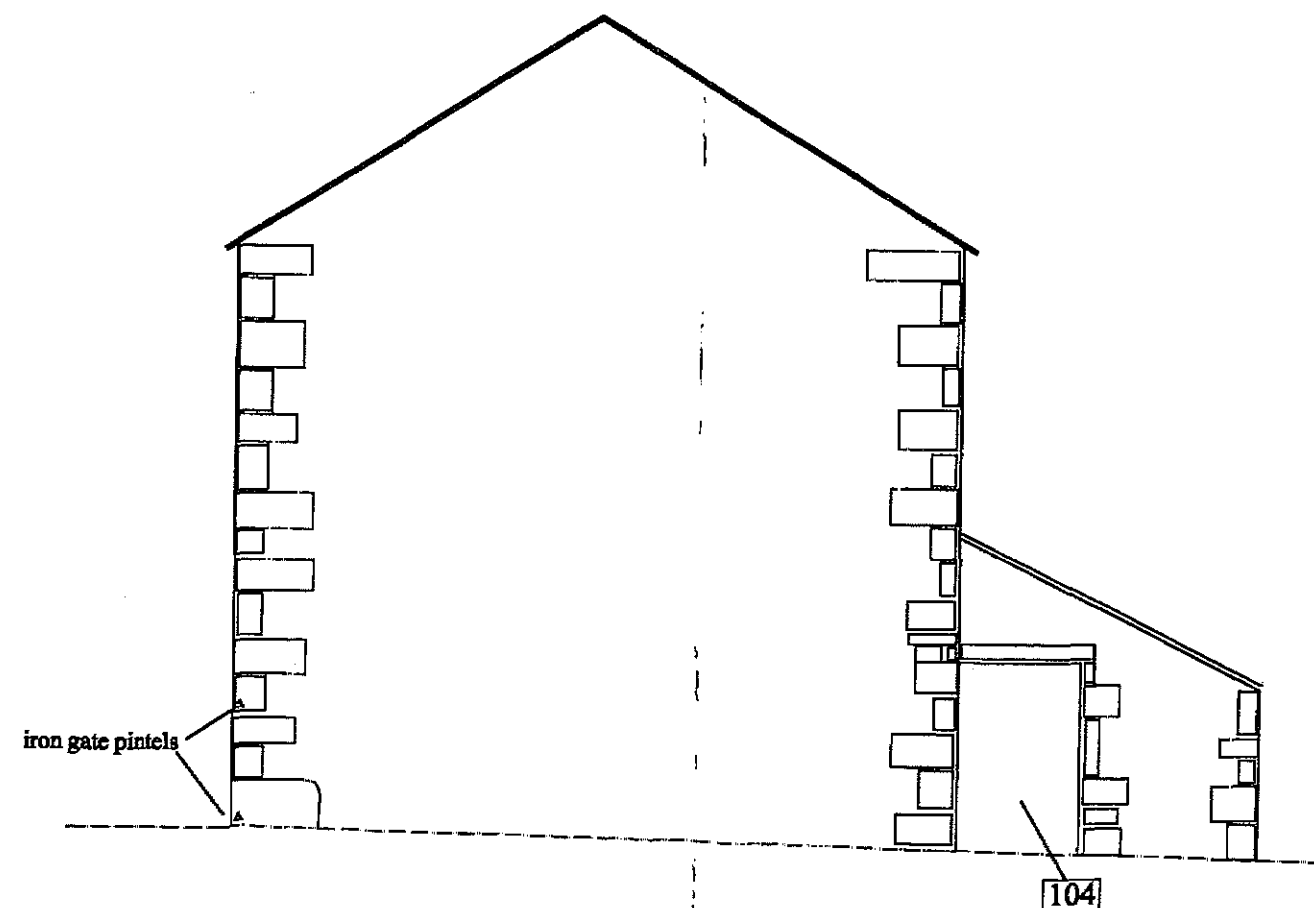
Figure 9: Cartshed showing southwest and northeast elevations

Southwest Elevation

Northeast Elevation
