## **HERITAGE STATEMENT**

**IN SUPPORT OF A PLANNING APPLICATION AND A  
LISTED BUILDING CONSENT APPLICATION TO  
CHANGE THE USE OF A BARN TO A CAFÉ AND  
VISITOR CENTRE CENTRE.**

**STEPHEN PARK, DALE HEAD, SLAIDBURN, BB7 4TS**

**Janet Dixon Town Planners Ltd.  
10A Whalley Road  
Clitheroe  
Lancashire  
BB7 1AW**

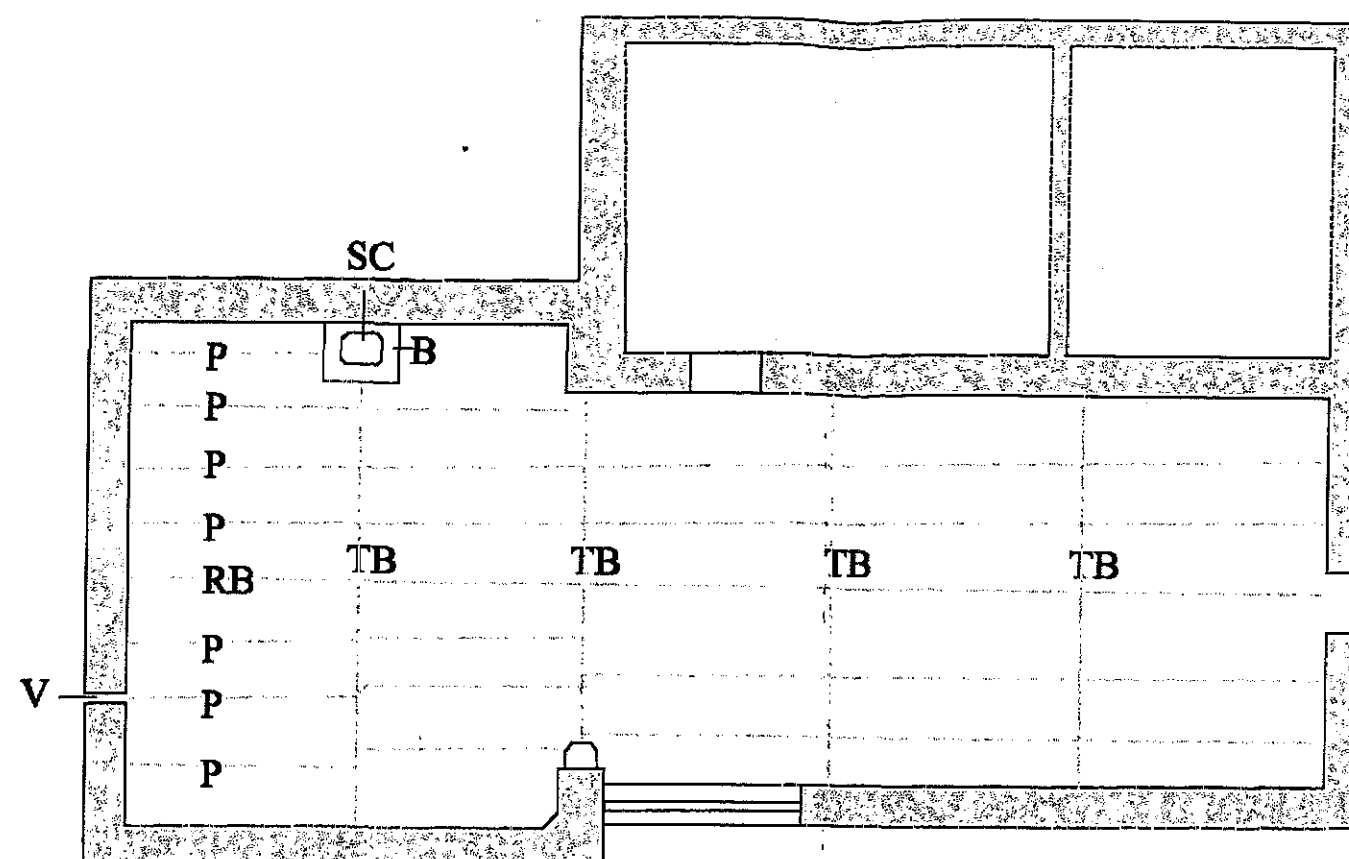
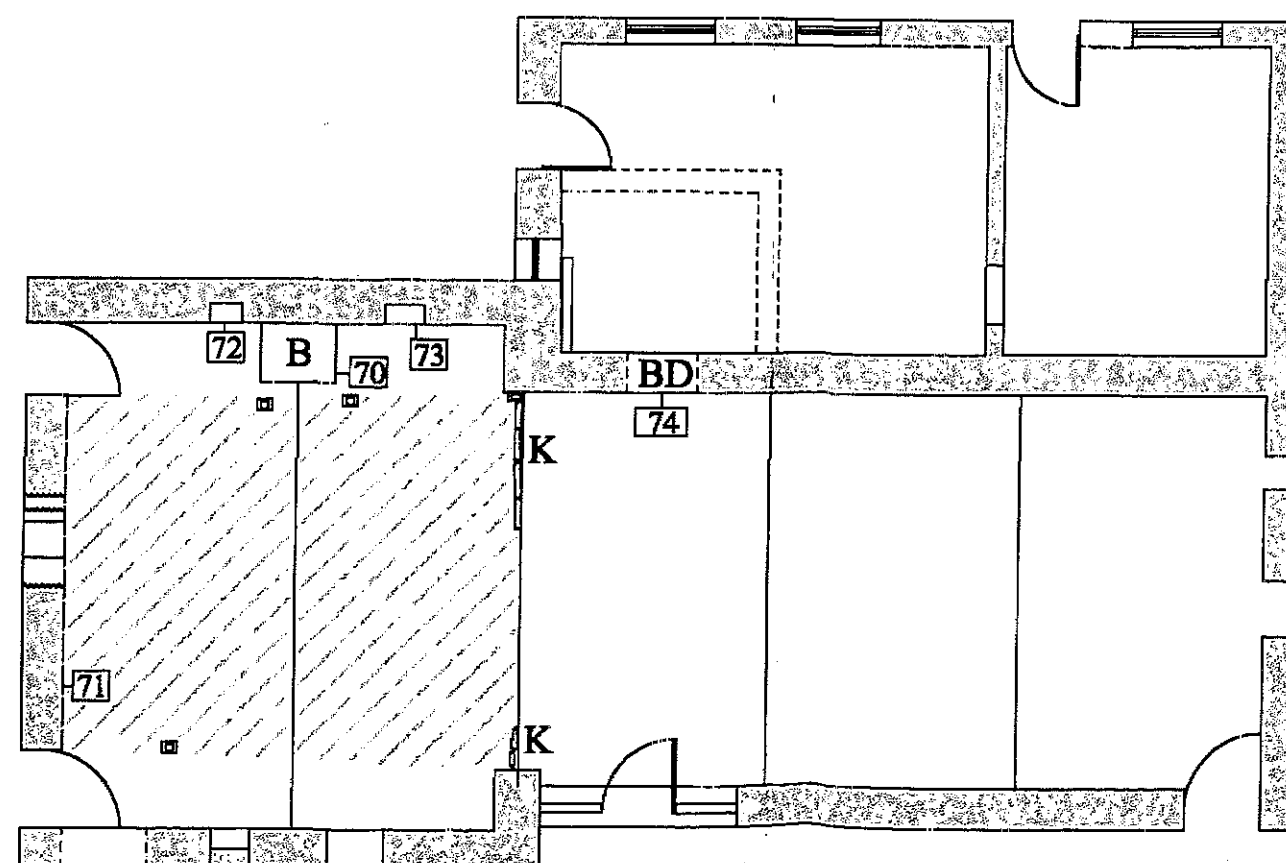
Figure 7: Ground and Upper Plans of the Old Barn

Upper Floor Plan

Ground Floor Plan

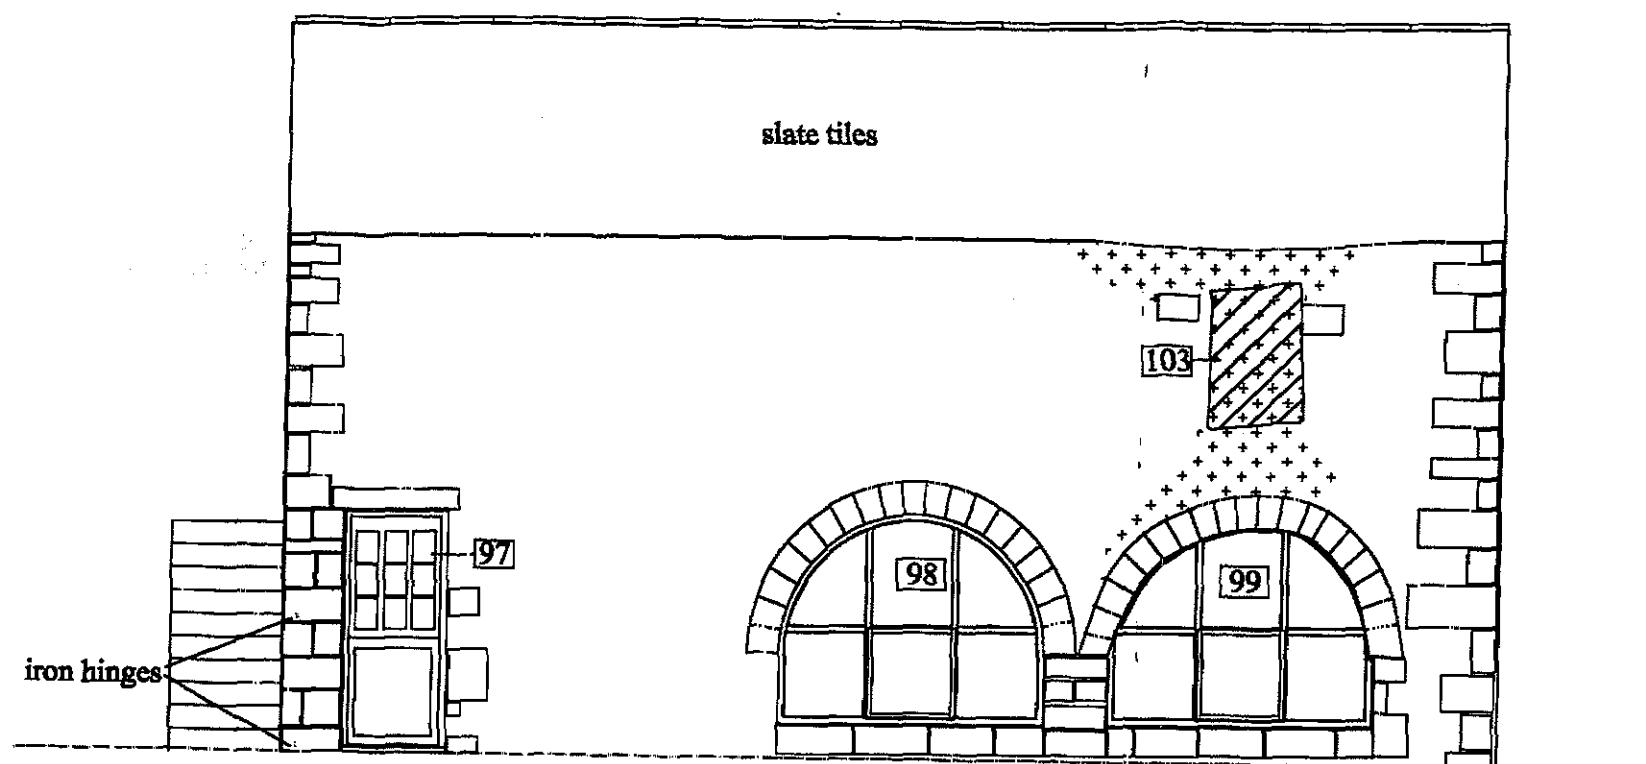
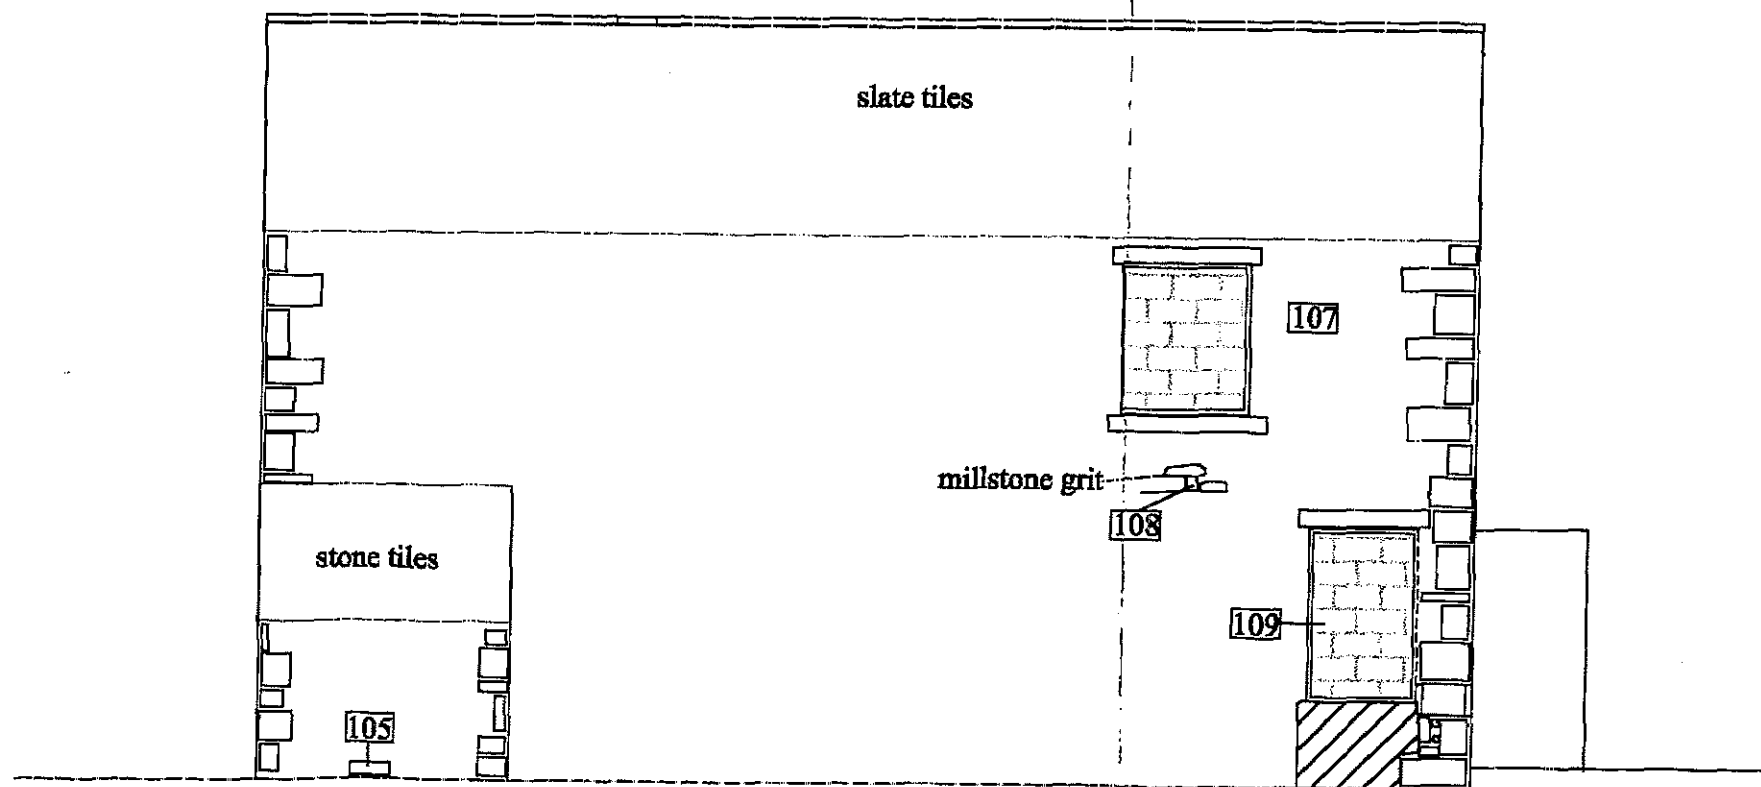
Figure 8 Cartshed showing northwest and southeast elevations

Northwest Elevation

Southeast Elevation

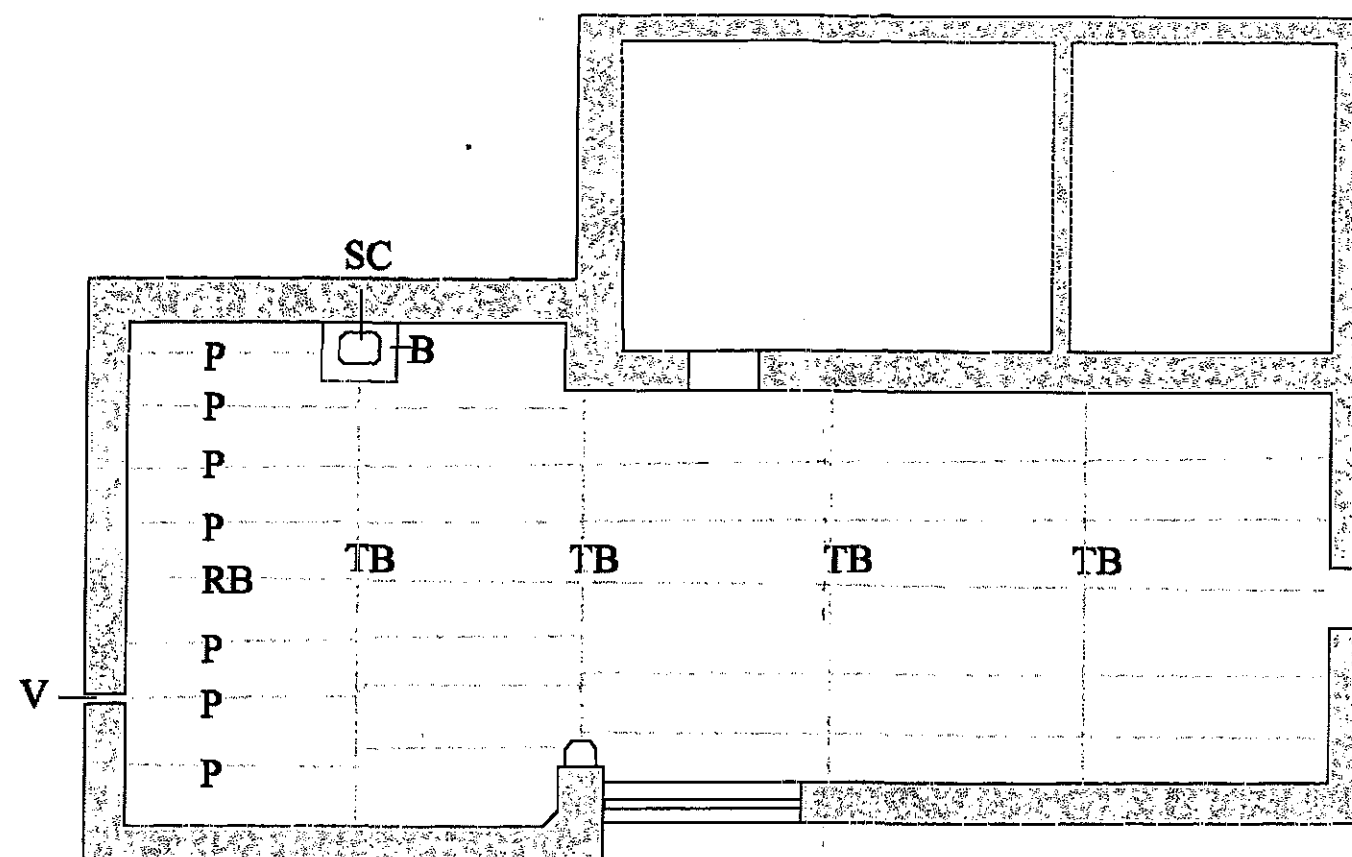
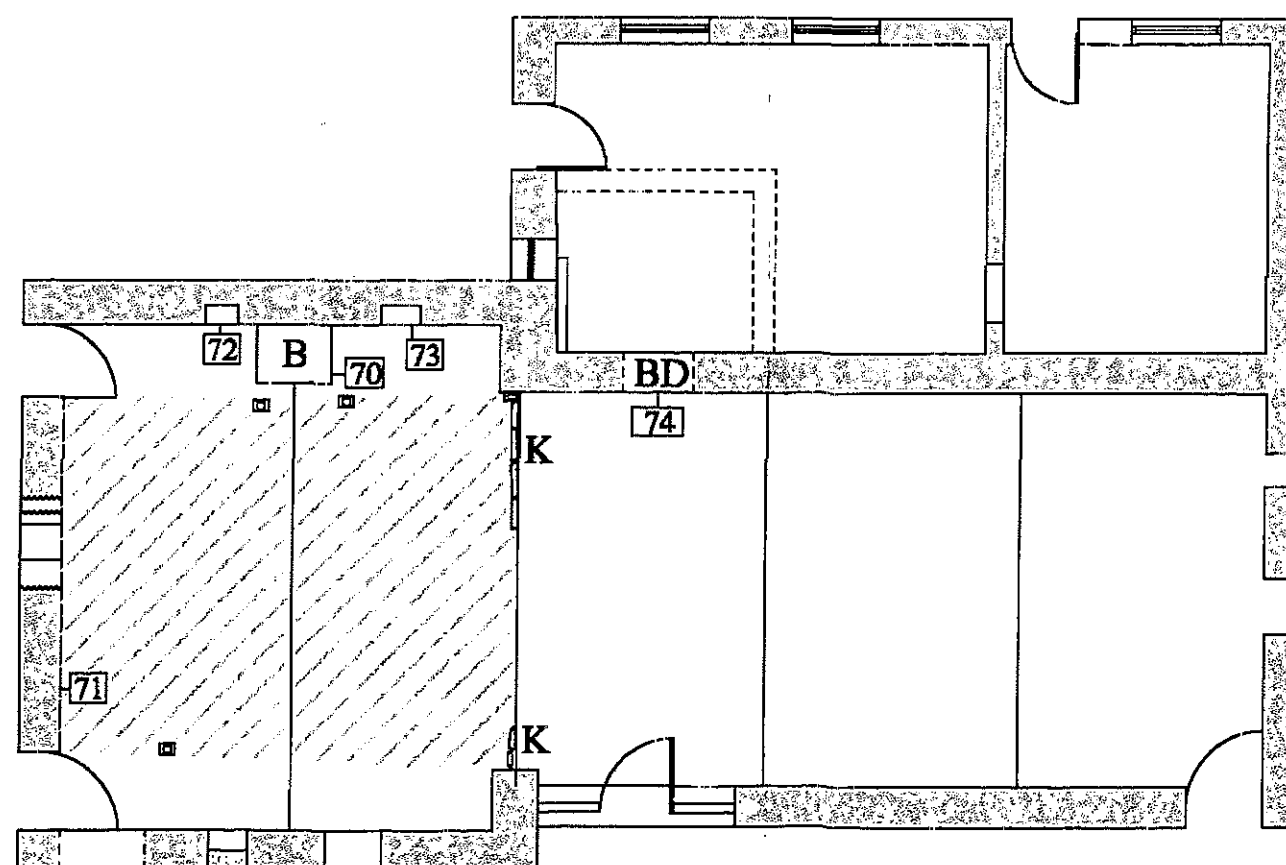
Figure 7: Ground and Upper Plans of the Old Barn

Upper Floor Plan

Ground Floor Plan

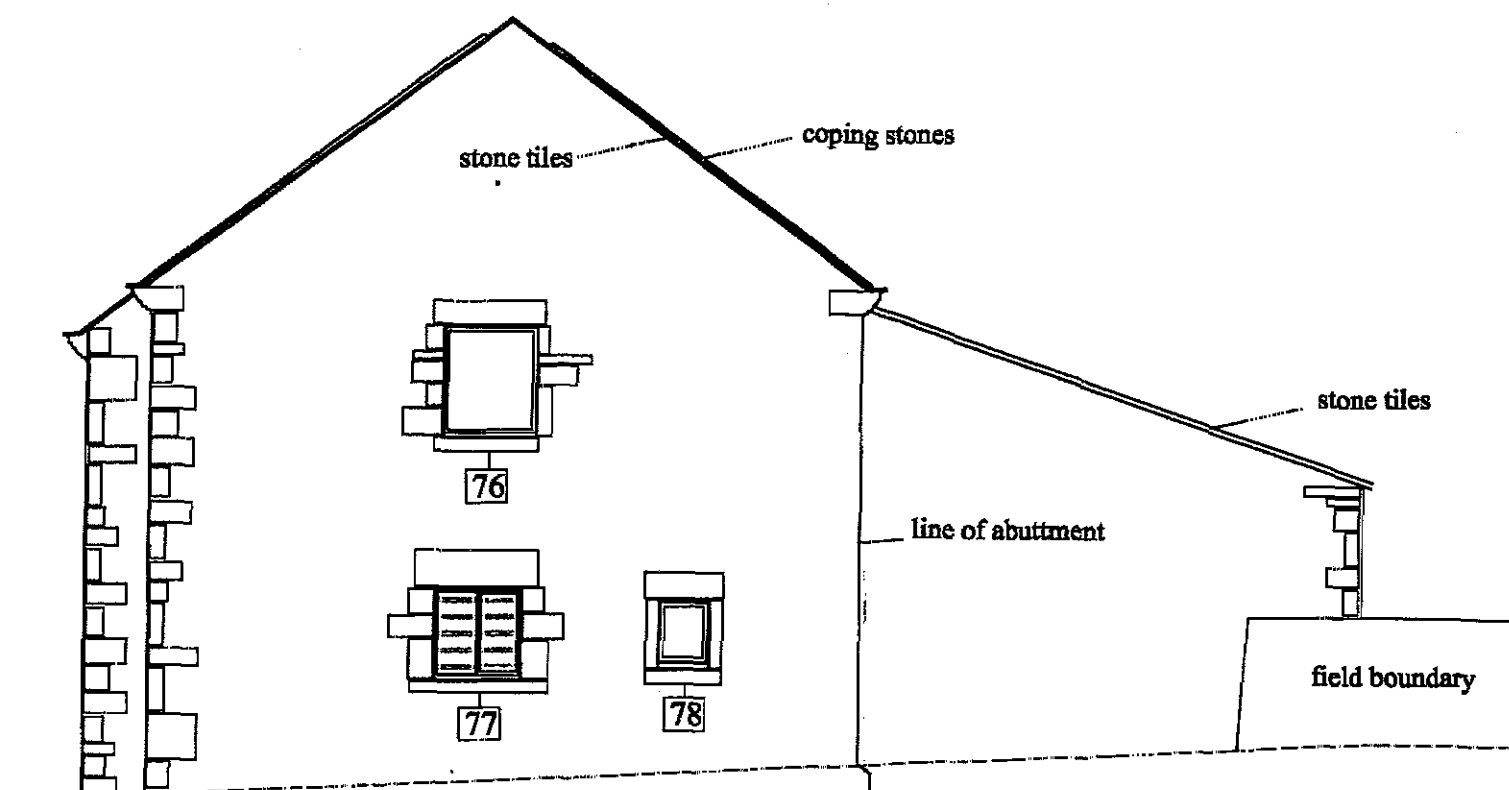
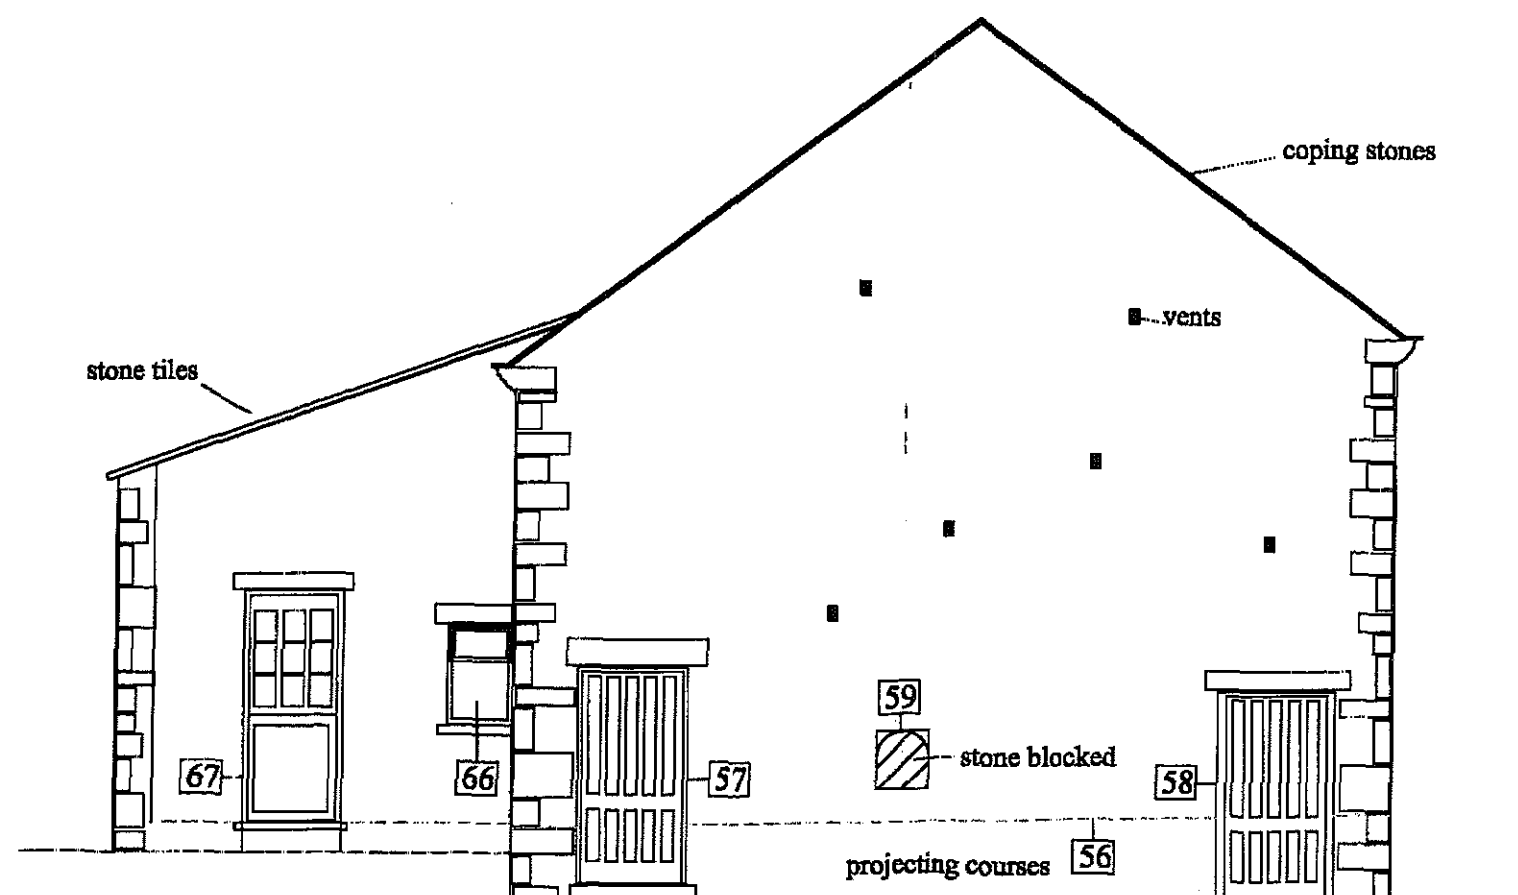
Figure 6: Old Barn showing northwest and southeast elevations

Northwest Elevation

Southeast Elevation
