Greengore

Hurst Green, Lancashire

Heritage Statement

March 2016

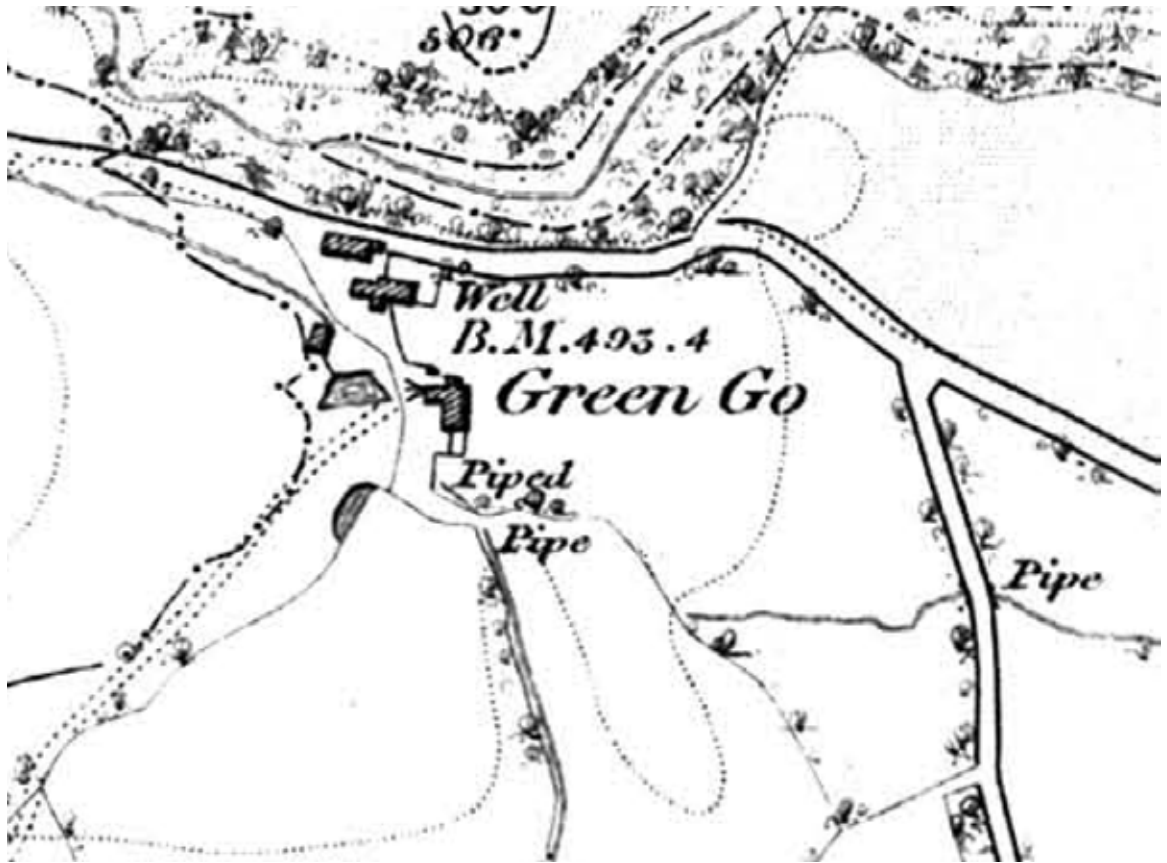
Figure 2. An extract from the first edition of the Six Inch Ordnance Survey map, surveyed in 1844.

The first edition of the six-inch Ordnance Survey map (Figure 2) was surveyed in 1844. It shows the large barn dated '1818' that lies approximately 50 metres to the south-east of the house and which is not included in the current application, and what is now the cottage and camping barn to the north. It shows the outline of the house extending further to the west than at present. However, architectural evidence, discussed below, makes it unlikely that the present house is the surviving wing of a larger building, and John Weld's undated drawing (Figure 1) shows a porch that was demolished later in the 19th century, but does not show any building to the west. It therefore seems likely that the building adjoining to the west of the house shown on the map was added at some time between the date of the drawing in the early 19th century and 1844, and demolished before the twenty-five inch Ordnance Survey map was surveyed in 1891-2 (Figure 3). The alterations to the the farm building that is now the camping barn and cottage date from the early / mid 19th century, and it is possible that a farm building was added to the west end of the house at around the same time.

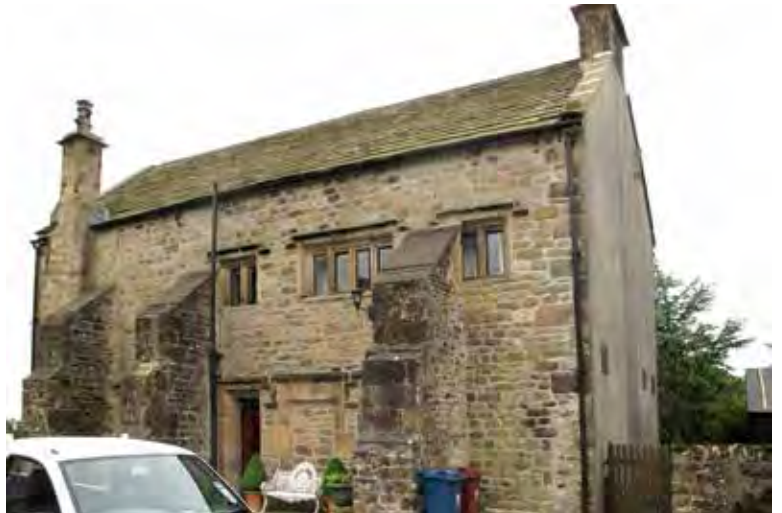
Photograph 15. The north side of the house. The corbelled chimney served a first floor fireplace that is now covered and may have been removed. There are fewer first floor windows on this side of the house and they lack transoms.

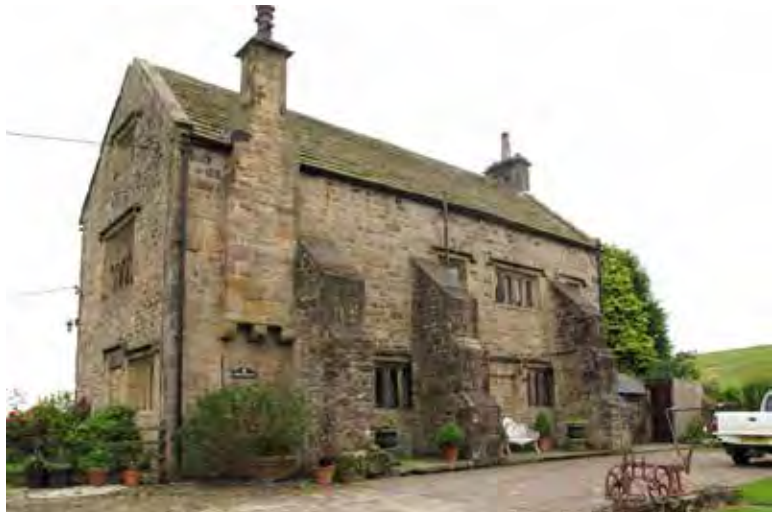
Photograph 16. The blocked doorway probably dates from later in the 17th century. Its hood mould is moulded and it seems to have been inserted between two existing windows.

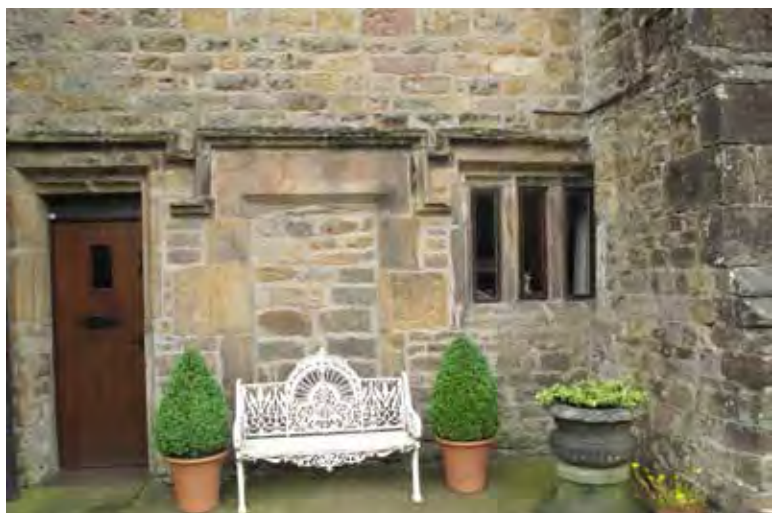
Photograph 17. Traces of a thin lime coating are visible on a few of the stones. Originally the rubble stonework would have been covered by a thin coating of lime roughcast and limewash.

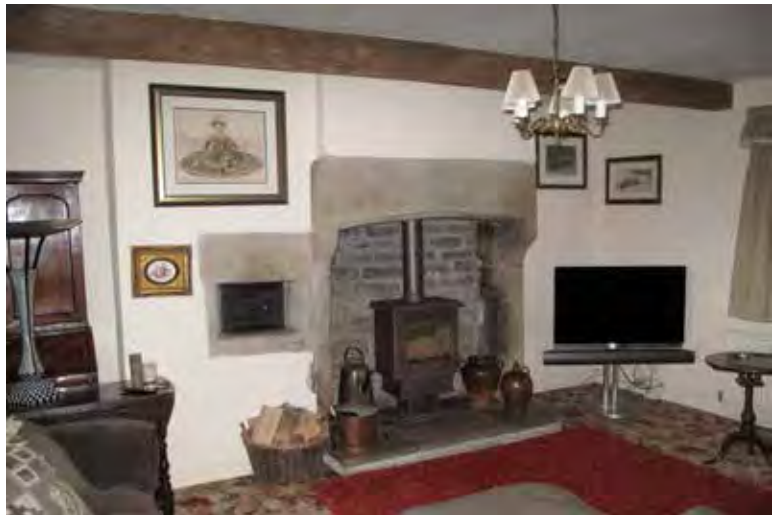
Photograph 22. The bressumer beam in front of the fireplace shows clear evidence that it was once part of a timber firehood: it has mortice holes for wattle staves and is only chamfered on one side.

The building has a number of unusual features. In the living room there is a ceiling beam in front of the fireplace that is chamfered on the side facing the room but only has a short section on the side facing the gable, close to the southern wall, that is chamfered, with stops at both ends. The remainder of the beam has a row of mortice holes for staves on its underside. This suggests that there was originally a large timber wattle and daub and plaster firehood at this end of the room, with a lower bressumer beam that is now missing and a short side wall or spere that is also now missing. This side wall would have formed a lobby inside the main door (now blocked) in the south wall and the firehood would have provided a large hearth area for cooking.

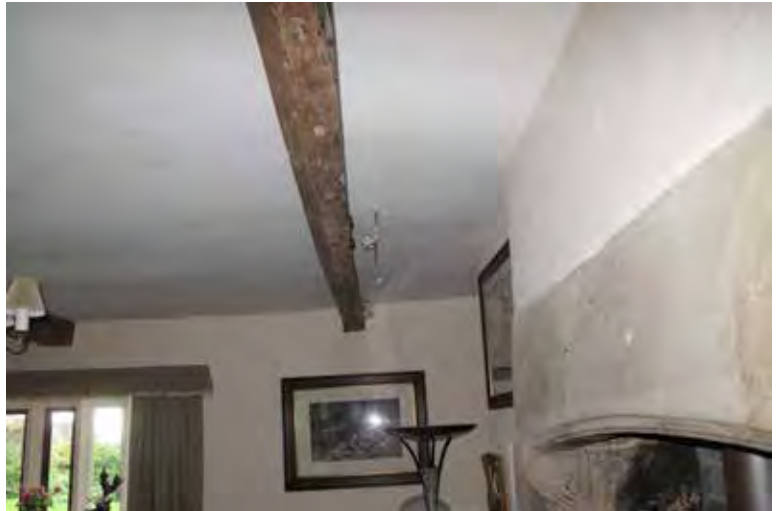
Photograph 23. At the southern end of the beam there is a chamfer with stops at both ends facing the gable wall. This is evidence that there was originally an entrance lobby here.

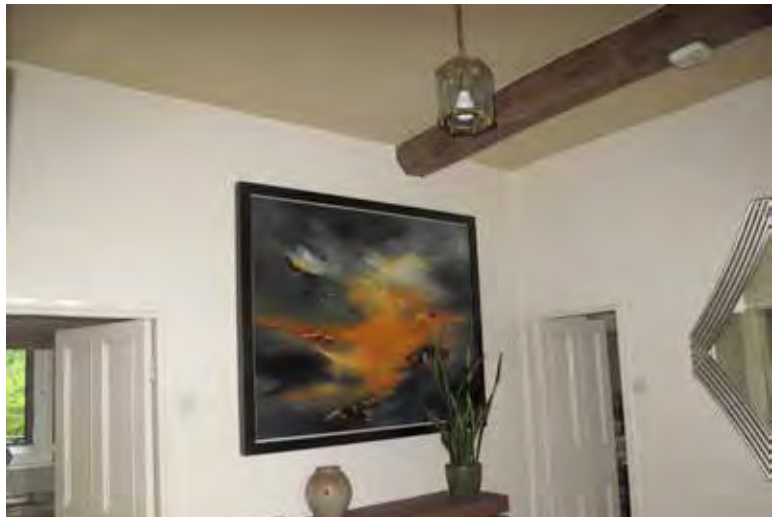
Photograph 26. The south-western bedroom. The chimney breast dates from the later 19th century alterations but the fireplace opening has now been bricked up.

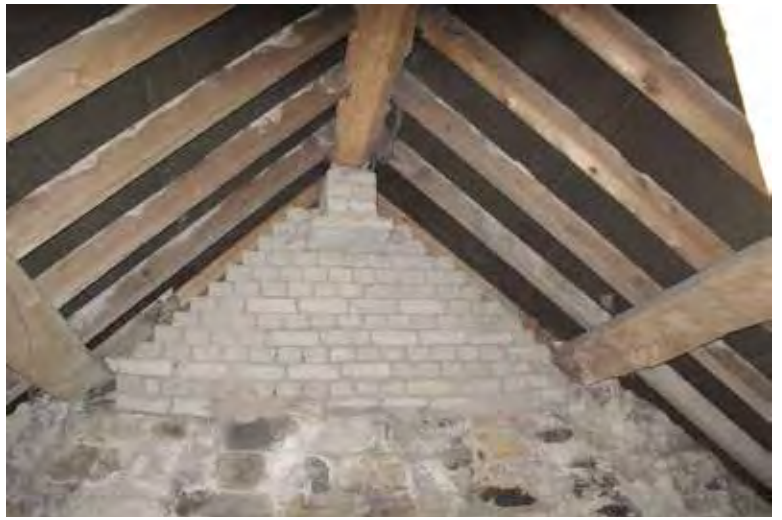
Photograph 30. The chimney breast against the west gable is brick and dates from the later 19th century.

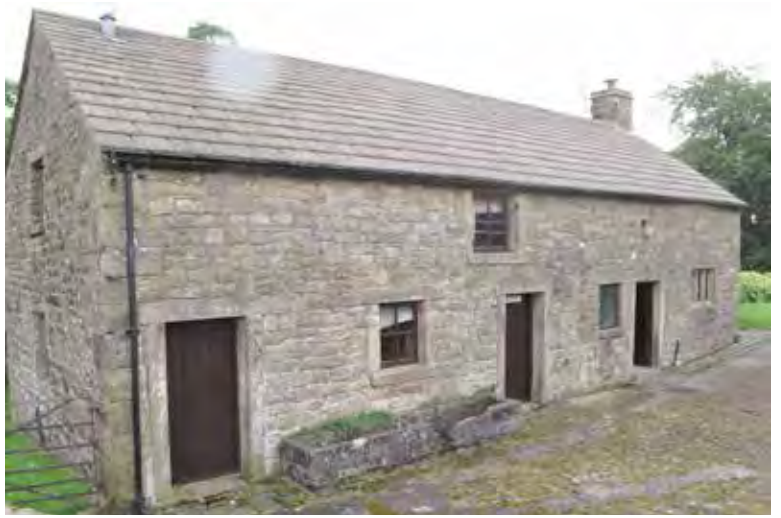
Photograph 34. The windows in the west gable wall appear to have been inserted as part of the conversion to a camping barn.

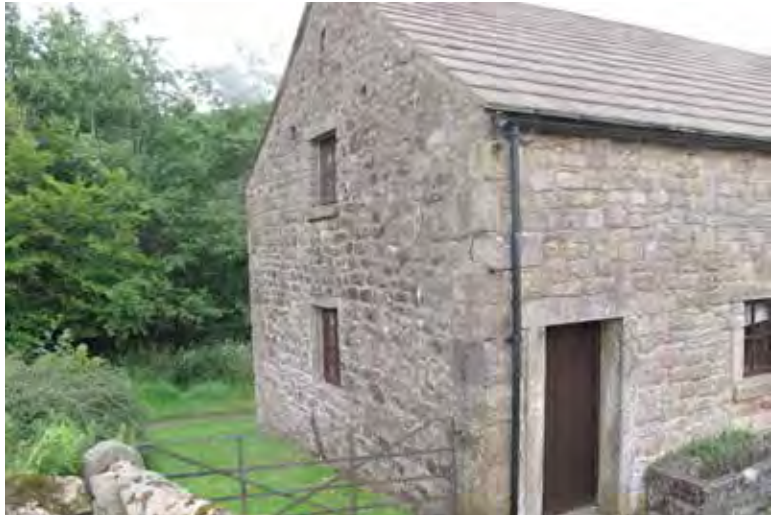
Photograph 35. The north side of the former shippon. Some lime mortar pointing and some of the original breather holes remain.

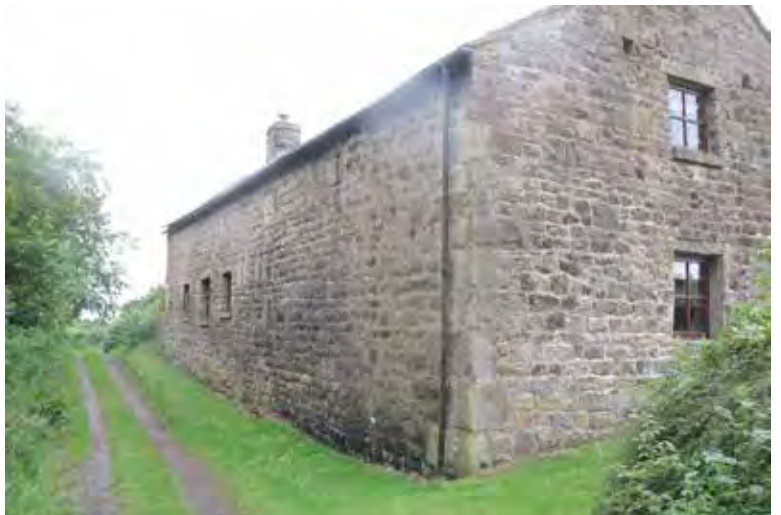
Photograph 36. The north side of the former shippon. The window openings appear to have been inserted when this end of the building was converted into a holiday cottage.

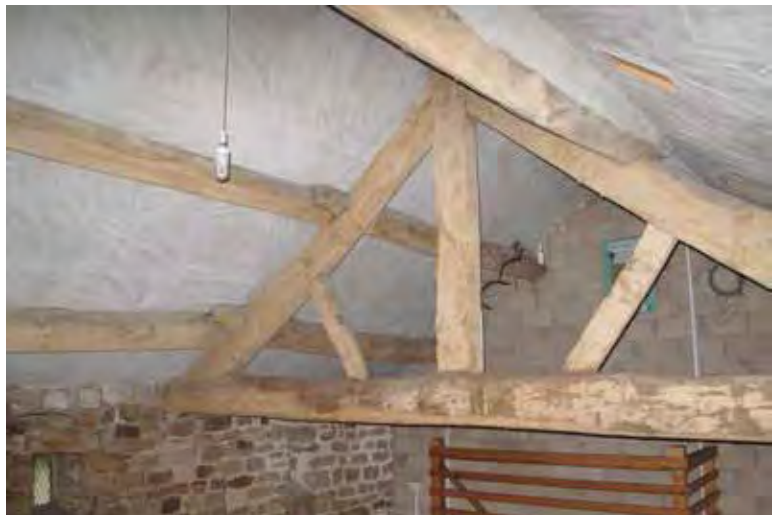
Photograph 40. The first floor in the central store is a later 20th century insertion.

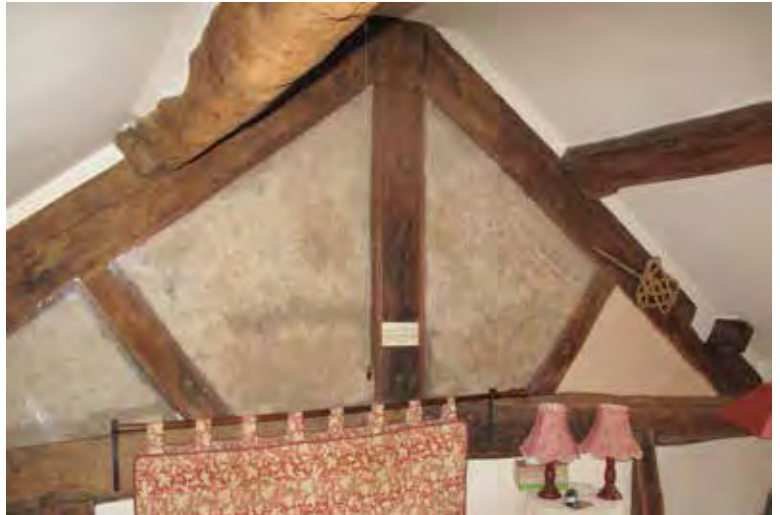
Photograph 43. The middle roof truss, visible in a first floor storage loft.
