# HERITAGE STATEMENT

**PROPOSED REFURBISHMENT WORKS AT WARDSLEY FARMHOUSE,  
BOWLAND WITH LEAGRAM, LANCASHIRE, PR3 2QT**

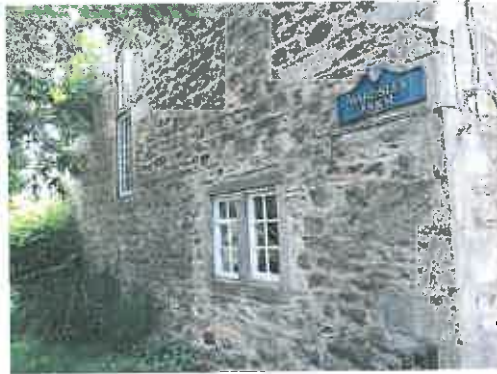
*Figure 1 - stairway window with semi-circular head*

The farmhouse's distinctive architectural feature is the stairway window with semi-circular head which is located on the East gable wall facing the roadside. This is an integral part of the internal space as it provides natural light to the ground floor hall, stairs and landing. Chipping Conservation Area is characterized by stone historic buildings of traditional construction dating mainly from the late 17th century to the early 19th century and Wardsley farmhouse is in keeping with traditional materials and construction forms. Stone walls, dressed stone quoins, stone windows and stone door architraves are commonplace to surrounding areas.
