RICS
Building Survey

Newton Hall
Newton In Bowland
CLITHEROE
Lancs
BB7 3DY

21 July 2016

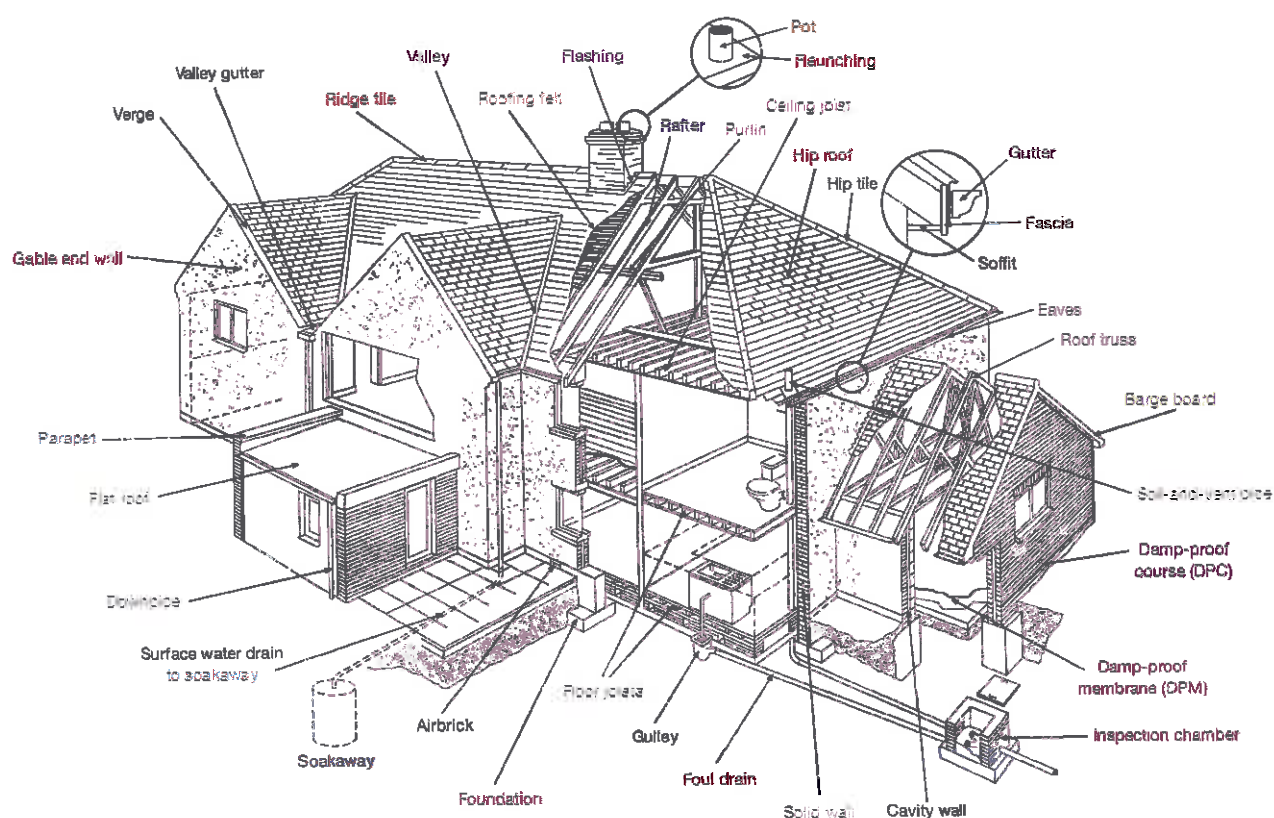
Typical house diagram

This diagram illustrates where you may find some of the building elements referred to in the report.
