STANWORTH HOUSE
Design, Access and Supporting Statements

Design, Access and Supporting Statements

Planning Documentation

September 2017

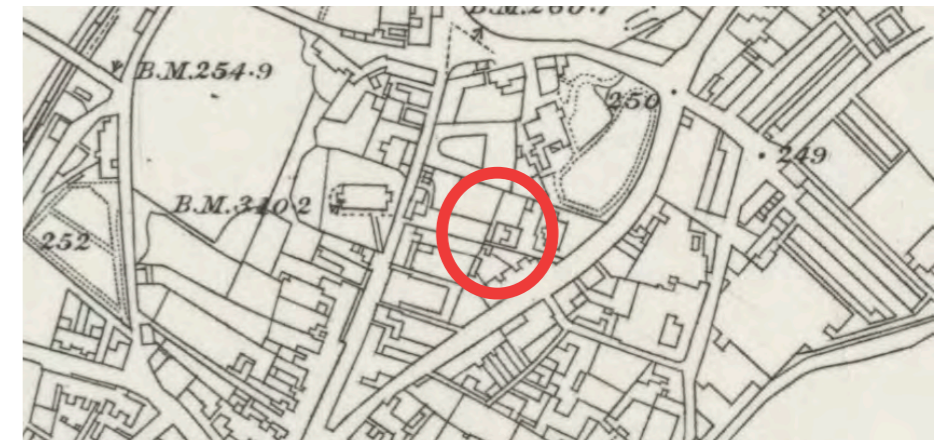
Plan from 1890, showing possible original 'T' shaped planform.

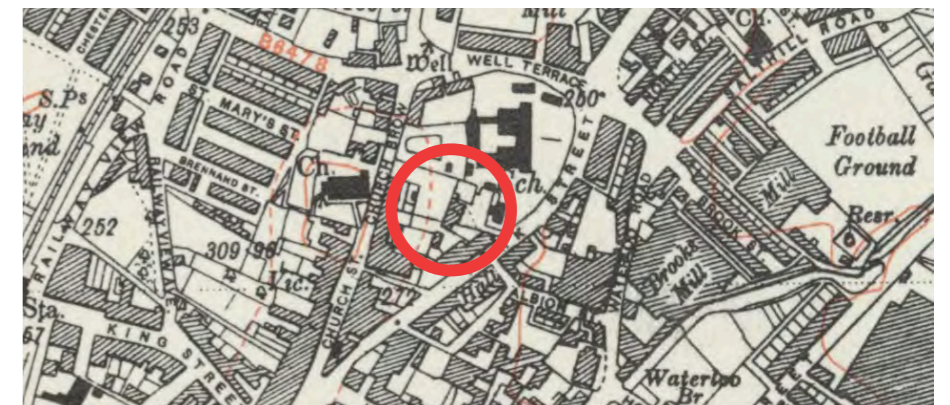
Plan from 1938, showing current property.

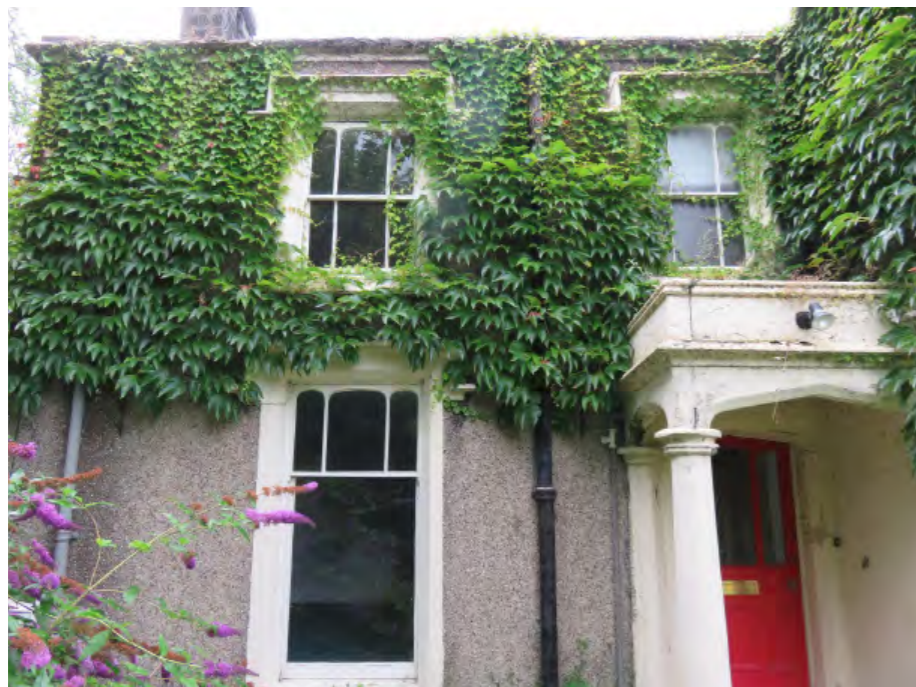
Overgrown ivy on East elevation and entrance porch.

The creepers are causing water retention problems and it is recommended that they are removed or severely cut back. The leaves over the summer period have been concealing the cement render and on close inspection there may be a need to undertake patch repairs to render when the creeper is removed. Cement render is not ideal for use on traditional stone buildings. Ideally in the future the cement render should be replaced with a breatheable render.

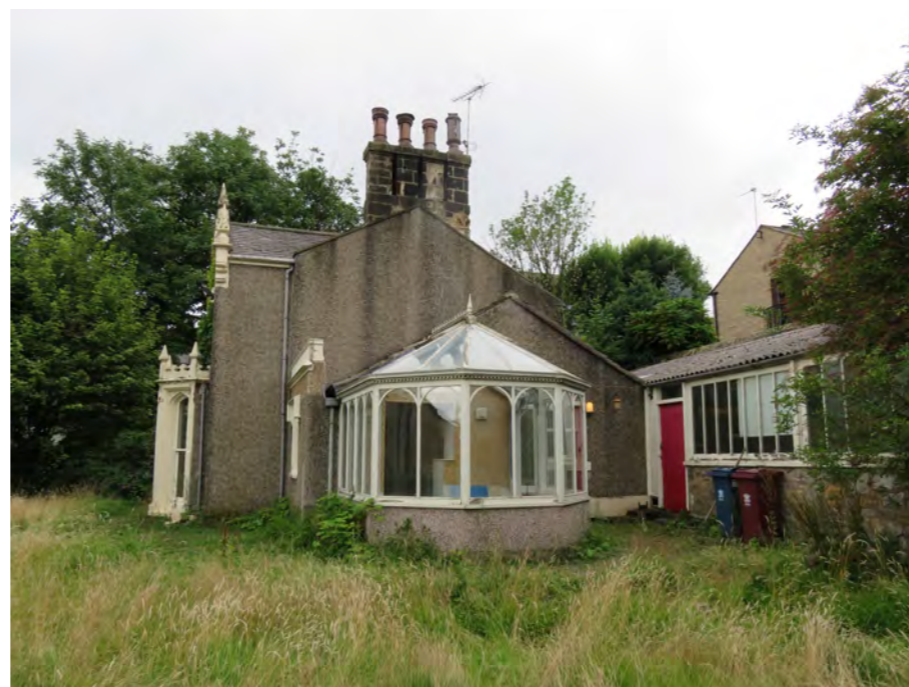
North end elevation, showing conservatory and garden room against West boundary wall.

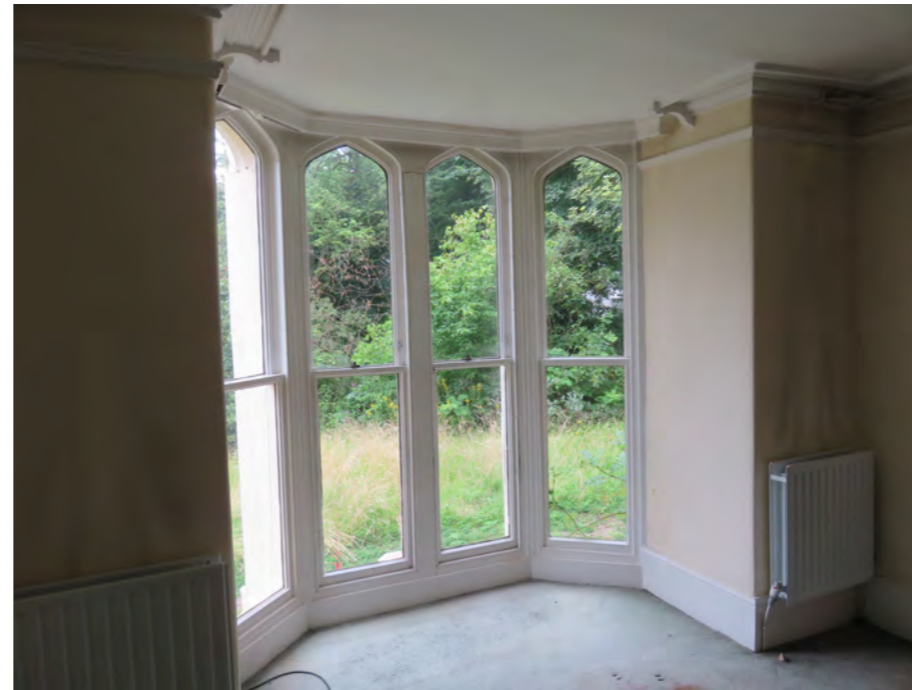
Existing full height front bay window.

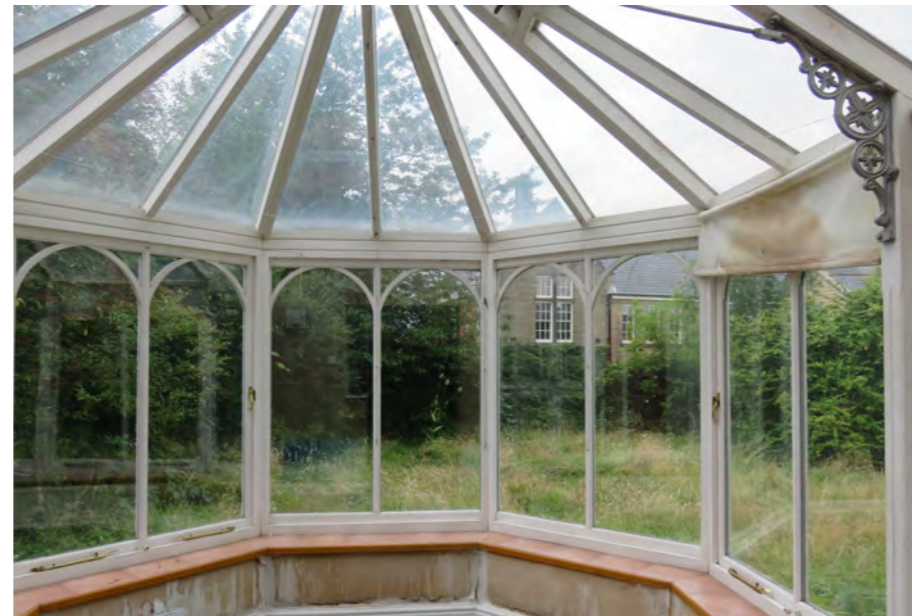
Existing Amdega conservatory, circa early 1980s.

In response to the pre-application advice the repair works remain unchanged, the kitchen door, as welcomed, will be reinstated and the conservatory will be removed to the benefit of the asset.

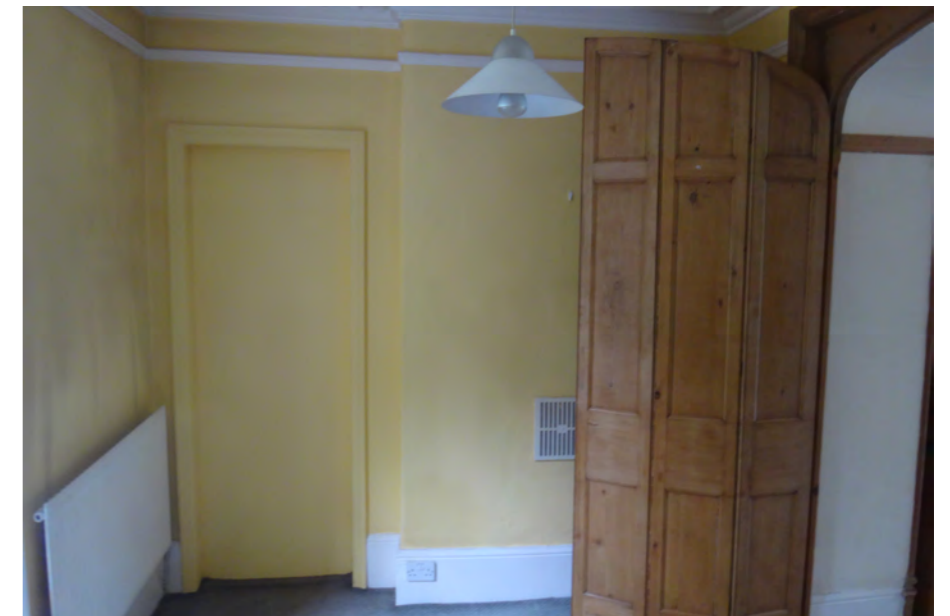
Existing infilled opening in rear Dining Room

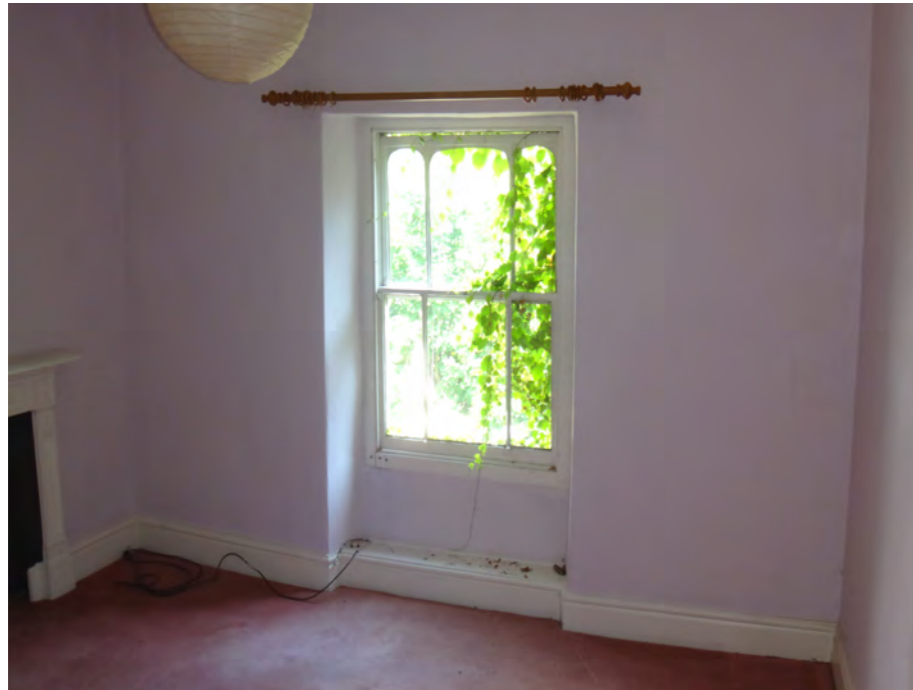
Poorly fitting sash window in front Bedroom, with vegetation ingress.

a capacity which is too small and has been blocking. The lack of any heating in cold and damp weather is causing further deterioration of the internal joinery. The windows and doors need a detailed schedule of repairs and in some cases replacement of the window frames.

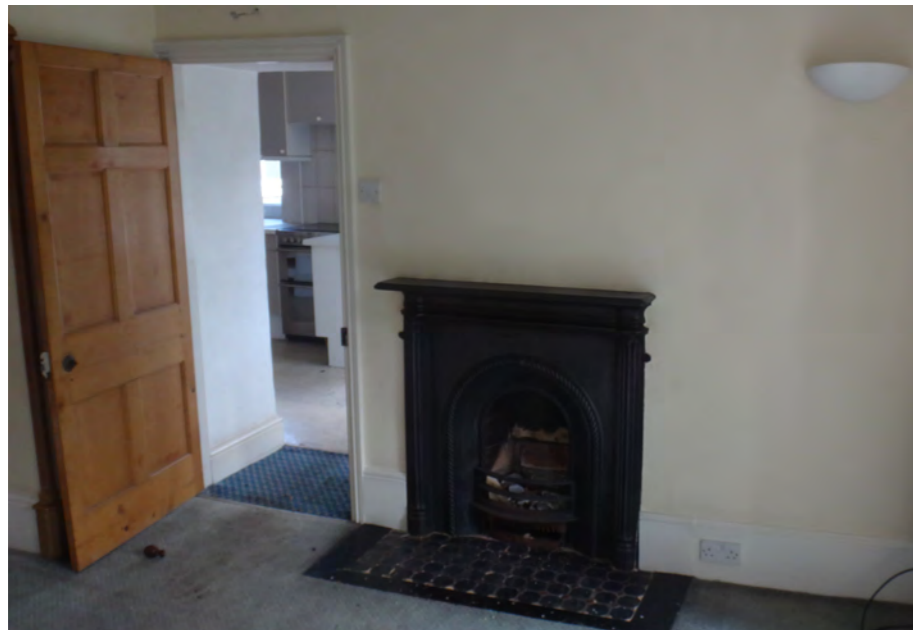
Existing door from Dining Room to Kitchen (to be infilled on Kitchen side, with recess or cupboard retained on Dining Room side).

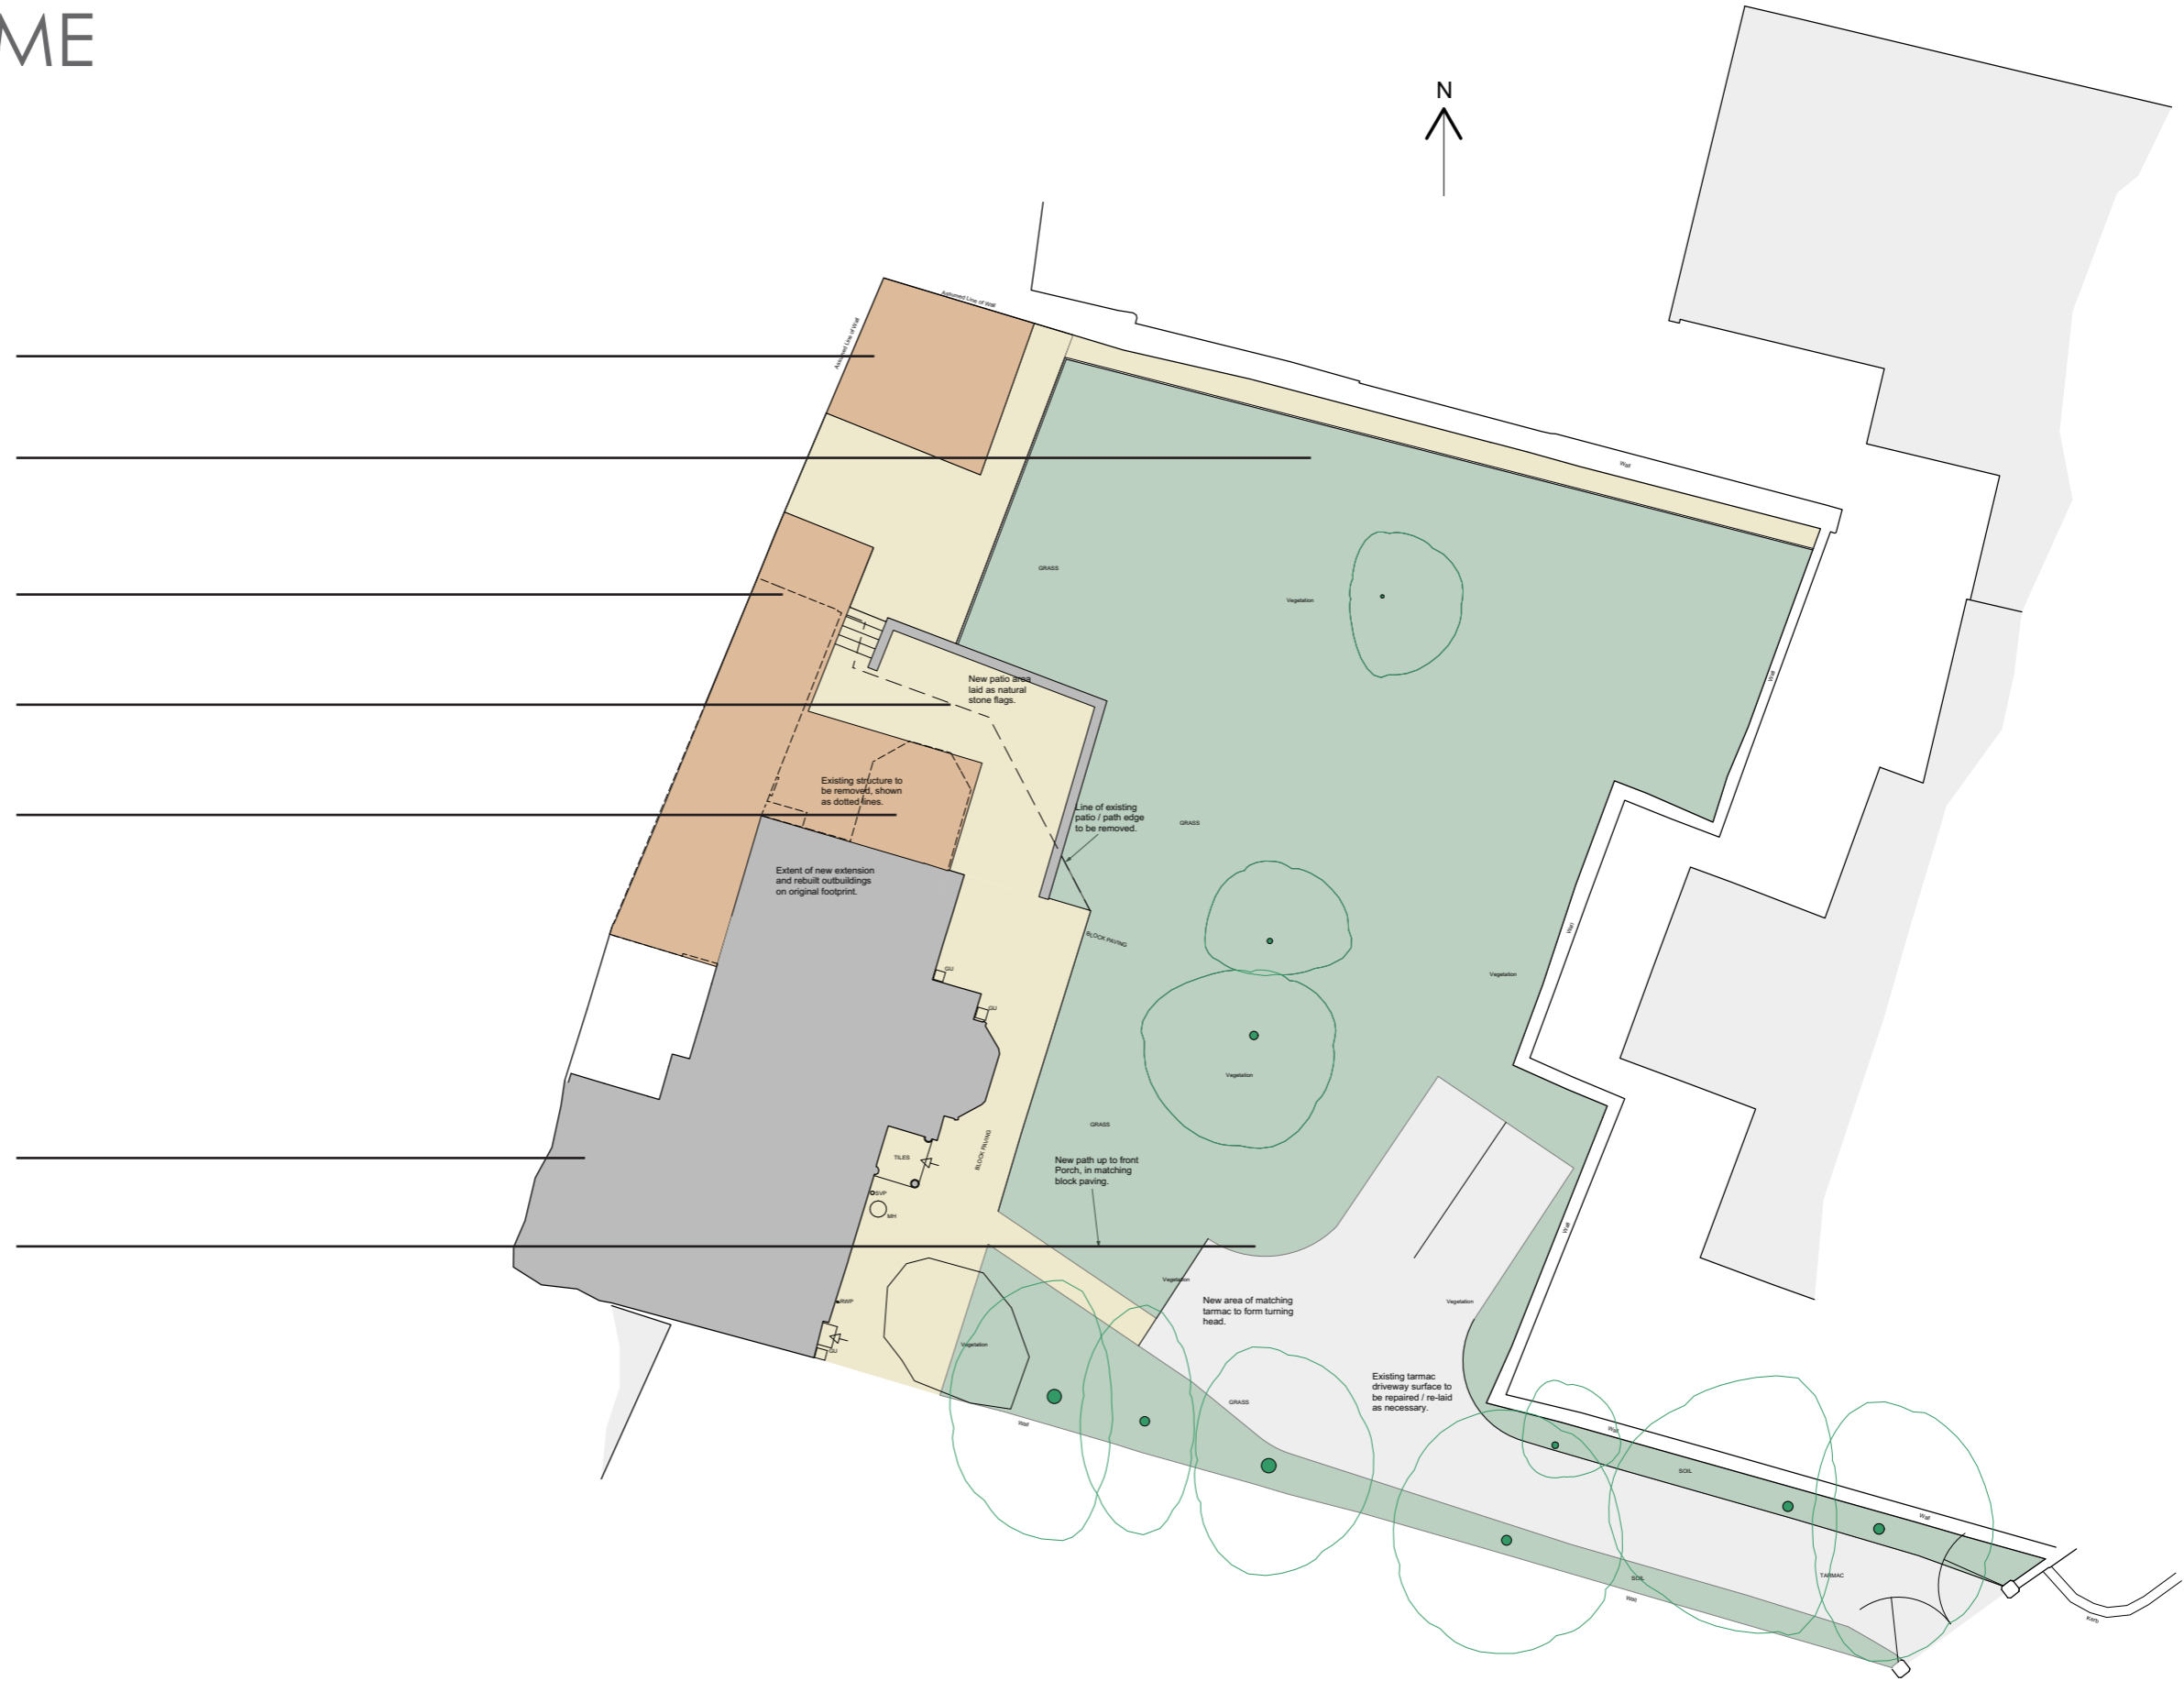
2.5 Site Plan:

REAR EXTENSION

NEW DRIVE LAYOUT

The scheme increases the footprint of the existing structures (house, conservatory and outbuildings) by less than 10% with only 16sqm additional footprint. The 27sqm garage has also been replaced with a 23sqm workshop reducing the impact of the garden structures.

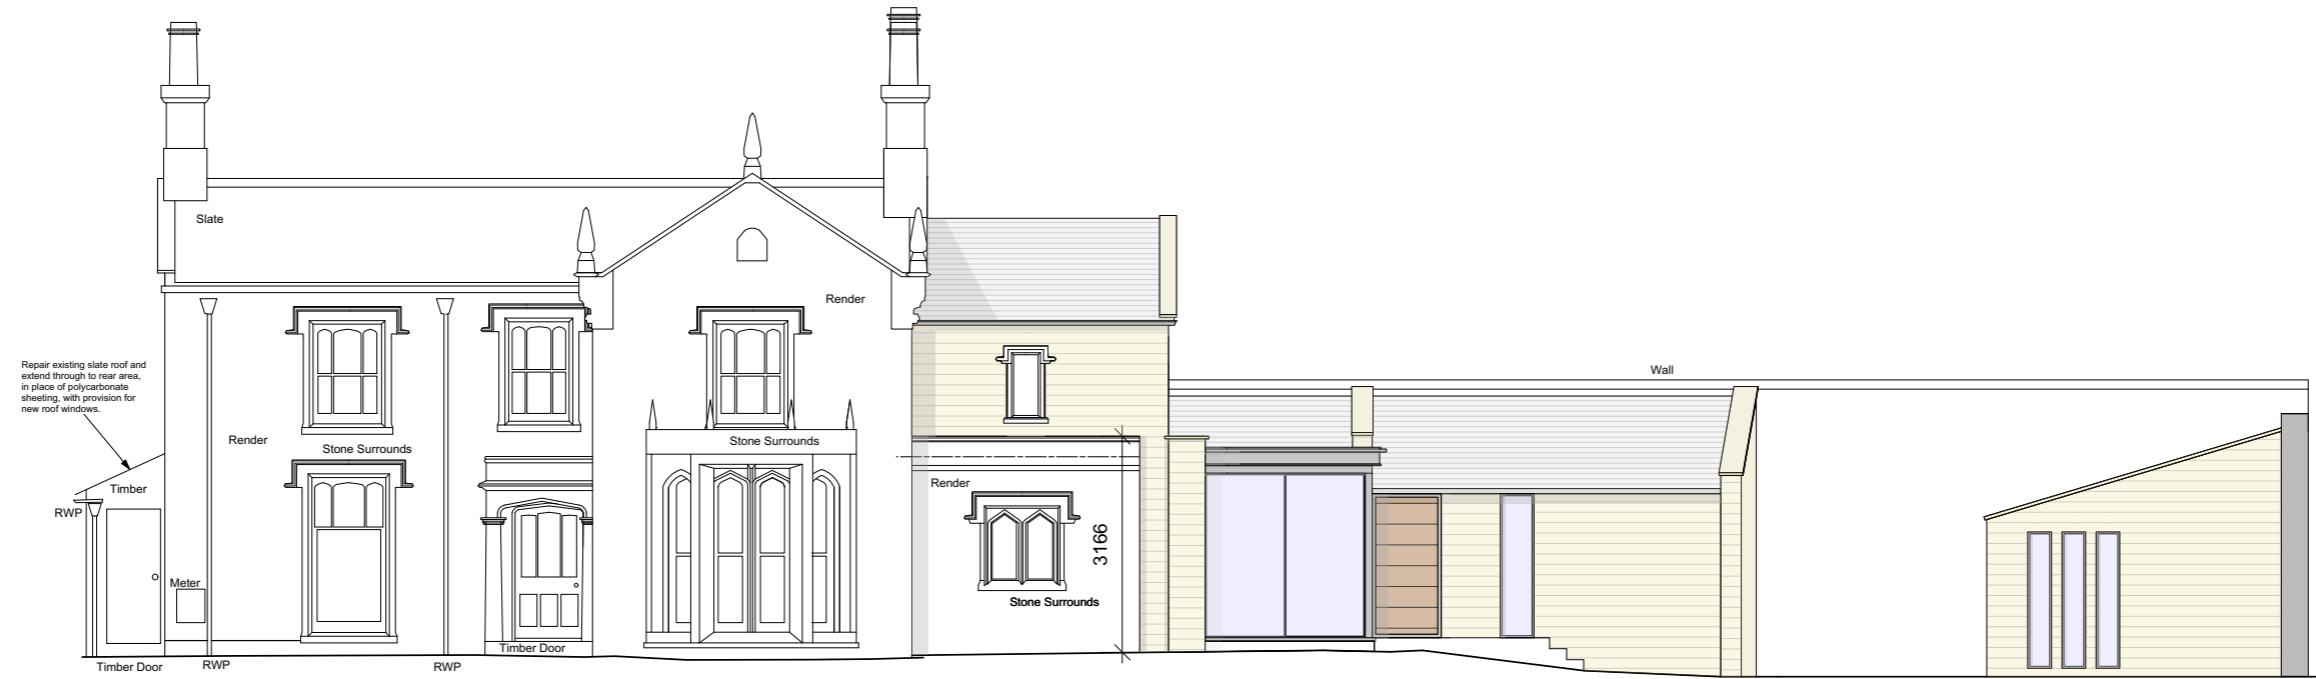
East Elevation

▼ 80.00m above OS Datum
